**Coddle Creek Tributary  
(Indian Run) Stream Restoration  
EEP Project # 94**

**Monitoring Report Year 1 of 5  
Cabarrus County, North Carolina**

HDR Engineering, Inc. of the Carolinas  
3733 National Drive, Suite 207  
Raleigh, NC 27612-4845

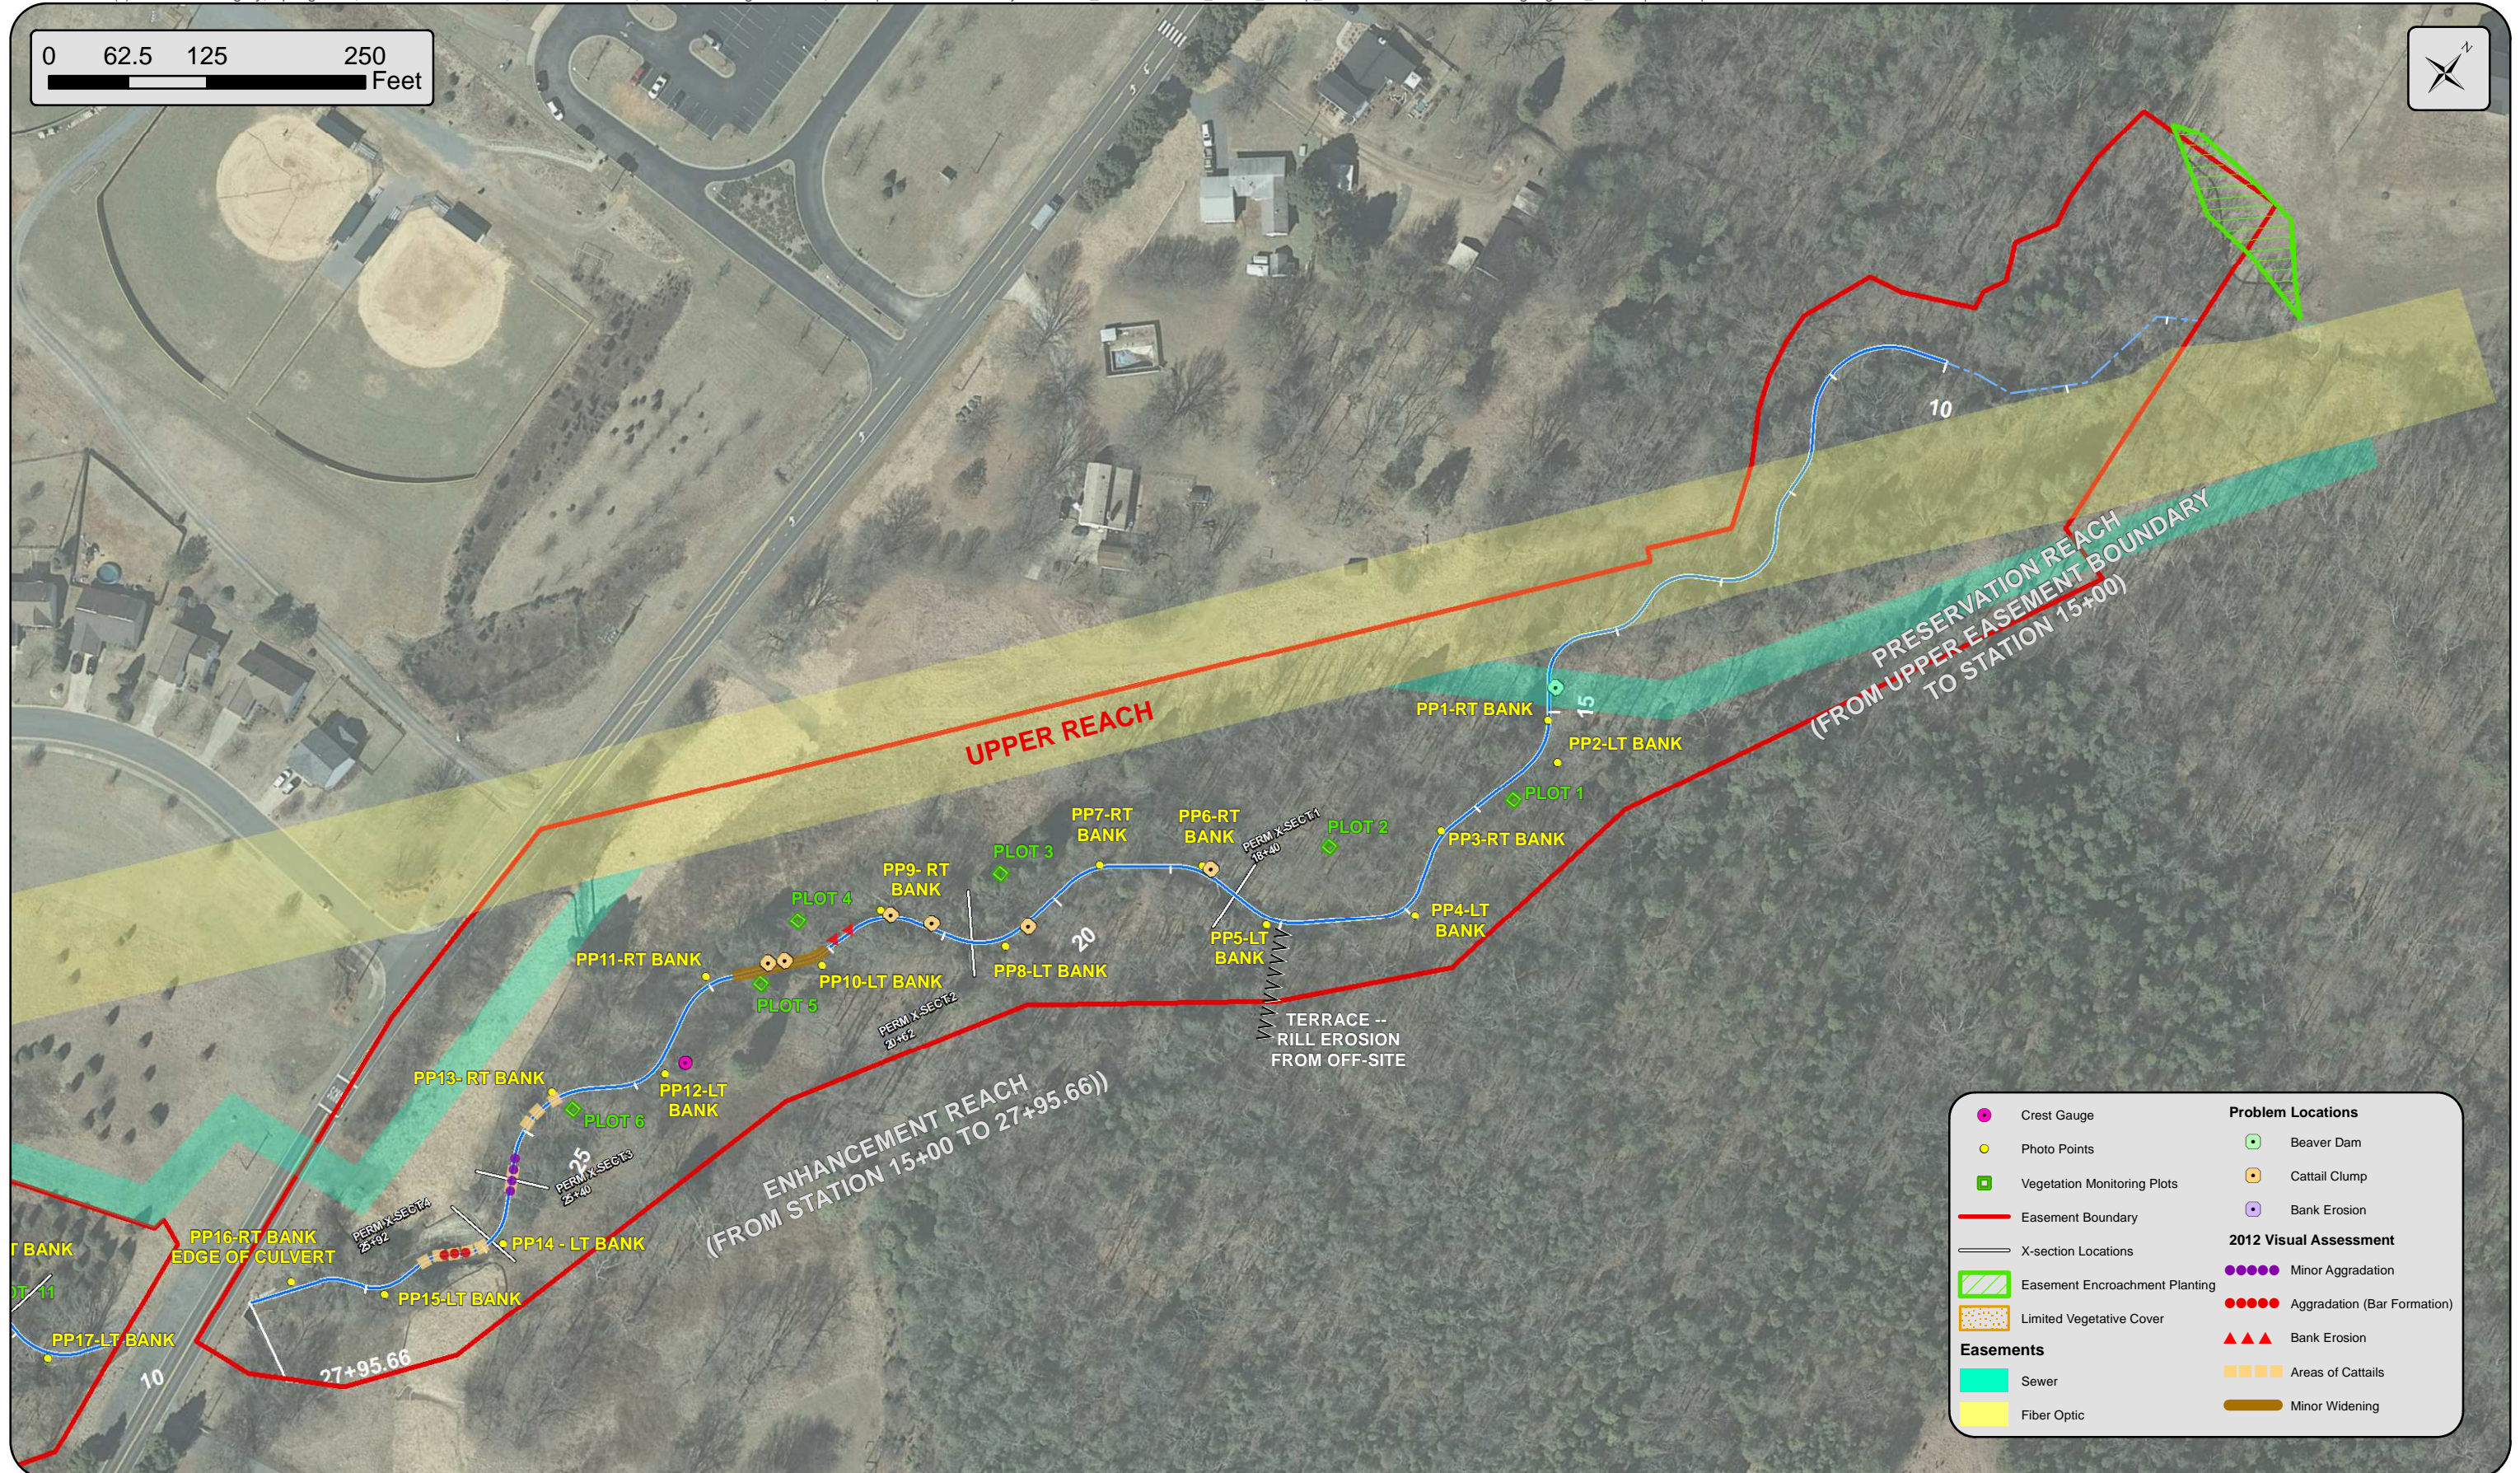
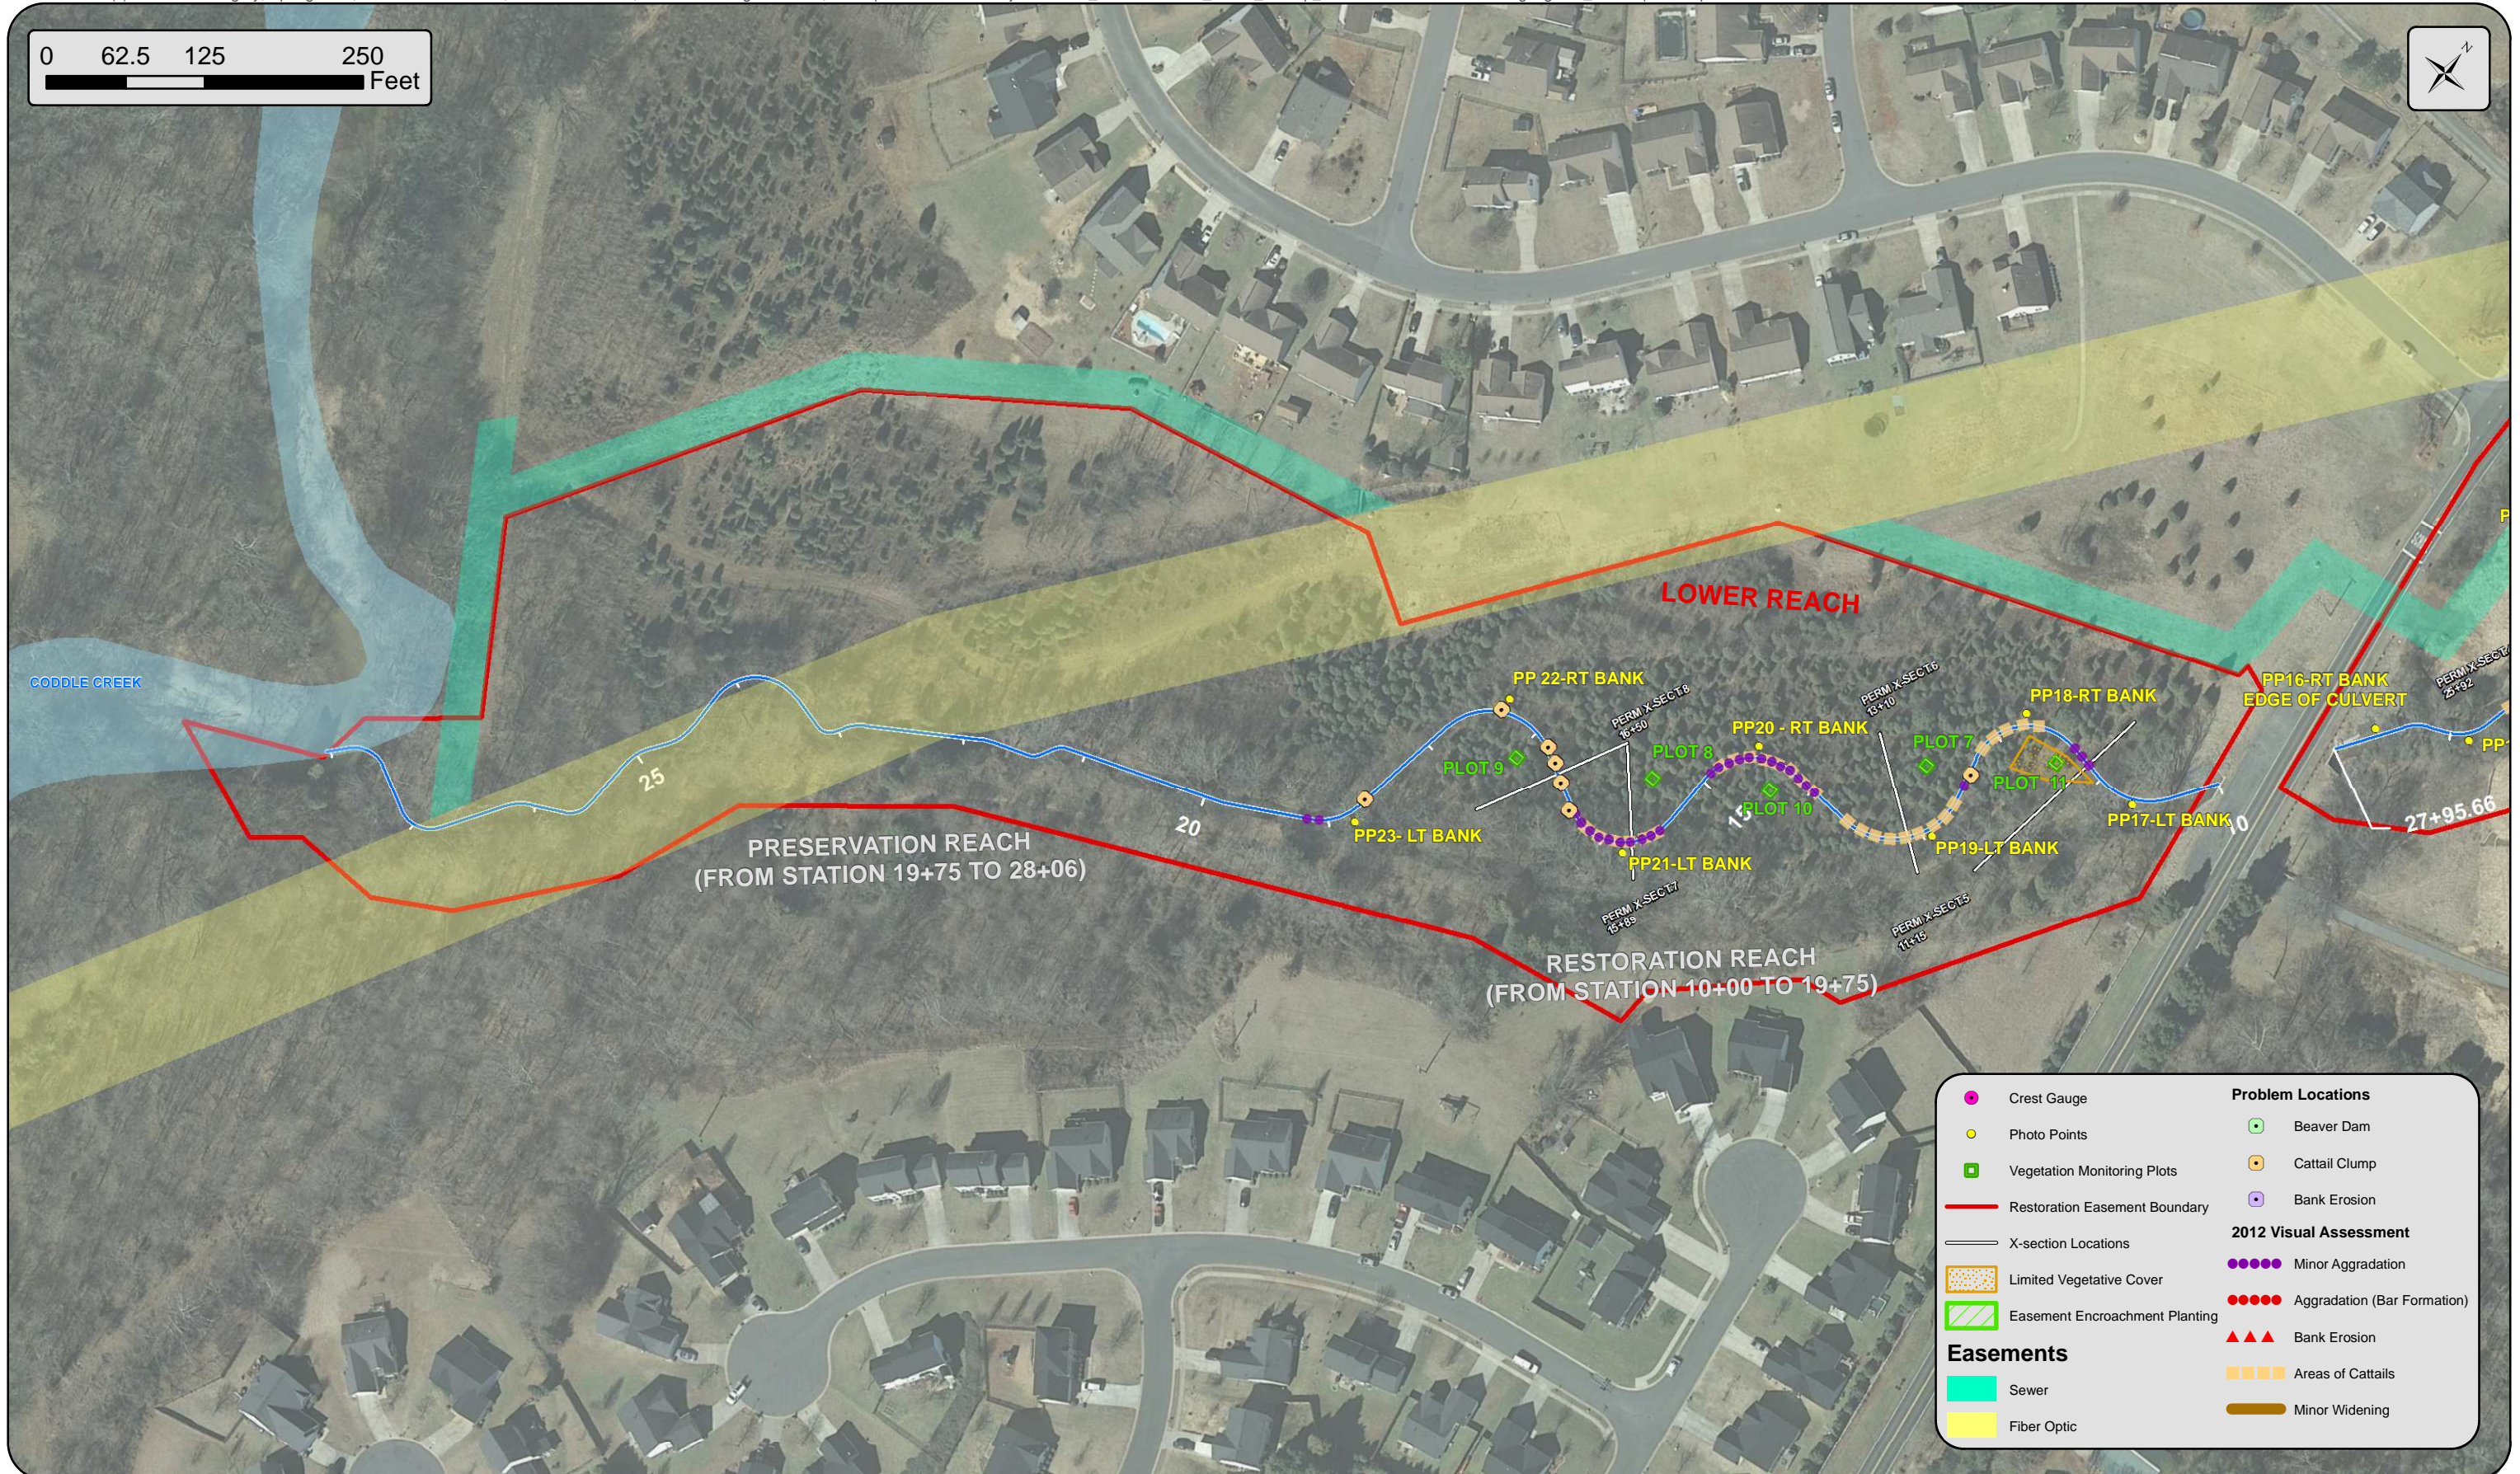
Figure 3a – Current Condition Plan View – Upper Reach

One location was noted along the reach as having sparse vegetation as a result of deposition on the floodplain. This area is located on the lower reach near Sta. 11+25 and illustrated on the Current Condition Plan View (CCPV) in Appendix B. In addition to this location, there is an increasing number of cattails (*Typha latifolia*) growing within the stream. These locations are noted on the CCPV and represent approximately 489 linear feet of the reach or 22 % of the total reach. The cattails are likely to continue to grow and take over additional stream footage without maintenance activities to control the growth. The cattails aren't currently creating issues to the current vegetation; however, they may start outcompeting other riparian herbaceous species and appear to be having some effects on channel morphology. The CCPV also illustrates an easement encroachment planting area. This area was replanted during construction as a developer had cleared into the conservation easement. No new encroachments were noted.

One notable area of aggradation was observed on the upper reach at Sta. 26+50. This area has a small midchannel bar forming and could be the result of some of the cattail growth in that location. Other minor areas of aggradation are noted on the CCPV. These areas seem to be closely associated with the cattails found growing in the channel. These areas do not appear to be negatively impacting the channel morphology at this time. One location of a bank failure occurred upstream of Sta. 22+00 on the upper reach and was approximately 25 linear feet. The cause of the bank erosion is not known but possibly due to poor bank material. The bank does have vegetation on it and will be monitored for further degradation. At approximately Sta. 18+00 on the left bank of the upper reach an area noted as a terrace rill was noted on the CCPV. This is an approximately 15-foot segment and will be monitored for additional erosion. This bank was heavily armored due to a storm event during construction and the structure looks to be in stable condition. One final area of concern was noted on the upper reach at approximately Sta. 14+75 beyond the project area. This area was collecting a growing amount of debris at the permanent sewer line crossing and was determined to be a beaver dam during the 8/16/2012 EEP site visit.

A large presence and growth of cattails was noted in the lower reach as well as a small portion of the lower end of the upper reach. The presence of cattails in these areas has removed distinct bed features (riffles, pools, etc.) or at least made them difficult to discern. Cattail removal is recommended to allow bed features to form.

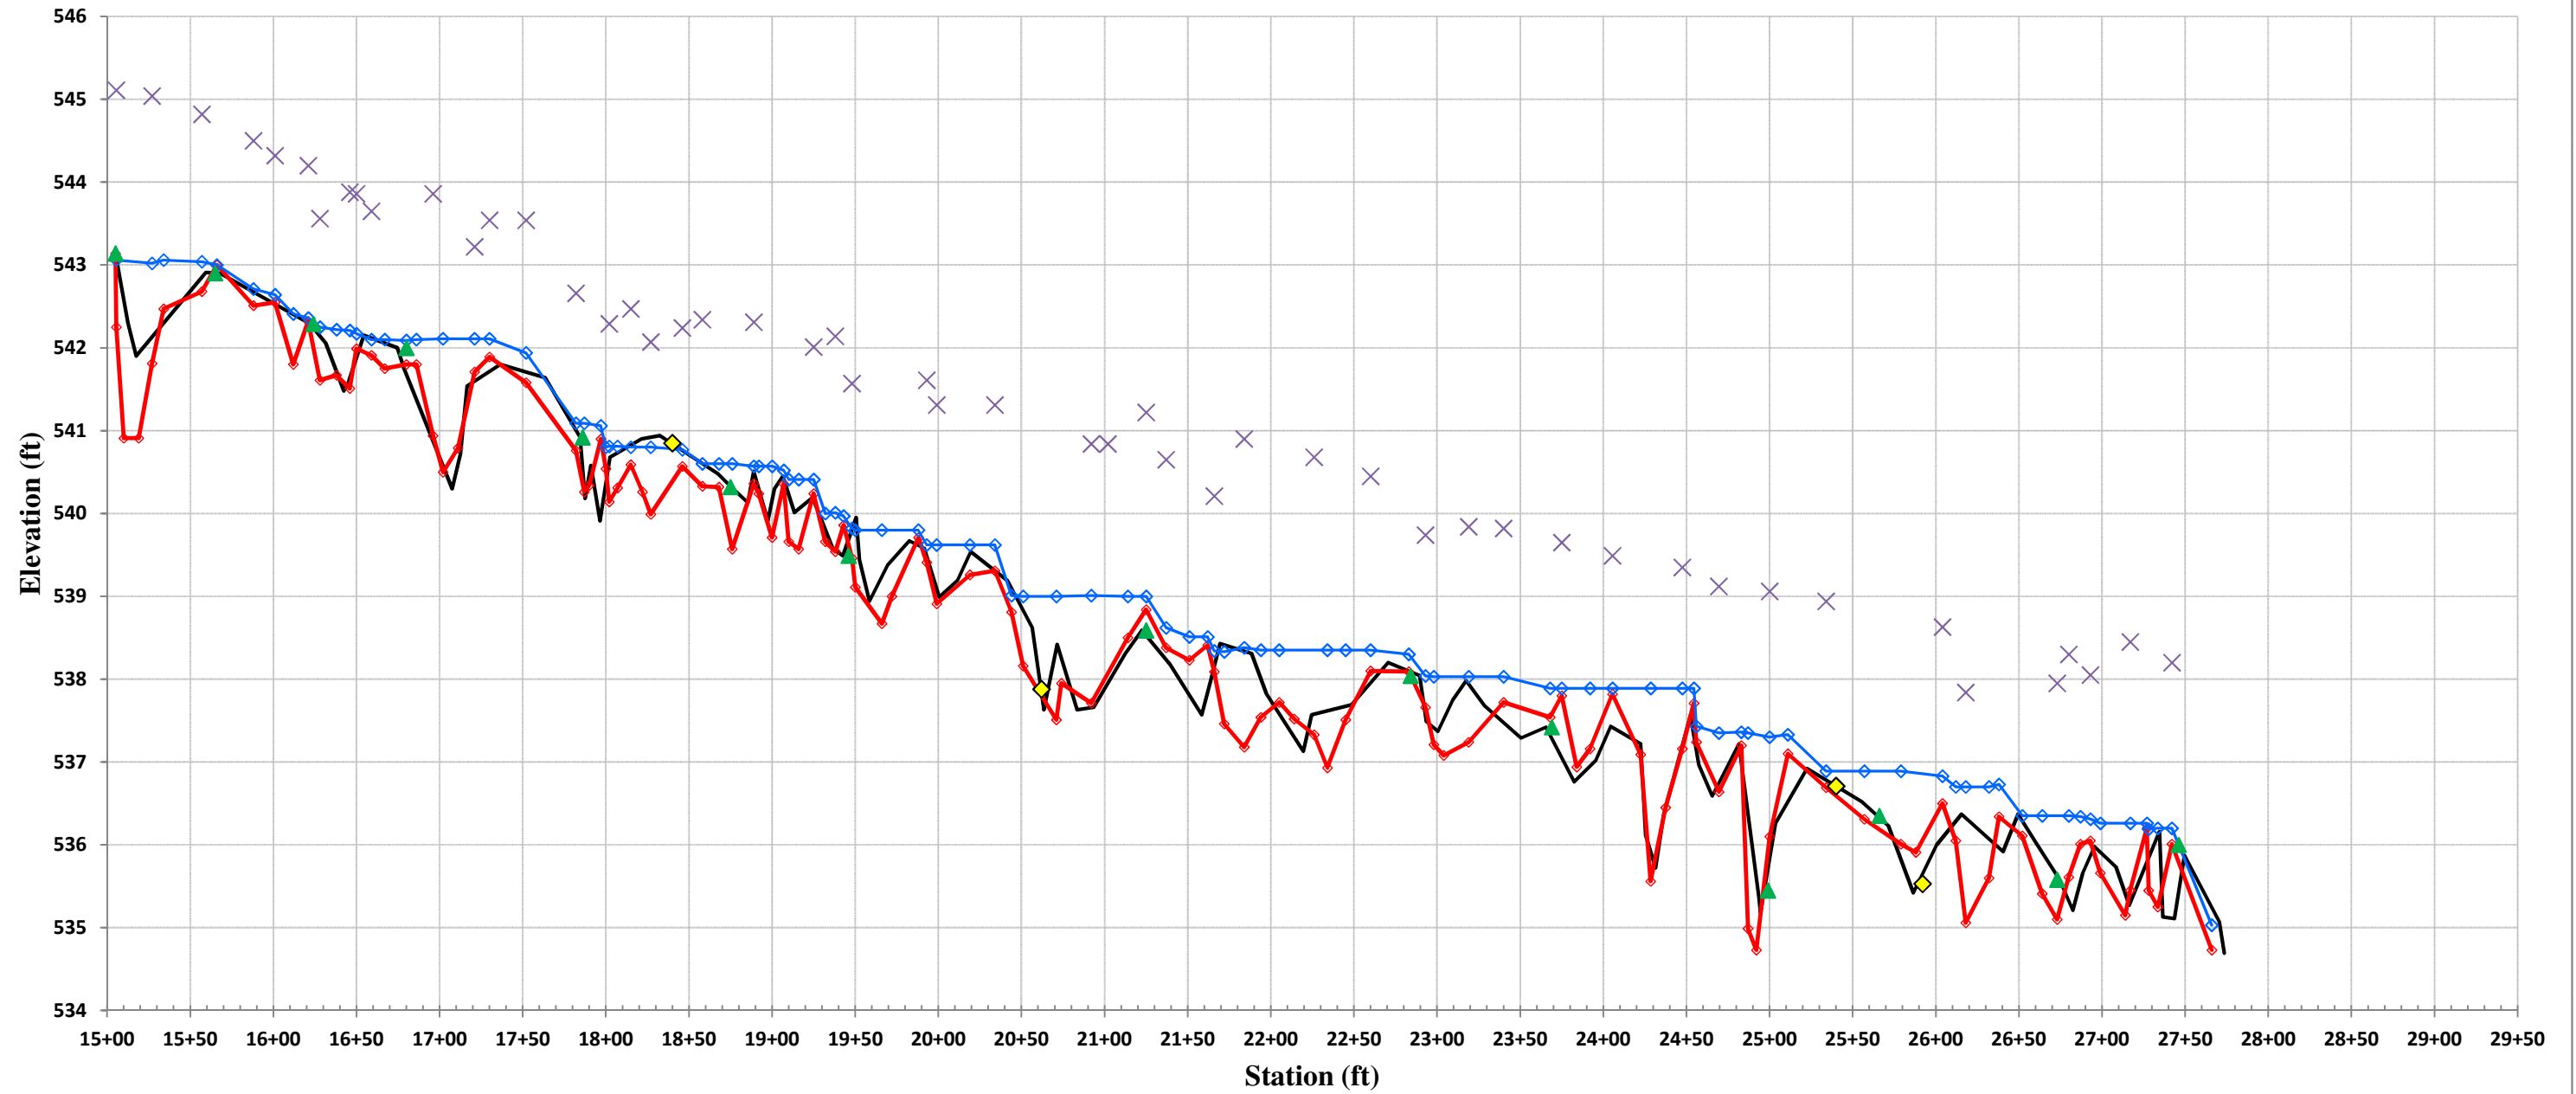
### Longitudinal Profile Indian Run - Upper Reach EEP Project #94

The entire length of the reach was surveyed by HDR using GPS and a rod and level. Multiple parameters were located including top of bank, thalweg, and water surface. The longitudinal profiles show that the bed features are stable. Riffles throughout the upper and lower reach show a general trend of becoming shorter and steeper in Year 1 as compared to baseline. However, overall channel and bankfull slopes remain consistent in comparison to the baseline condition. Pool slopes and depths remain stable and similar to baseline values as well.
