**Coddle Creek Tributary  
(Indian Run) Stream Restoration  
EEP Project # 94  
DENR Contract # 5360**

**Monitoring Report Year 2 of 5  
Cabarrus County, North Carolina**

**Construction Completed: March 27, 2011  
Data Collected: December 2013  
Report Submission: March 2014**

SEPI Engineering and Construction  
1025 Wade Avenue  
Raleigh, NC 27605

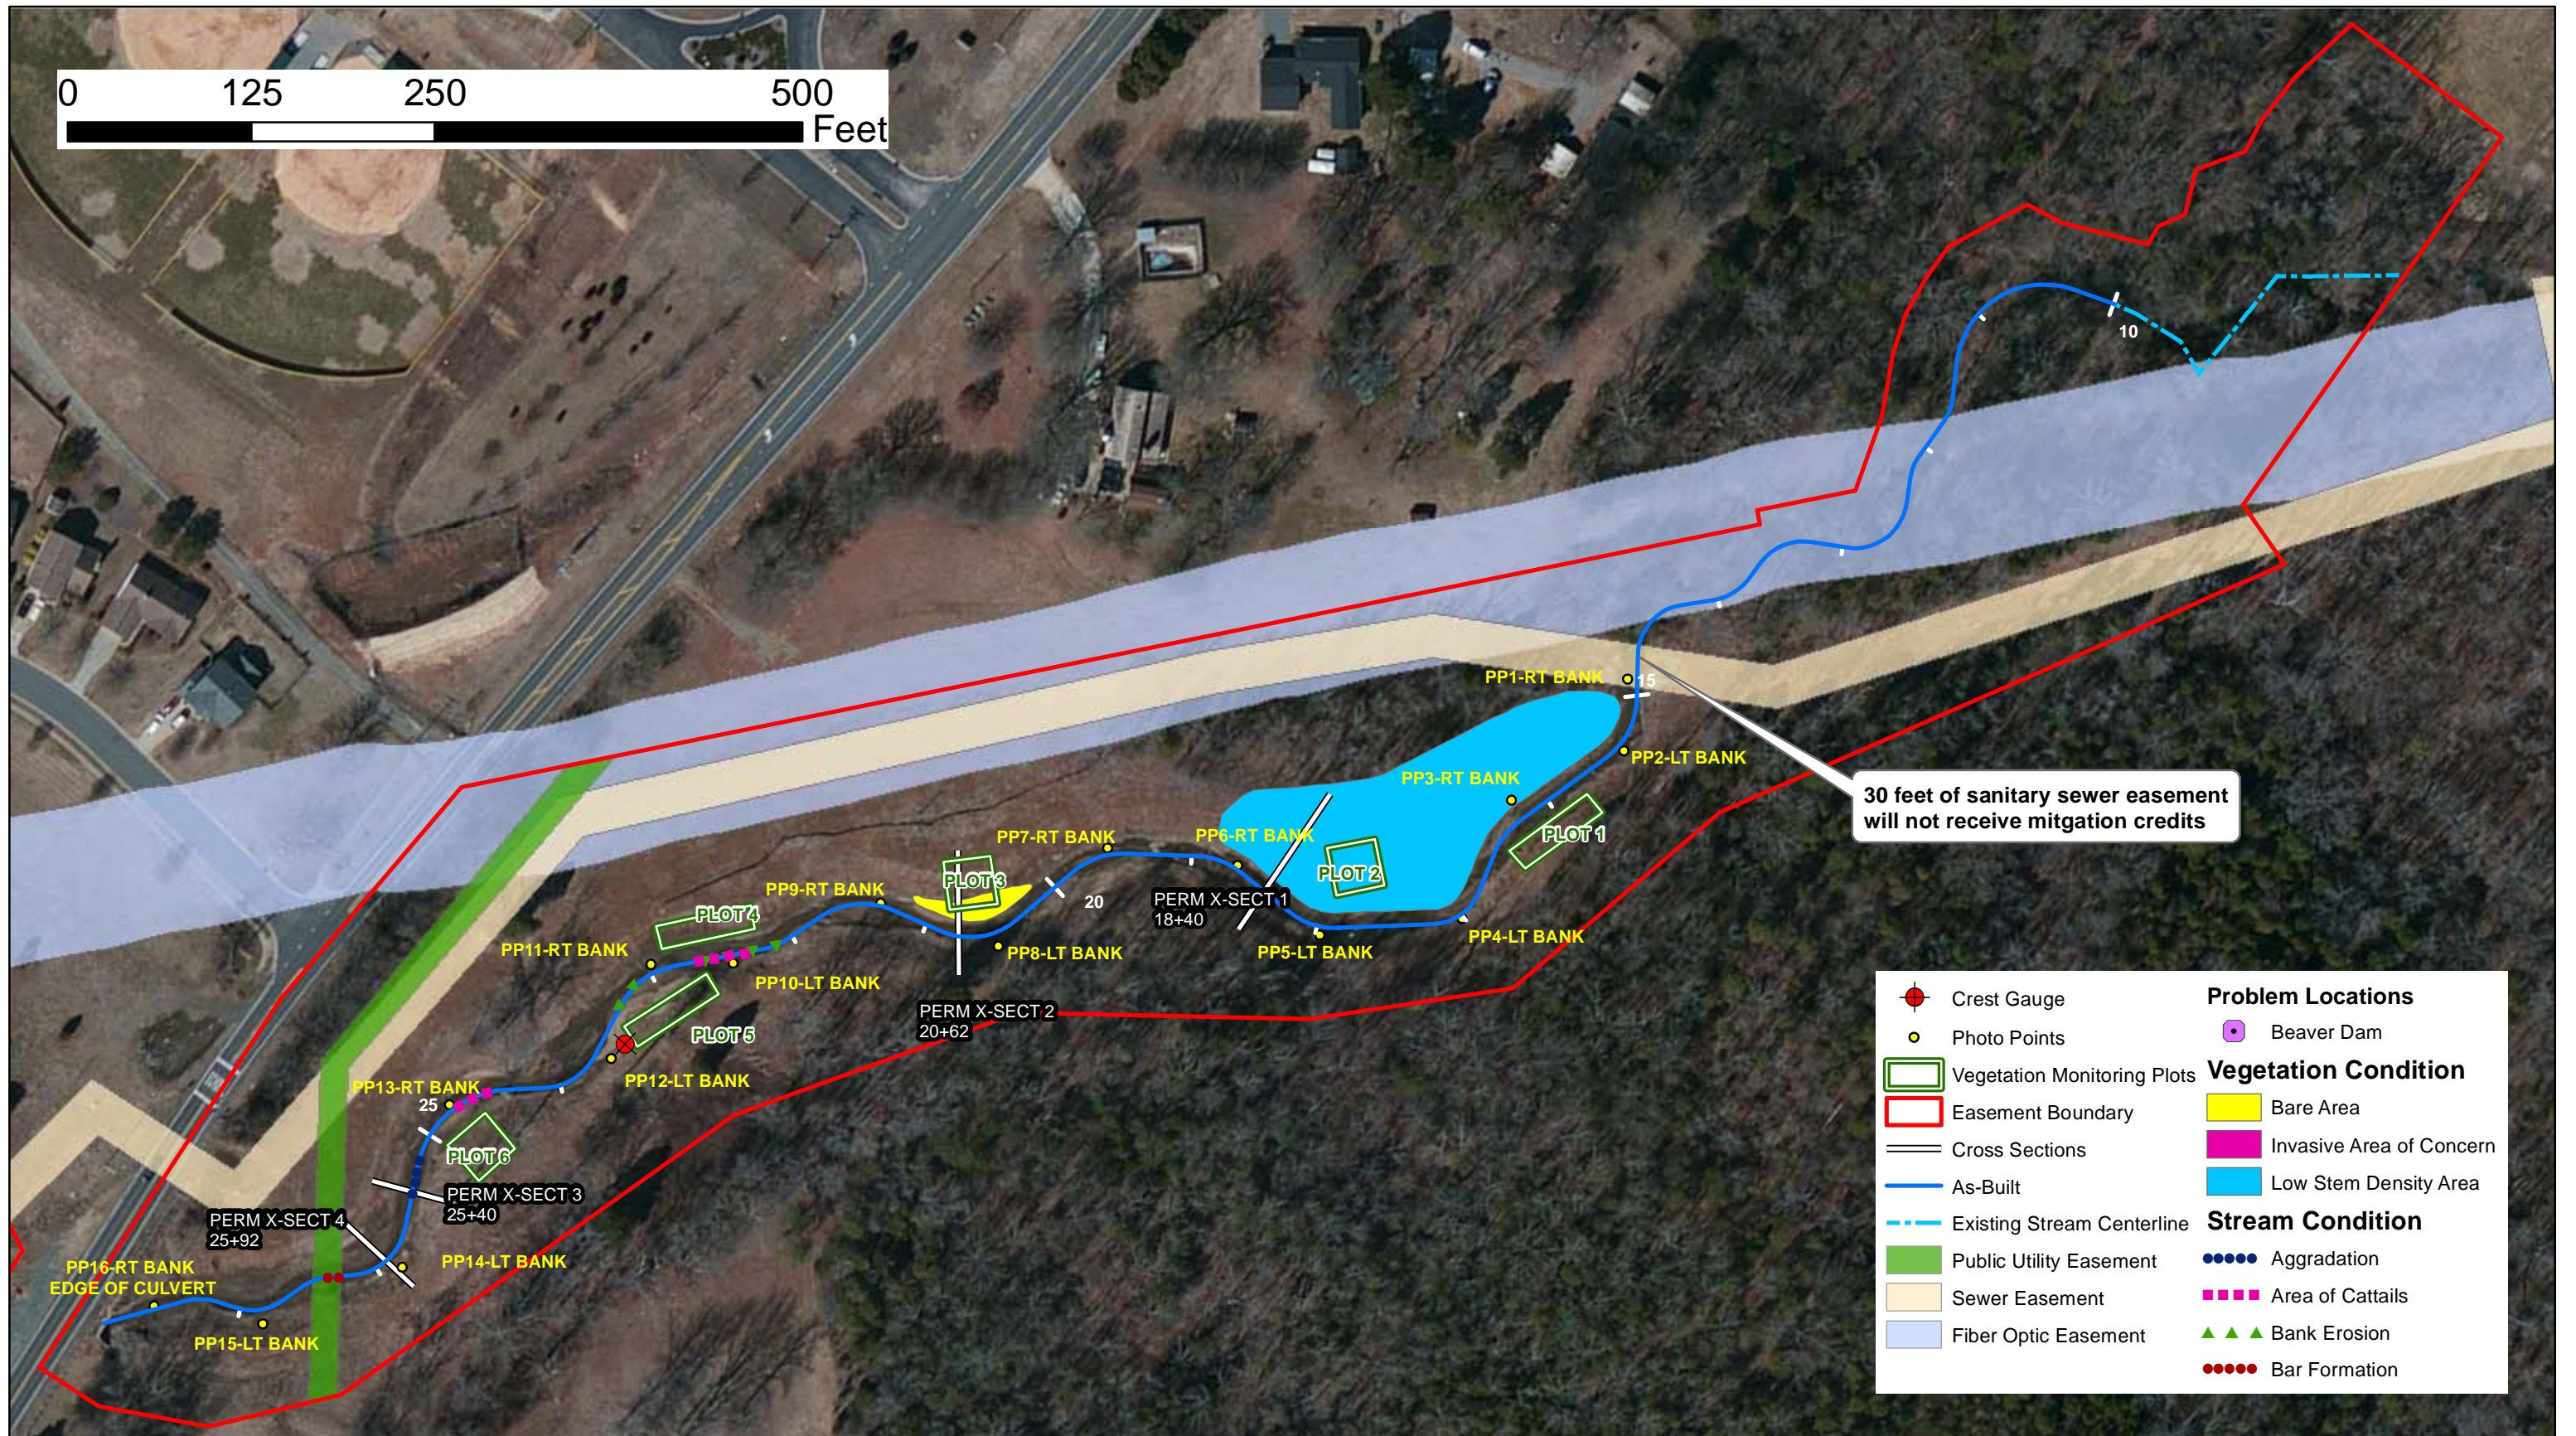
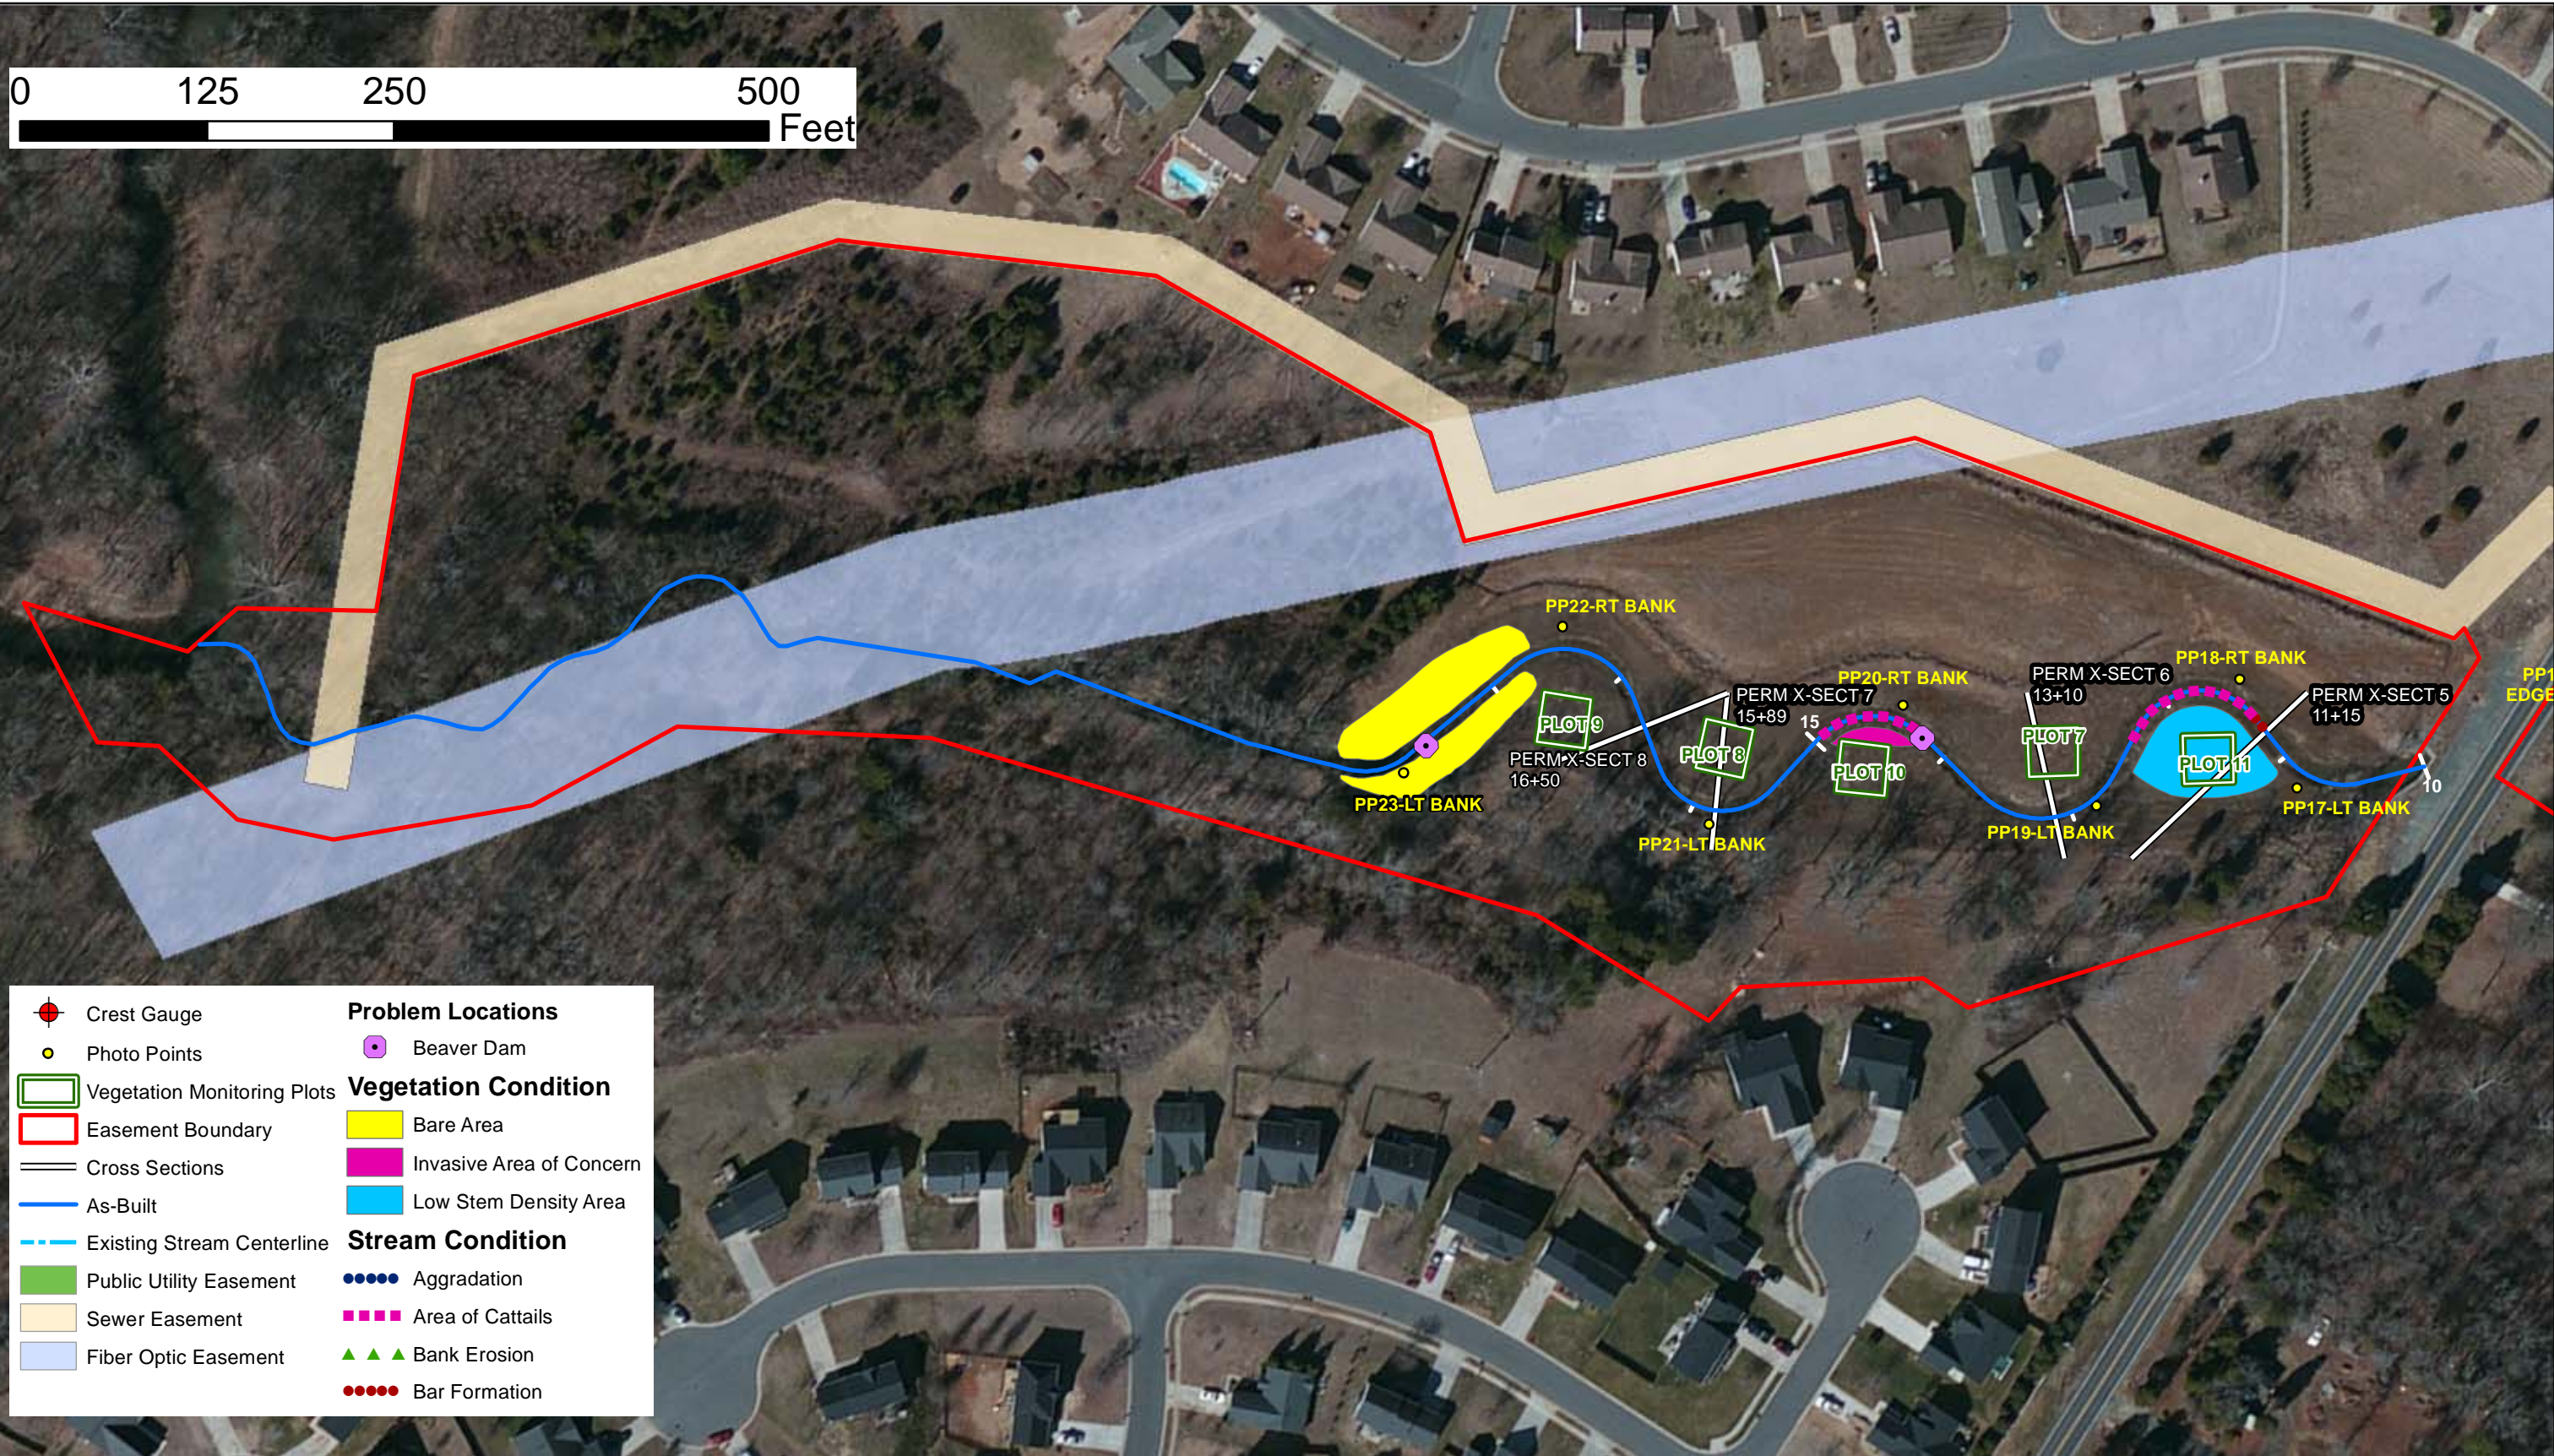
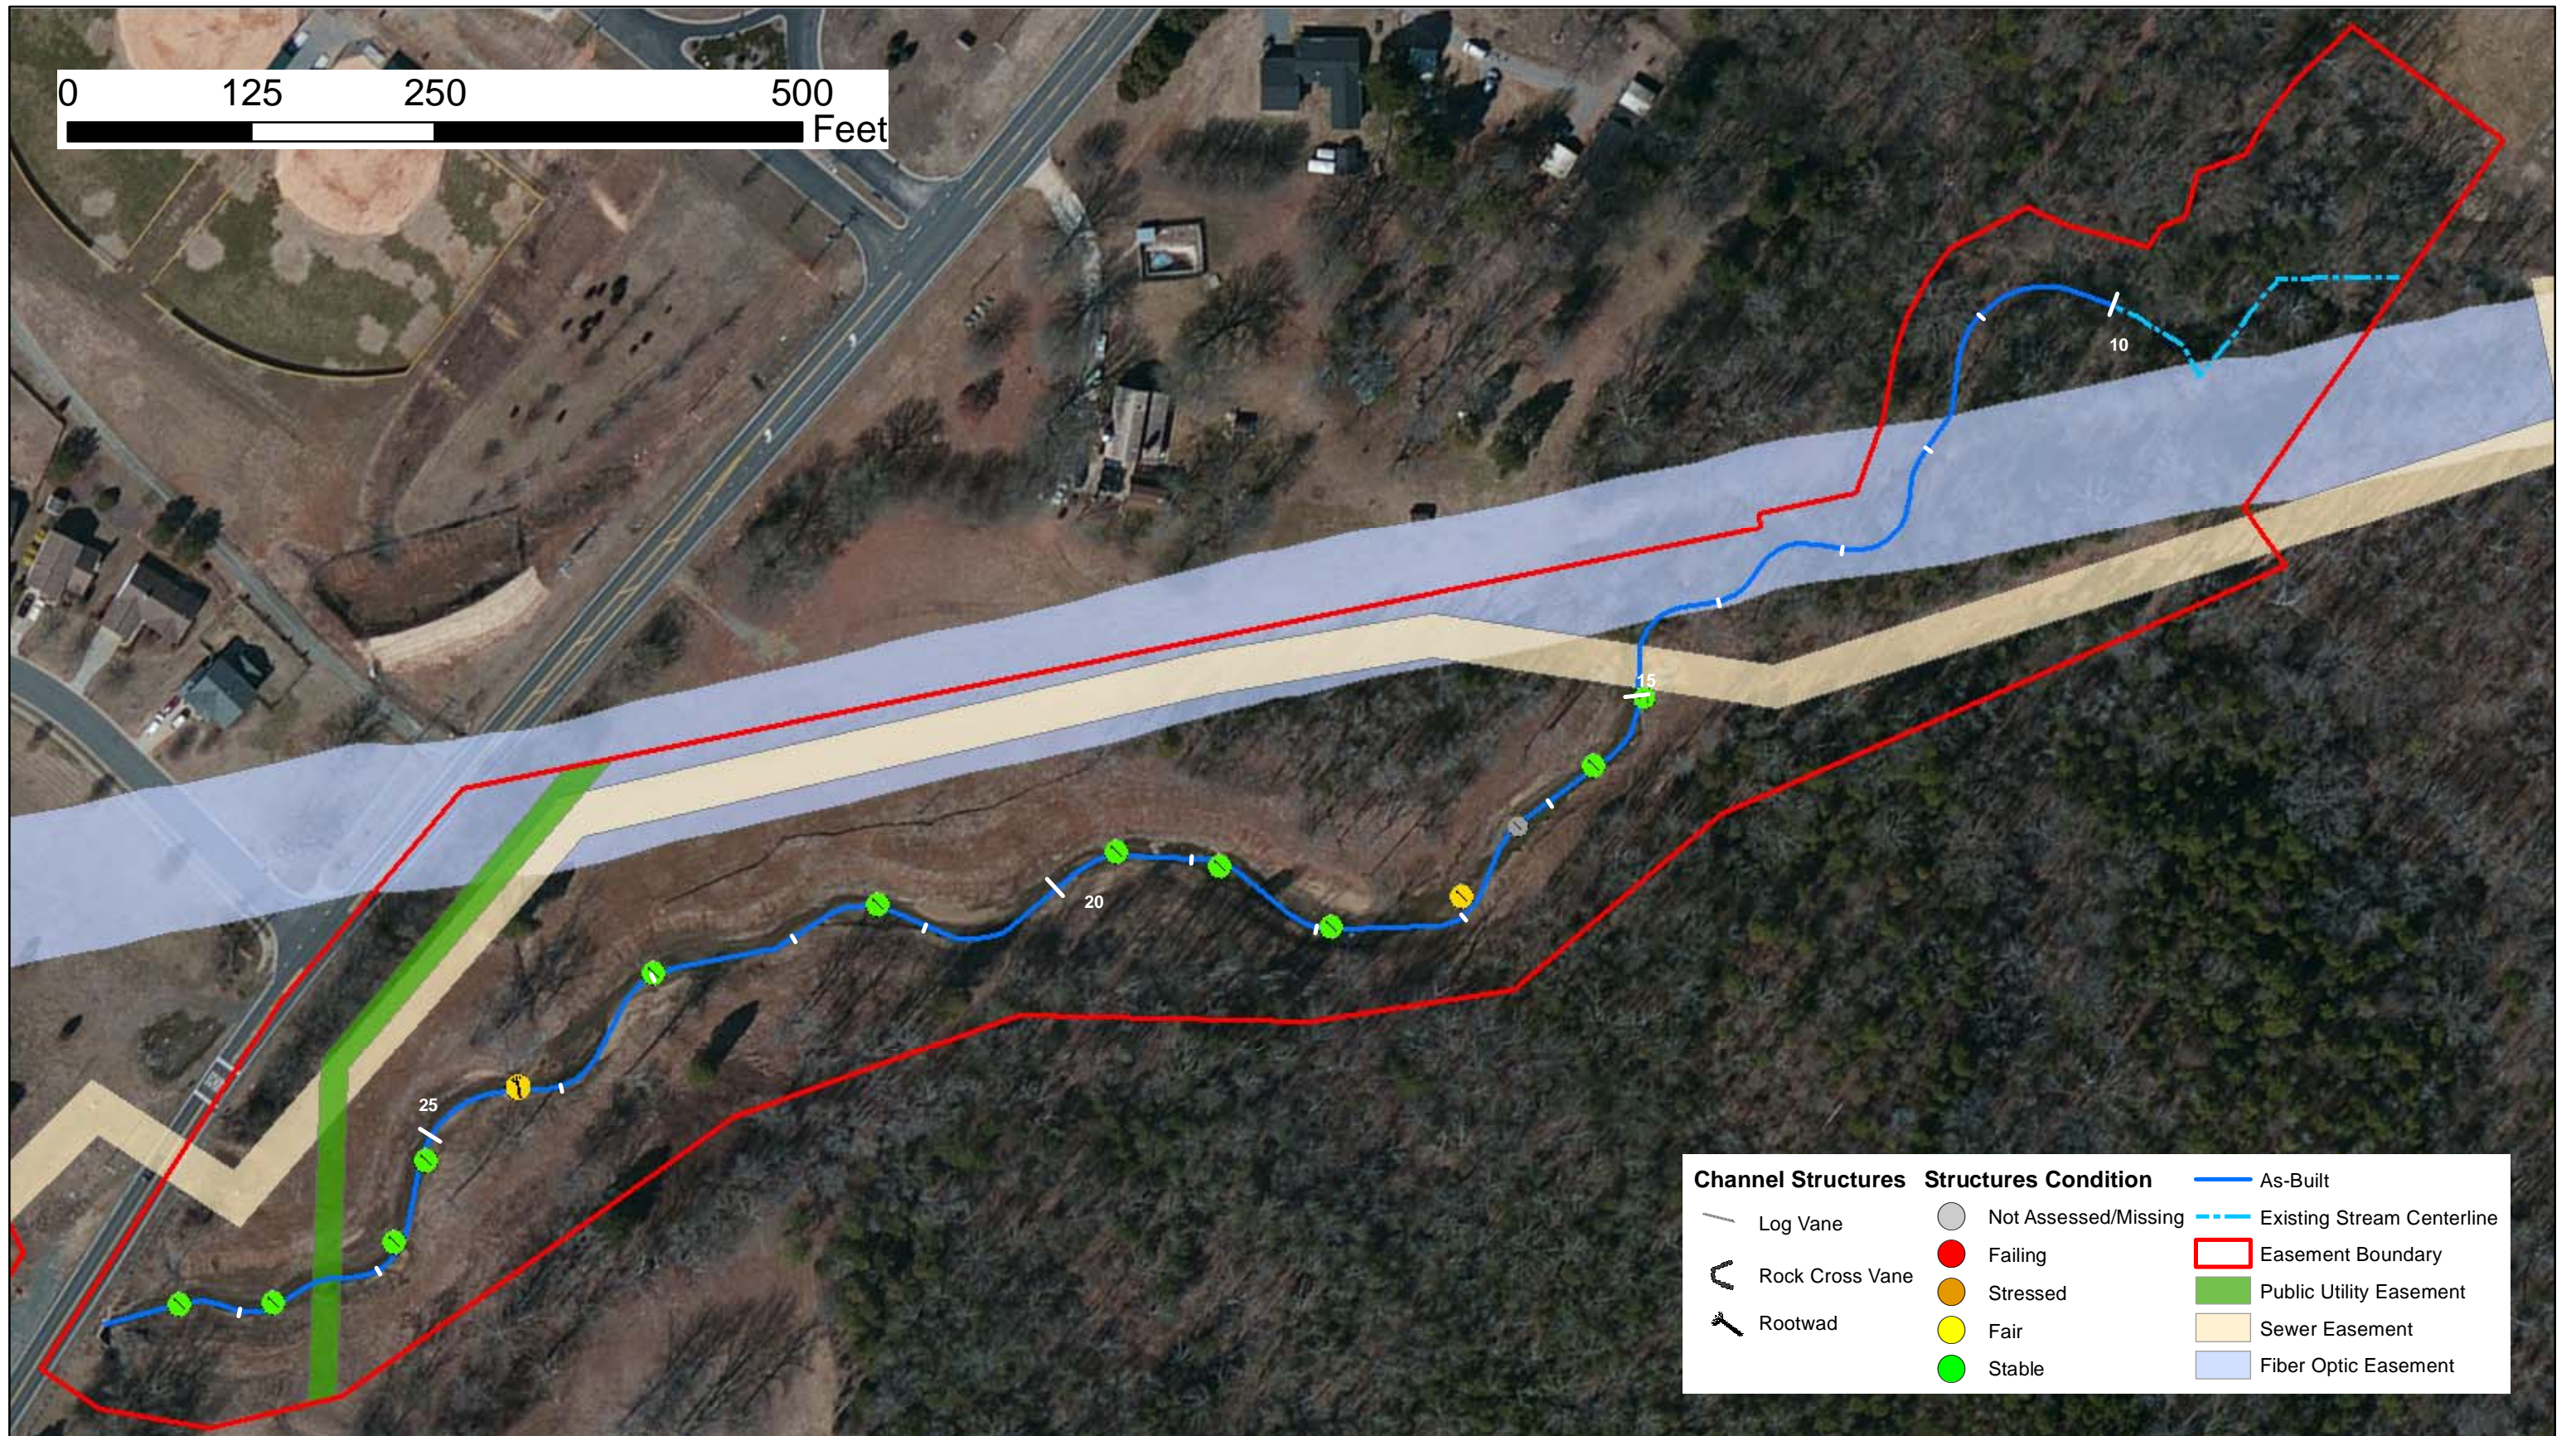
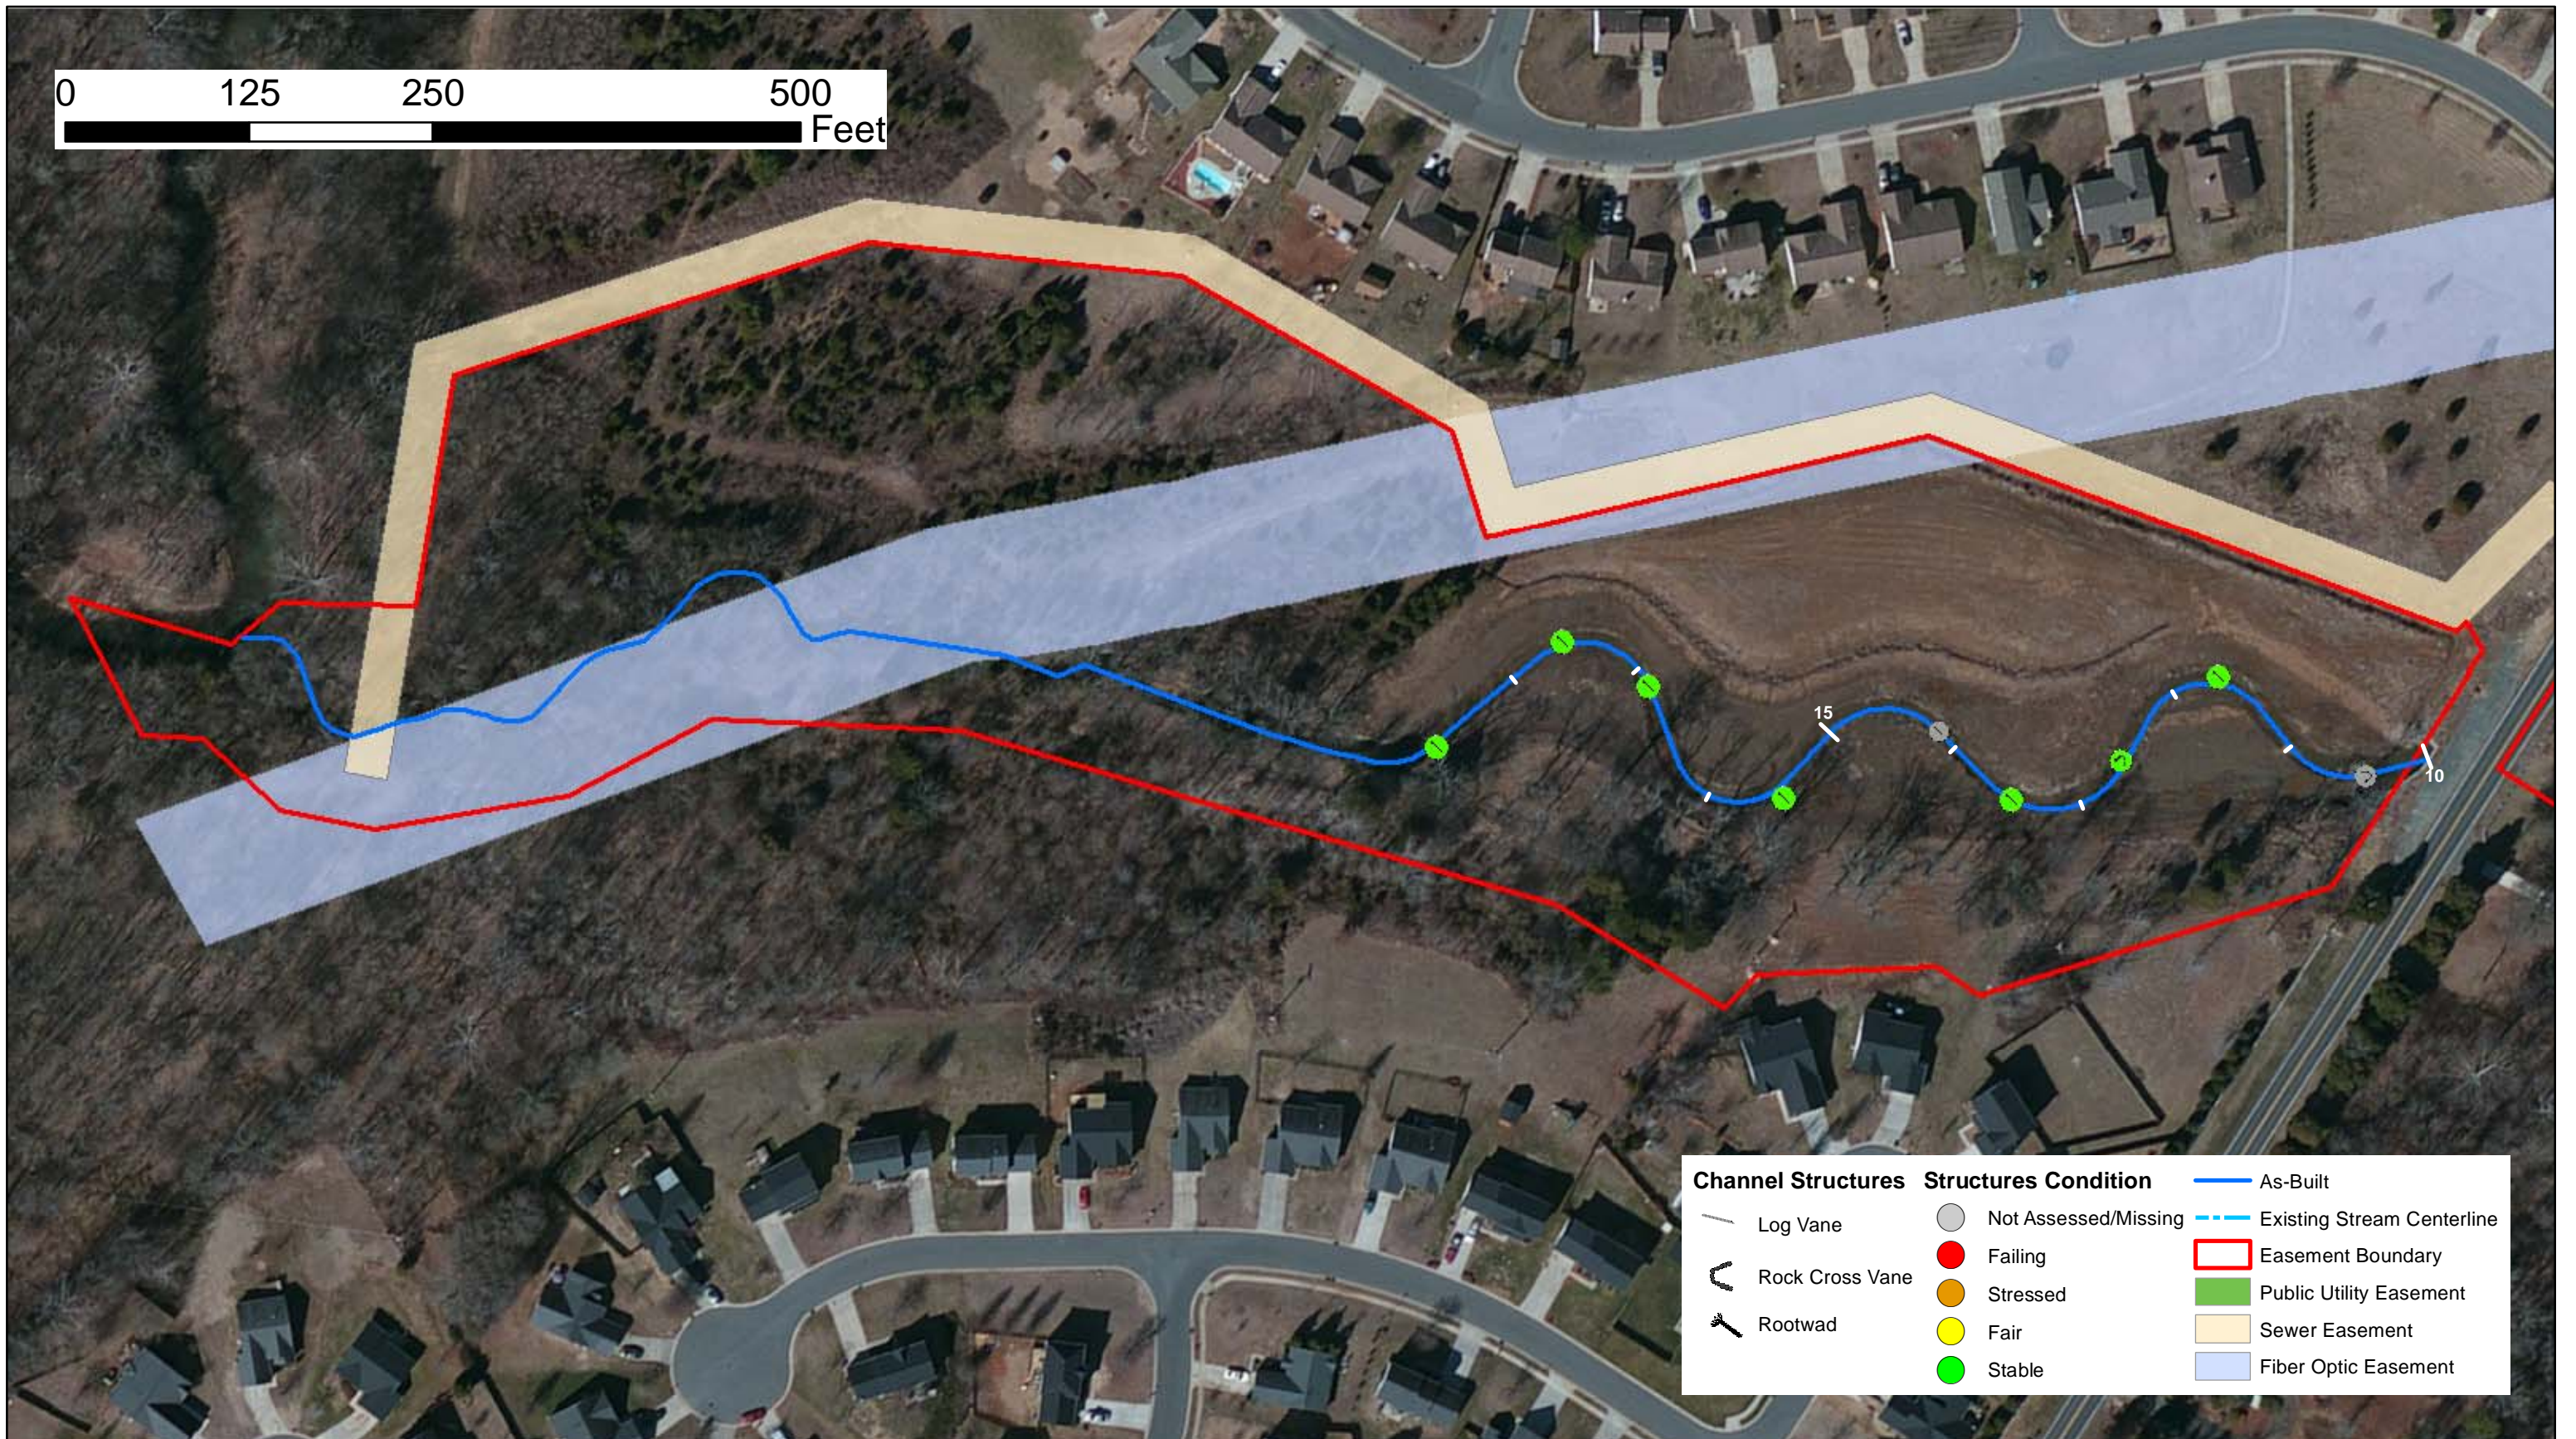
A few areas were noted along the reach as having sparse vegetation as a result of deposition on the floodplain. These areas are located near Sta. 21+00 on the upper reach and Sta. 18+00 to 19+00 on the lower reach. Both areas are illustrated on the Current Condition Plan View (CCPV) in Appendix B. In addition to this location, there is an increasing number of cattails (*Typha latifolia*) growing within the

stream. These locations are noted on the CCPV and represent approximately 250 linear feet of the reach or 11 % of the total reach. The cattails are likely to continue to grow and take over additional stream footage without maintenance activities to control the growth. The cattails aren't currently creating issues to the current vegetation; however, they may start outcompeting other riparian herbaceous species and appear to be having some effects on channel morphology. No other invasive species were observed. No new easement encroachments were noted.

One notable area of aggradation was observed on the upper reach at Sta. 25+00. This area has a small midchannel bar forming and could be the result of some of the cattail growth near that location. Two areas of bar formation were noted at Sta. 26+50 on the upper reach and Sta. 11+25 on the lower reach. These areas do not appear to be negatively impacting the channel morphology at this time. Two areas of bank erosion were noted near Sta. 22+50 and Sta. 23+50 on the upper reach. The terrace rill at approximately Sta. 18+00 on the left bank of the upper reach was noted in the Monitoring Year 1 report, but appears to have stabilized. This area will continue to be monitored for erosion. Two beaver dams were noted on the lower reach at Sta. 14+25 and 19+00 and removed from the site in November 2013.
