**Coddle Creek Tributary
(Indian Run) Stream Restoration
EEP Project # 94
DENR Contract # 5360**

**Annual Monitoring Report Year 3 of 5
Cabarrus County, North Carolina**

**Construction Completed: March 27, 2011
Data Collected: September 2014
Report Submission: December 2014**

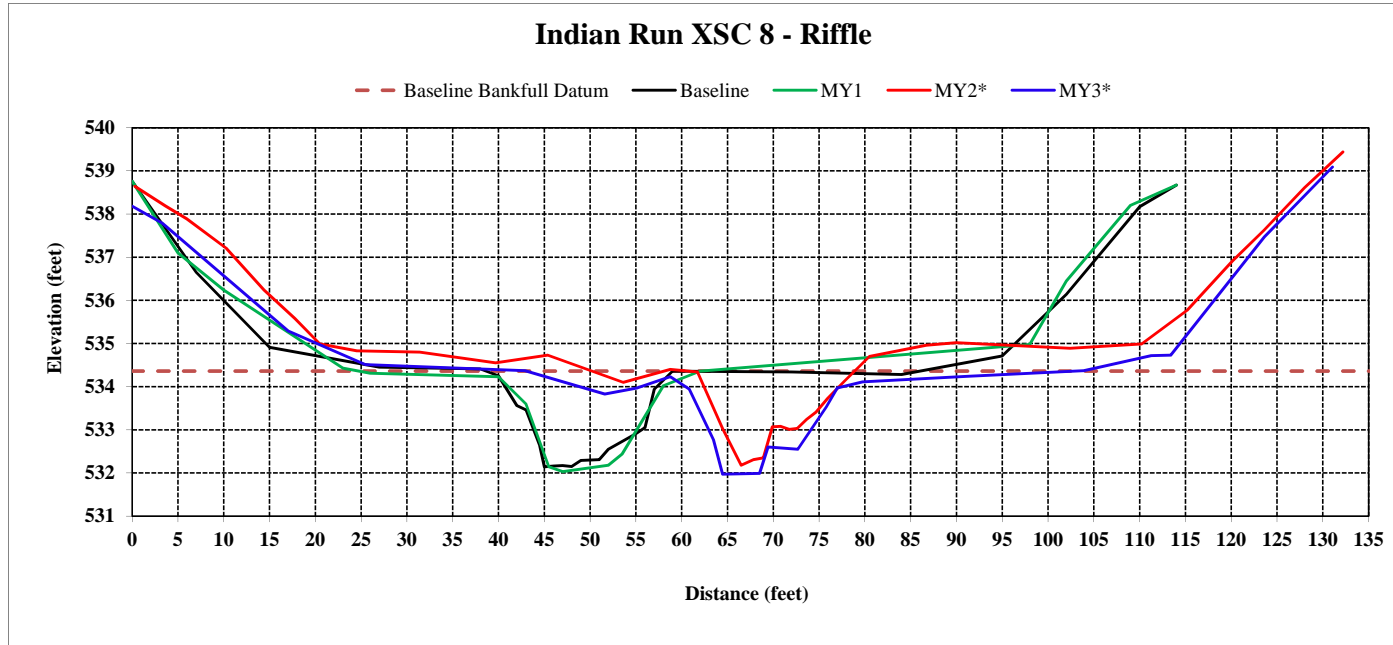
Sta. 16+50 Looking Upstream

*The pins for XS8 were not located in the field. The location of the cross section for MY3 is approximate and was set during MY2.
