**Collins Creek Stream Restoration Site
Monitoring Report – MY01
Orange County, NC
Basin 03030002 - Contract # D05011**

KCI
ASSOCIATES OF
NORTH CAROLINA, PA

December 2008

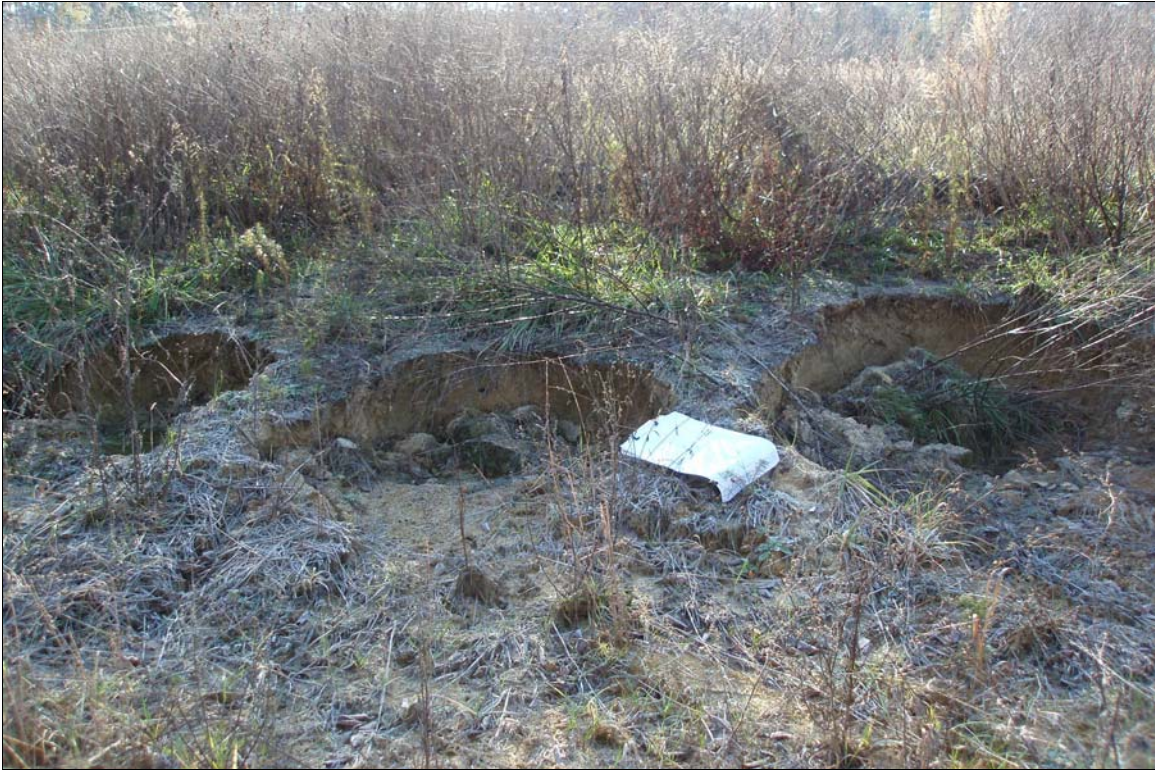
The stream assessment found the stream to be stable overall. Periods of high flow caused isolated bed degradation in T1A-1 and T1A-2. One of these areas is visible on the longitudinal profile of T1A. Overland flow has caused scour on the floodplain on the left side of T1B. It is expected that this issue will stabilize as vegetation becomes established on the floodplain. The rest of the project's stream banks, streambed, and floodplain have experienced little to no erosion throughout the project. The structures are performing well and as designed. The bed degradation will continue to be monitored to determine if corrective action are necessary.

SP1 – Floodplain erosion taken near Station 107+00. 11/24/08 - MY 01

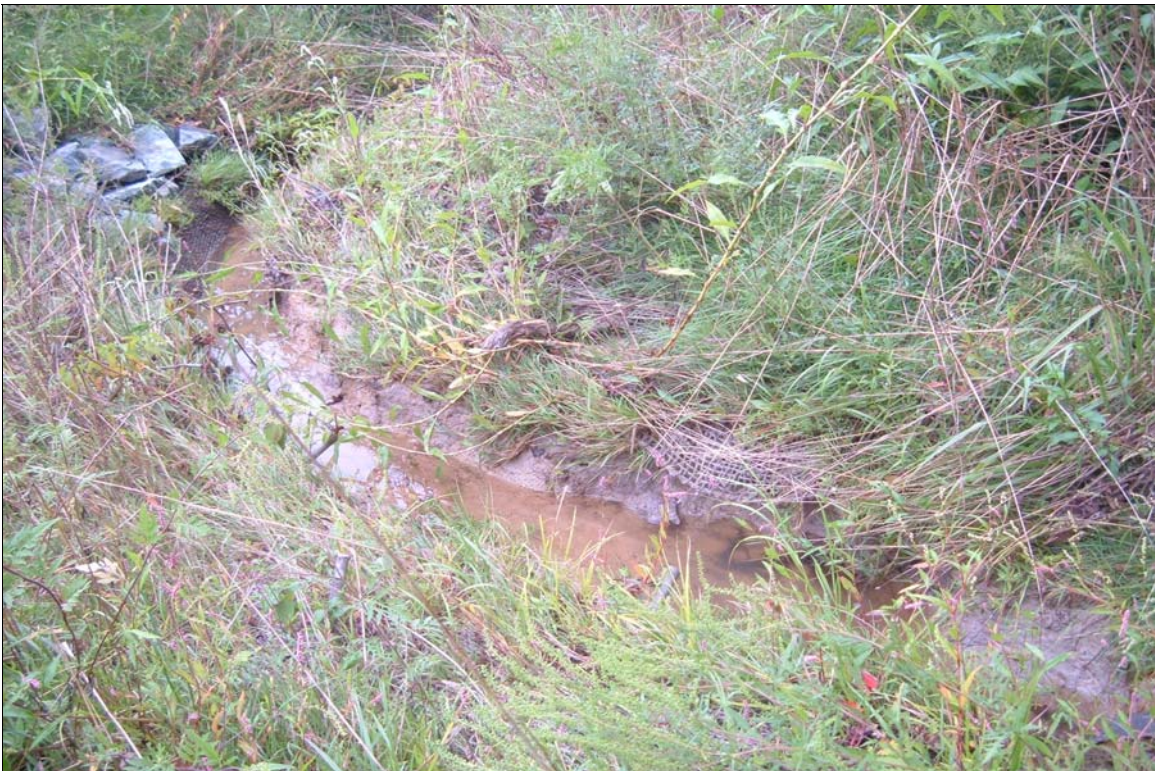
SP2 – Bed degradation taken near Station 80+50. 9/9/08 - MY 01
