**Collins Creek Stream Restoration Site
Monitoring Report – MY02
Orange County, NC
Basin 03030002 - Contract # D05011**

December 2009

**Design Engineer: Gary M. Mryncza, P.H., P.E.
Email: gary.mryncza@kci.com
KCI Project No: 12054130-01**

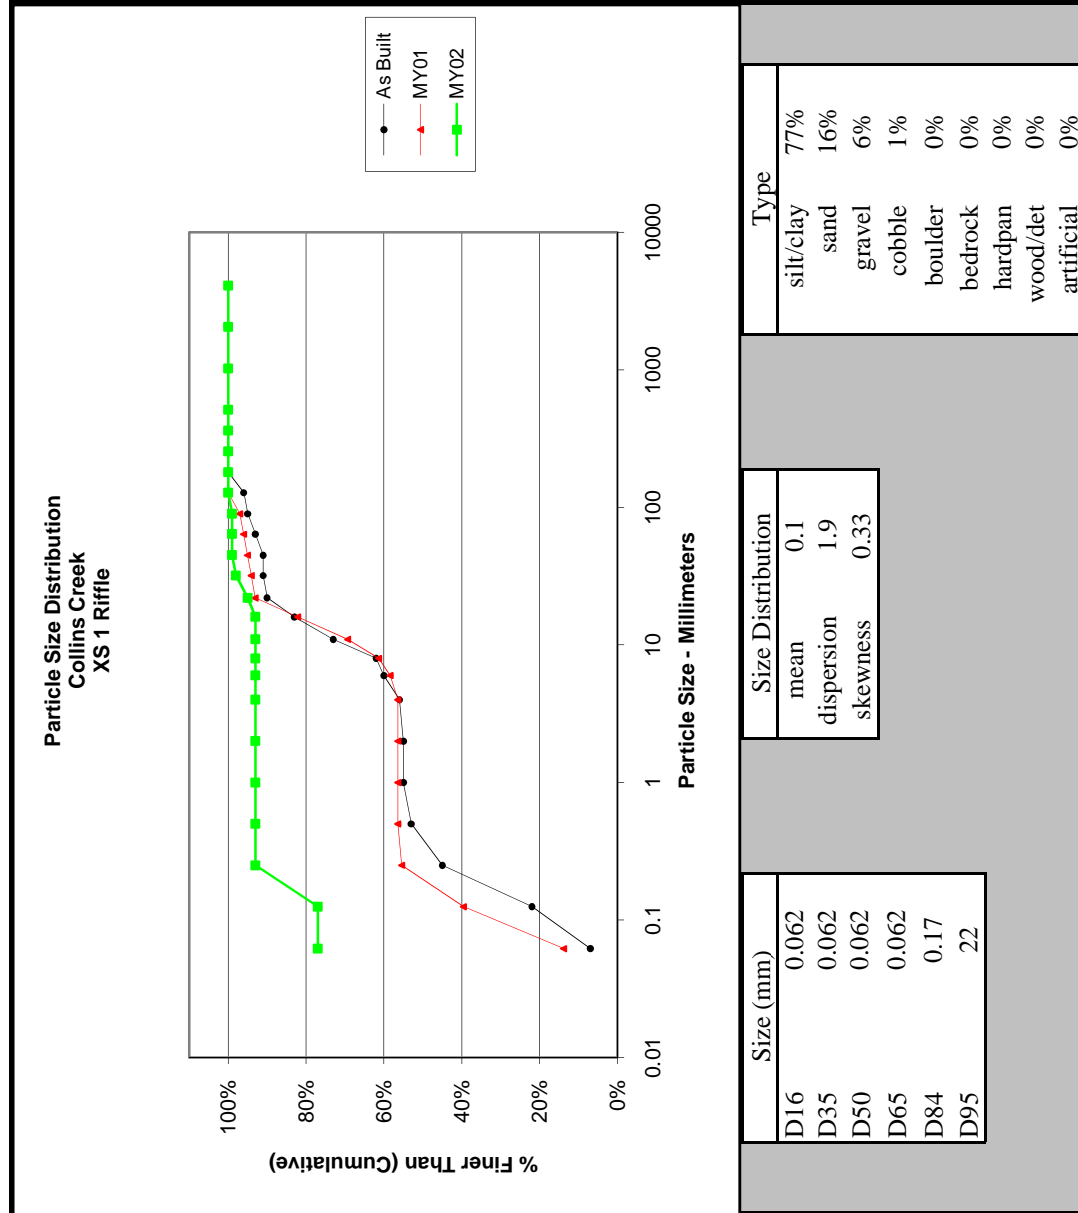
Note: Heavy vegetation in stream bed

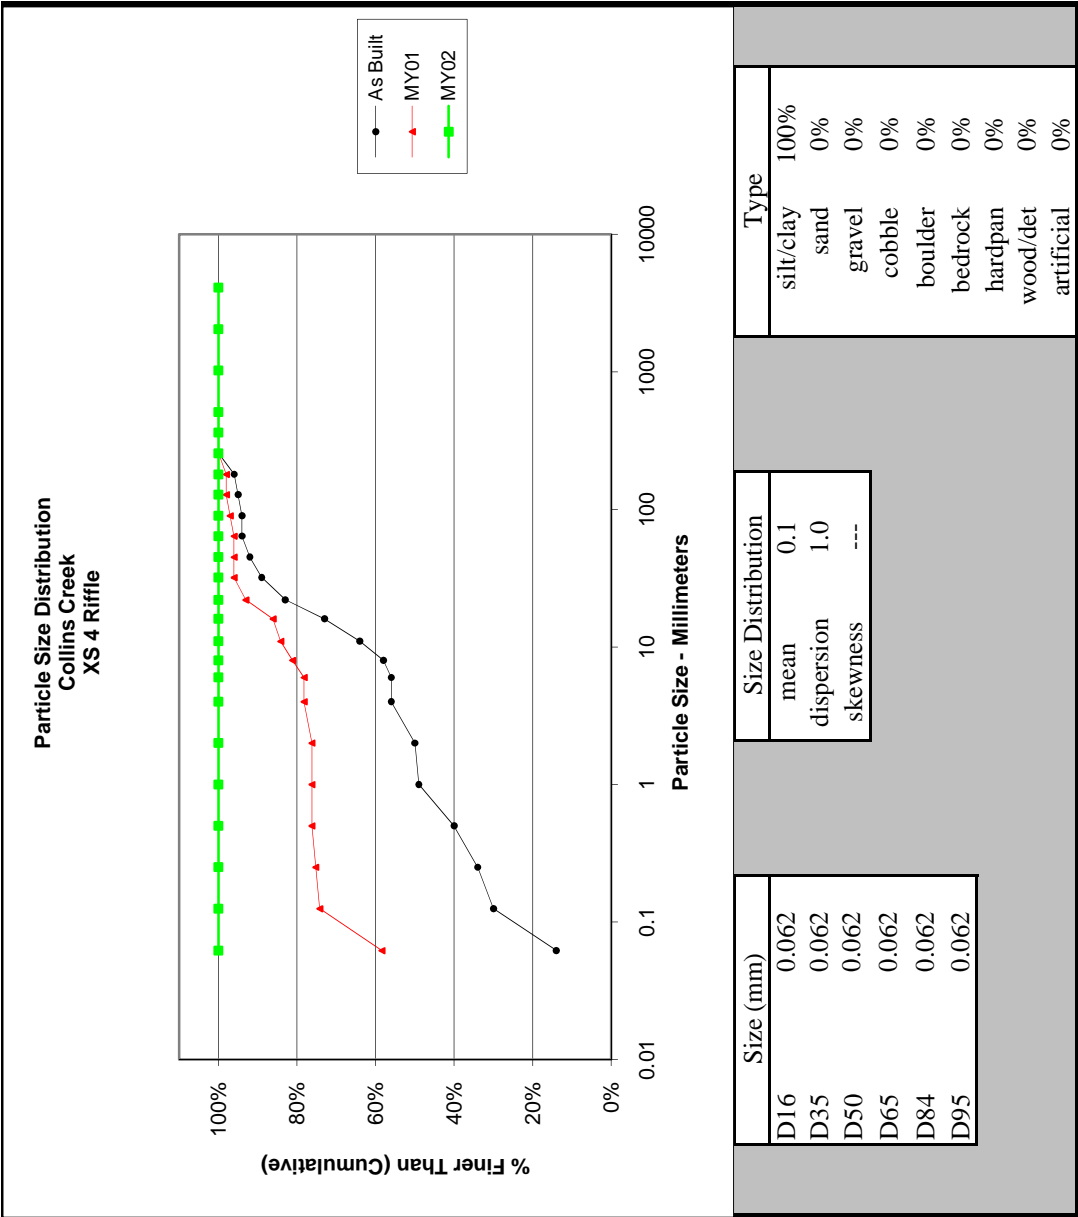
Note: Heavy vegetation in stream bed

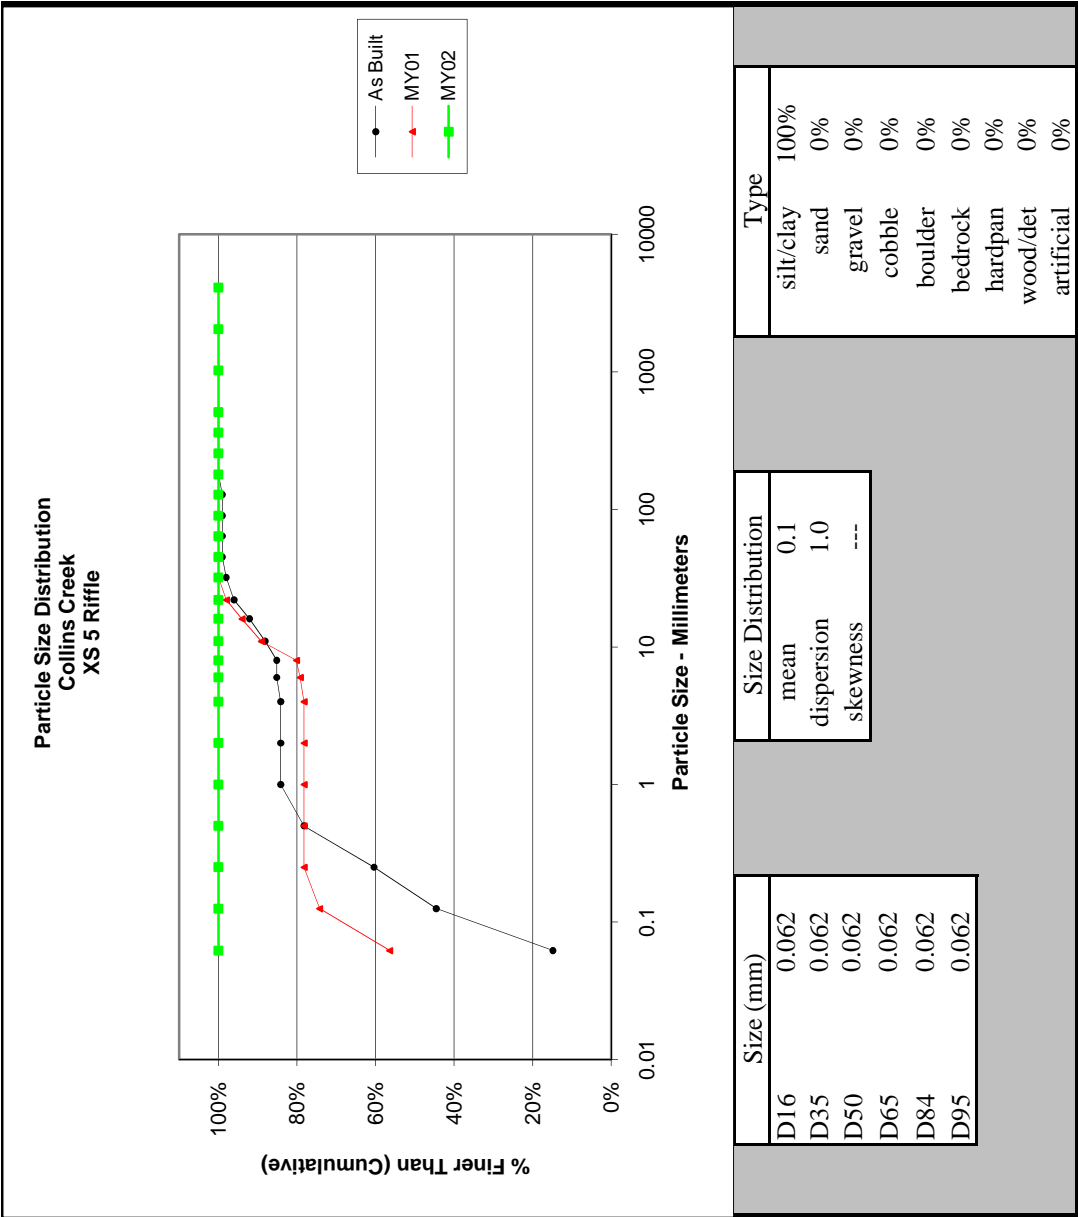
Note: Heavy vegetation in stream bed

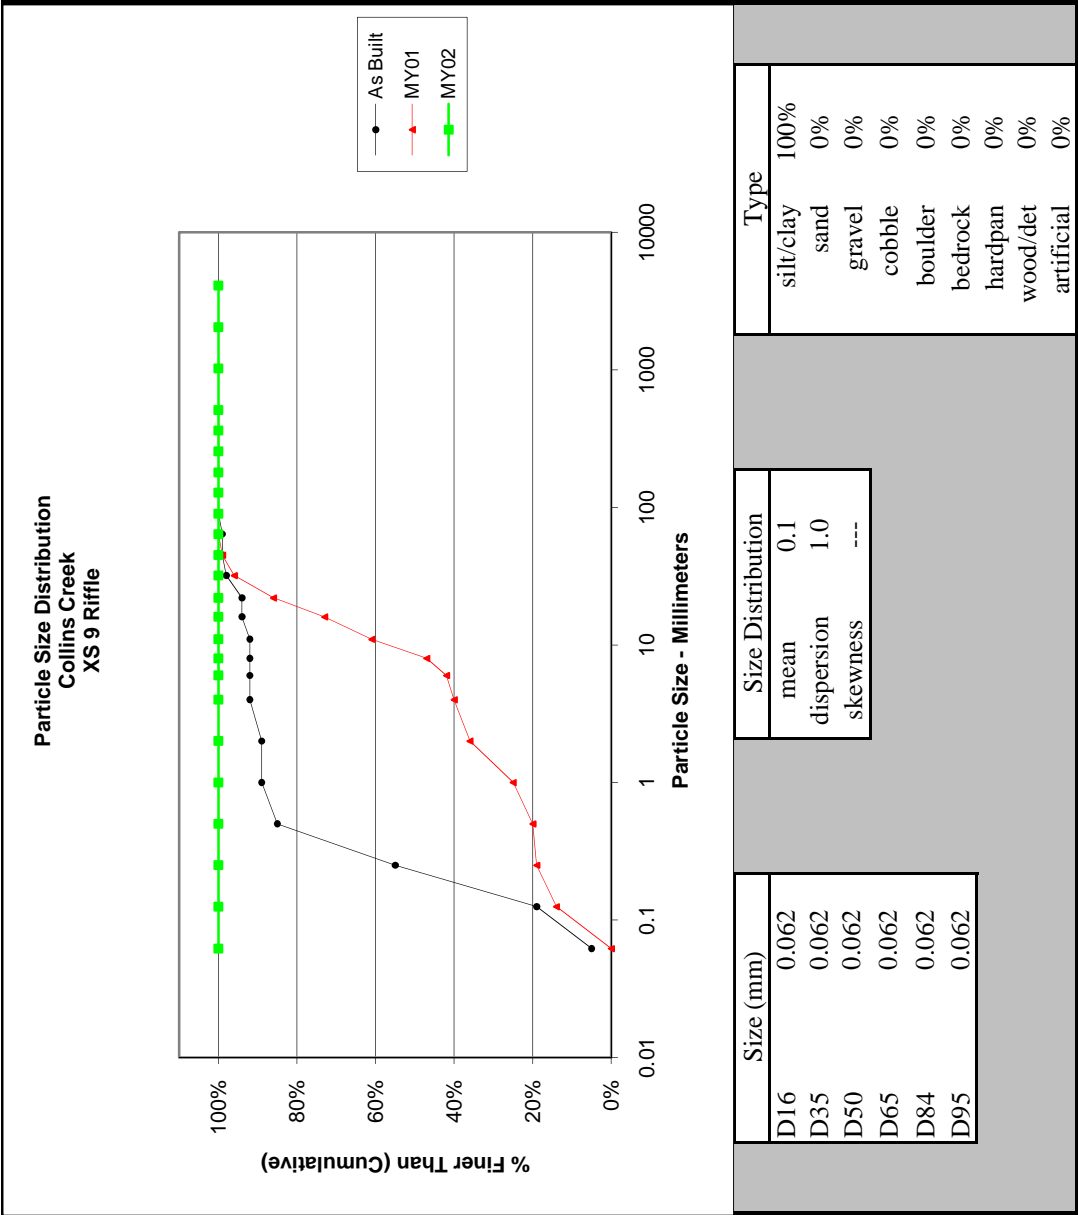
Note: Heavy vegetation in stream bed

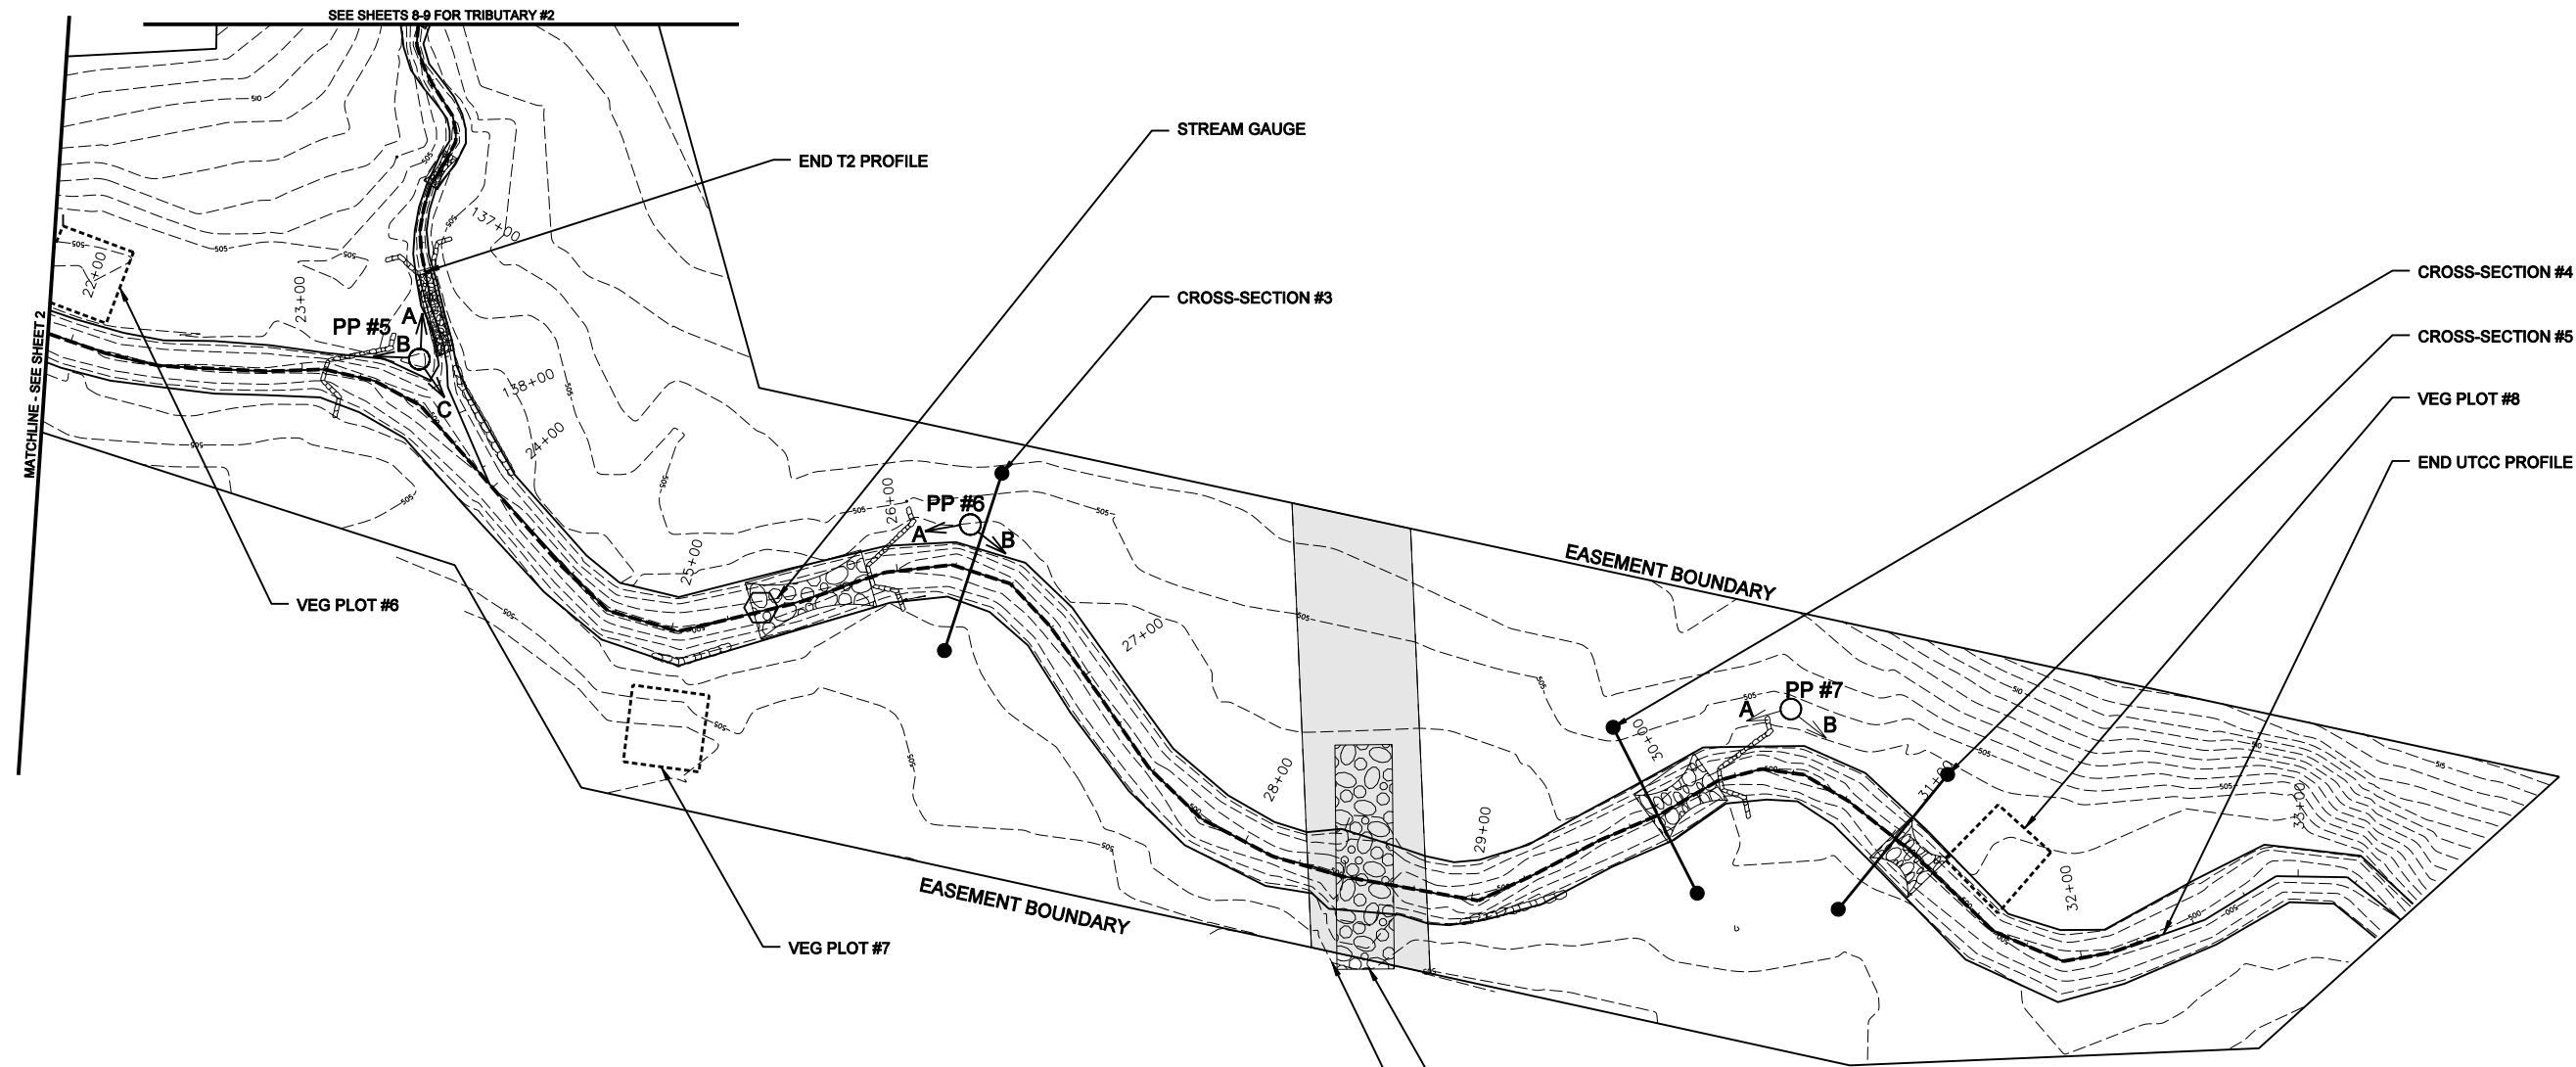
DATE: DECEMBER 2009
 SCALE: 1"=60'
**CURRENT
 CONDITION
 PLAN VIEW**
 SHEET 2 OF 9

ROCK FORD CROSSING
 ROCK FORD CROSSING AND ADJACENT STREAM BANKS REGRADED AND STABILIZED WITH STONE TO REPAIR CATTLE DAMAGE.
