**Collins Creek Stream Restoration Site
Monitoring Report MY03
Orange County, NC
Basin 03030002 - Contract # D05011**

KCI Associates of NC, Inc.
Landmark Center II, Suite 220
4601 Six Forks Road
Raleigh, NC 27609

January 2011

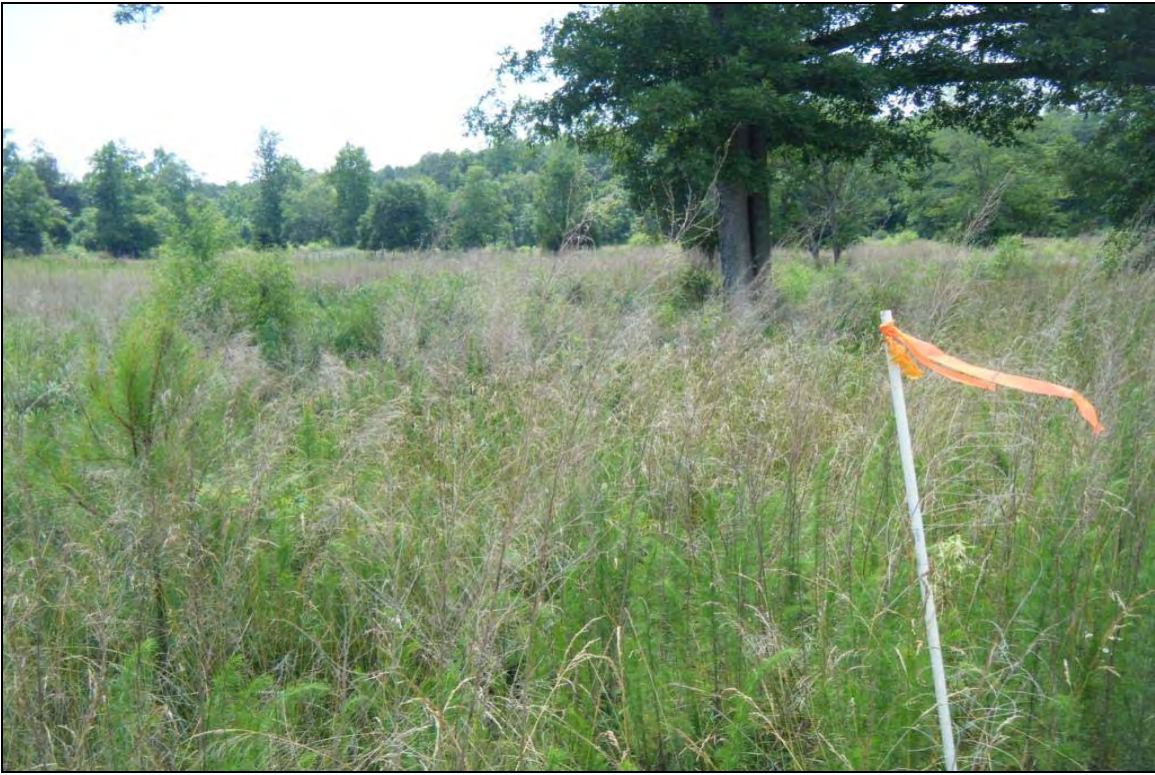
Plot 15 Photo – 6/16/10 - MY 03

The monitored vegetation plots within the stream revealed that the planted vegetation is growing well with an average of 597 stems/acre. There is one monitoring plot (Plot 15) that has a calculated planted stem density less than 320 stems/acre. This is not seen as problematic given the high potential for desirable volunteers to become established in the plots and across the site. Like natural vegetative communities, some areas will have slightly higher densities than others, but the data from the vegetation monitoring plots reveal that the site has an adequate average stem density. The vegetation assessment found the site to be on track to meeting the vegetative success criteria. The vegetative monitoring results are displayed in Appendix A.
