YEAR 2 (2010)
ANNUAL MONITORING REPORT
COLUMBUS SWAMP WETLAND RESTORATION SITE
ROBESON/COLUMBUS COUNTIES, NORTH CAROLINA
(Contract 000619)

FULL DELIVERY PROJECT
TO PROVIDE RIPARIAN WETLAND MITIGATION
IN THE LUMBER RIVER BASIN
CATALOGING UNIT 03040203

August 2010

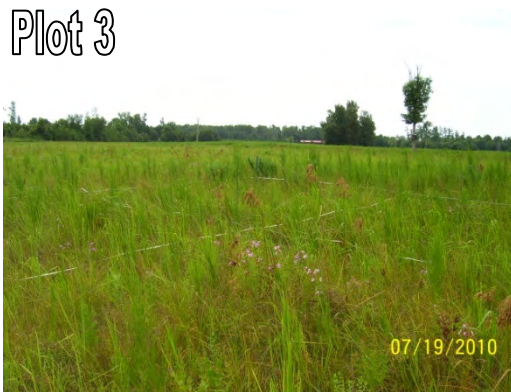
Vegetation sampling across the Site was above the required average density with an overall average of 943 planted stems per acre. In Year 1 (2009), one of the ten vegetation plots (Plot 3) contained no planted stems due to extreme wetness in that portion of the Site. Groundwater Gauge 3, immediately adjacent to this plot, indicated the longest hydroperiod (108 consecutive days or 44.6% of the growing season) of all gauges on the site for the same year. Ground observations indicated that approximately four acres around Plot 3 were vegetated by heavy stands of obligate wetland plants with evidence of standing water. Supplemental planting in this area occurred in late 2009 with species tolerant of long periods of soil saturation or surface inundation (*Nyssa biflora*, *Taxodium distichum*, and *Betula nigra*). This area appears to be doing well and no vegetation problem areas were noted during the Year 2 (2010) monitoring season.
