MONITORING YEAR 1 ANNUAL REPORT

COOL SPRINGS MITIGATION SITE

Harnett County, NC
Cape Fear River Basin
HUC 03030004

DMS Project No. 100166
NCDEQ Contract No. 0302-02
DMS RFP No. 16-20190302/Issued: December 20, 2019
USACE Action ID No. SAW-2020-01400
DWR Project No. 2020-1279

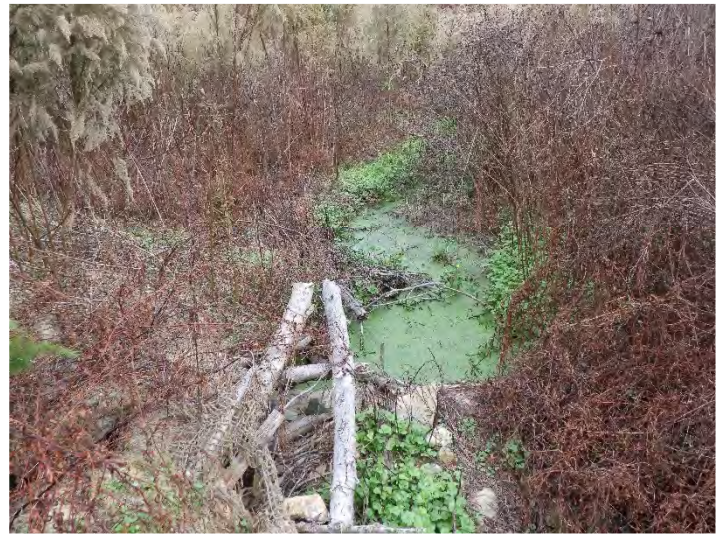
Photo Point 8 T2 – downstream (11/10/2023)

There is undercutting occurring on T2 adjacent to Photo Point 8. This portion of T2 is where mechanical repairs are planned to take place on a series of three failing structures. The status of repairs on T2 is documented in the MY1 report.

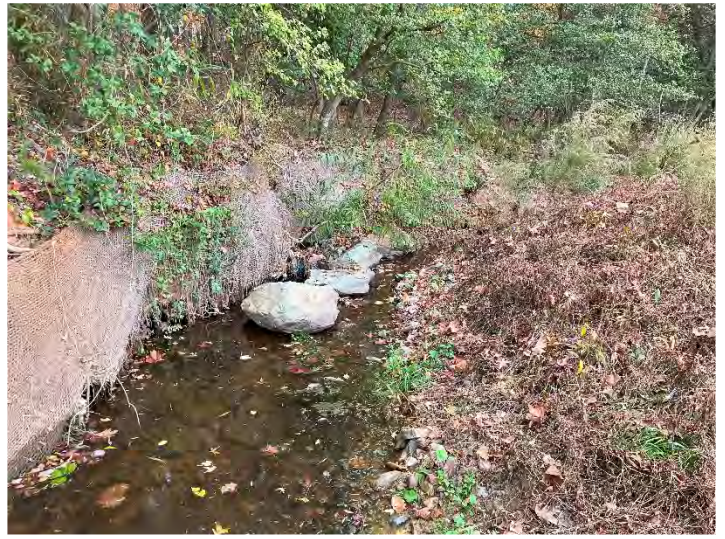
Within the not-for-credit portion of UT to Cedar Creek, located at the lower end of the project stream outside of the easement, localized bank erosion is occurring (see Figure 1b). Boulder toe within this portion of the stream bank dislodged, resulting in bank erosion. Overtime, erosion has spread and worsened, resulting in a partially fallen, mature tree just downstream of the dislodged boulder toe (refer to Appendix A for Stream Area of Concern Photographs). The affected area is approximately 70 linear feet in length. The affected area will continue to be observed, and, if erosion continues to worsen, mechanical repairs may take place in subsequent monitoring years.

UT to Cedar Creek STA 127+74-128+44: Before – Dislodged Boulder Toe on Right Bank Causing Bank Erosion (11/10/2023)

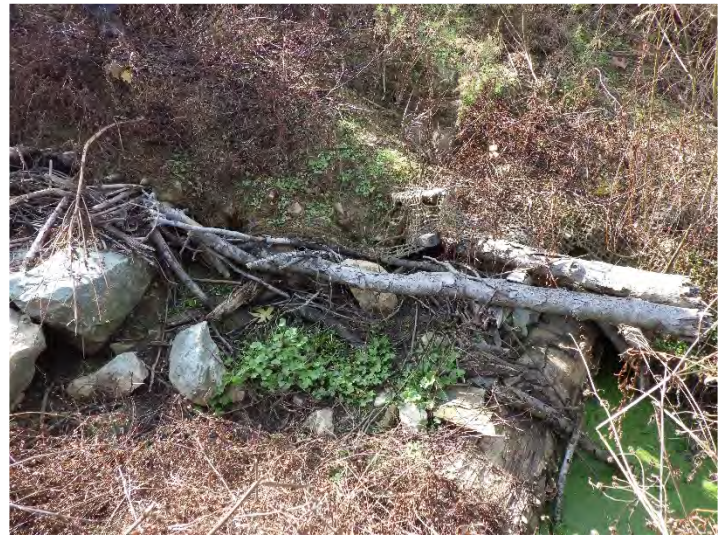
Within the bottom half of T2 adjacent to photo point 8, water is piping around a series of structures consisting of a rock sill and two log sills, resulting in scouring of the left bank and dislodging of associated brush toe (refer to Appendix A for Stream Area of Concern Photographs). The affected area is approximately 24 linear feet in length (see Figure 1a). Hand repairs are planned to take place during MY2 and mechanical repairs will then be utilized if necessary.

T2 STA 303+05-303+20: Before – Piping Log Sill Causing Dislodged Brush Toe and Scouring of the Left Bank (11/29/2023)

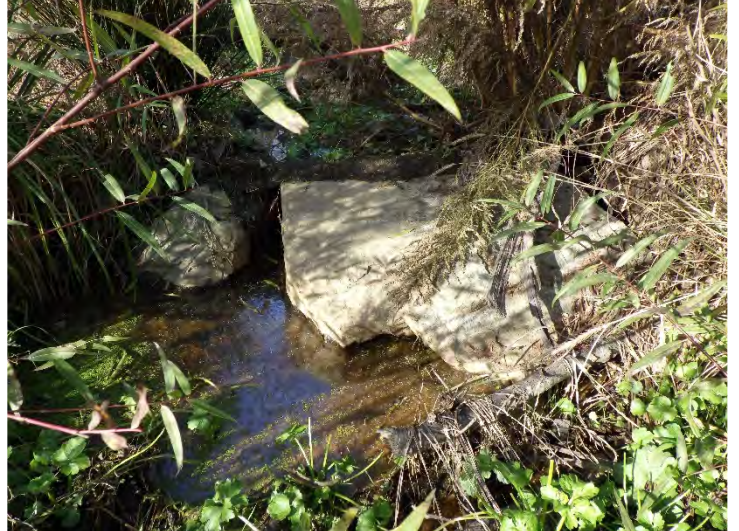
Water is piping around a log sill on T8 adjacent to photo point 20, resulting in scouring of the left bank totaling approximately one foot (see Figure 1b and refer to Appendix A-Stream Area of Concern Photographs). Hand repairs have been performed during MY1 and will be implemented in subsequent monitoring years as necessary. If hand-repairs are unsuccessful, mechanical repairs will be utilized.

T8 STA 902+59: After –Piping Rock Sill Causing Localized Scouring (11/29/2023)

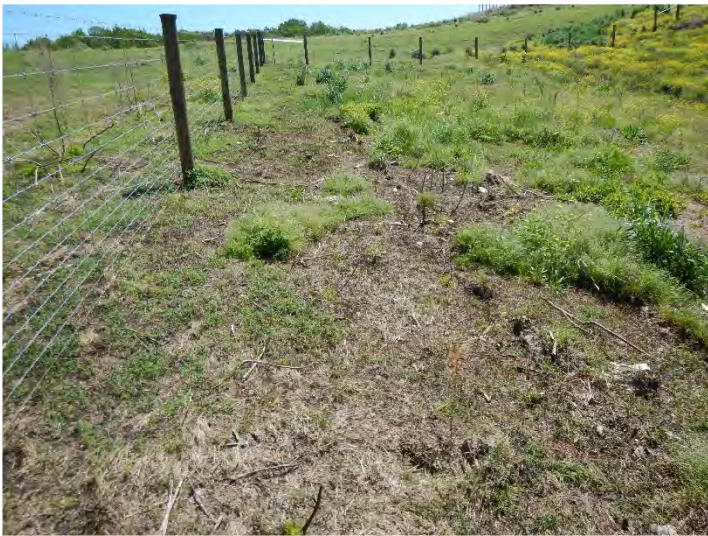
T2 – Four Days After Burned Area First Discovered (4/18/2023)

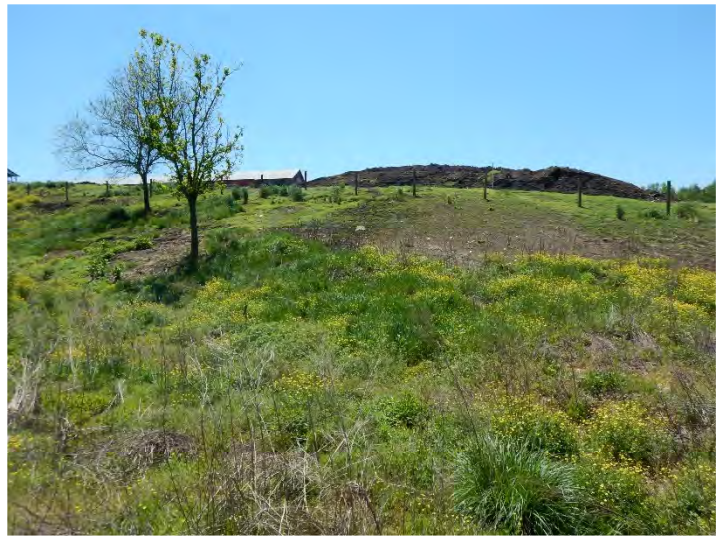
T2 – Four Days After Burned Area First Discovered (4/18/2023)

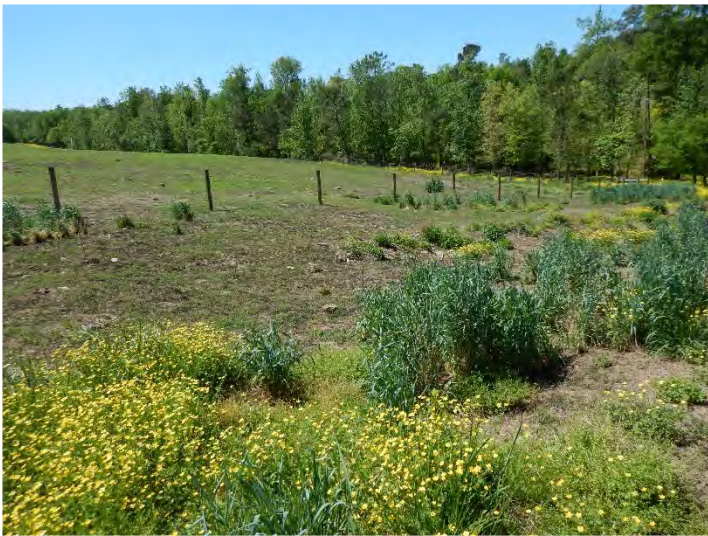
BMP 5 – Four Days After Burn First Discovered (4/18/2023)

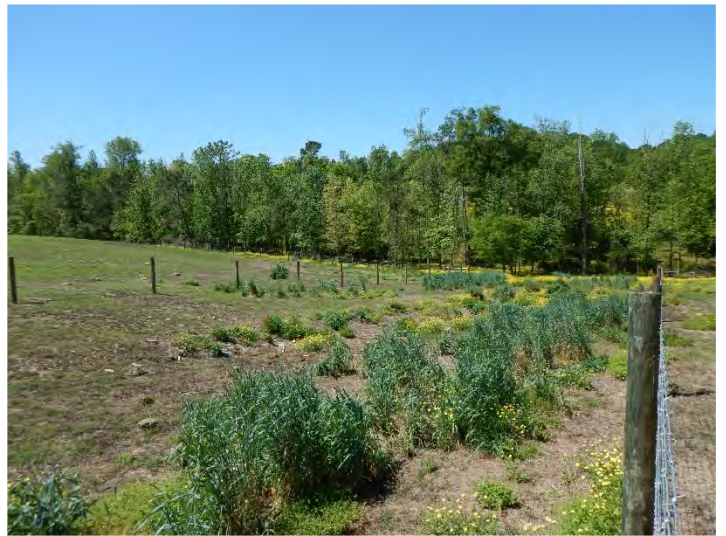
BMP 5 – Four Days After Burn First Discovered (4/18/2023)

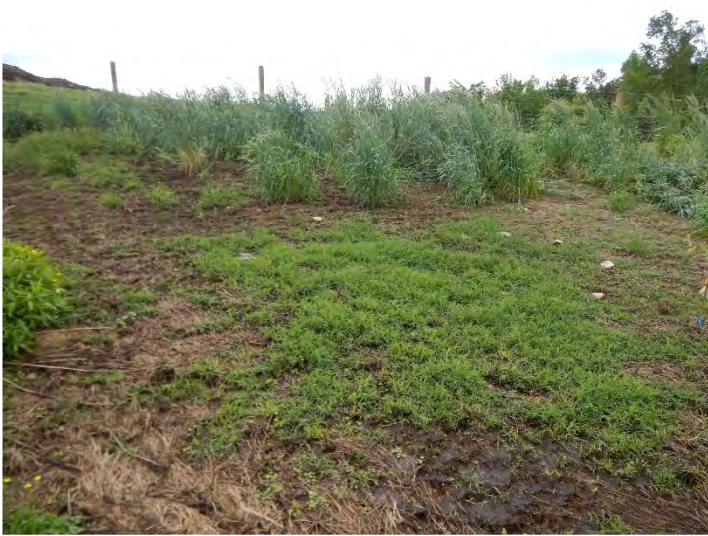
T2 VP 3 – Three Weeks After Burned Area First Discovered (5/4/2023)

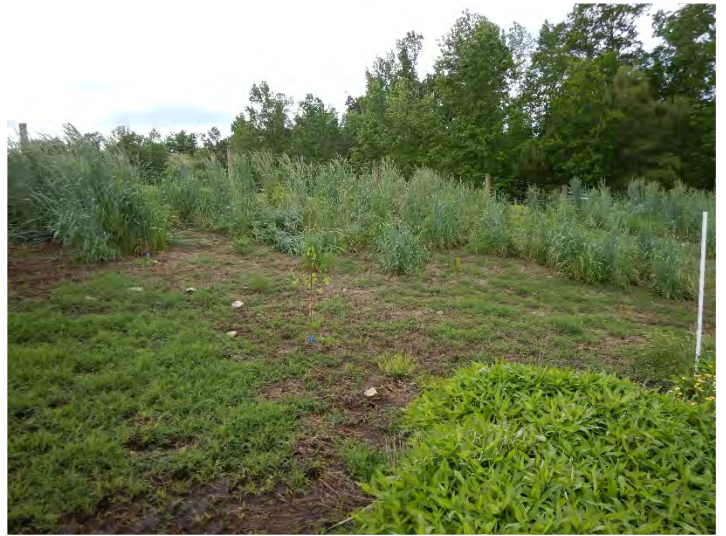
T2 VP 3 – Three Weeks After Burned Area First Discovered (5/4/2023)

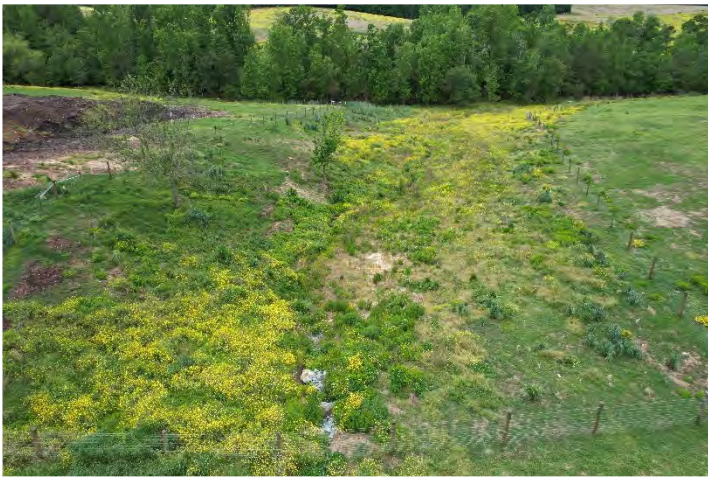
Aerial View of T2 Facing West – Three Weeks After Burned Area First Discovered (5/4/2023)

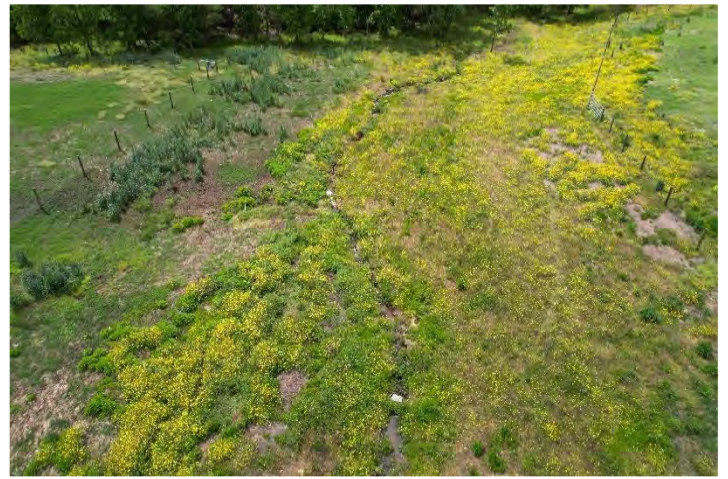
Aerial View of T2 Facing West – Three Weeks After Burned Area First Discovered (5/4/2023)

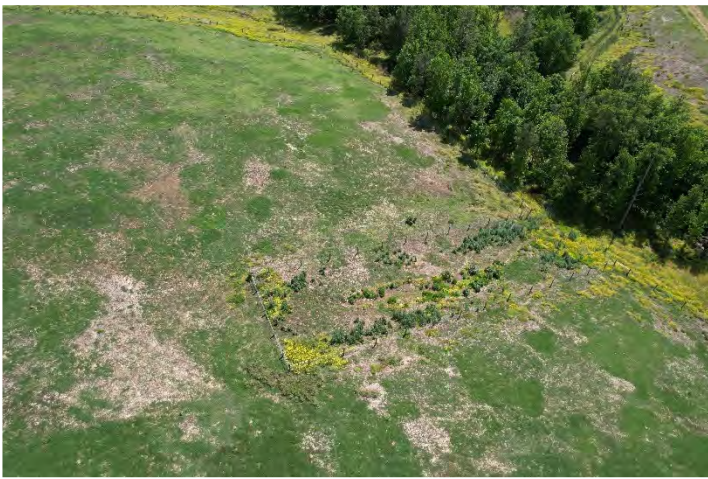
Aerial View of BMP 5 and Adjacent Land Three Weeks After Burned Area First Discovered (5/4/2023)

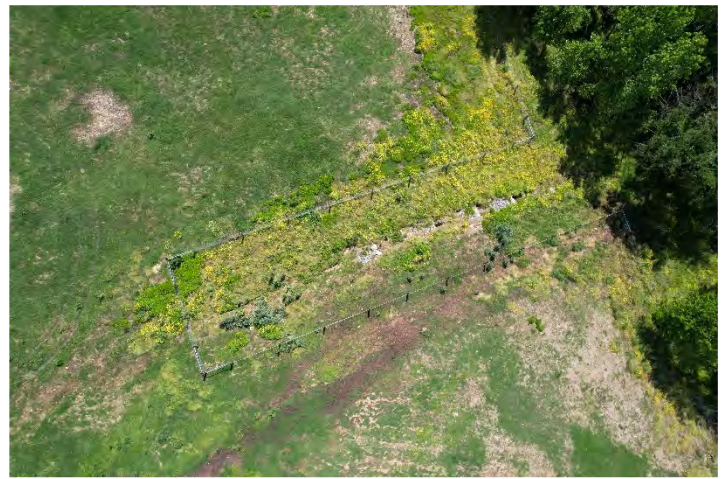
Aerial View of BMP 3 and Adjacent Land Three Weeks After Burned Area First Discovered (5/4/2023)

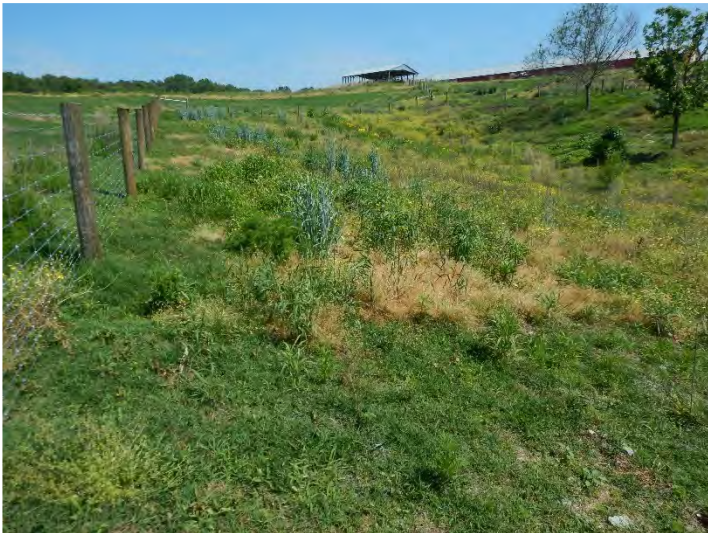
T2 – Four Weeks After Burned Area First Discovered (5/12/2023)

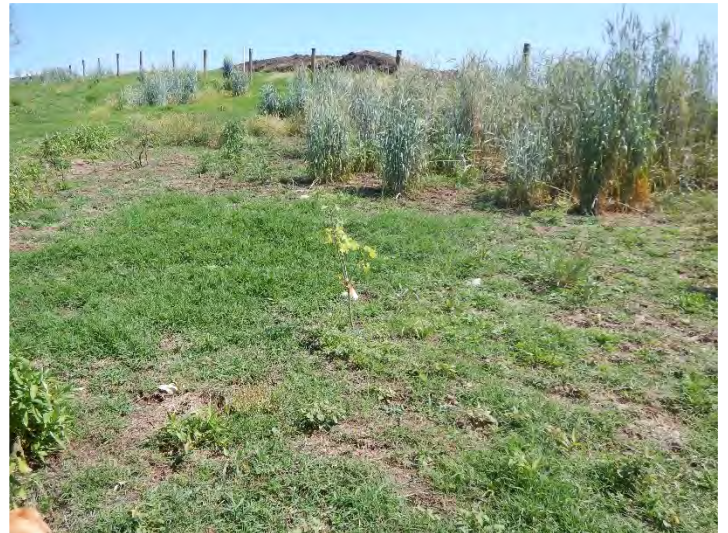
T2 VP 3 – Four Weeks After Burned Area First Discovered (5/12/2023)

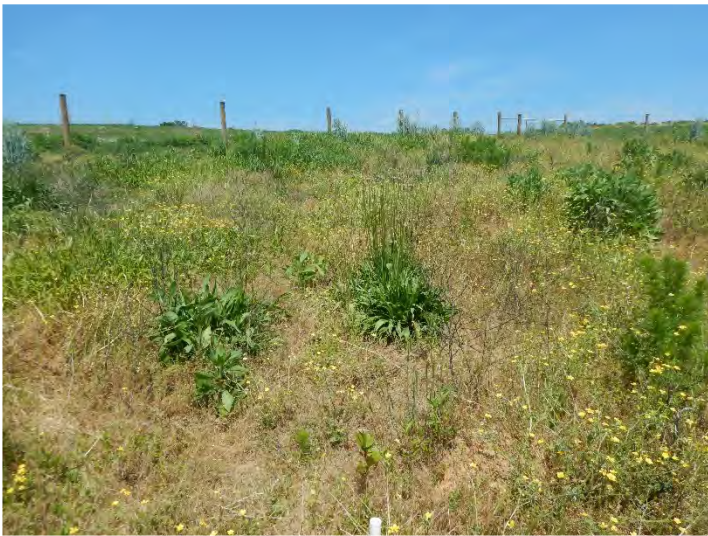
T2 – Four Weeks After Burned Area Discovered (5/12/2023)

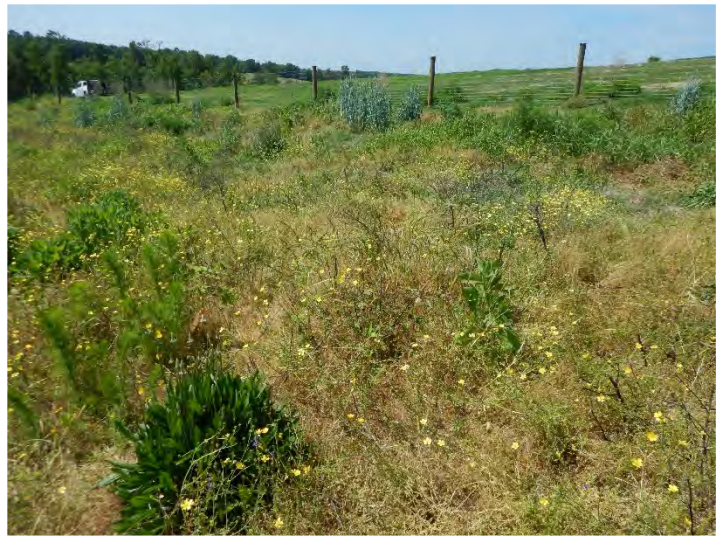
T2 – Four Weeks After Burned Area Discovered (5/12/2023)

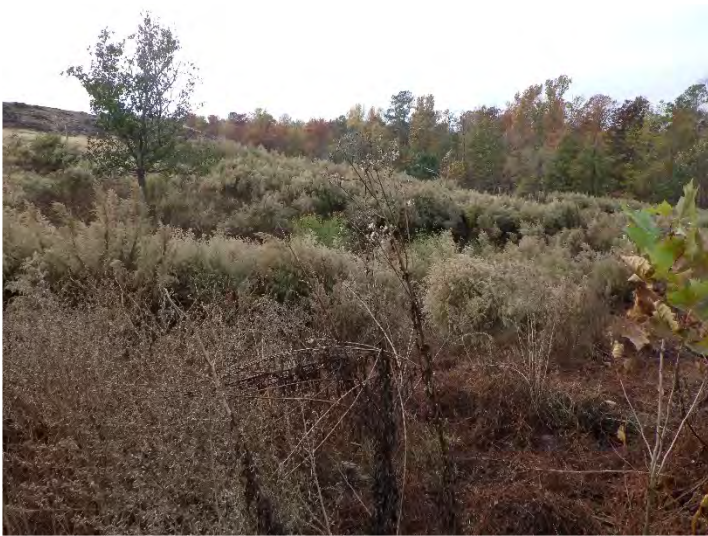
In response to the fire encroachment in MY0, Bermuda grass (*Cynodon dactylon*) has been observed growing prolifically during MY1 along T2 and BMP 3. Foliar spray treatments for smartweed (*Polygonum* sp.) and Bermuda grass were applied in affected areas along T2 and BMP 3 (see Figure 1a). Soil amendments were applied in a localized manner around the base of trees throughout the Site in the spring of 2023. Broadcast seeding was applied in bare areas throughout the Site, and around trees in burned areas where there is heavy Bermuda grass growth. All project streams received foliar spraying for in-stream vegetation, and pockets of *Murdannia keisak* were treated in streams and in wetlands

T2 – Seven Months After Burned Area Discovered (11/10/2023)

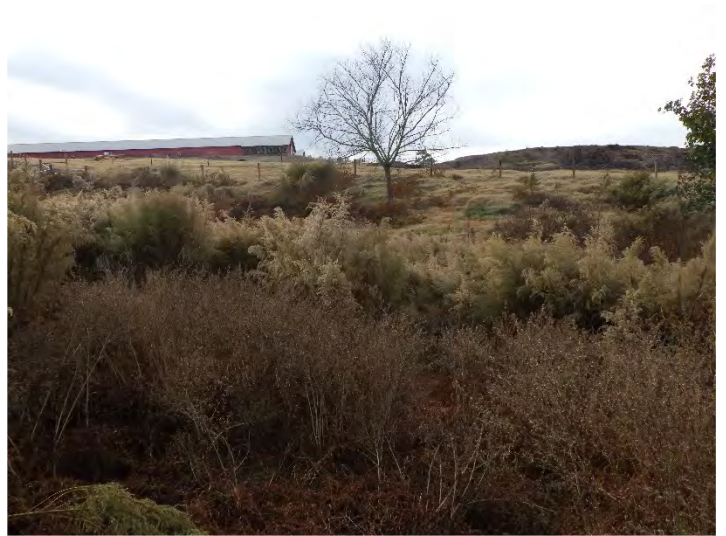
T2 – Seven Months After Burned Area Discovered (11/10/2023)

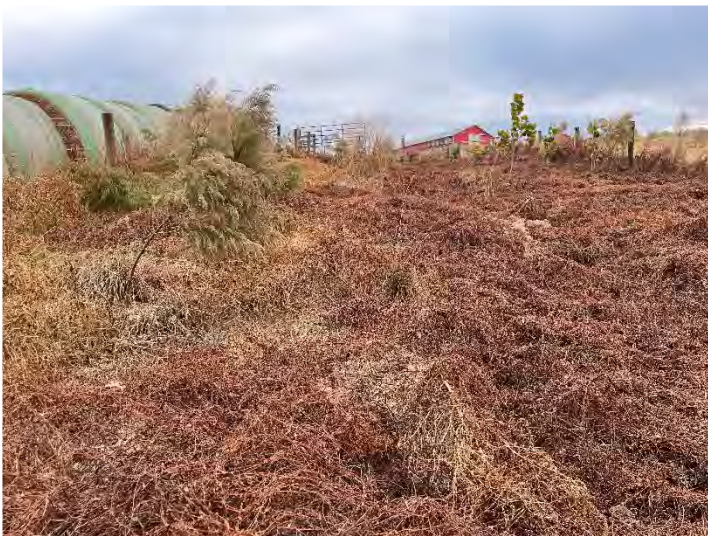
BMP 3 – Seven Months After Burned Area First Discovered (11/10/2023)

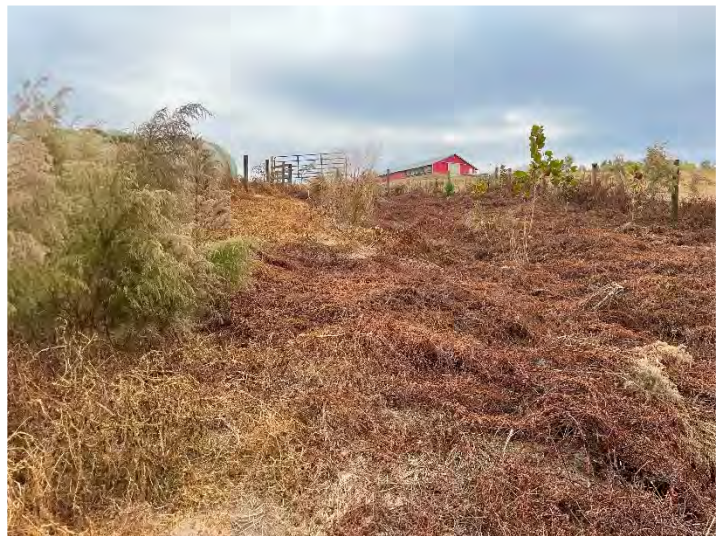
BMP 3 – Seven Months After Burned Area First Discovered (11/10/2023)

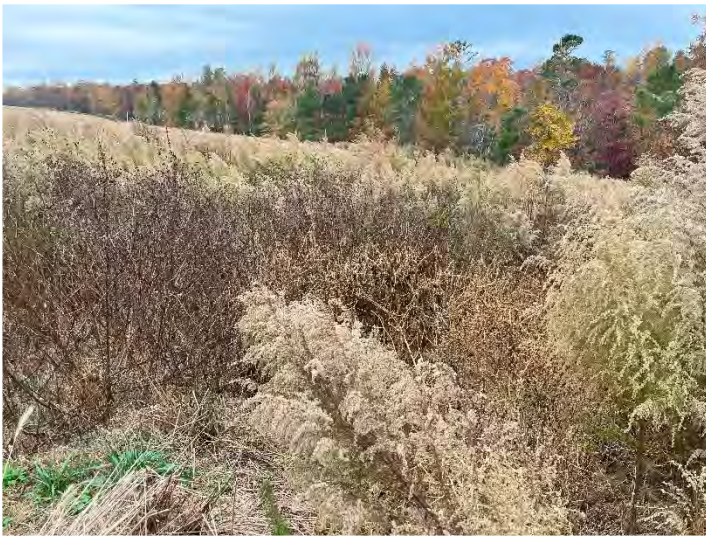
**BMP 5 – Seven Months After Burned Area First Discovered
(11/10/2023)**

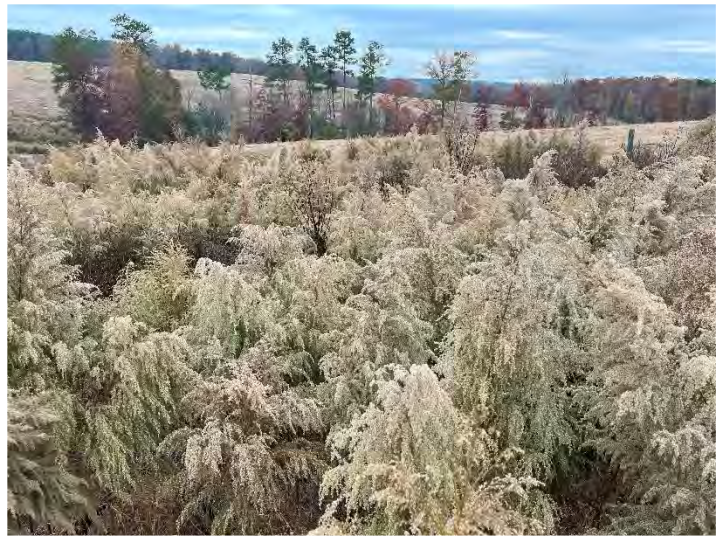
**BMP 5 – Seven Months After Burned Area First Discovered
(11/10/2023)**

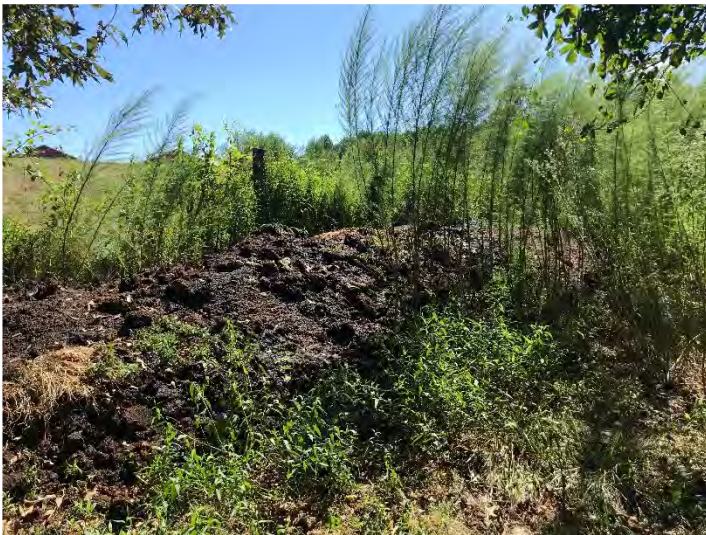
A chicken manure pile spanning approximately 560 square feet was found in the conservation easement near BMP 2 during an August, 2023 Site visit (see Figure 1a and Appendix A). Because the pile doesn't cover more than a couple of planted stems, the pile will not be removed. However, it has been seeded to assist in stabilization. The landowner has been notified, and the easement will continue to be monitored for future manure dumping.

**Chicken Litter Pile Dumped at Fenceline Directly Perpendicular
to BMP 2 (9/1/2023)**
