MONITORING YEAR 0 ANNUAL REPORT

COOL SPRINGS MITIGATION SITE

Harnett County, NC
Cape Fear River Basin
HUC 03030004

DMS Project No. 100166
NCDEQ Contract No. 0302-02
DMS RFP No. 16-20190302/Issued: December 20, 2019
USACE Action ID No. SAW-2020-01400
DWR Project No. 2020-1279

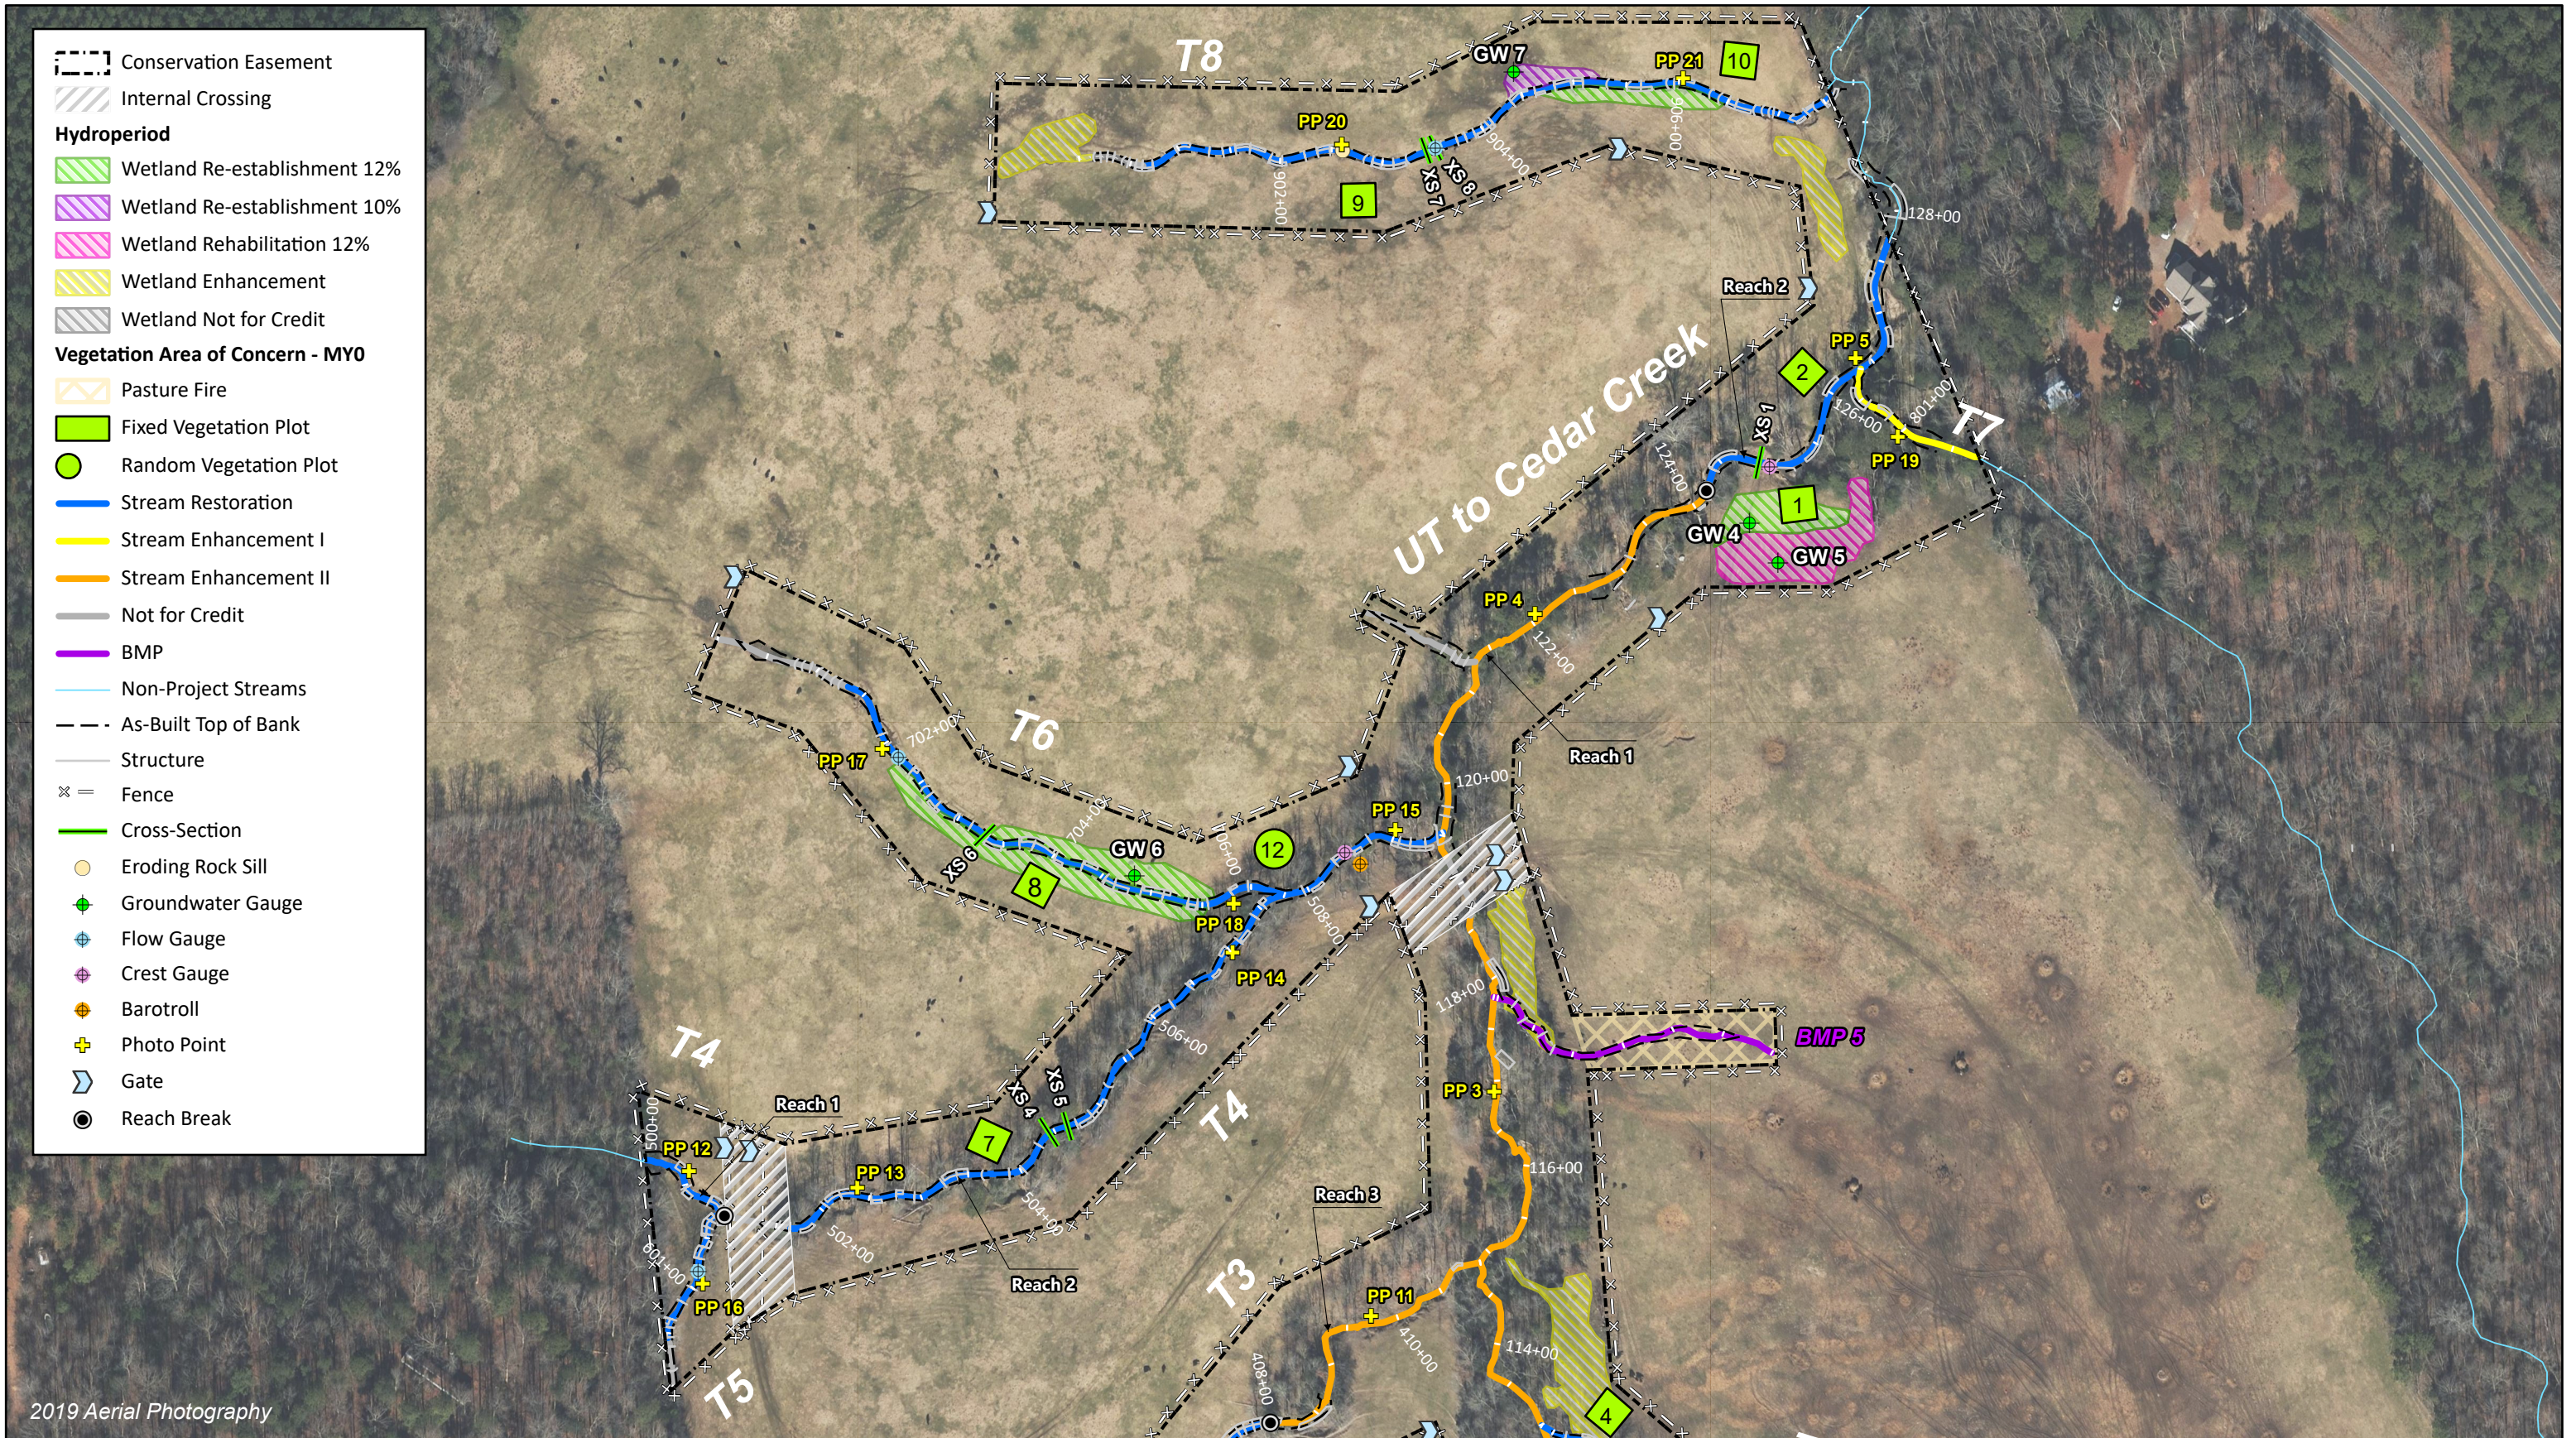
Figure 1b. Current Condition Plan View
Cool Springs Mitigation Site
DMS Project No. 100166
Monitoring Year 0 - 2023

Water is piping around a boulder sill on T8 adjacent to photo point 20, resulting in scouring of the left bank totaling approximately one foot (see Figure 1b and refer to Appendix A-Stream Area of Concern Photographs). Hand repairs are planned to take place during MY1 or MY2. If hand-repairs are unsuccessful, mechanical repairs may be utilized.

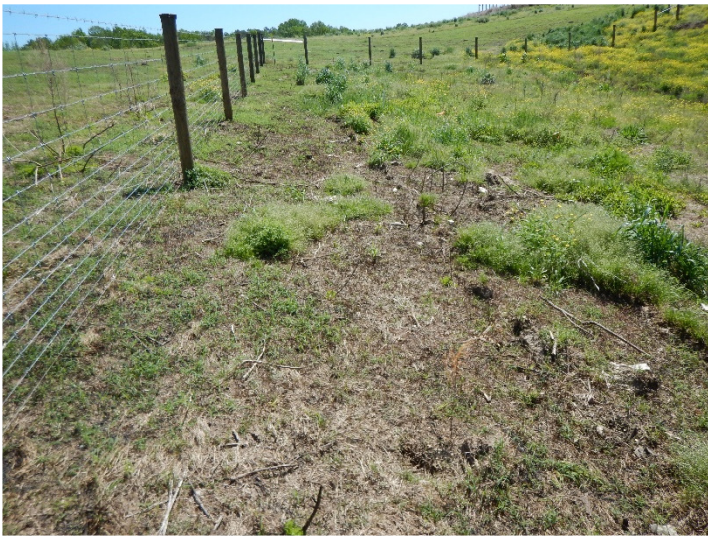
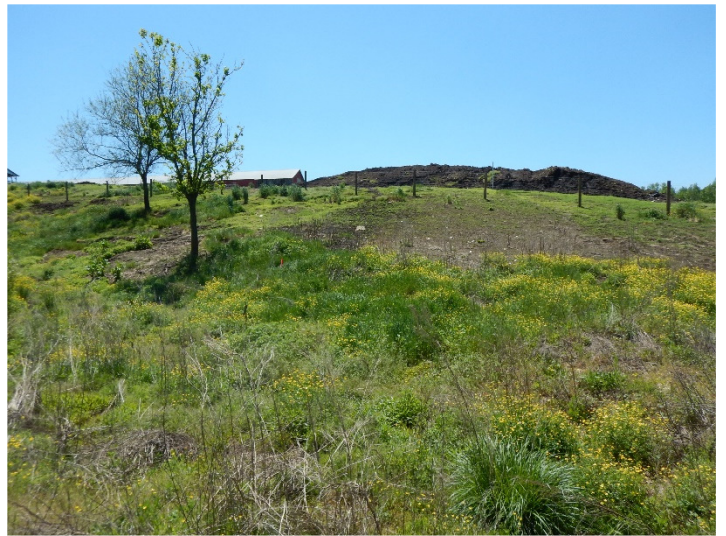
Evidence of a fire was observed on April 14, 2023 throughout pastureland directly adjacent to the conservation easement. Based on the level of surface charring, the fire is estimated to have occurred within the first two weeks of April. The fire is the result of a landowner prescribed pasture management practice and is unrelated to Wildlands. The prescribed burn encroached into the following portions of the conservation easement: portions of T2 and BMP 3, 4, and 5 (see Figure 1a-1b). In total, approximately 1 acre of the conservation easement was affected by the prescribed fire. The entirety of vegetation plot 3 was burned; however, planted stems seem to have survived, as evidenced by new sprouts and new leaf growth (refer to Appendix A for Easement Encroachment Photographs). Herbaceous cover has started to return on all charred areas of T2, BMP 3, 4, and 5. Vegetation plot 3 will be monitored and reported on during MY1. A random (mobile) vegetation plot along T2 will be monitored and reported on during MY1 to assess the extent of burn damage, as well.

T2 – Four Days After Burned Area First Discovered (4/18/2023)

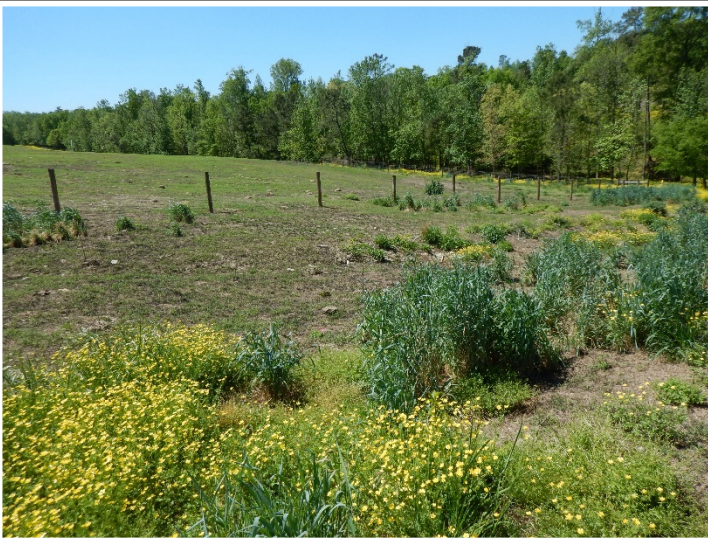
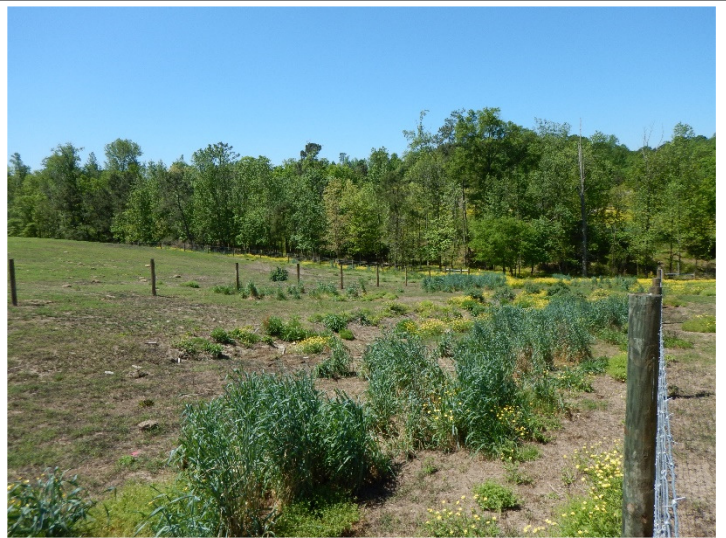
BMP 5 – Four Days After Burn First Discovered (4/18/2023)

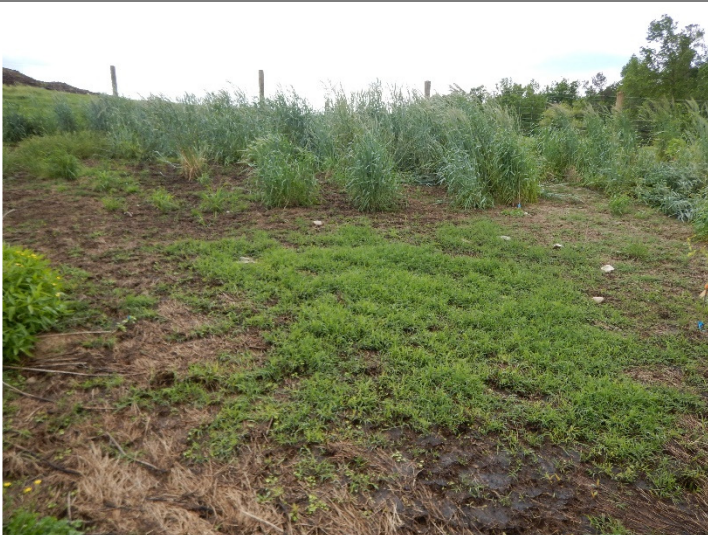
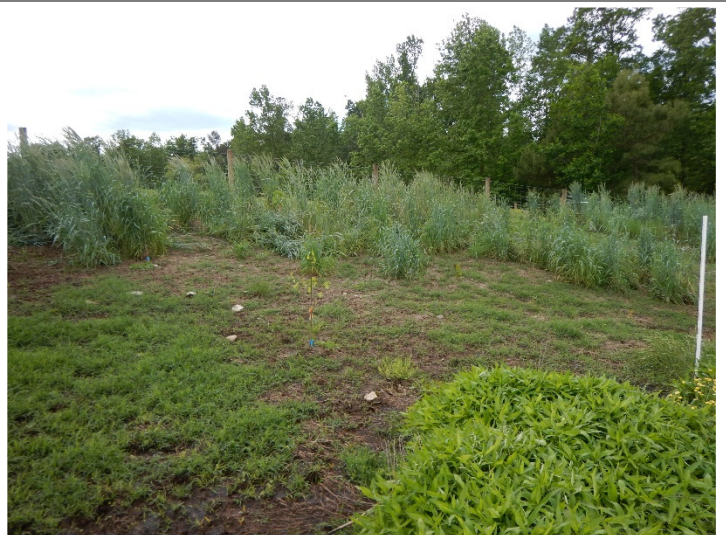
T2 VP 3 – Three Weeks After Burned Area First Discovered (5/3/2023)

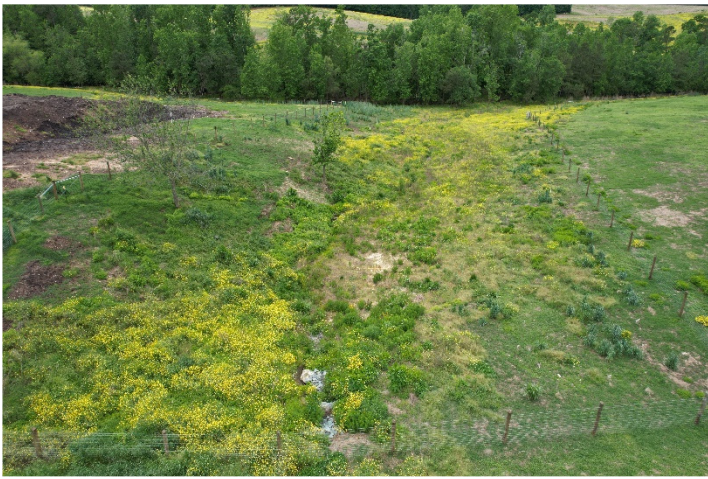
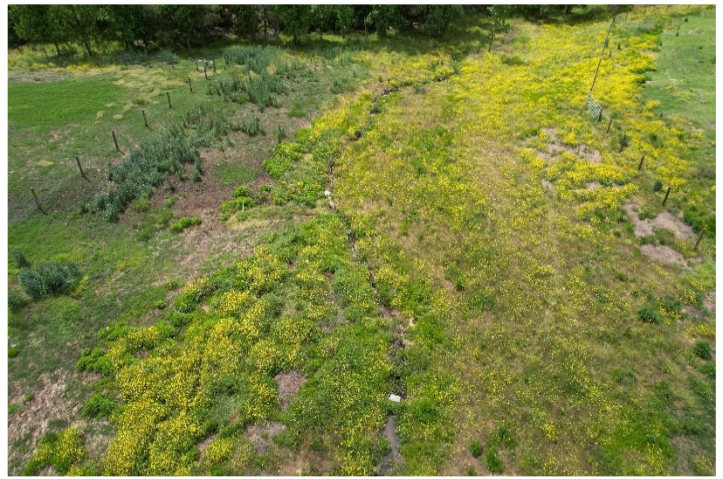
Aerial View of T2 Facing West – Three Weeks After Burned Area First Discovered (5/3/2023)

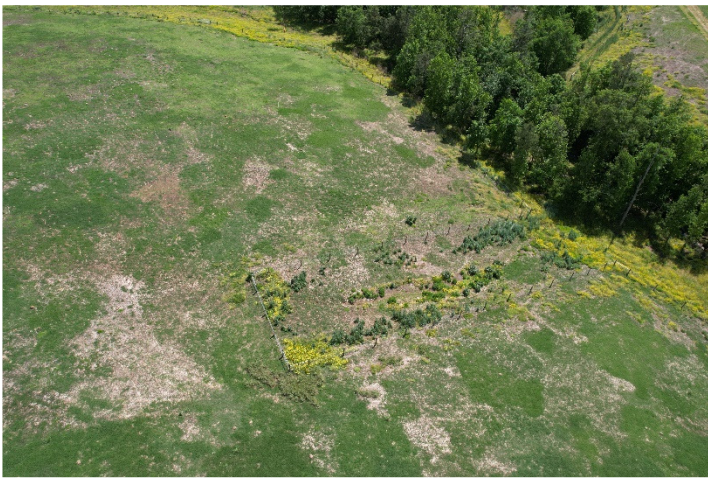
Aerial View of BMP 5 and Adjacent Land Three Weeks After Burned Area First Discovered (5/3/2023)

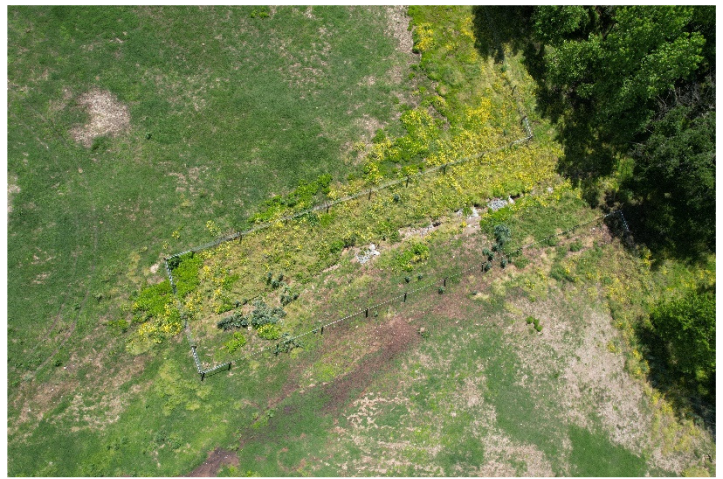
Aerial View of BMP 3 and Adjacent Land Three Weeks After Burned Area First Discovered (5/3/2023)

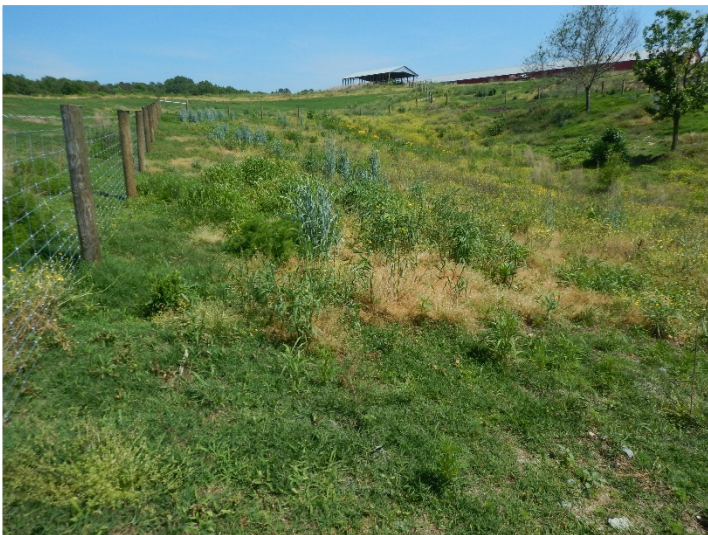
T2 – Four Weeks after Burned Area First Discovered (5/12/2023)

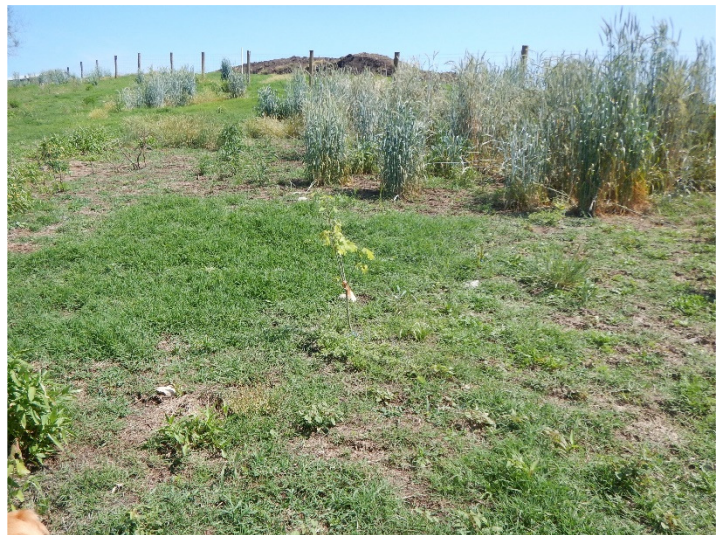
T2 VP 3 – Four Weeks After Burned Area First Discovered (5/12/2023)

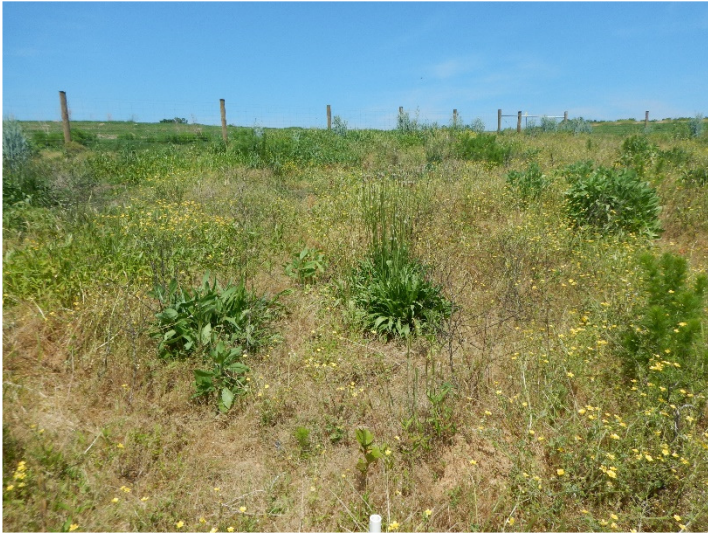
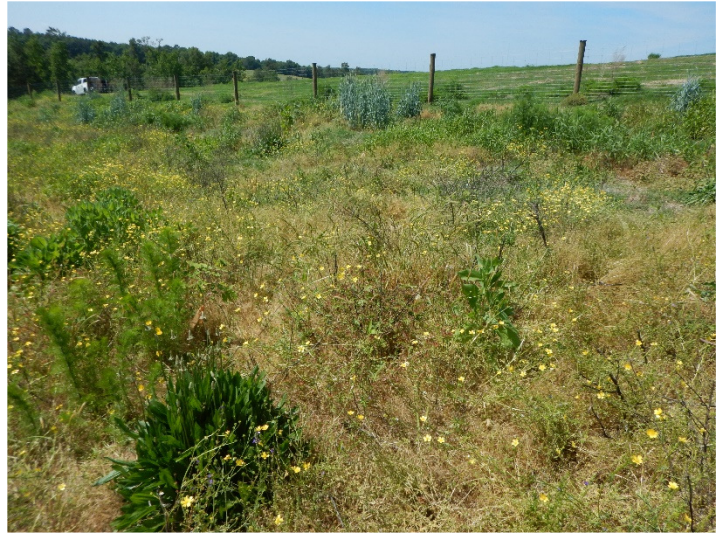
T2 RVP 11 – Four Weeks after Burned Area First Discovered
(5/12/2023)

T2 RVP 11 – Four Weeks After Burned Area First Discovered
(5/12/2023)
