**Coon Creek Riparian Buffer and Nutrient Offset Mitigation Project  
2018 Monitoring Report  
Monitoring Year 5 of 5**

**Granville County, North Carolina  
Tar-Pamlico River Basin  
USGS Hydrologic Unit 03020101**

**NCDMS Project No. 95807  
NCDMS Contract No. 5153**

2018 Monitoring Report – Year 5 of 5

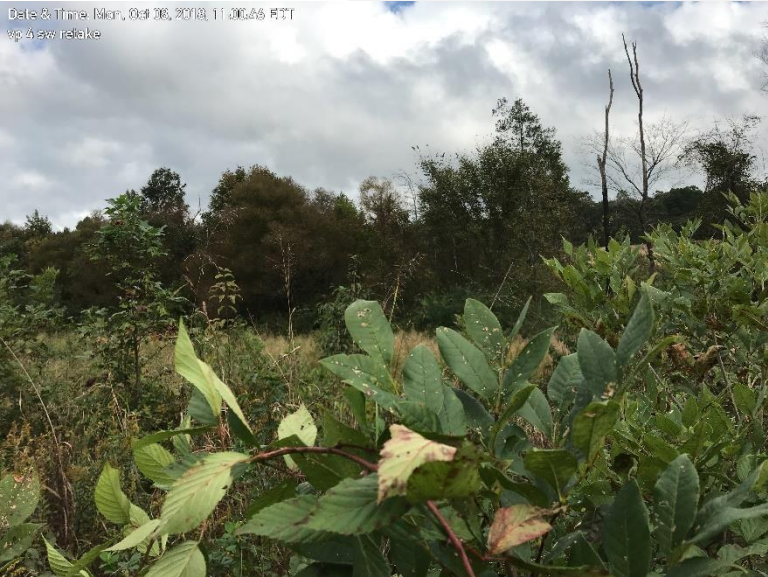
<b>Client Name:</b> DMS		<b>Site Location:</b> Coon Creek Riparian Buffer and Nutrient Offset Mitigation Project	<b>Project No.</b> NCDMS No. 95807
<b>Photo No.</b> 4	<b>Date:</b> 10/8/2018

<p><small>Date &amp; Time: Mon, Oct 08, 2018, 11:00:45 EDT vp 4 aw release</small></p>	
<b>Description</b> Vegetation Plot #4. Standing in the southwest corner, facing northeast.

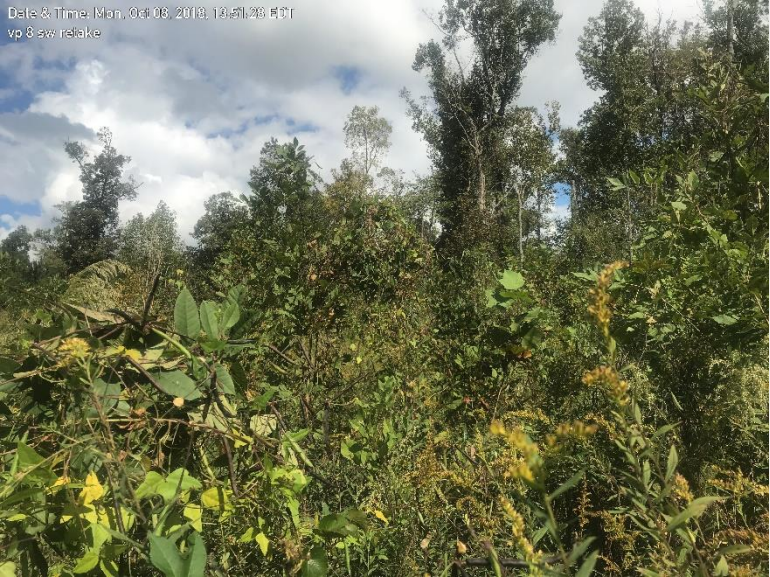
<b>Client Name:</b> DMS		<b>Site Location:</b> Coon Creek Riparian Buffer and Nutrient Offset Mitigation Project	<b>Project No.</b> NCDMS No. 95807
<b>Photo No.</b> 8	<b>Date:</b> 10/8/2018

<p><small>Date &amp; Time: Mon, Oct 08, 2018, 14:51:28 EDT vp 8 sw-relake</small></p>	
<b>Description</b> Vegetation Plot #8. Standing in the southwest corner, facing northeast.

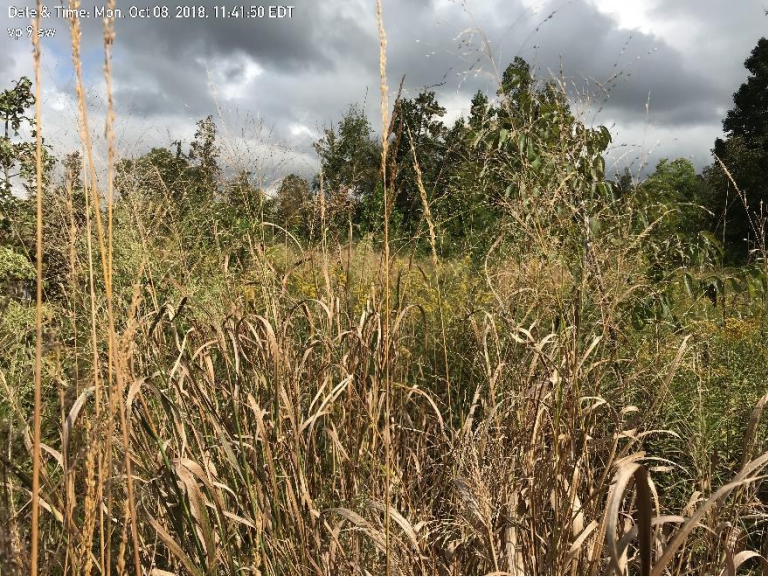
<b>Client Name:</b> DMS		<b>Site Location:</b> Coon Creek Riparian Buffer and Nutrient Offset Mitigation Project	<b>Project No.</b> NCDMS No. 95807
<b>Photo No.</b> 9	<b>Date:</b> 10/8/2018

<b>Description</b> Vegetation Plot #9. Standing in the southwest corner, facing northeast.

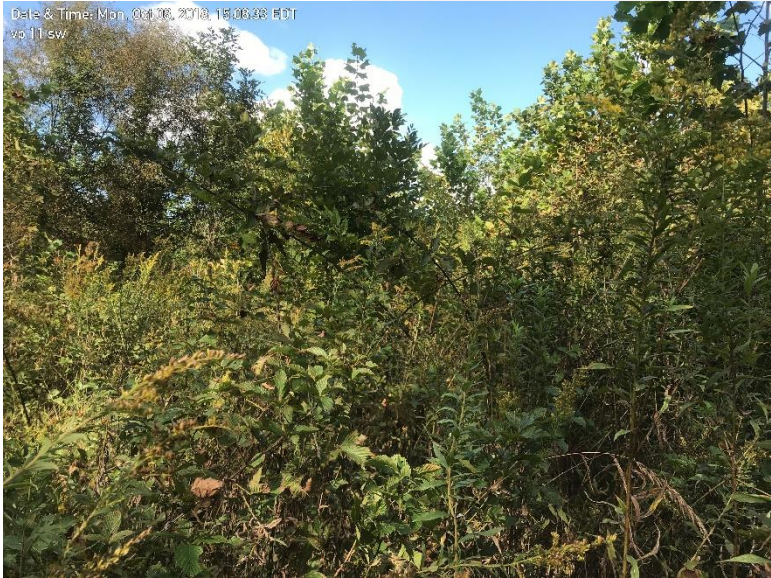
<b>Client Name:</b> DMS		<b>Site Location:</b> Coon Creek Riparian Buffer and Nutrient Offset Mitigation Project	<b>Project No.</b> NCDMS No. 95807
<b>Photo No.</b> 11	<b>Date:</b> 10/8/2018

<b>Description</b> Vegetation Plot #11. Standing in the southwest corner, facing northeast.

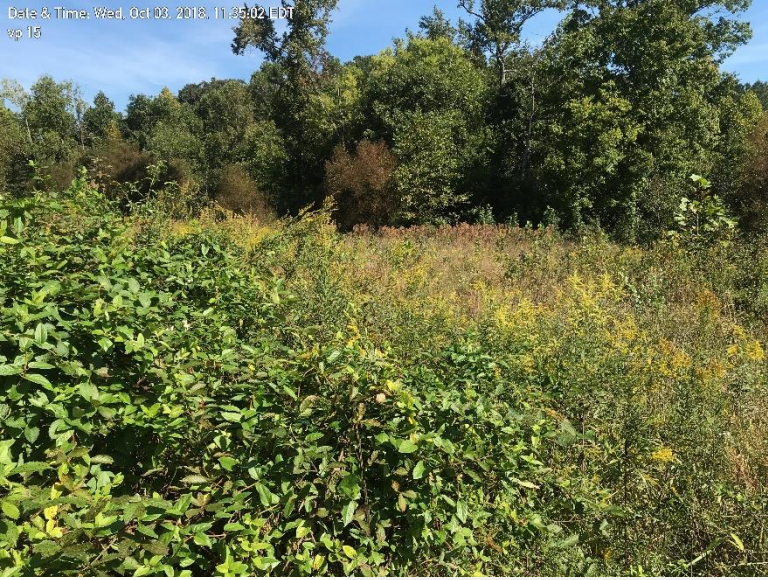
<b>Client Name:</b> DMS		<b>Site Location:</b> Coon Creek Riparian Buffer and Nutrient Offset Mitigation Project	<b>Project No.</b> NCDMS No. 95807
<b>Photo No.</b> 15	<b>Date:</b> 10/3/2018

<p><small>Date &amp; Time: Wed, Oct 03, 2018, 11:35:02 EDT vp.15</small></p>	
<b>Description</b> Vegetation Plot #15. Standing in the southwest corner, facing northeast.

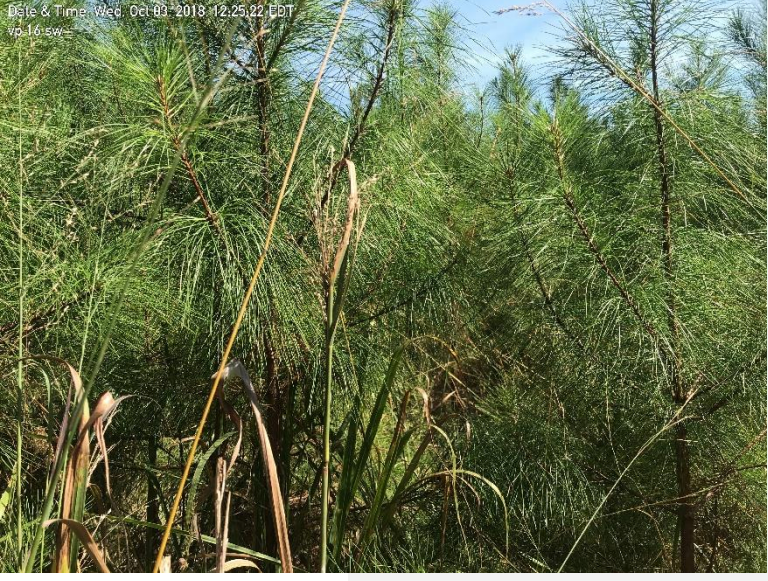
<b>Client Name:</b> DMS		<b>Site Location:</b> Coon Creek Riparian Buffer and Nutrient Offset Mitigation Project	<b>Project No.</b> NCDMS No. 95807
<b>Photo No.</b> 16	<b>Date:</b> 10/3/2018

<p><small>Date &amp; Time: Wed, Oct 03, 2018, 12:25:22 EDT vp.16-sw</small></p>	
<b>Description</b> Vegetation Plot #16. Standing in the southwest corner, facing northeast.

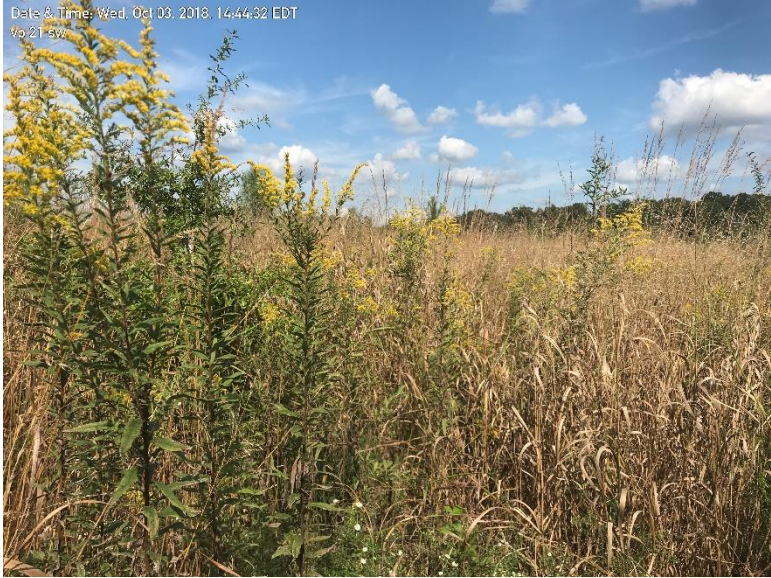
<b>Client Name:</b> DMS		<b>Site Location:</b> Coon Creek Riparian Buffer and Nutrient Offset Mitigation Project	<b>Project No.</b> NCDMS No. 95807
<b>Photo No.</b> 21	<b>Date:</b> 10/3/2018

<p>Date &amp; Time: Wed, Oct 03, 2018, 14:44:32 EDT tp 21.sw</p>	
<b>Description</b> Vegetation Plot #21. Standing in the southwest corner, facing northeast.

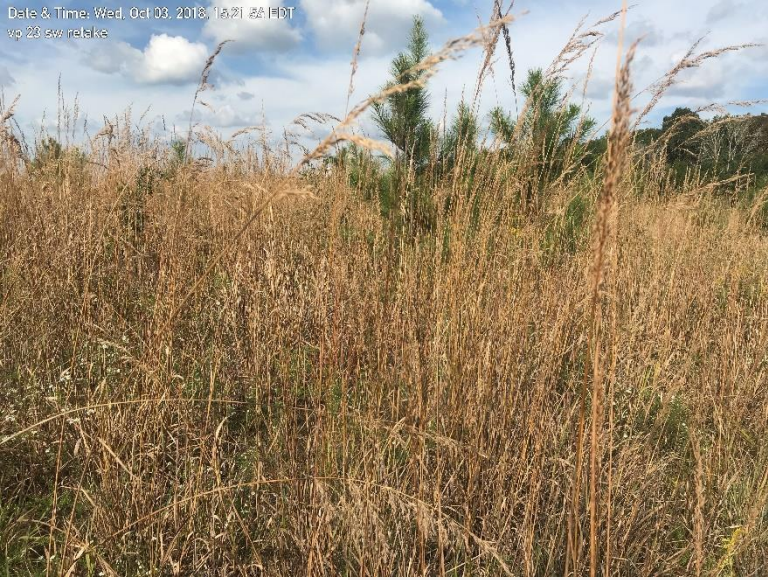
<b>Client Name:</b> DMS		<b>Site Location:</b> Coon Creek Riparian Buffer and Nutrient Offset Mitigation Project	<b>Project No.</b> NCDMS No. 95807
<b>Photo No.</b> 23	<b>Date:</b> 10/3/2018

<b>Description</b> Vegetation Plot #23. Standing in the southwest corner, facing northeast.

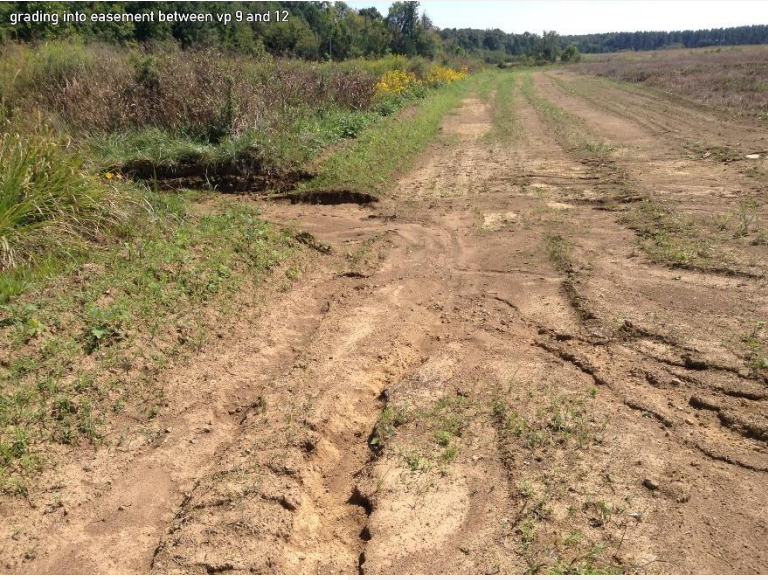
<b>Client Name:</b> DMS		<b>Site Location:</b> Coon Creek Riparian Buffer and Nutrient Offset Mitigation Project	<b>Project No.</b> NCDMS No. 95807
<b>Photo No.</b> 25	<b>Date:</b> 9/13/2017

Grading into the easement was observed in September of MY4, between Vegetation Monitoring Plot 9 and 12. The grading appeared to have been done by the landowner to address a drainage problem on the farm road at the edge of the easement. This did not appear to have impacted planted stems or contributed sediment to the project stream. OBG worked with the landowner to reach an adequate solution. The area within the easement was returned to original grade, matted, and re-seeded with an appropriate native species seed mix. The farm road was reinforced with riprap, and the upslope area was stabilized to prevent further sediment from entering the easement.

<p>grading into easement between vp 9 and 12</p>	
<b>Description</b> Pre-construction view of erosion issue between vegetation plot 9 and 12. Phot taken facing south.
