COOR ISLAND MITIGATION SITE

Year 1 Monitoring Report (2023)
Wayne County, North Carolina
Neuse River Basin - 03020201

DMS Project ID No. 100183
Full Delivery Contract No. 0402-03
DWR Project No. 2021 0021 v3
RFP No. 16-20200402

**FINAL
MY1 (2023) MONITORING REPORT**

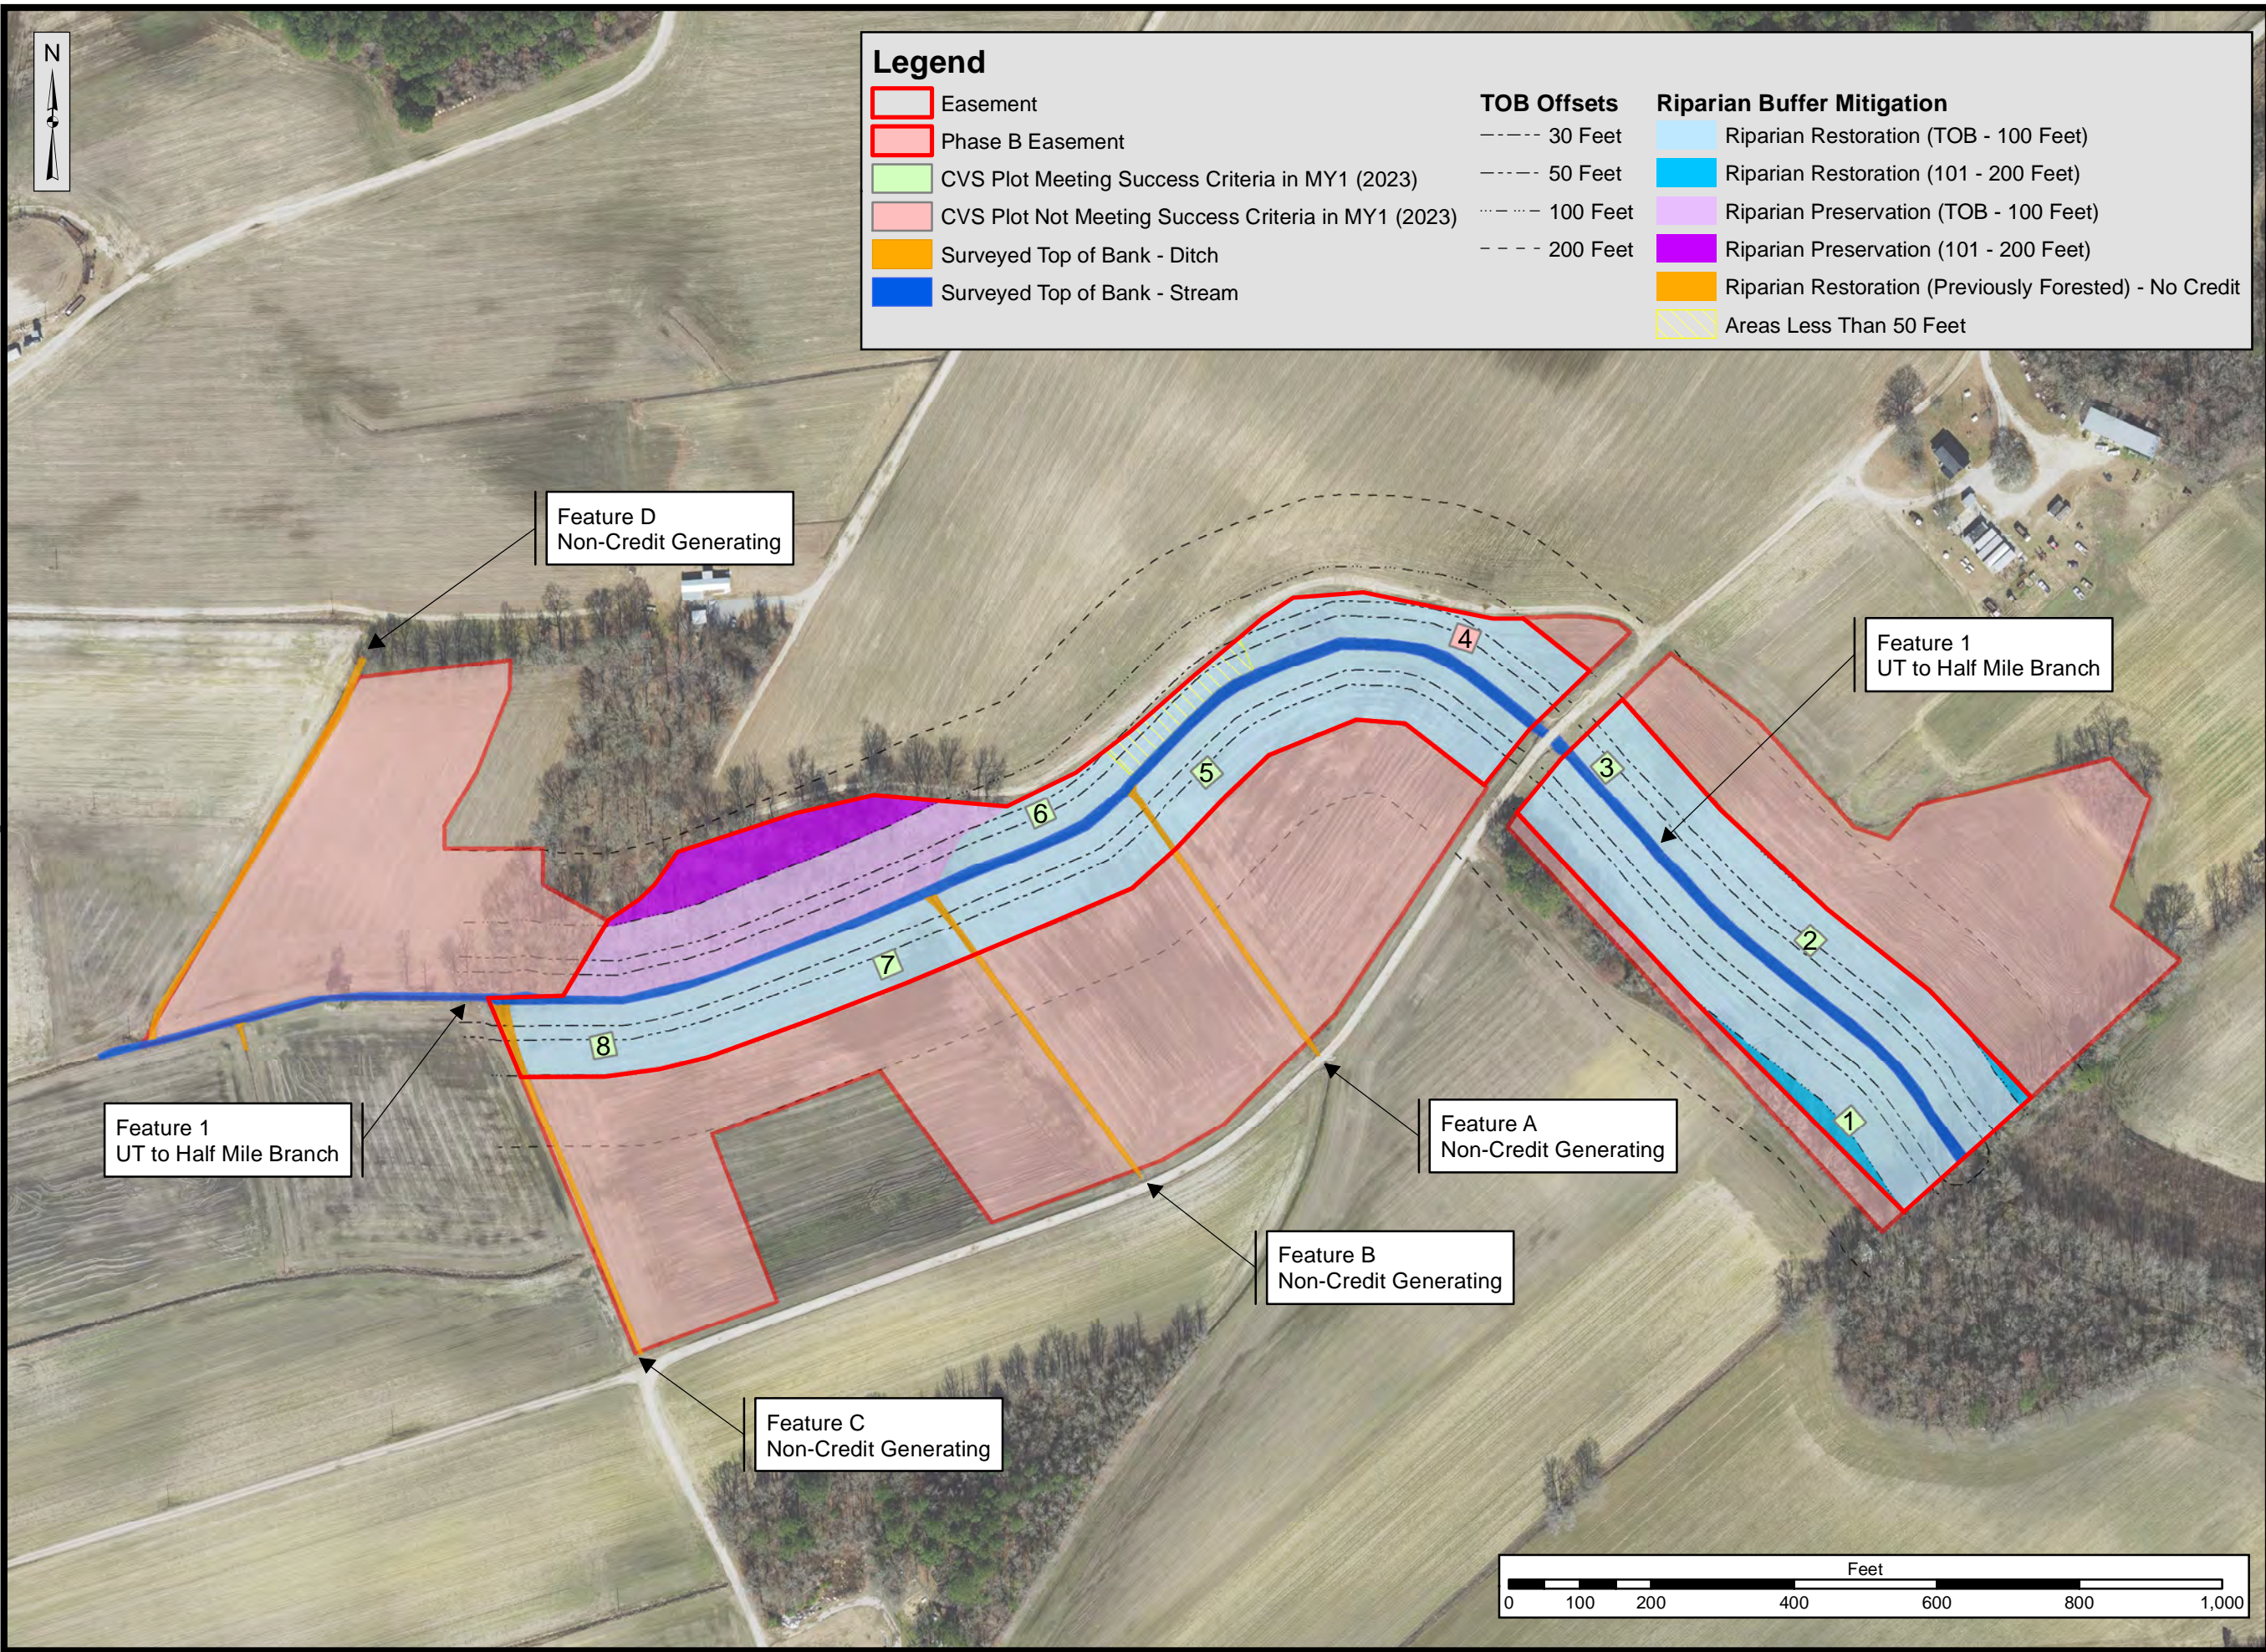
CURRENT CONDITIONS PLAN VIEW

1. Figure 2: Please include the Phase B easement on the figure.
Response: The Phase B easement has been added to the CCPV figure.
2. Figure 2: Please make the symbology for streams vs ditches different.
Response: The symbology on the CCPV has been updated. Streams are depicted in blue and ditches in orange.
3. Please provide documentation of completed MYO boundary inspection comment action items.
Response: A response to the MYO boundary inspection action items was added as Appendix C.
4. Please include the buffer credit table excel spreadsheet in the digital submittal.
Response: The MYO Buffer Credit Table – excel spreadsheet was added to the digital submittal.

- Measurements of the 8 vegetation plots resulted in an average of 430 planted stems/acre. All individual plots met success criteria except plot 4. Plot 4 failed to meet the success criteria by less than 10% with an average of 243 stems/acre.
- All 8 vegetation plots contained at least 4 native hardwood and native shrub species where no one species was greater than 50 % of stems.
