County Line Creek Stream Restoration (High Vista) 2004 Annual Monitoring Report

March, 2005

2004 County Line Creek Monitoring Abstract

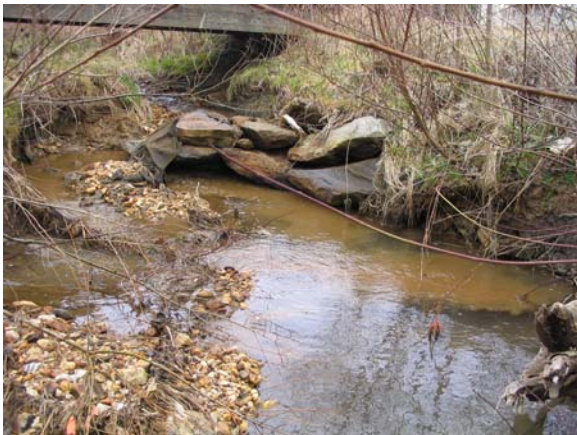
Issue Photo 1. Failed Structure STA: 35+10

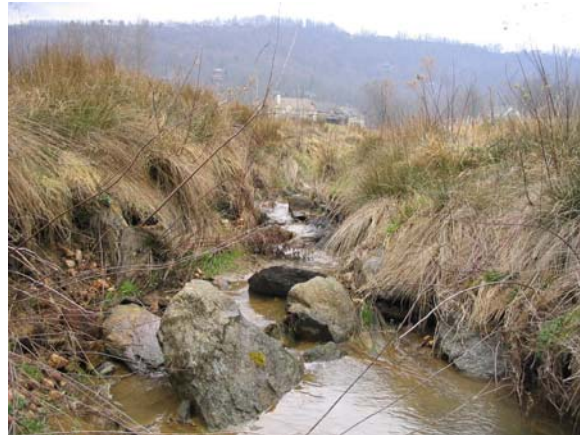
- At station 28+60 the rock cross vane has failed and needs to be repaired as soon as possible the reach near this failed rock vane has a severe head-cut of about one and a half foot. The banks near this reach are severely unstable and the channel is enlarged significantly

Issue Photo 2. Bank Erosion & Failed Rock Vane STA: 28+60

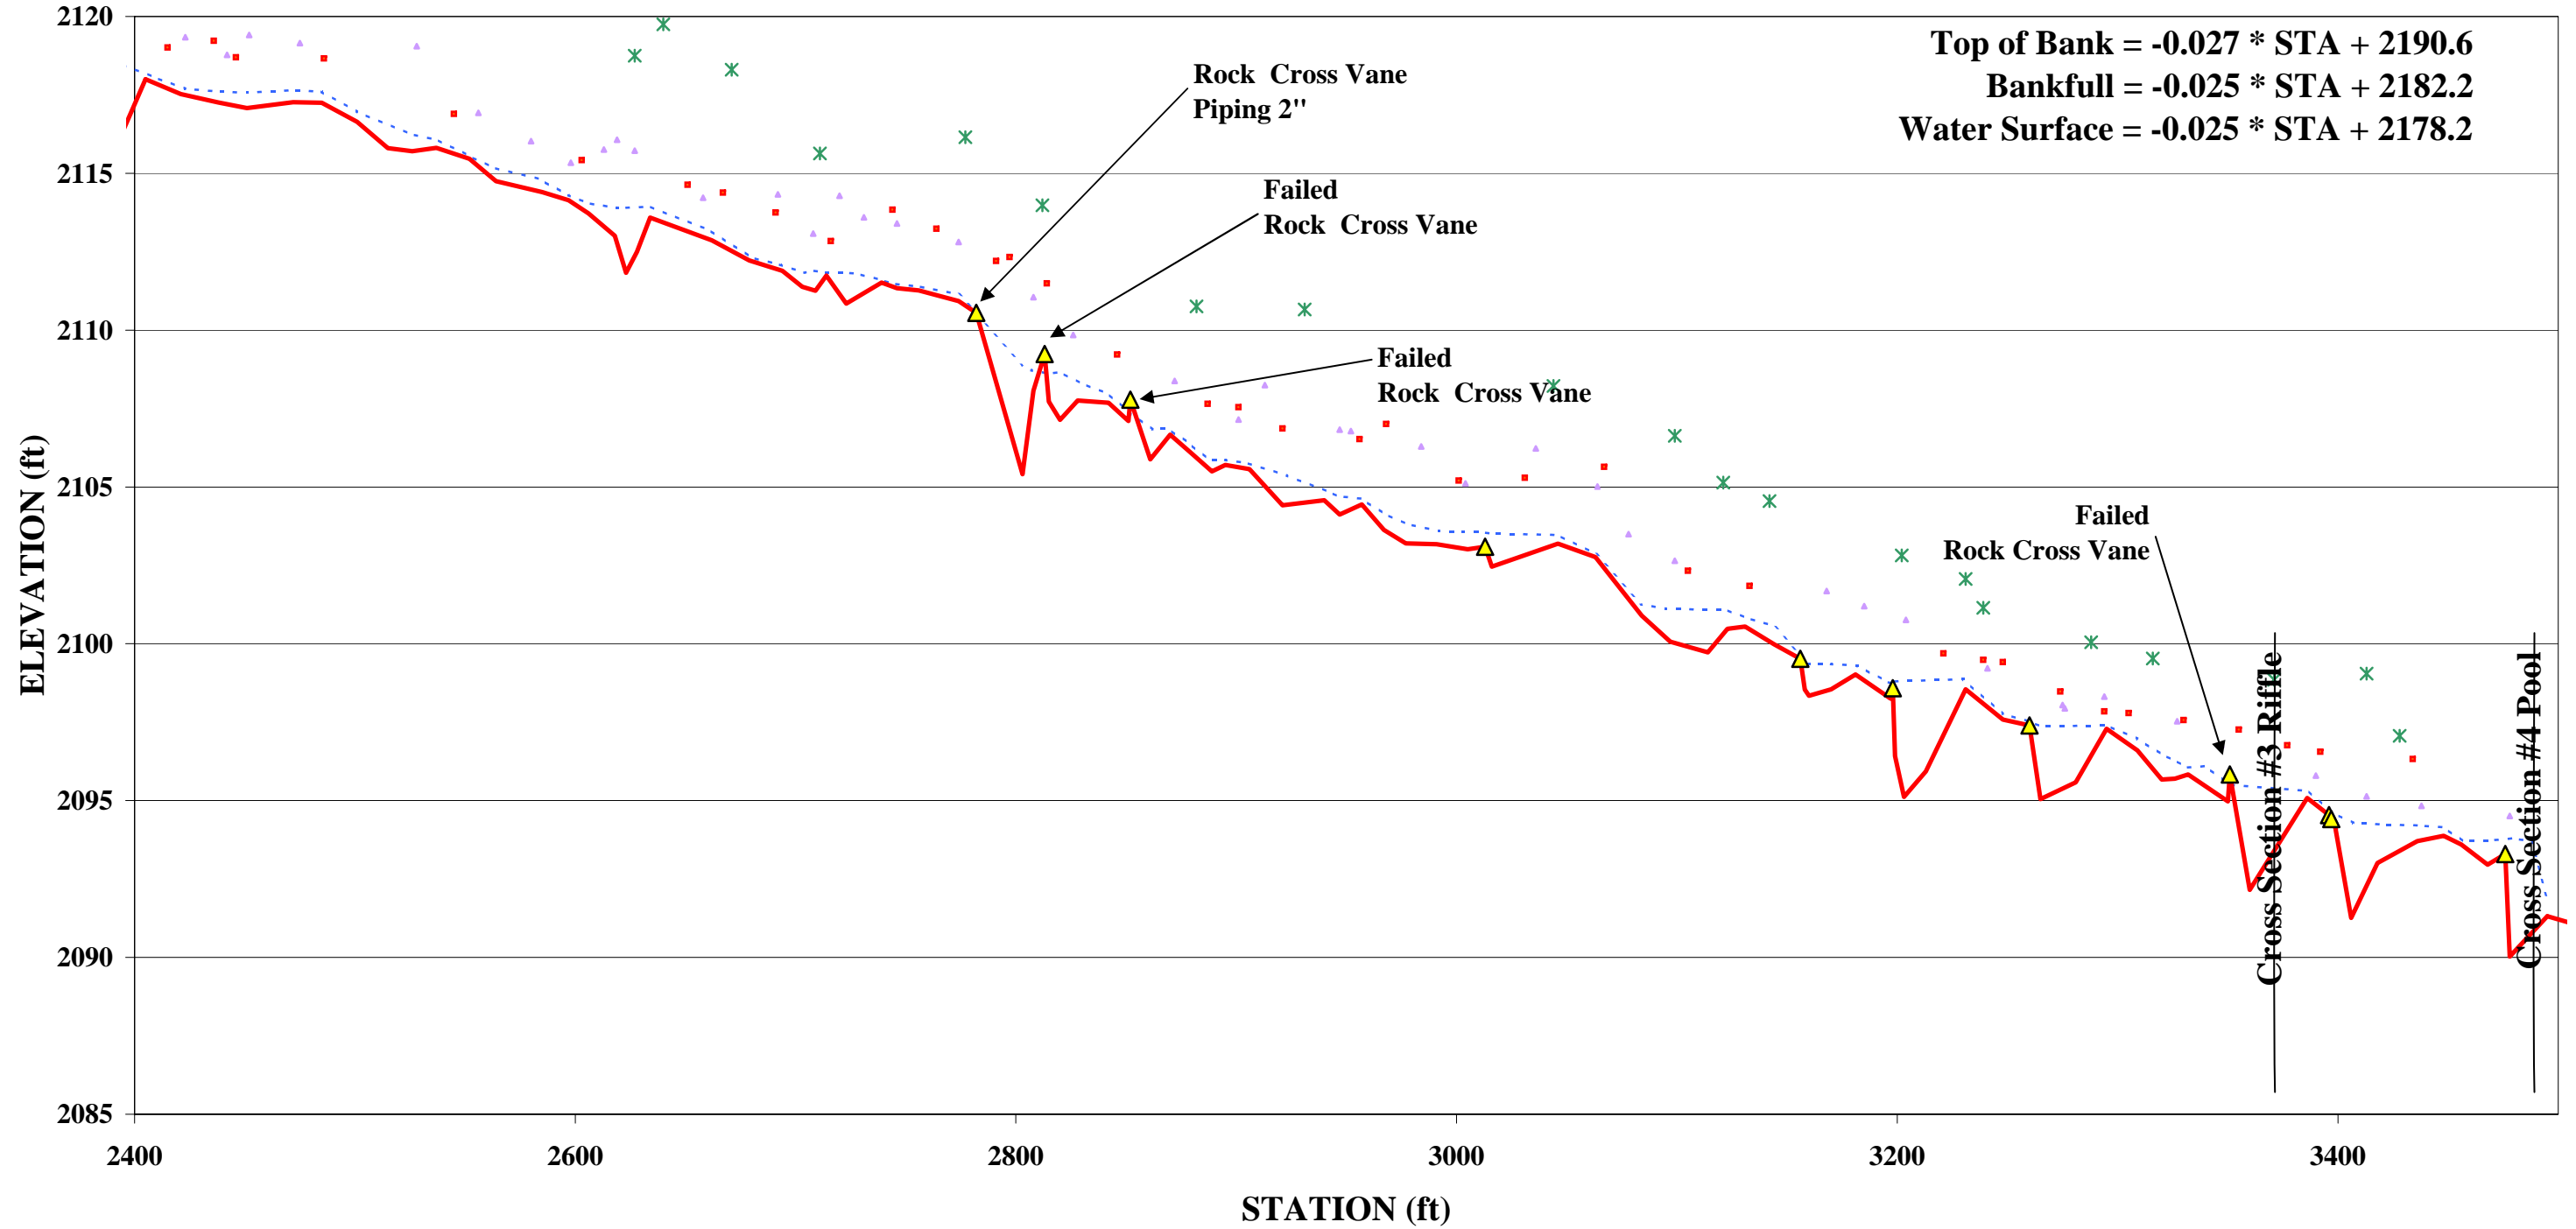
**COUNTY LINE CREEK
LONG PROFILE
DOWN-STREAM REACH
2004 MONITORING**

Rock Cross Vane
Piping 2"

Failed
Rock Cross Vane

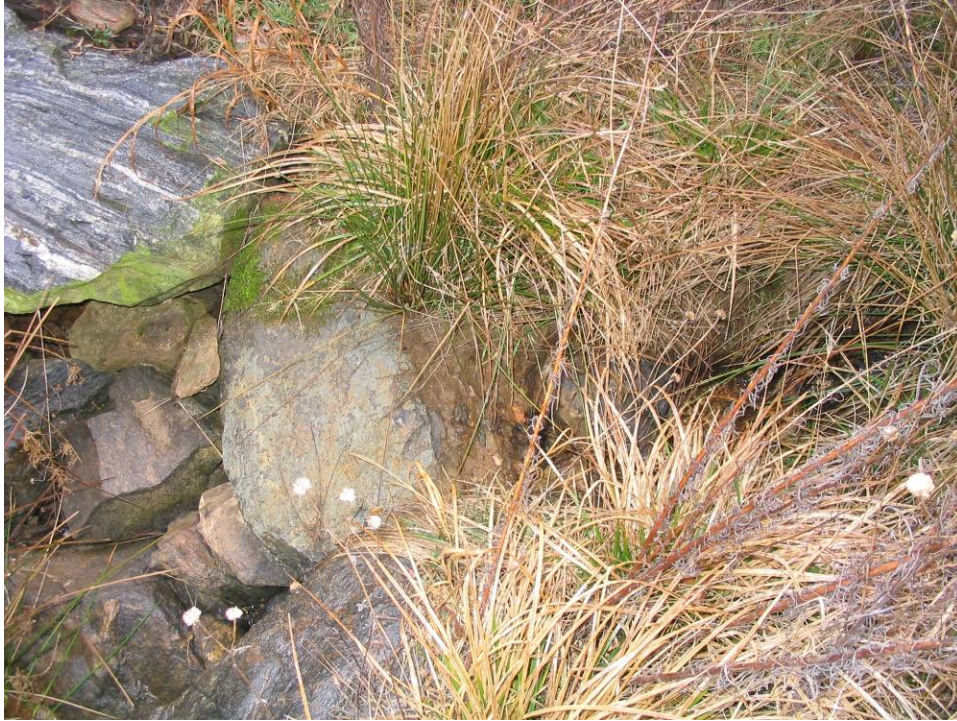
- At station 3+60 the rock cross vane has water piping under the invert rock with a head loss of 2 inches due to the piping. At this point the structure is not at risk of complete failure due to the boulder size used for the vane construction, the total number of vanes in the project, and the existing vegetation.

STA 3+70 Looking Upstream at Rock Cross Vane and Water Piping Through Vane

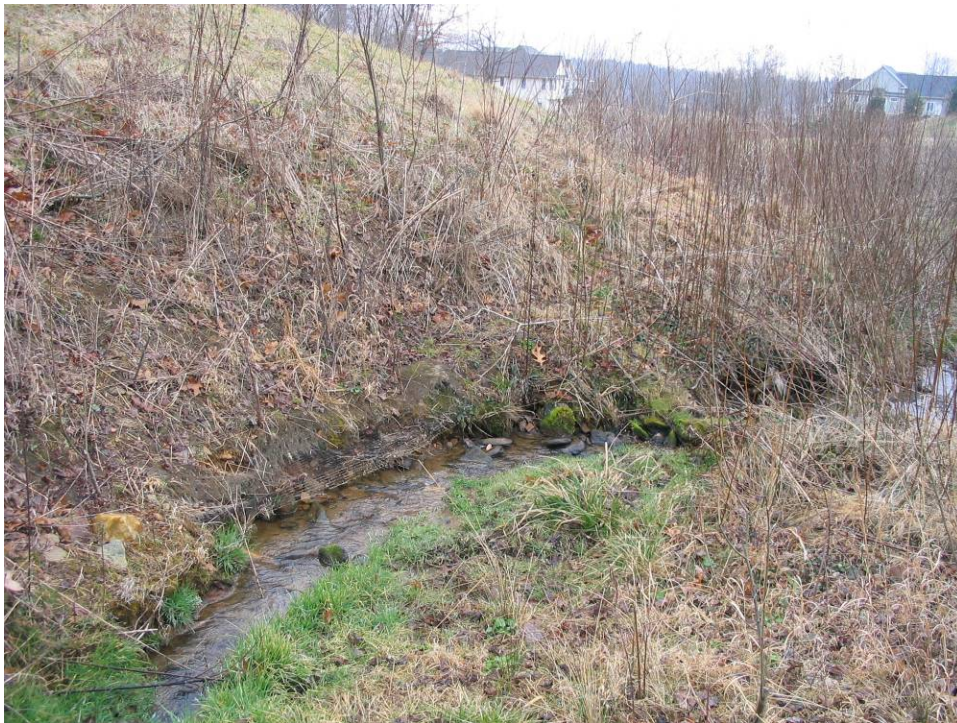
STA 9+10 Looking Downstream at Meander Bend and Bank Erosion

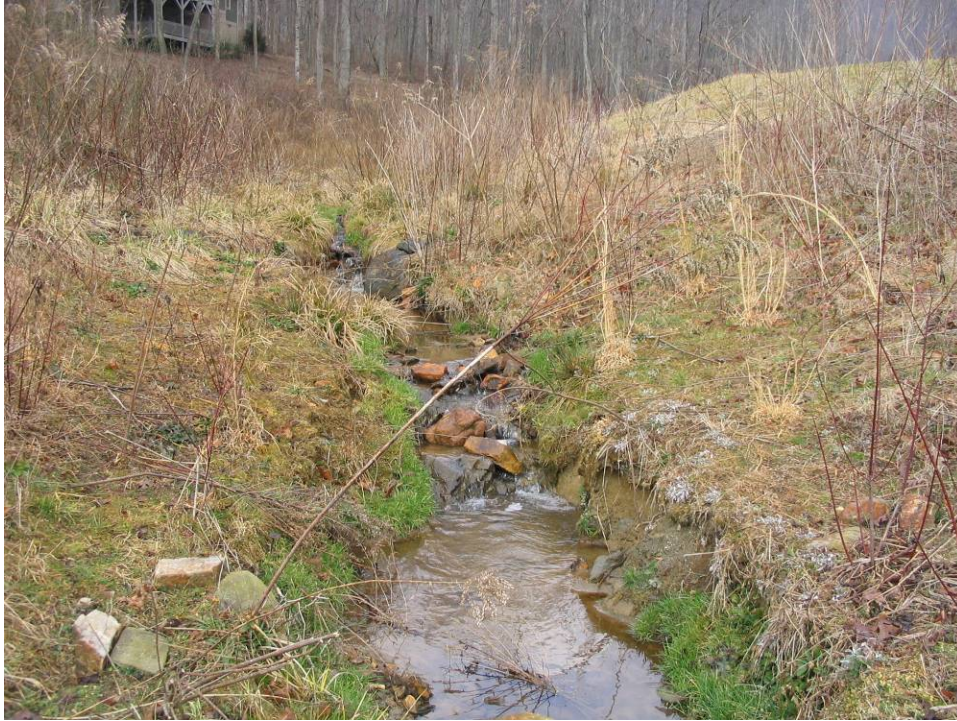
STA 10+80 Looking Upstream at Steep Riffle and Bank Erosion on Left Bank

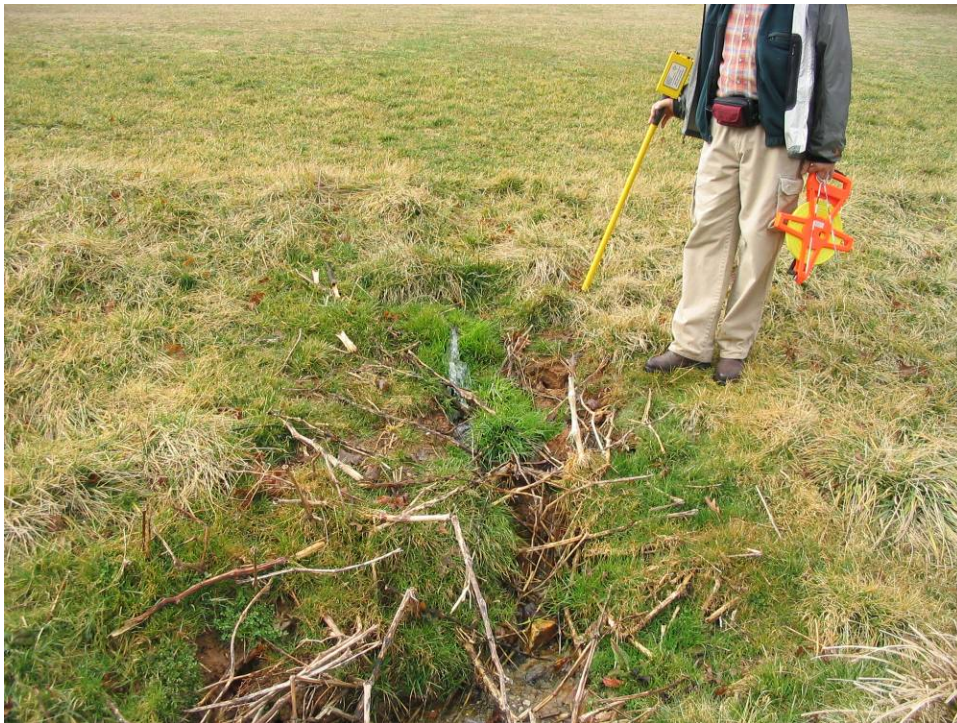
- There are two areas of major bank erosion due to the overland flow and seepage at station 11+45 on the left bank and station at 33+00 on the left bank Possible repairs would include regarding the gully, preparing this area and seeding with a tackafier and straw mulch

STA 11+40 Looking at Right Bank Upland Gully Erosion

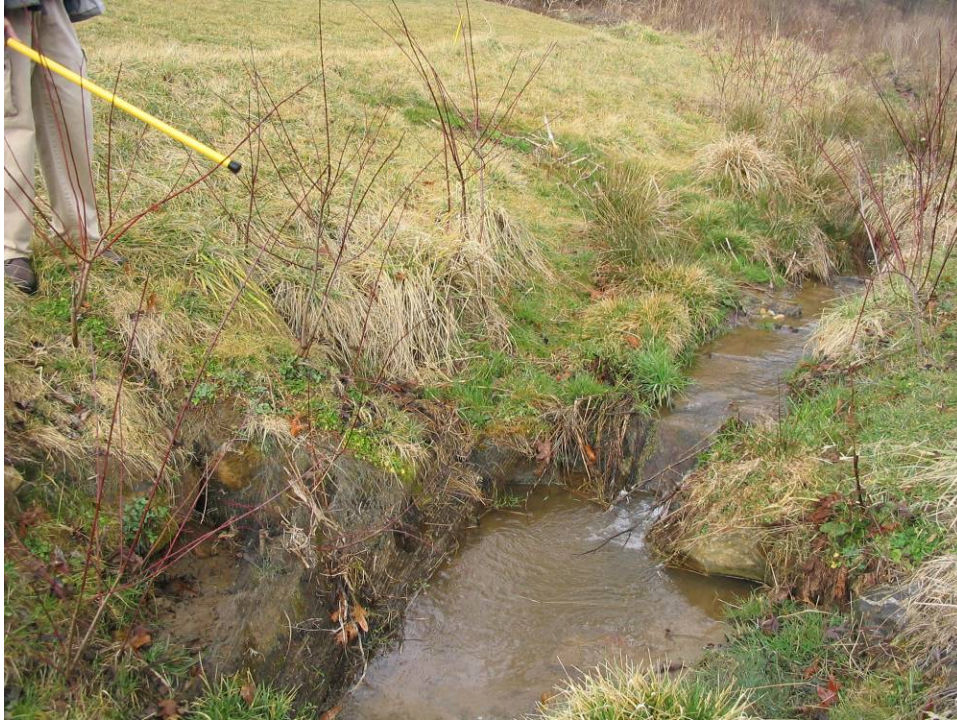
STA 11+50 Looking Upstream at Rock Cross Vane with Right Bank Erosion

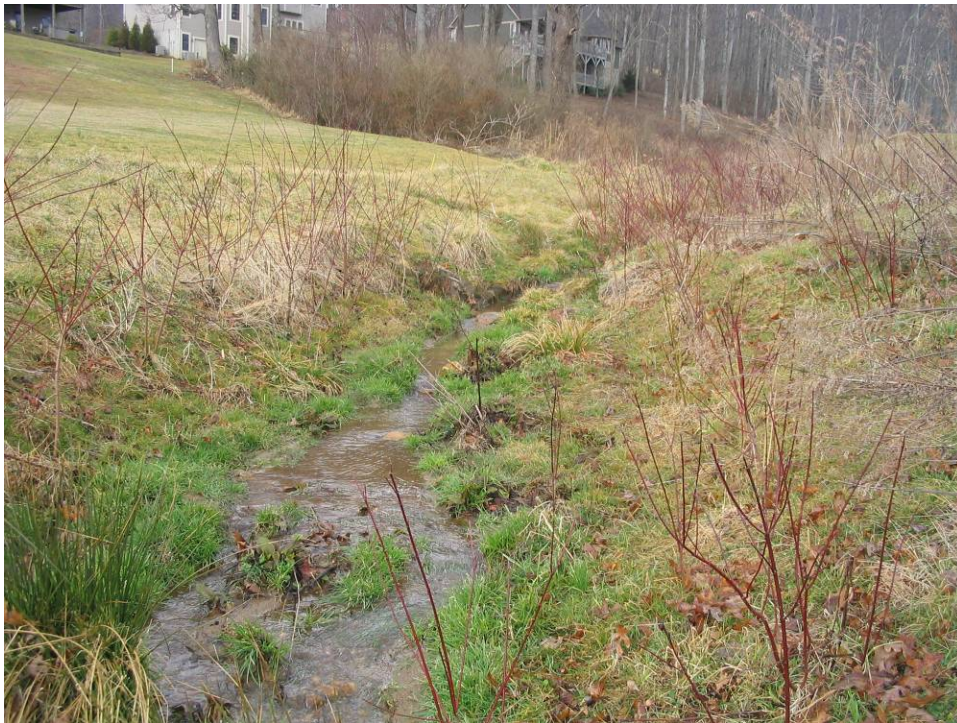
STA 12+00 Looking Upstream at Mid-Channel Bar

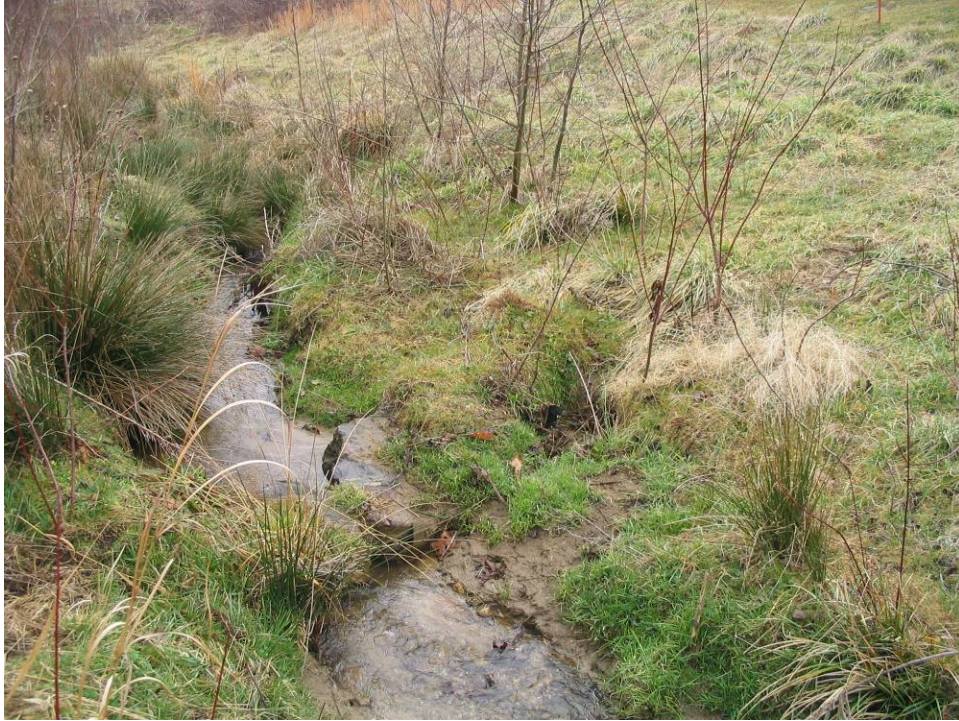
- At station 13+10 the rock cross vane has water piping under the invert rock with a head loss of 6 inches due to the piping. At this point the structure is not at risk of complete failure due to the boulder size used for the vane construction, the total number of vanes in the project, and the existing vegetation.

STA 13+20 Looking Downstream at Water Piping Through Rock Cross Vane

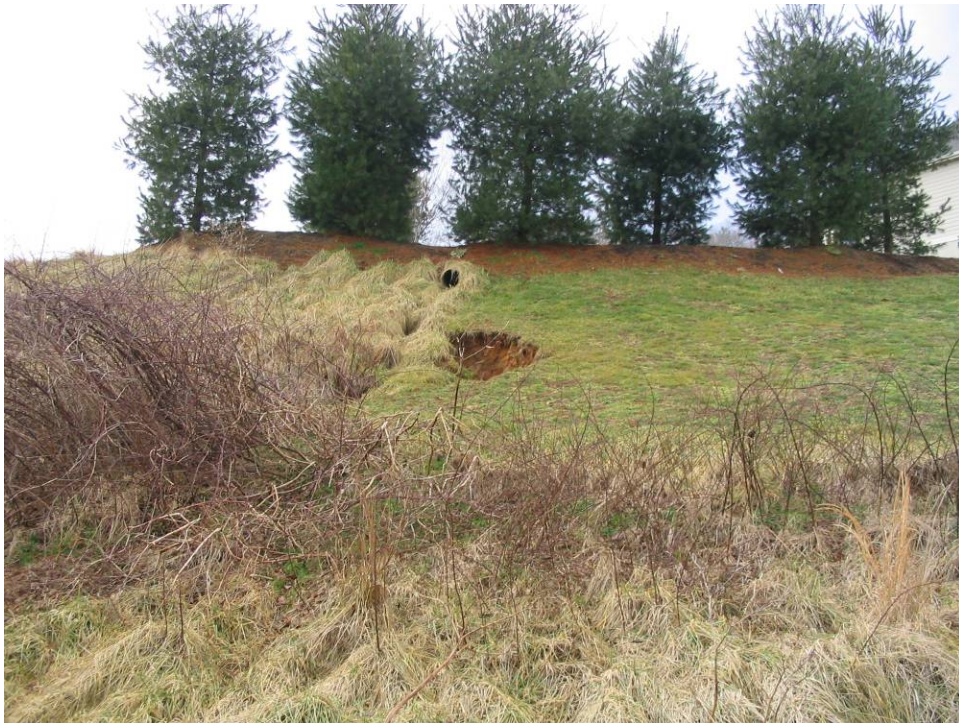
STA 14+40 Looking at Right Bank Hill Slope Erosion

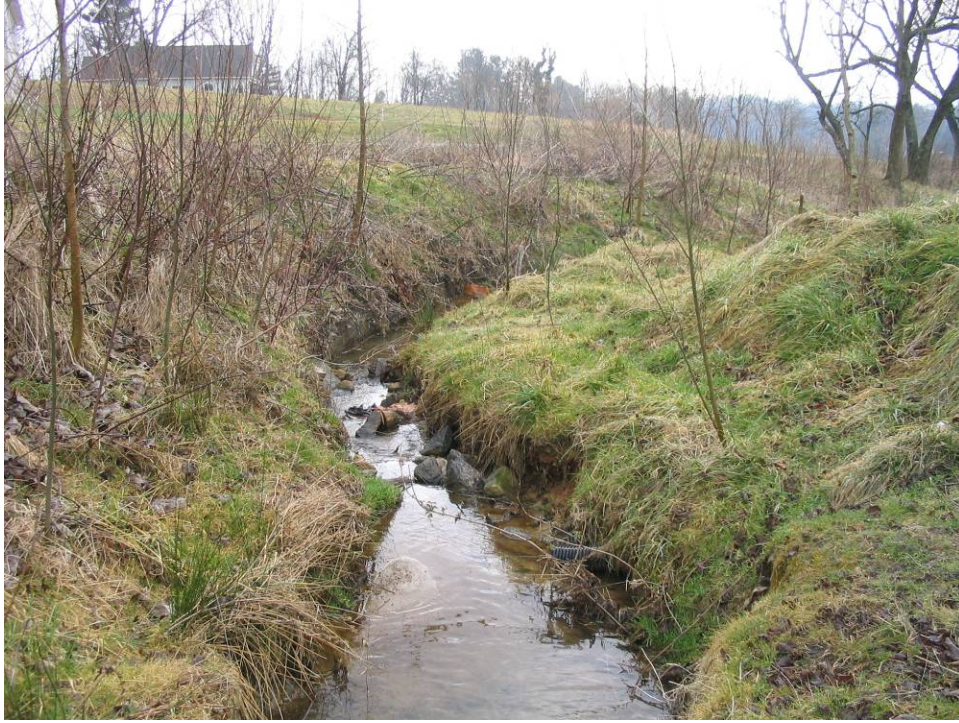
STA 15+30 Looking Downstream at Down-Cutting and Bank Erosion

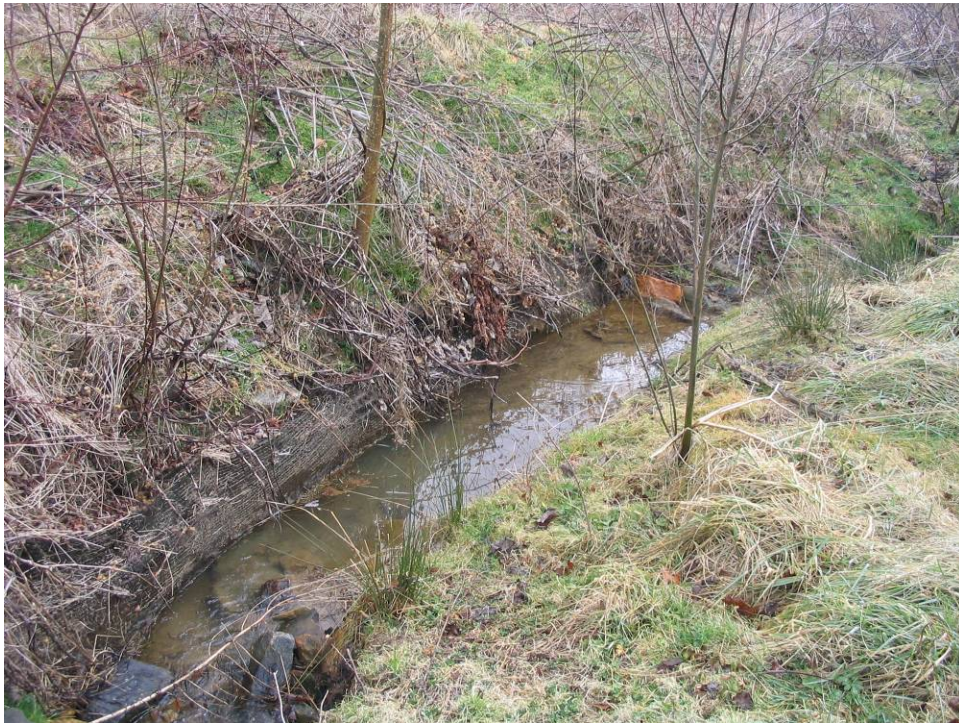
STA 15+50 Looking Downstream at Bank Erosion

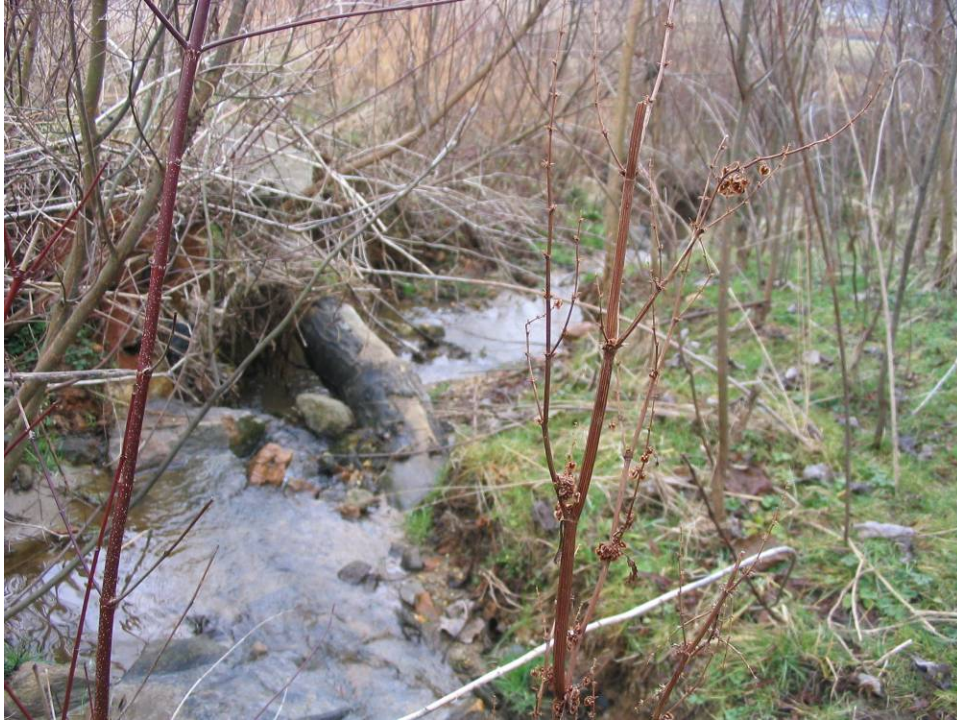
STA 20+45 Looking Downstream at Undercut Log vane

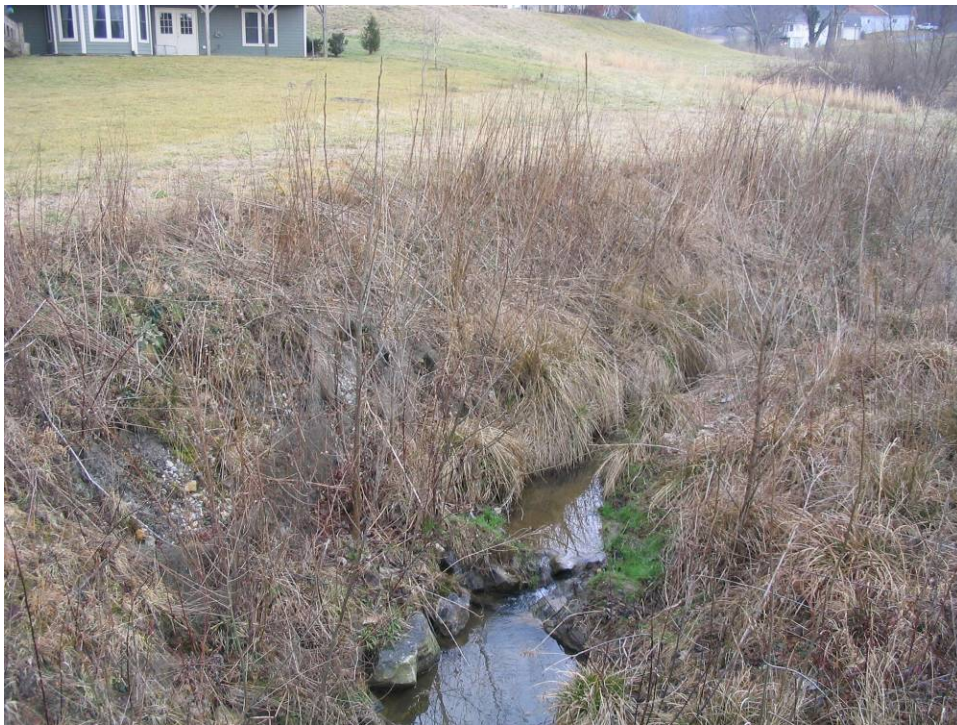
STA 22+80 Looking Upstream at Rock Vane with Confined Right Bank Erosion

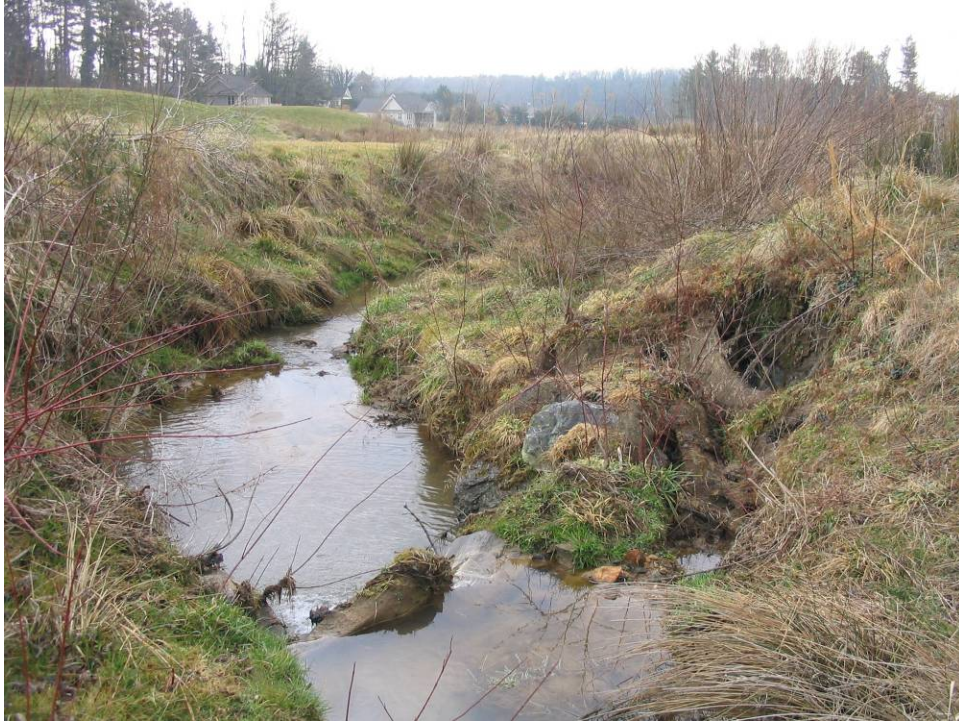
STA 24+25 Looking Downstream at Rock Vane with Right Bank Erosion

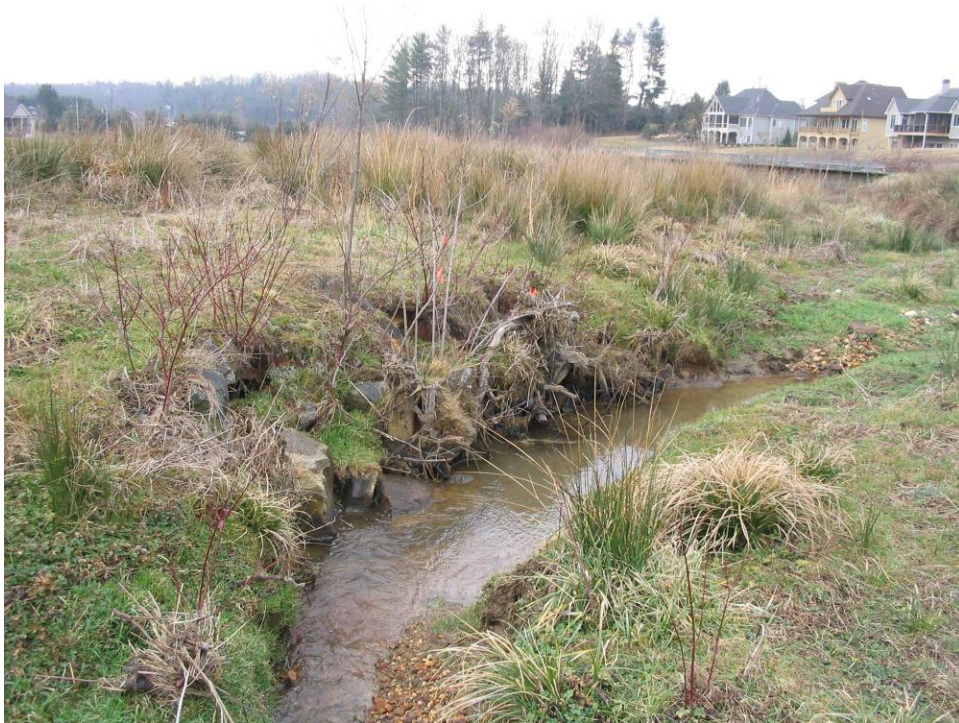
STA 27+30 Looking Downstream at Pool Root Wad with Bank Erosion

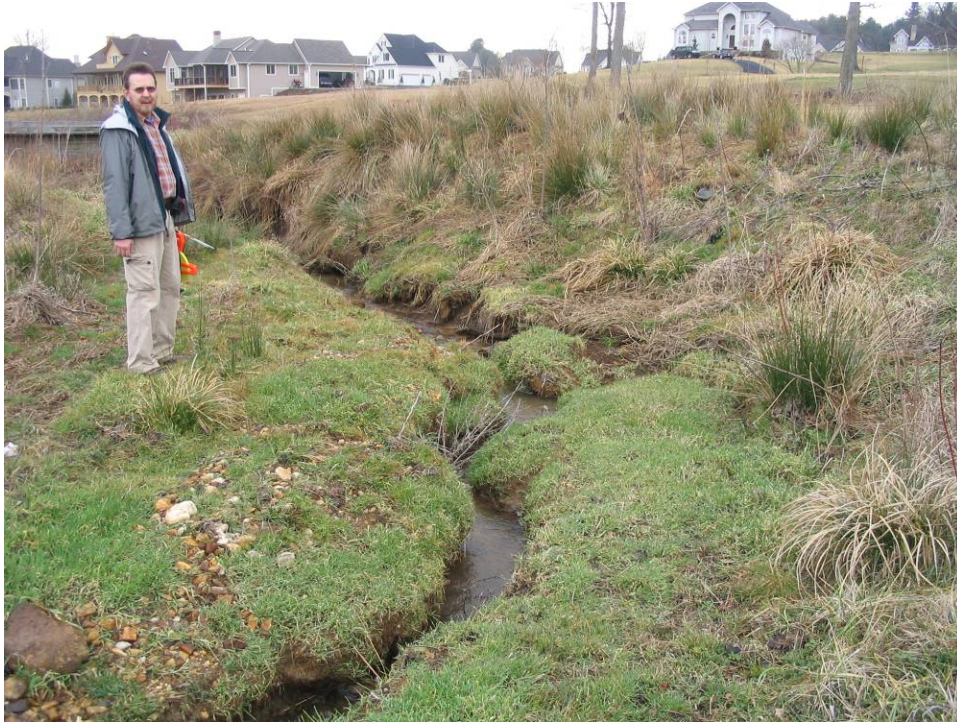
STA 27+60 Looking Downstream at Bankfull Bench Down-Cut

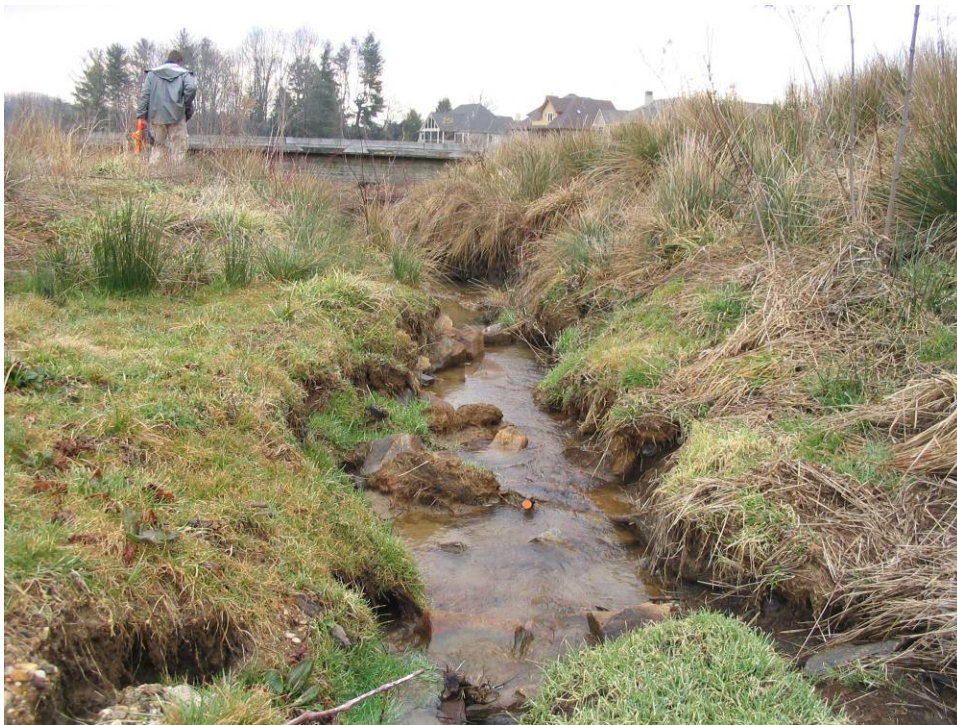
- At station 27+90 the rock cross vane has water piping under the invert rock with a head loss of 2 inches due to the piping. A head cut is working upstream toward this rock vane structure. There are two structures directly downstream from this structure that has failed. At this point the structure is not at risk of complete failure due to the boulder size used for the vane construction, the total number of vanes in the project, and the existing vegetation, but if the two structures downstream are not repaired this structure will most likely fail.

STA 27+75 Looking Downstream at Failing Rock Vane and Down-Cutting Channel

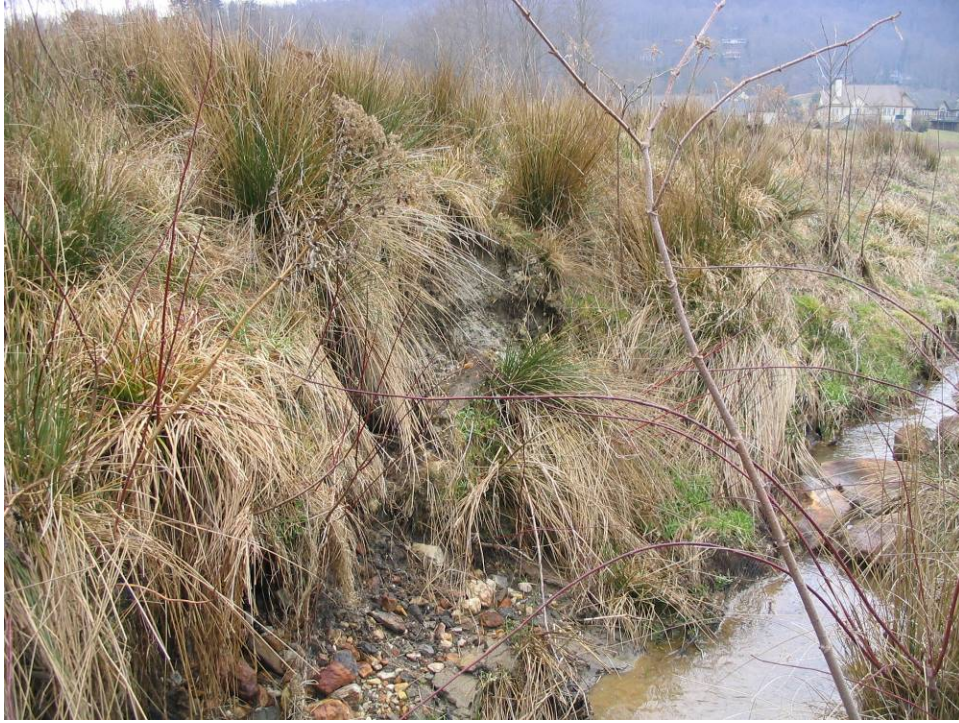
STA 28+20 Looking Upstream at Bank Erosion on Right Bank

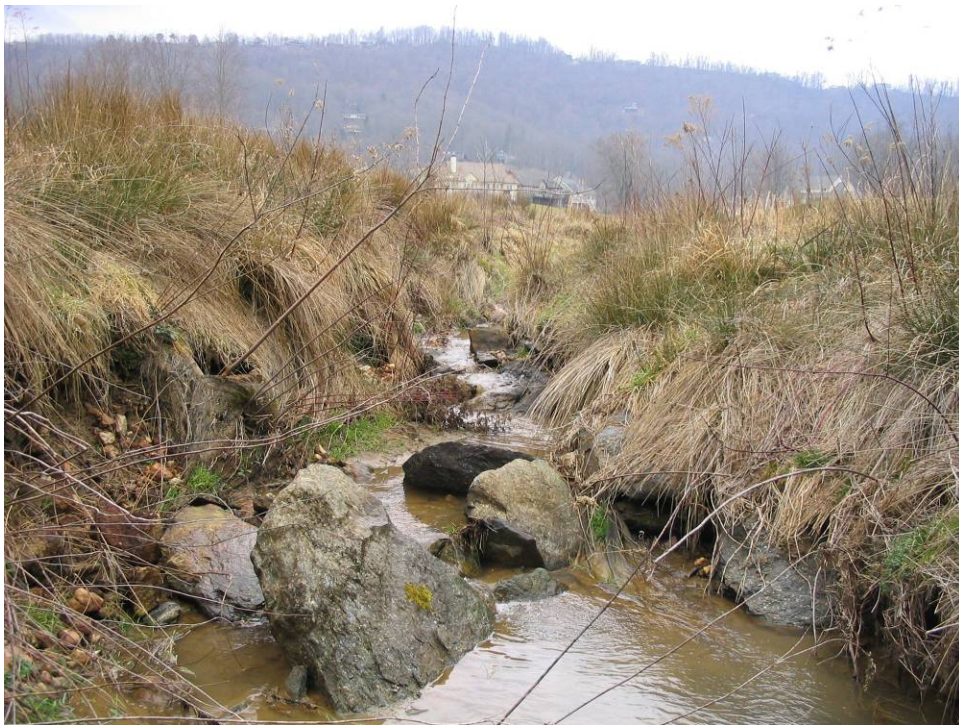
- At station 28+10 the rock cross vane has failed and needs to be repaired as soon as possible the reach near this failed rock vane has a severe head-cut of about one foot.

STA 28+20 Looking Upstream at Water Piping Through Rock Cross Vane

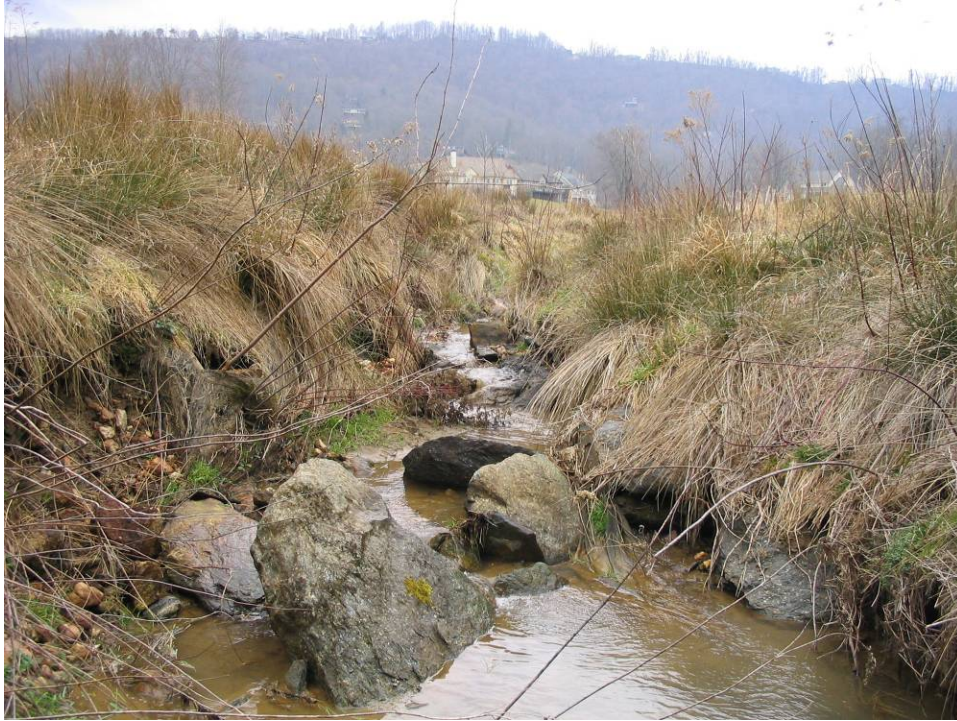
STA 28+50 Looking Upstream at Failed Rock Cross Vane

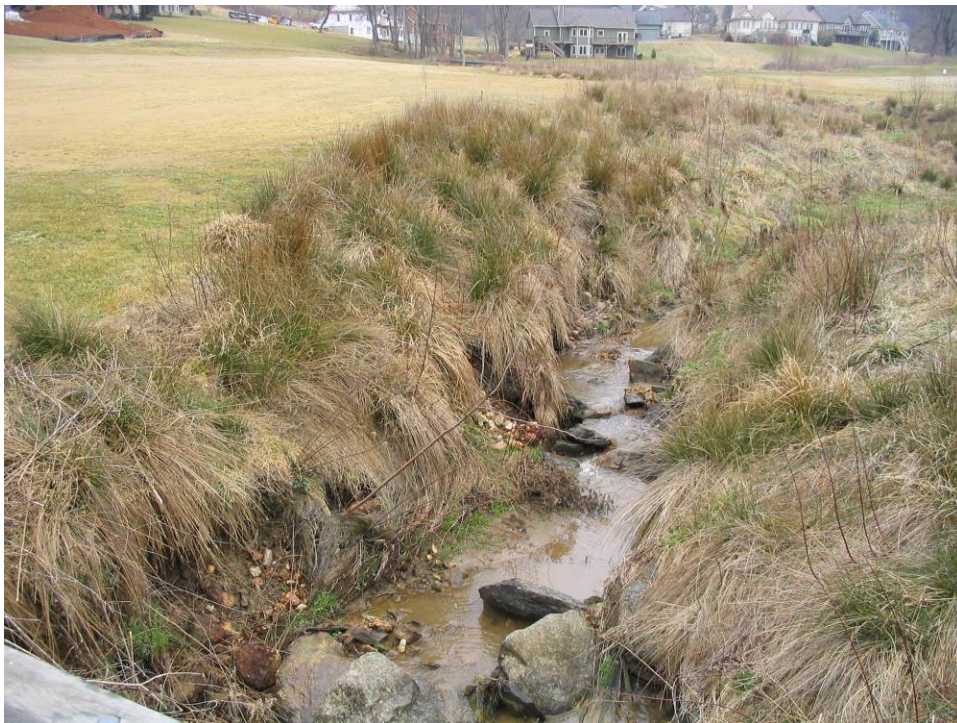
STA 28+60 Looking Upstream from Bridge at Down-Cutting and Failed Rock Cross Vanes

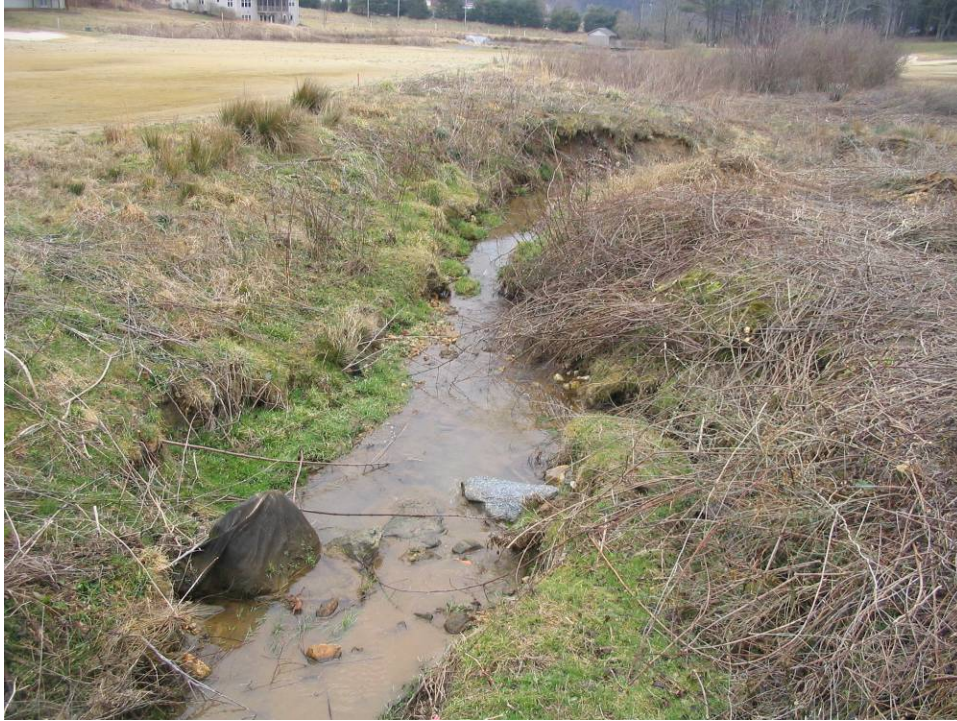
STA 28+70 Looking Downstream at Bank Erosion and Failed Rock Cross Vane

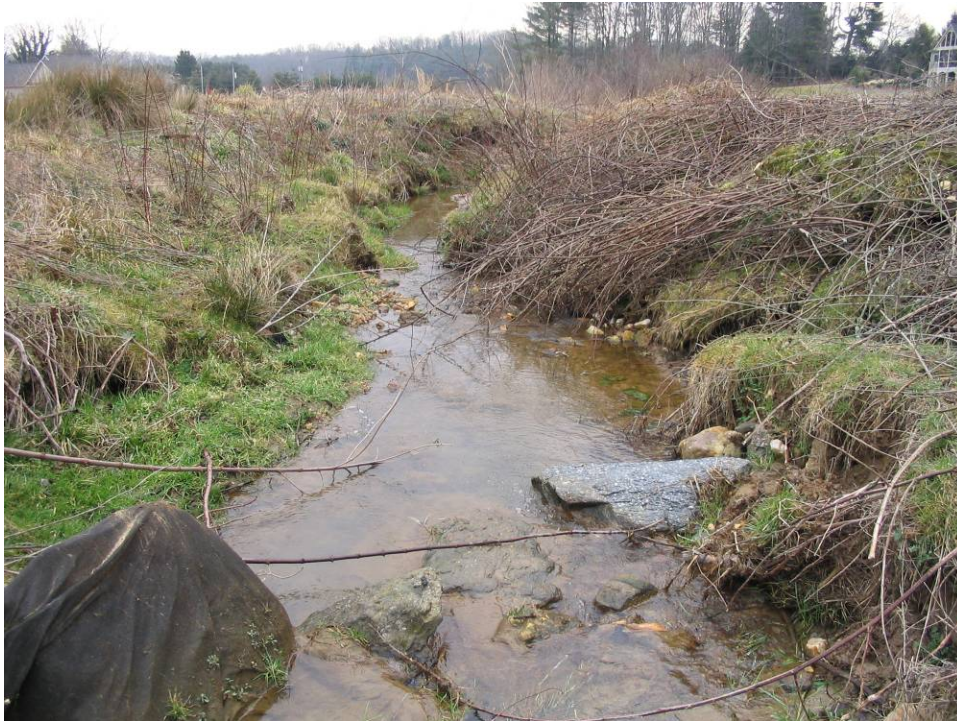
STA 28+75 Looking Downstream at Enlarged Channel and Failed Rock Cross Vane

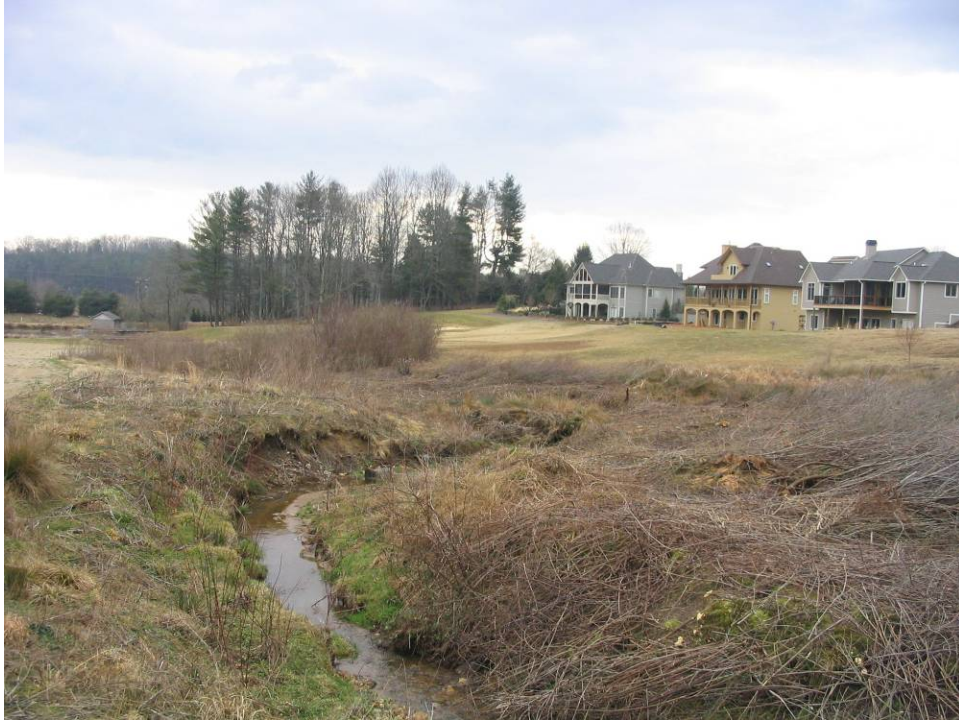
STA 29+10 Looking Downstream at Severe Bank Erosion on Left Bank

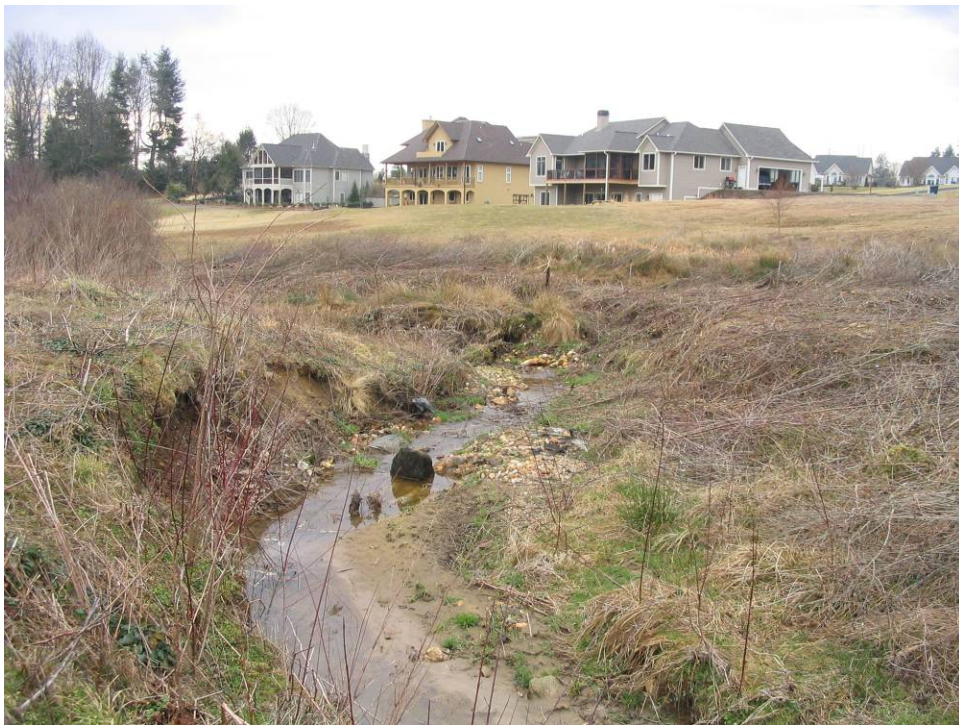
STA 29+30 Looking Downstream at Severe Bank Erosion on Left Bank and Head-Cut

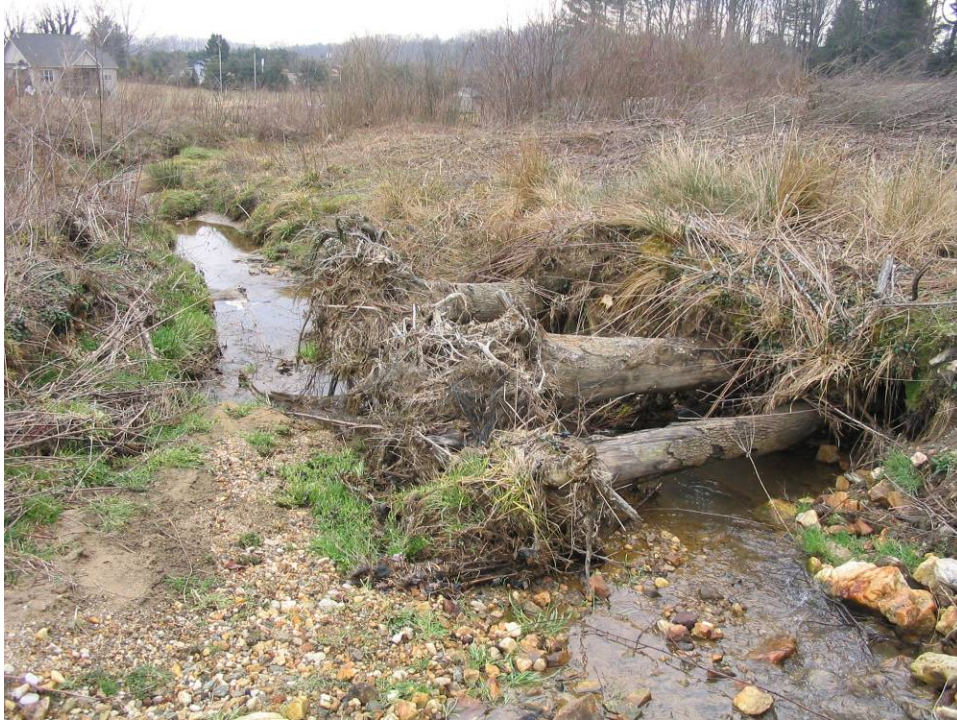
STA 29+90 Looking Downstream at Severe Head-Cut that has Exposed Root Wads

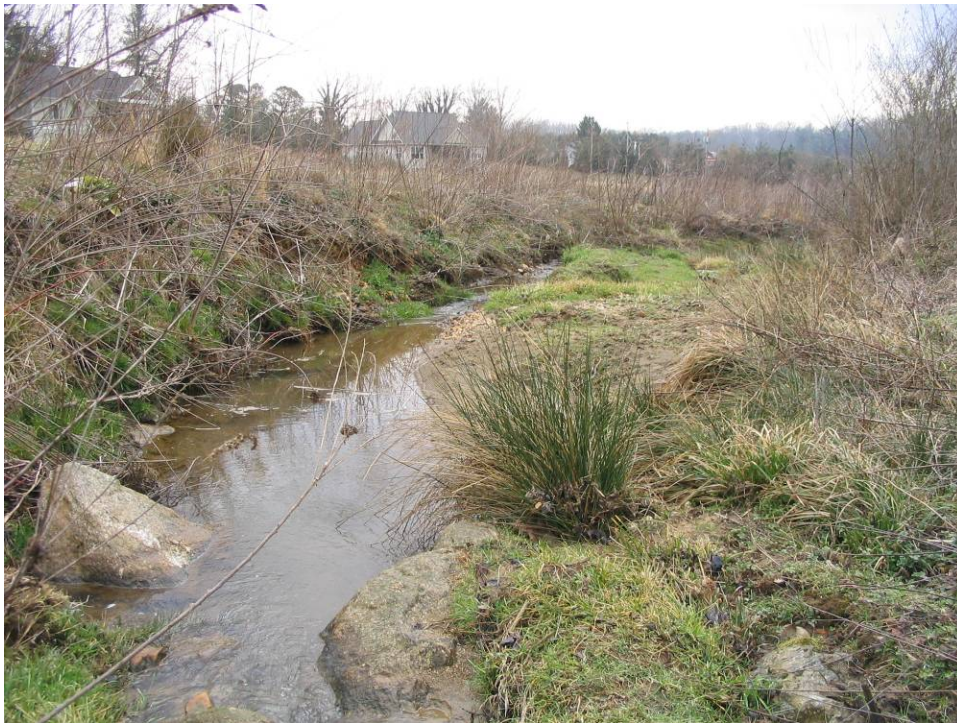
STA 31+40 Looking Downstream at Bank Erosion on Left Bank and Rock Cross Vane Holding Grade
