County Line Creek Stream Restoration (High Vista) 2004 Annual Monitoring Report

March, 2005

2004 County Line Creek Monitoring Abstract

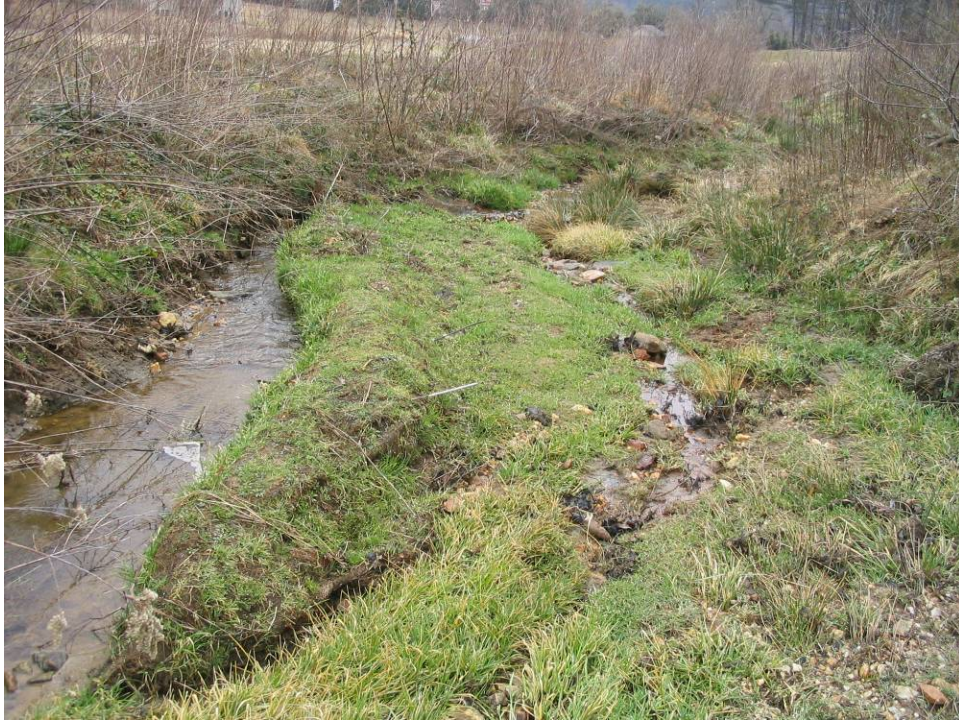
STA 31+70 Looking Downstream with Chute Cut-Off Forming

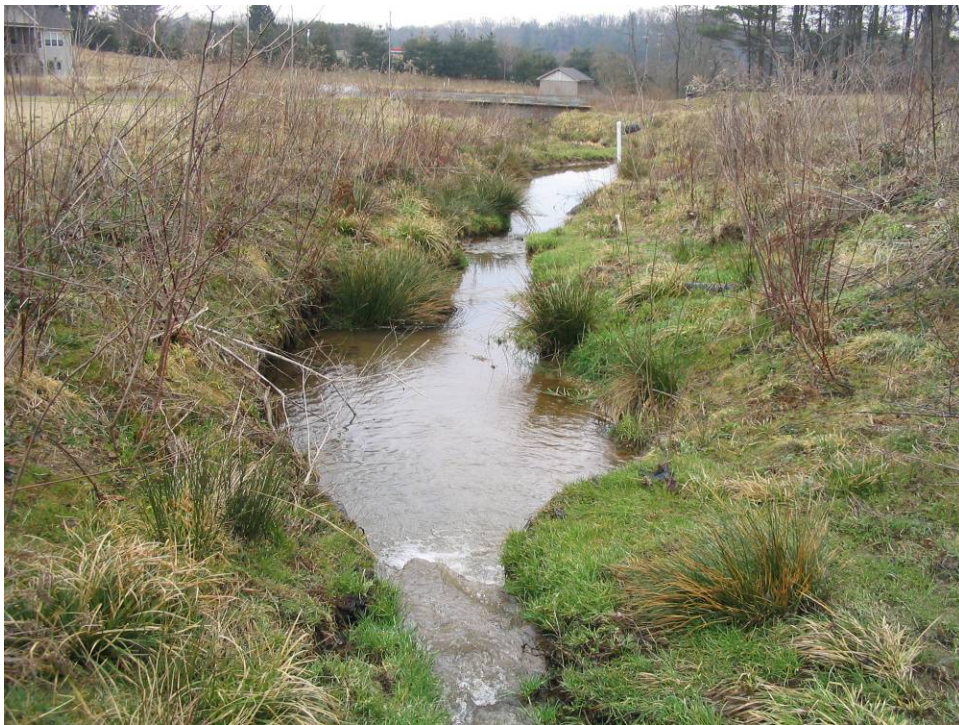
STA 31+80 Looking Downstream at Scour Pool and Rock Cross Vane

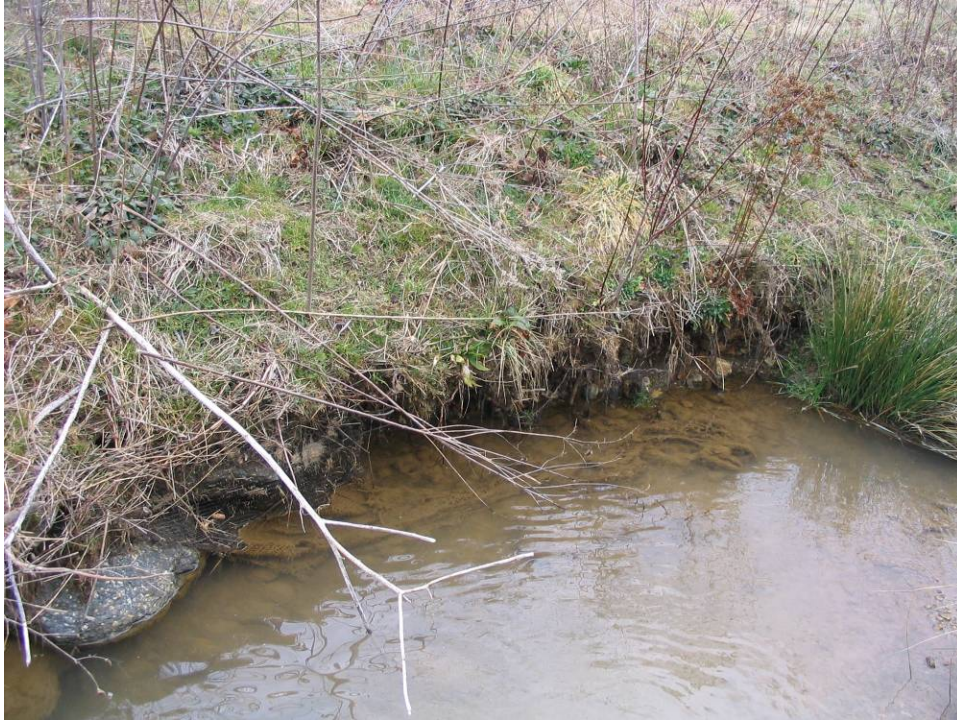
STA 32+00 Looking at Undercut Left Bank

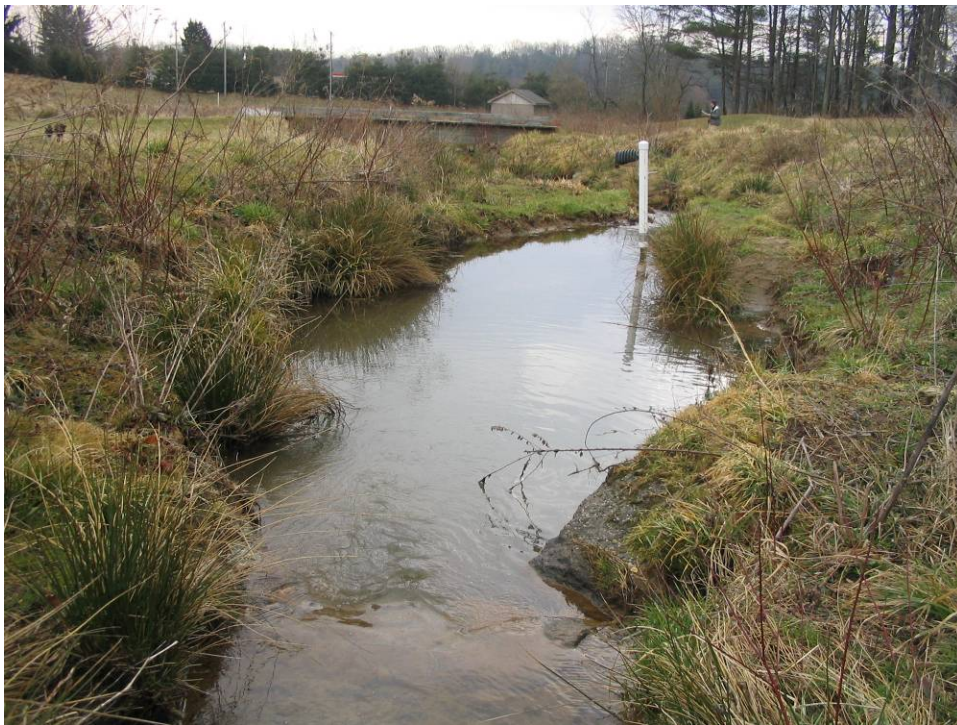
STA 32+20 Looking Downstream at Scour Pool and Rock Cross Vane

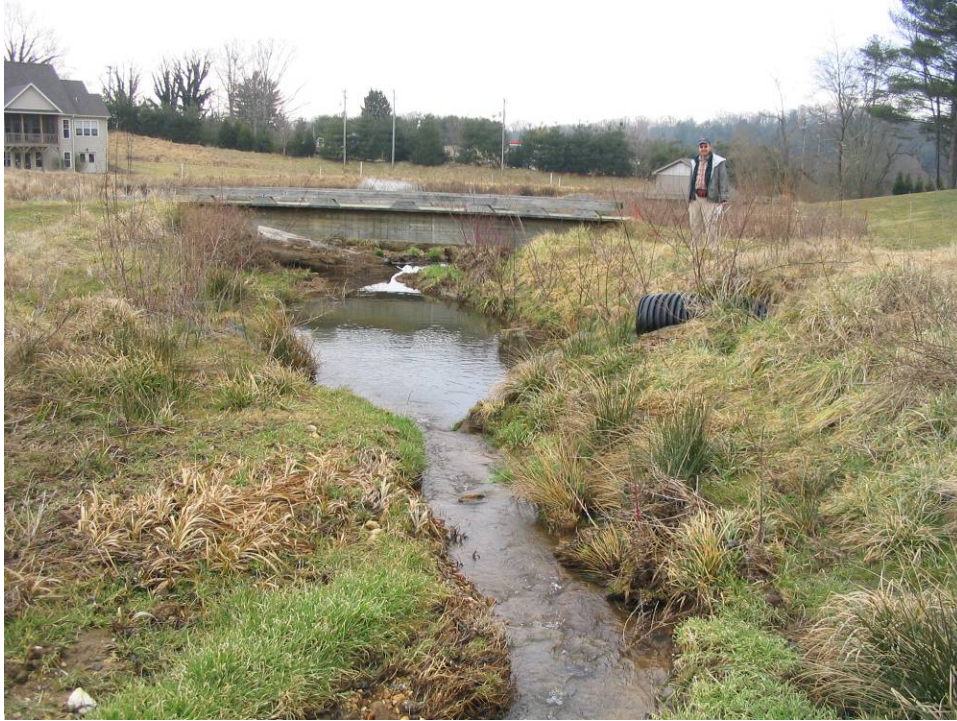
**STA 32+90 Looking Downstream at Rock Cross Vane, Large Scour Pool,
and 24" Storm-Water CPP**

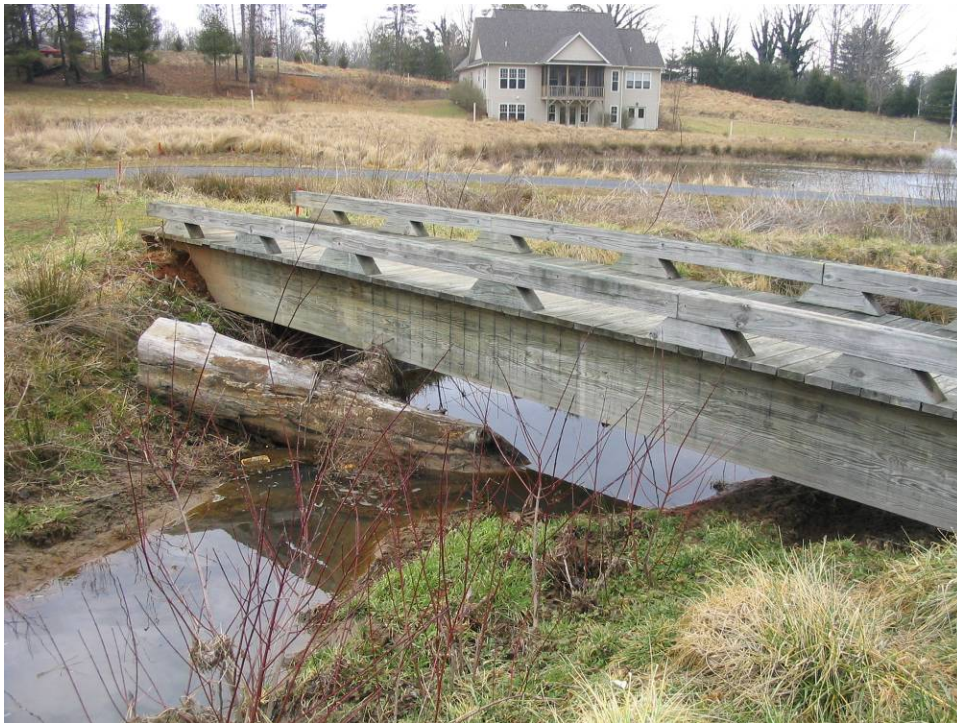
STA 33+30 Looking Downstream at Bridge and Log Debris Jam

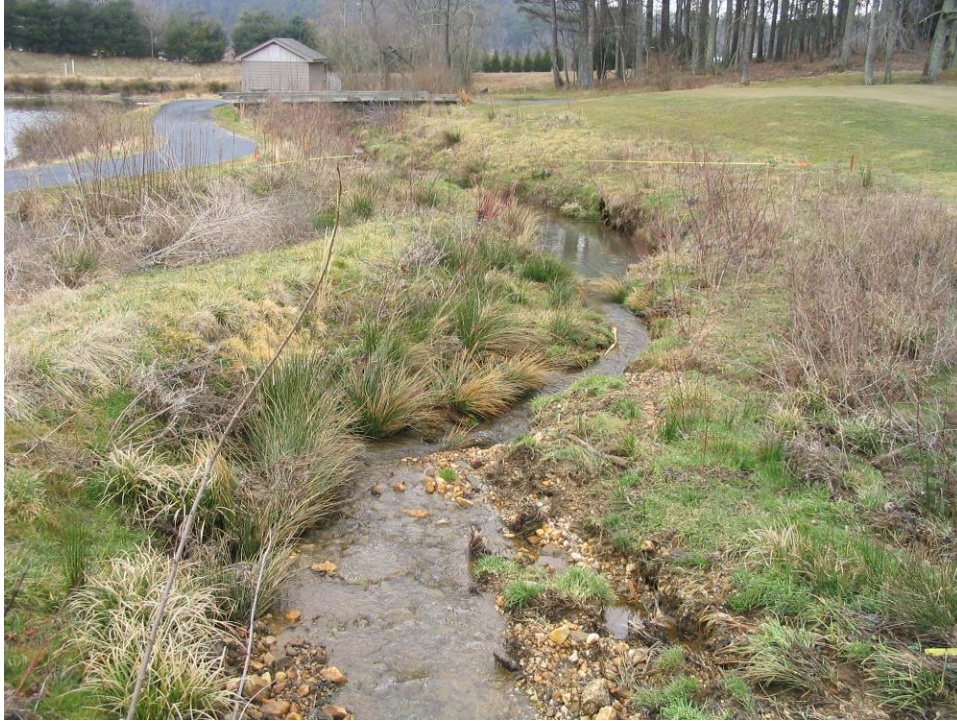
STA 33+40 Looking Downstream at Pool Filling with Course Substrate

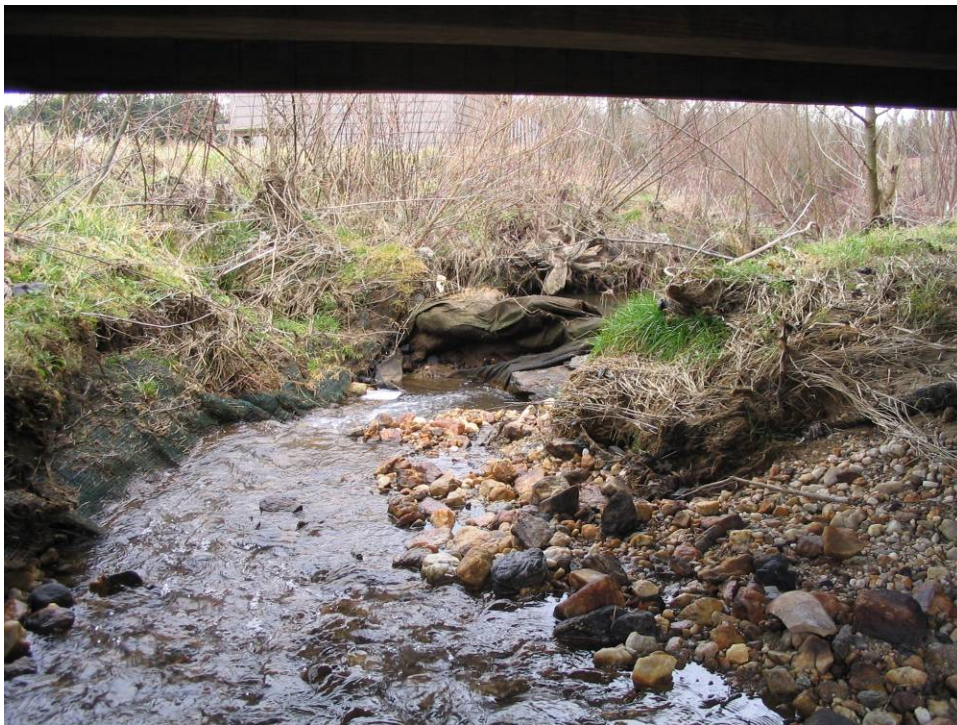
- At station 34+70 the rock cross vane has failed and needs to be repaired as soon as possible the reach near this failed rock vane has a severe head-cut of about one foot.

STA 34+90 Looking Downstream at Failed Rock Cross Vane

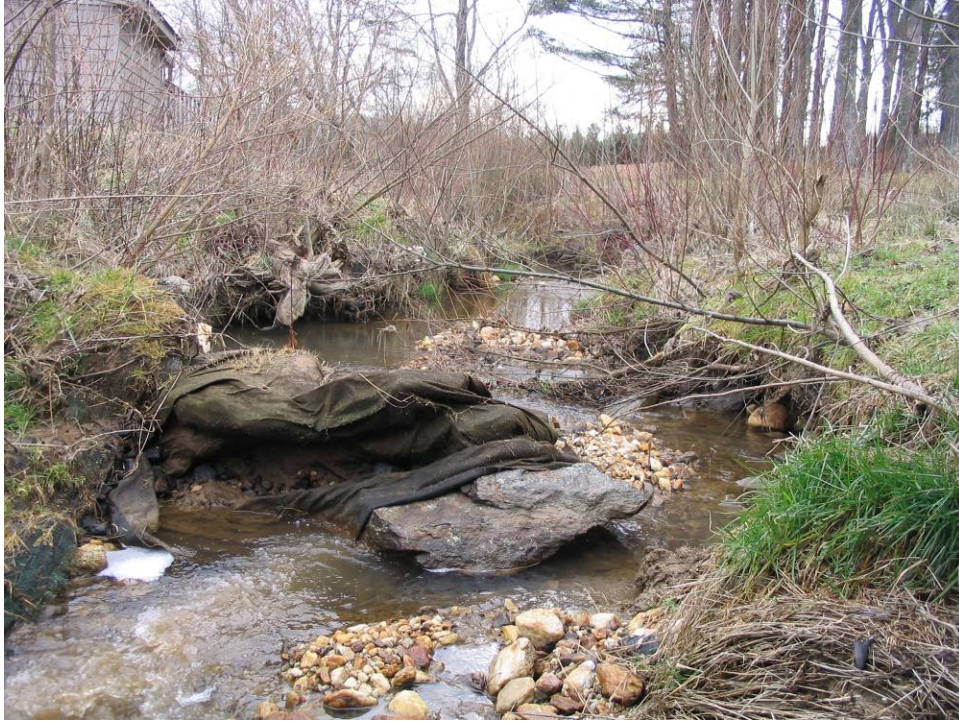
STA 35+00 Looking Down Stream at Failed Rock Cross Vane

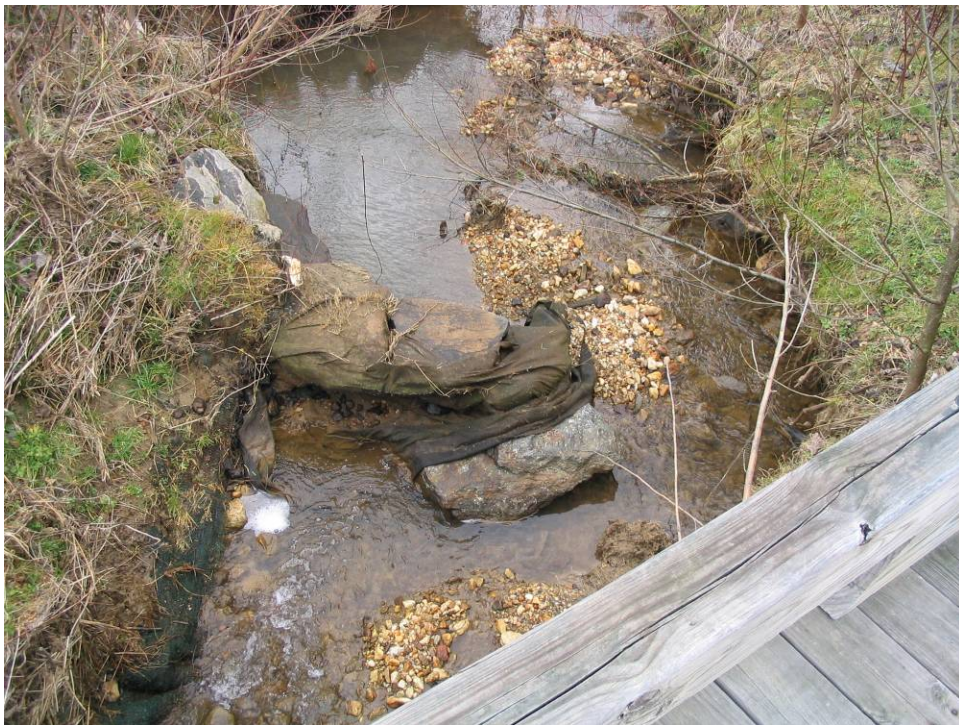
STA 35+00 Looking Down Stream at Failed Rock Cross Vane from Bridge

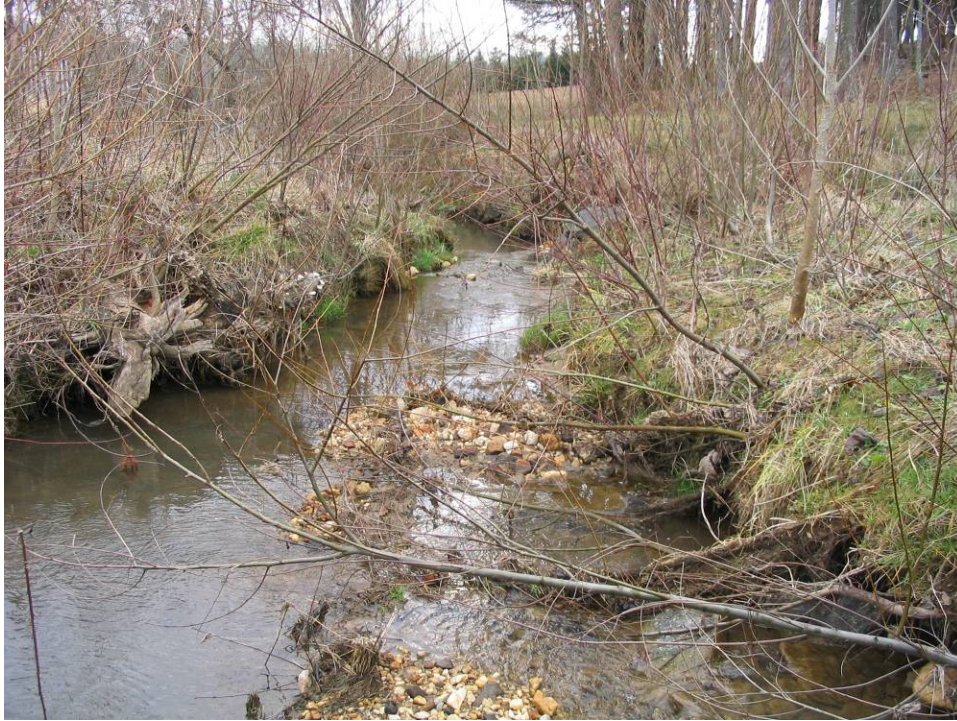
STA 35+10 Looking Downstream Bank Erosion and Slumping

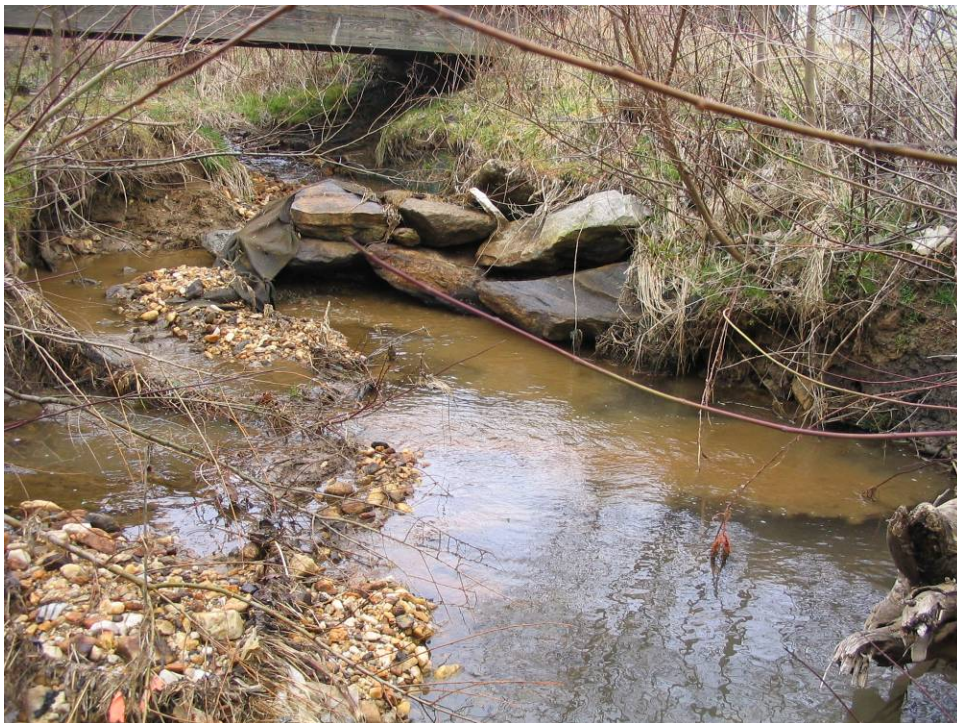
STA 35+20 Looking Upstream at Failed Rock Cross Vane
