Year 3 Monitoring Report

County Line Creek (High Vista) Stream Restoration

February 2006
S&EC Project No. 9445.D1
EEP Project No. 00044

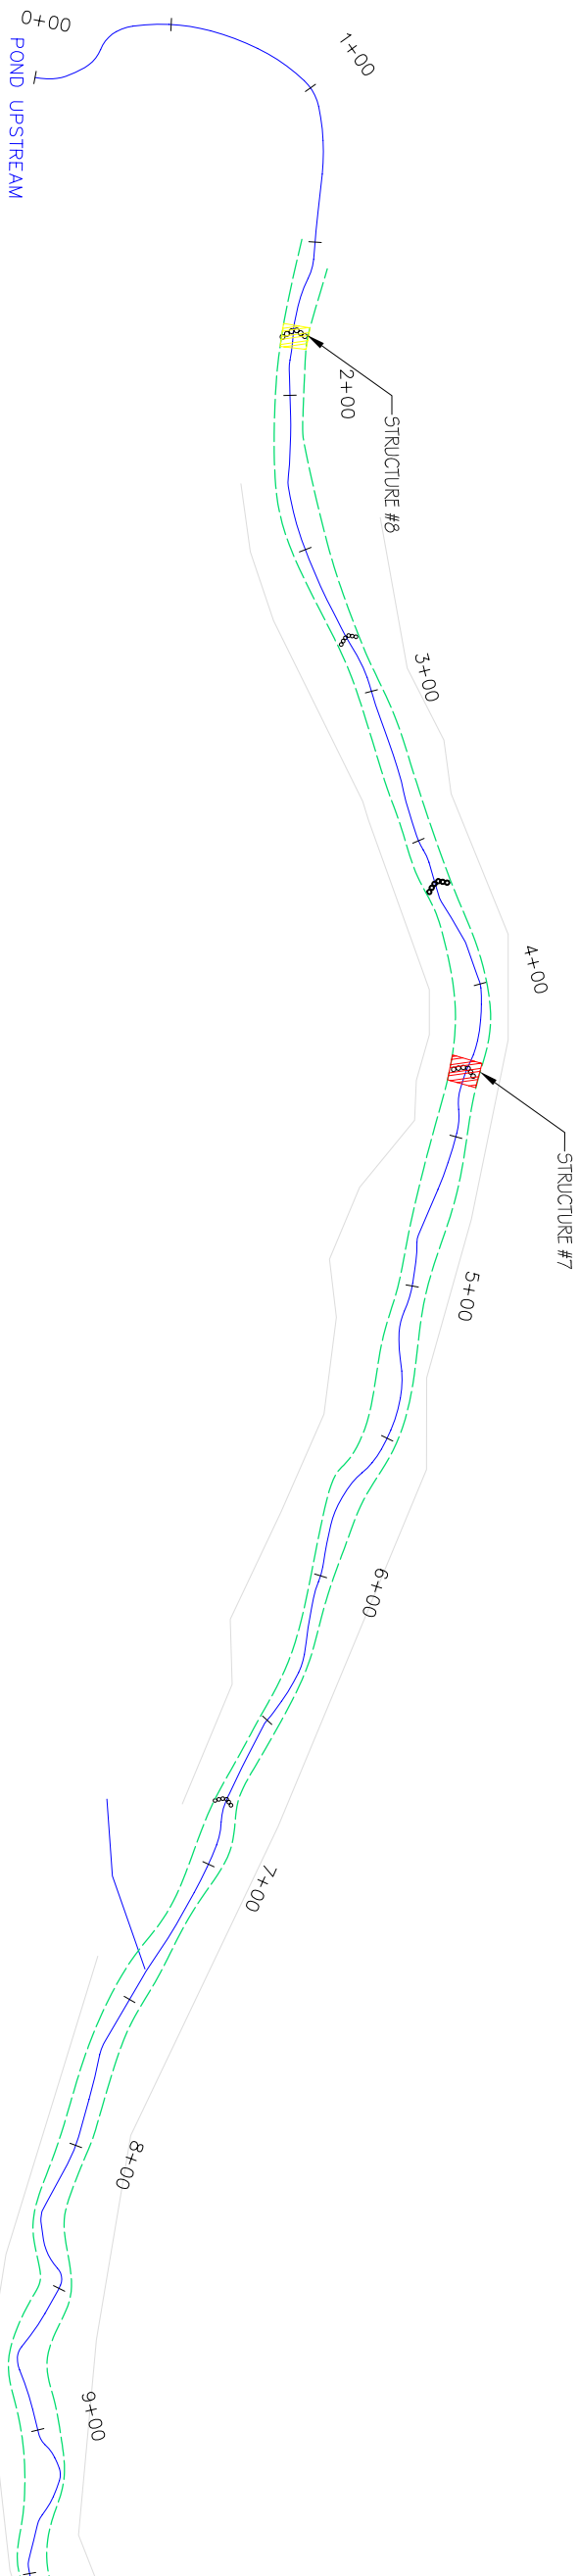
Project: HIGH VISTA ESTATES STREAM RESTORATION		Project No.: 9445.D1
Location: HENDERSON / BUNCOMBE CO.	Client: NCEEP	Proj. Mgr.: PKS Drawn: JER
Sheet Title: PAPV - SEGMENT I		Scale: 1" = 60'
		Sheet No.: 5 OF 8

An assessment of the stability of the channel was performed on August 10, 2005, by S&EC. Several areas of concern were observed and documented including localized bank scour and several failing structures. These problem areas are shown on Sheets 5 through 8 (Problem Area Plan View).

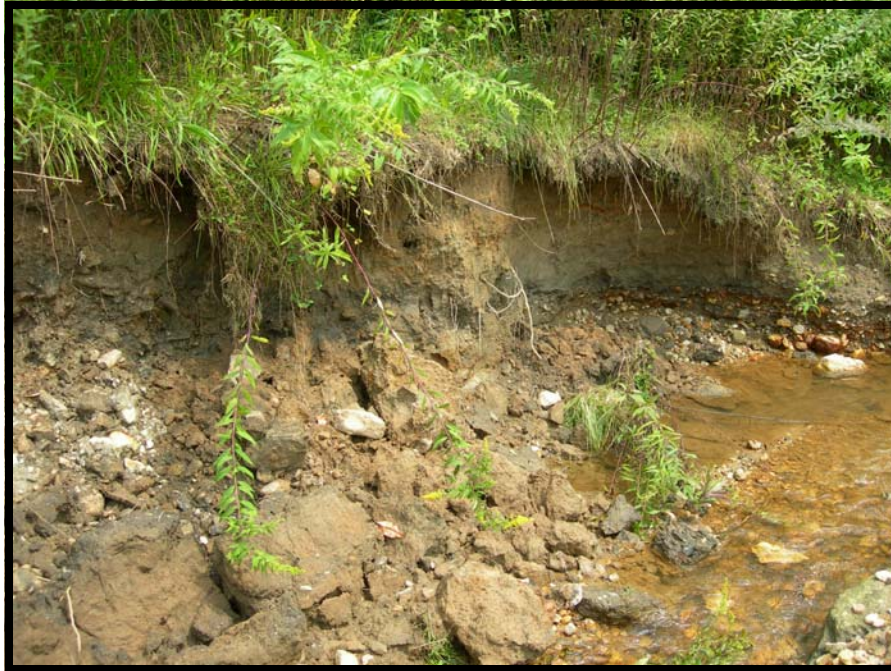
Feature Issues	Station numbers	Suspected Cause	Photo number
Bank Scour	31+59 to 31+72	High velocity/excess shear	Stream Problem Area Photos 1-2
	29+68	Structure scour	
	27+50 to 26+92	High velocity/excess shear	
	27+28	Scour at rootwad	
	15' up UT to 23+78	High velocity/excess shear	
	13+12	Scour at structure	
Failing Structures	34+75	Rock shift at apex of vane	Stream Problem Area Photos 2-4
	34+00	Large drop over structure	
	29+68	Rootwad scour (span channel)	
	28+94	Large drop over structure	
	27+28	Scour at rootwad	
	13+12	Scour at structure	
	4+27	Large drop over structure -scour at structure	
	1+80	Water flowing under vane

Figure 1— Typical Bank Scour

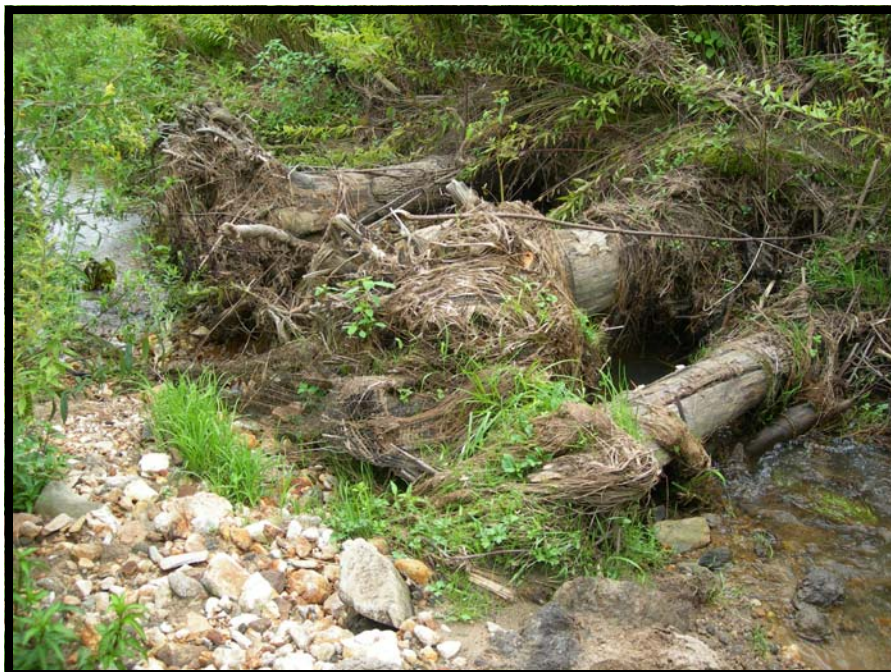
Figure 2— Typical Bank Scour / Failing Structure

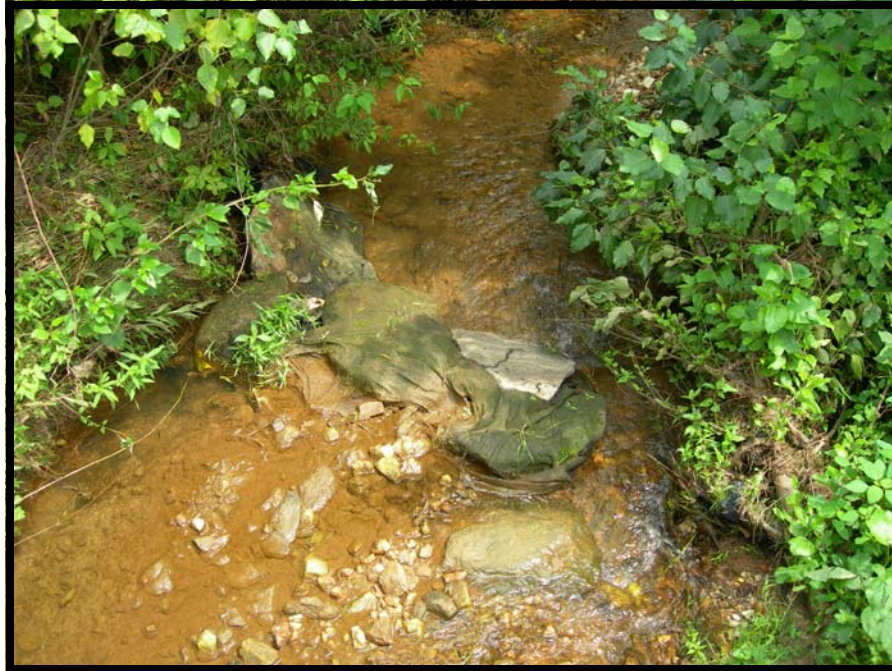
Figure 3—Typical Failing Structure

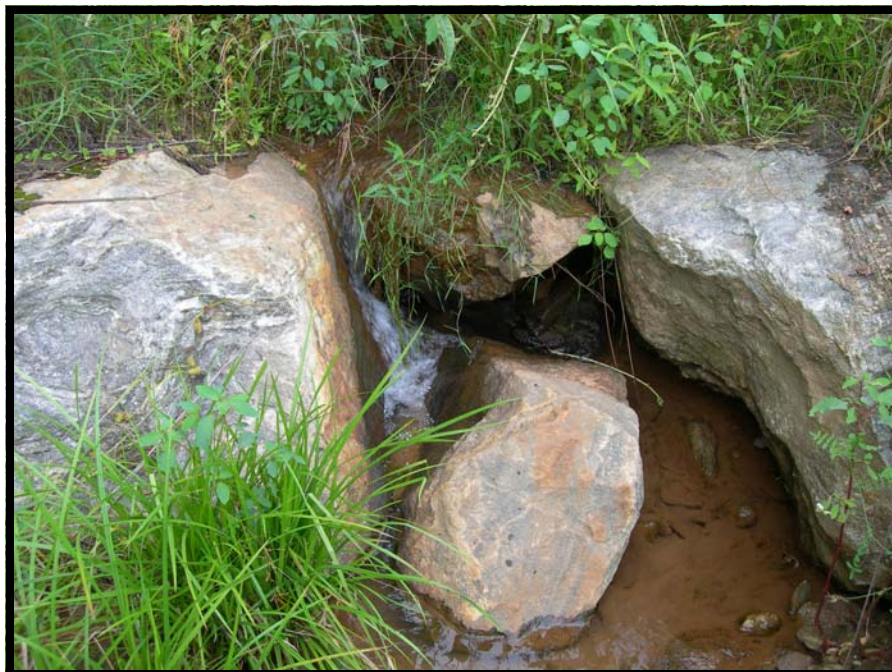
Figure 4—Typical Failing Structure
