County Line Creek (High Vista) Monitoring Report Year 5 of 5 (2008)

Buncombe and Henderson Counties, North Carolina

Project ID No. 00044

May 2009

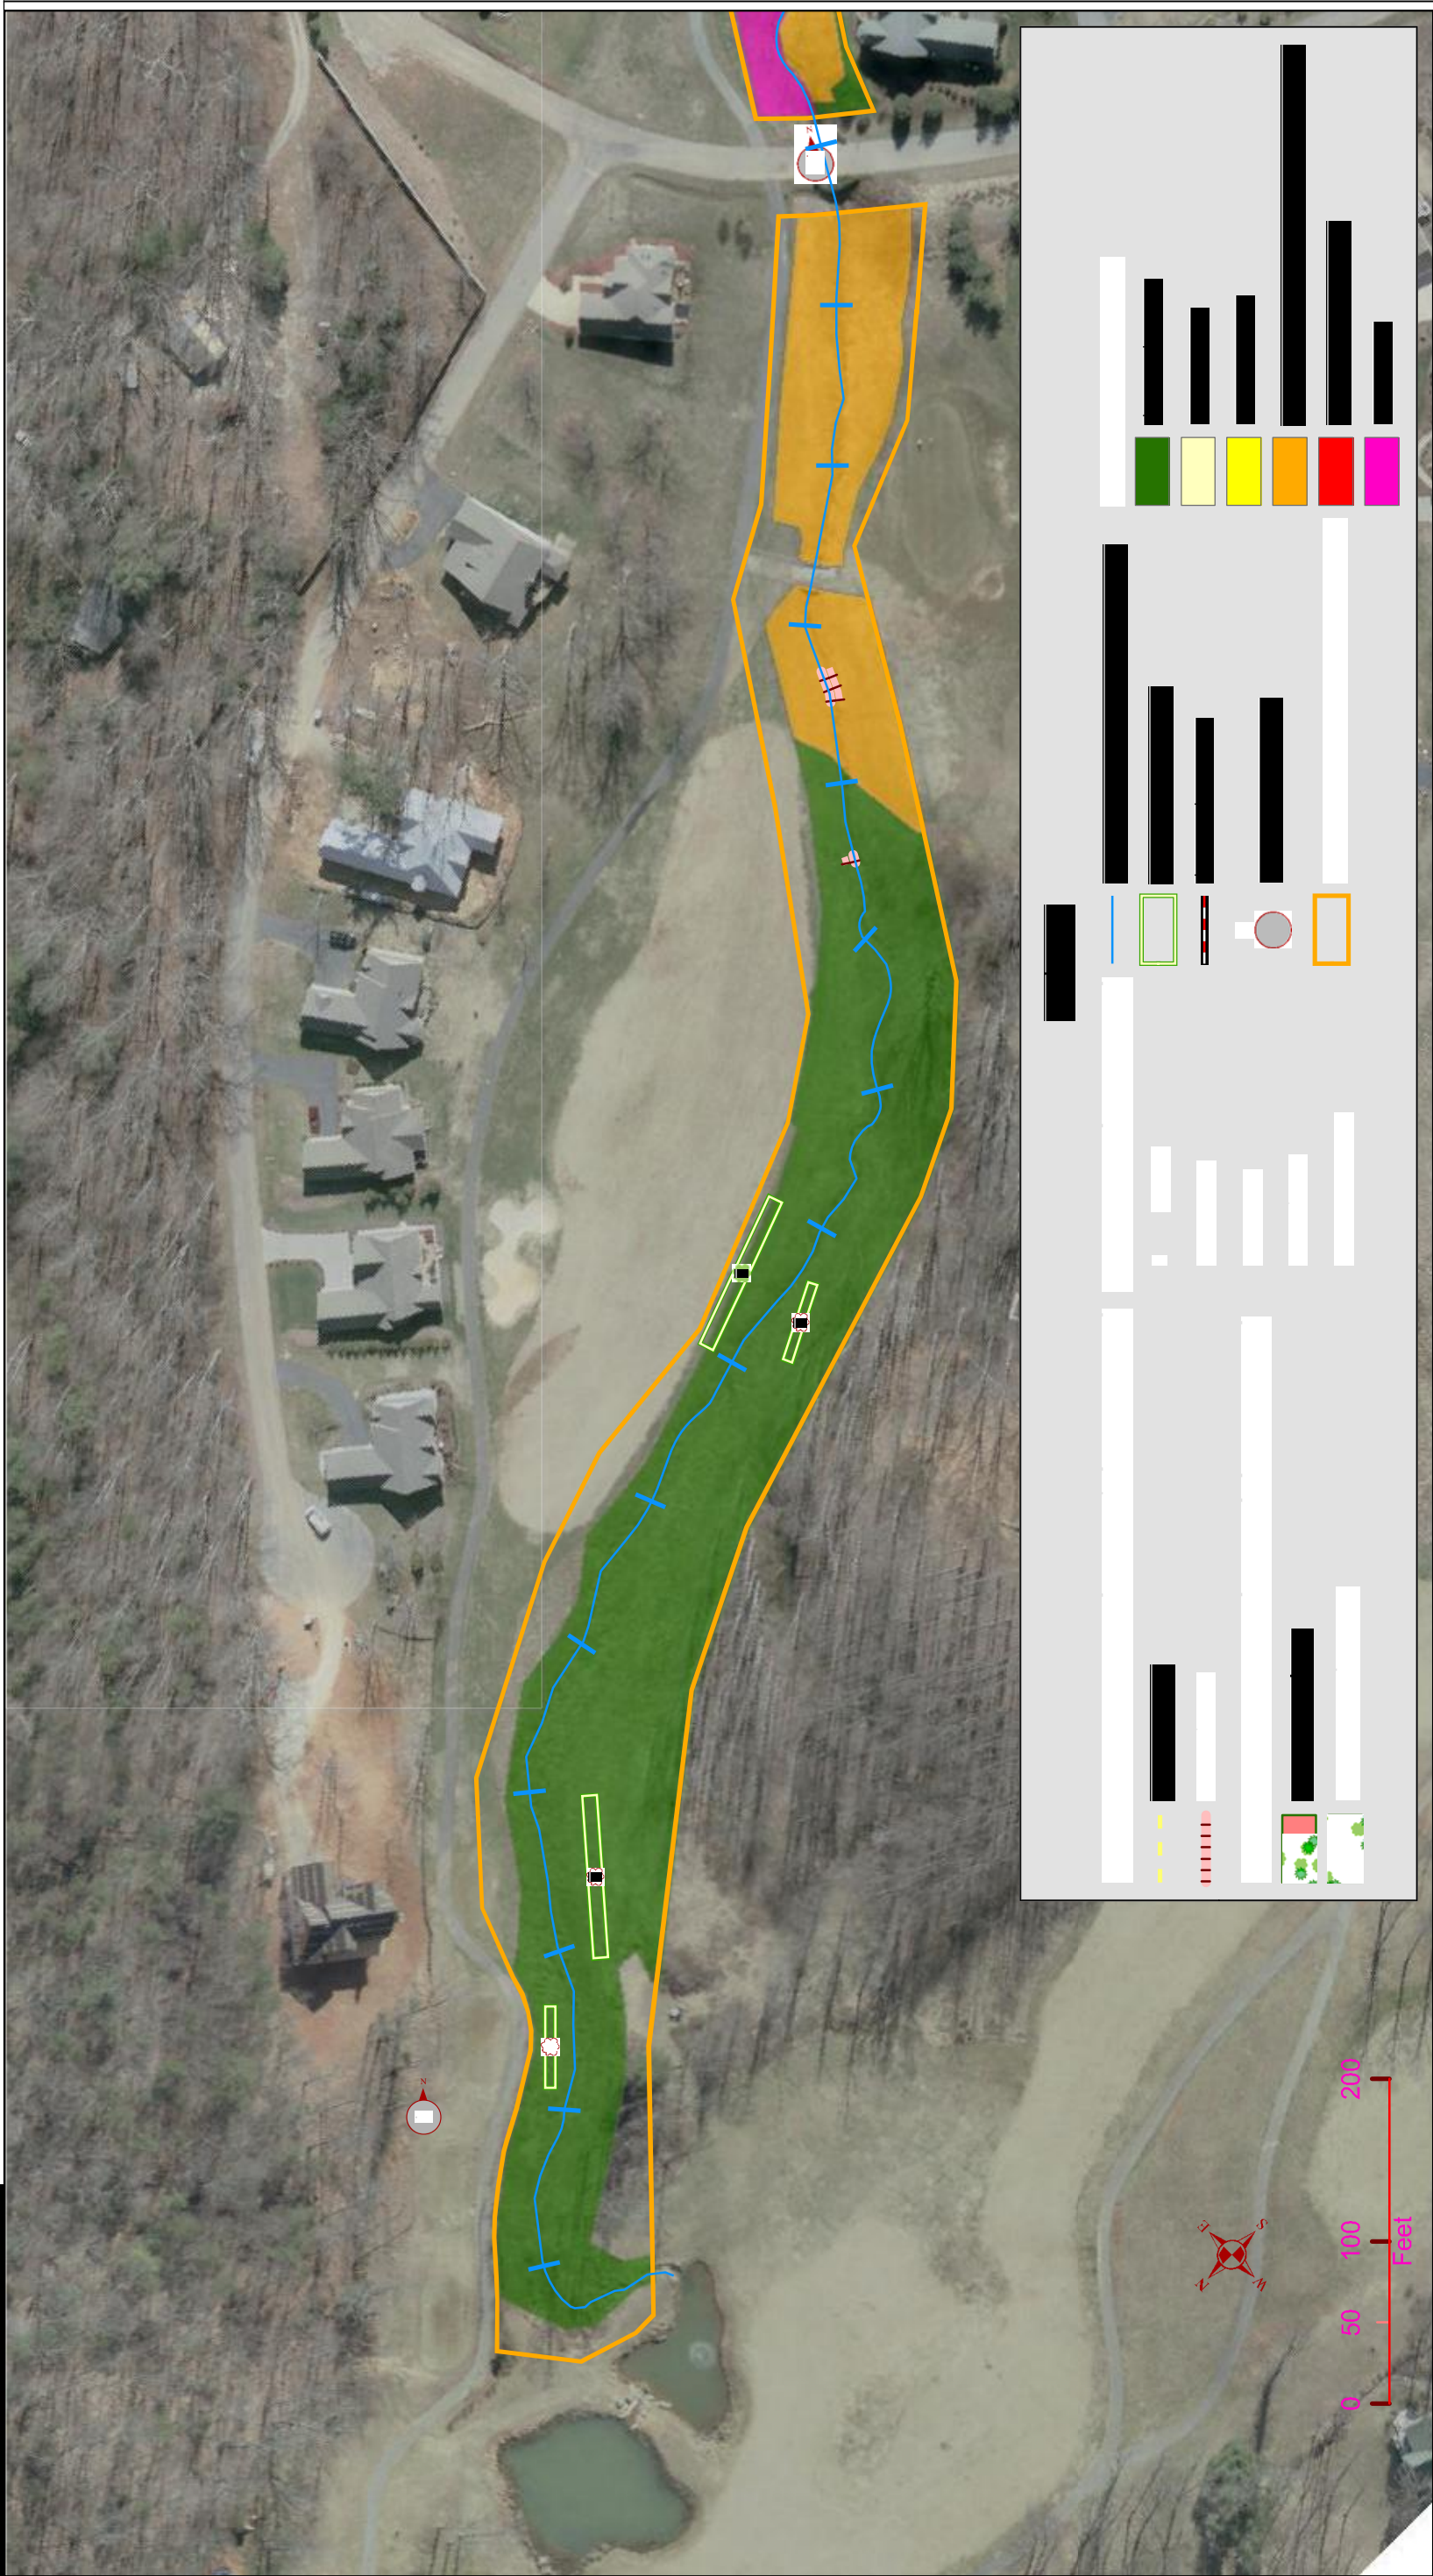
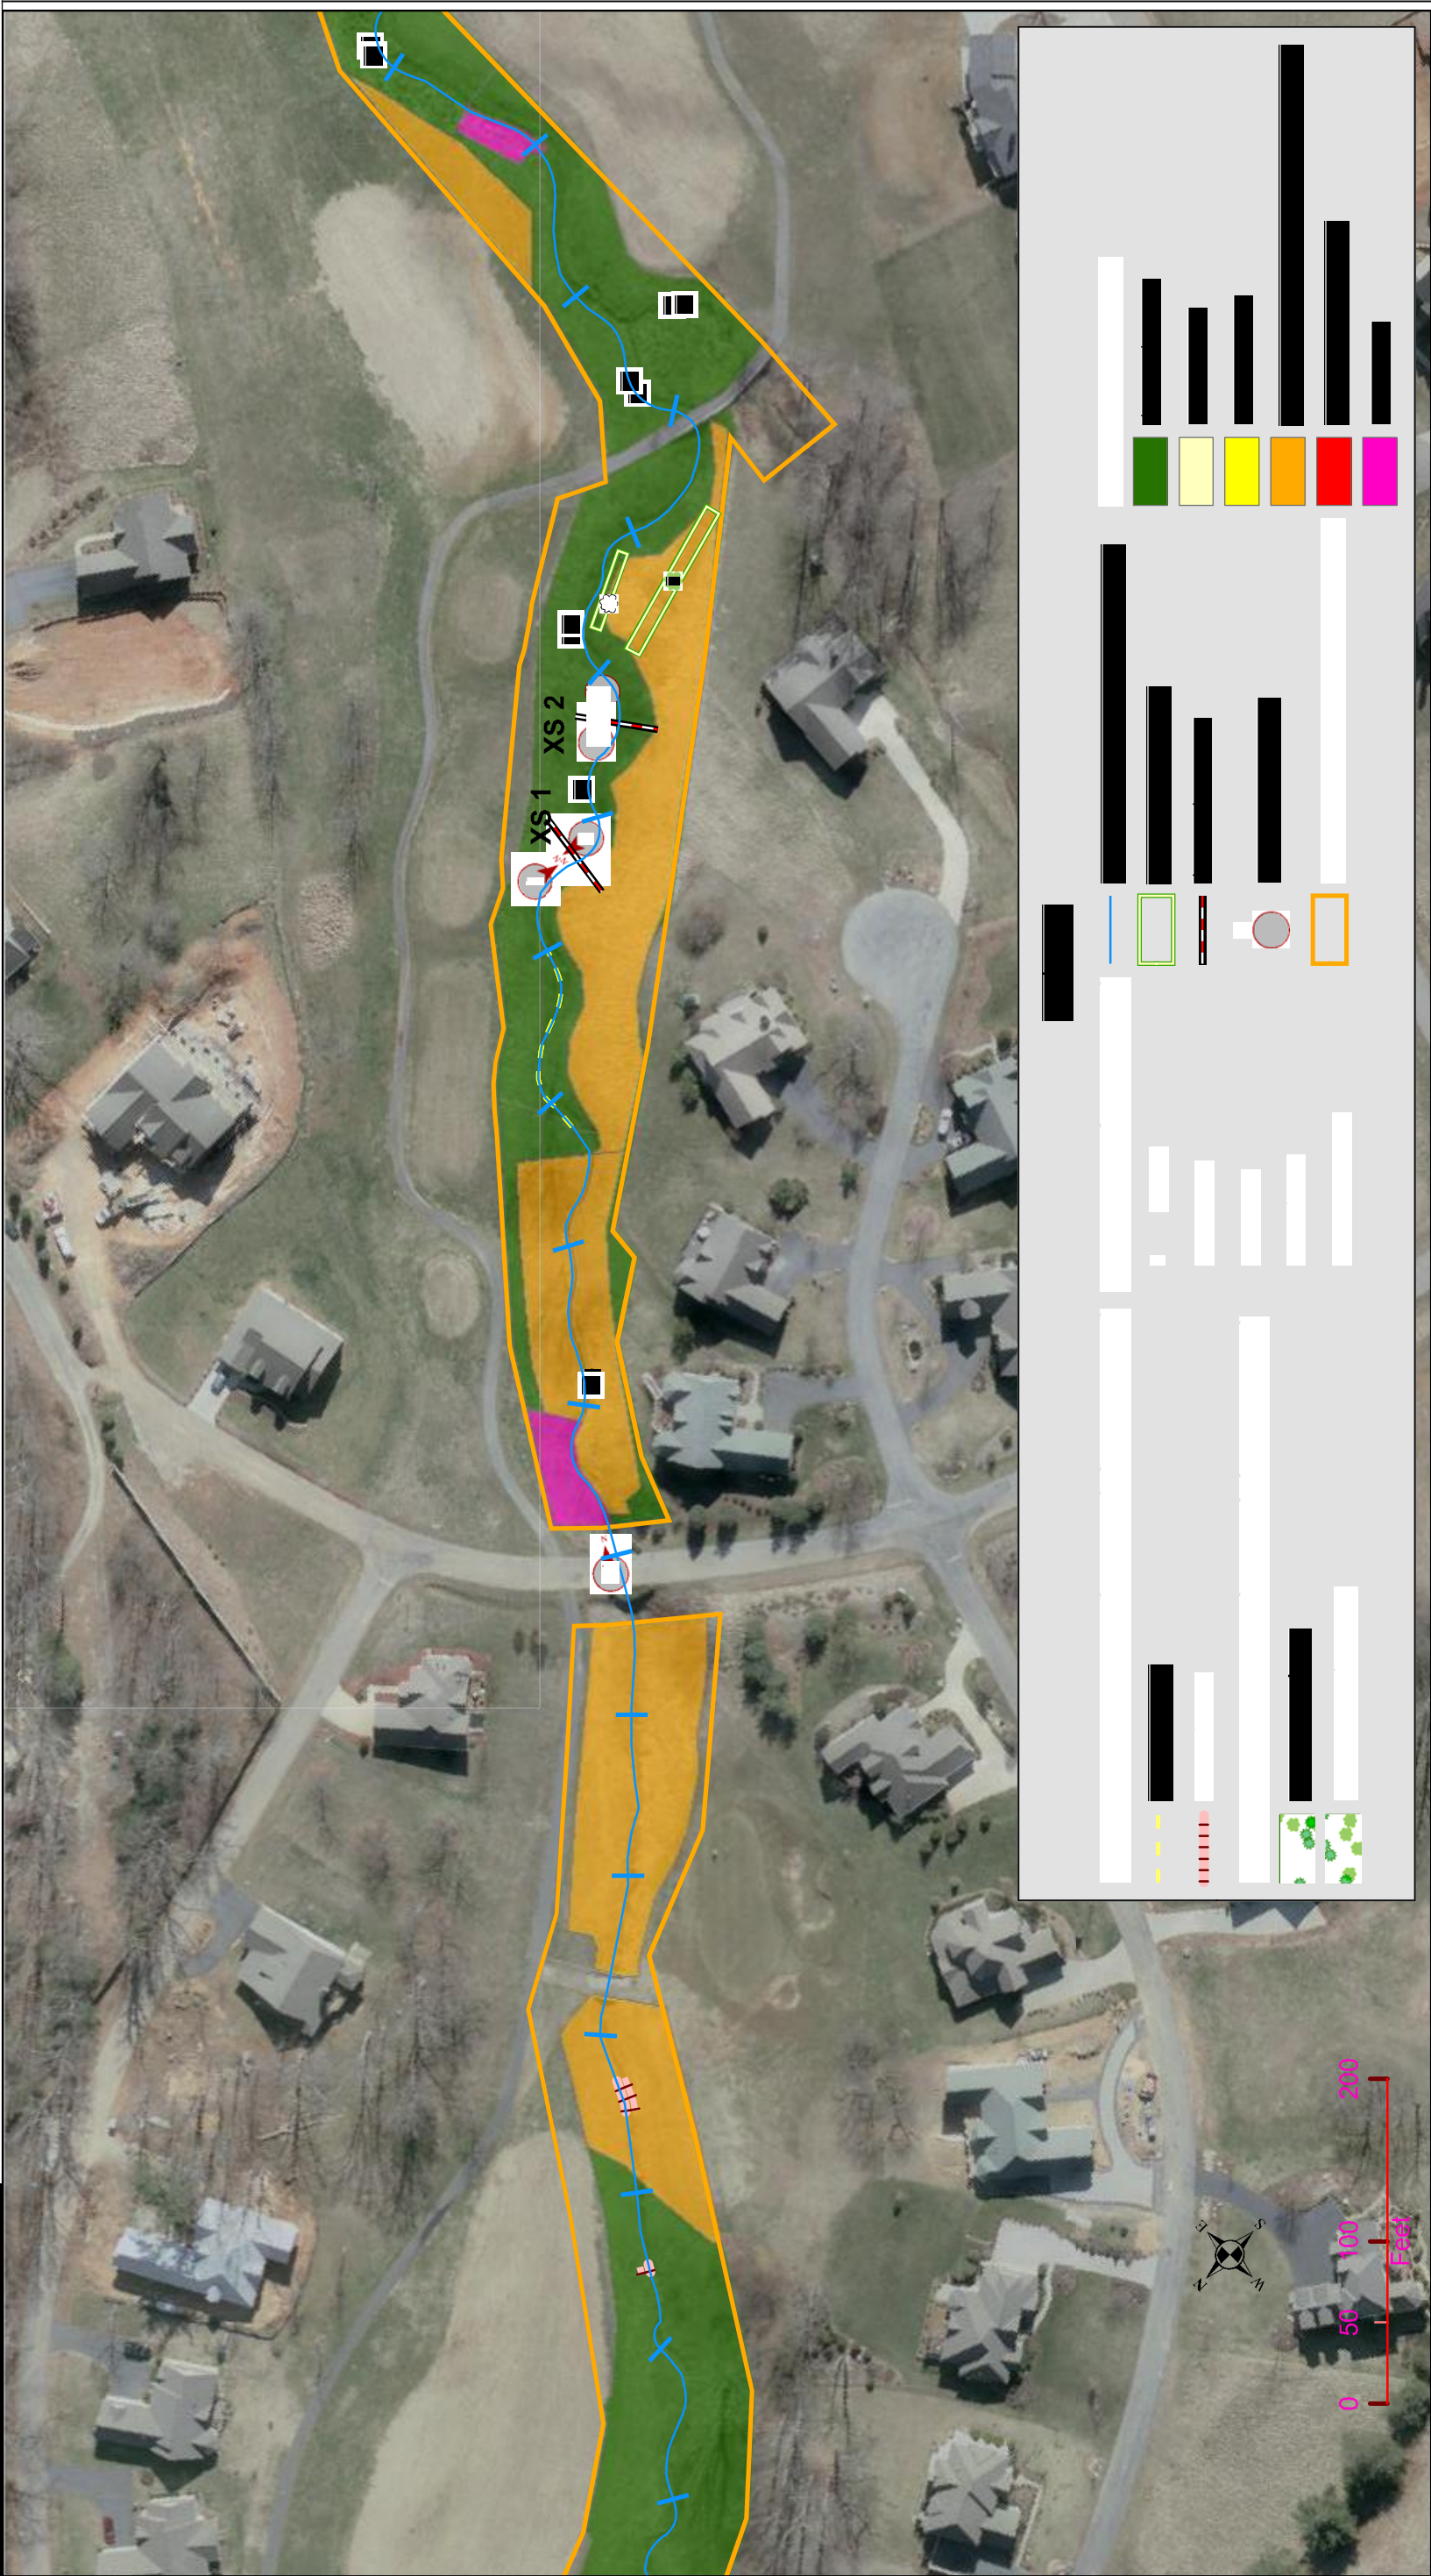
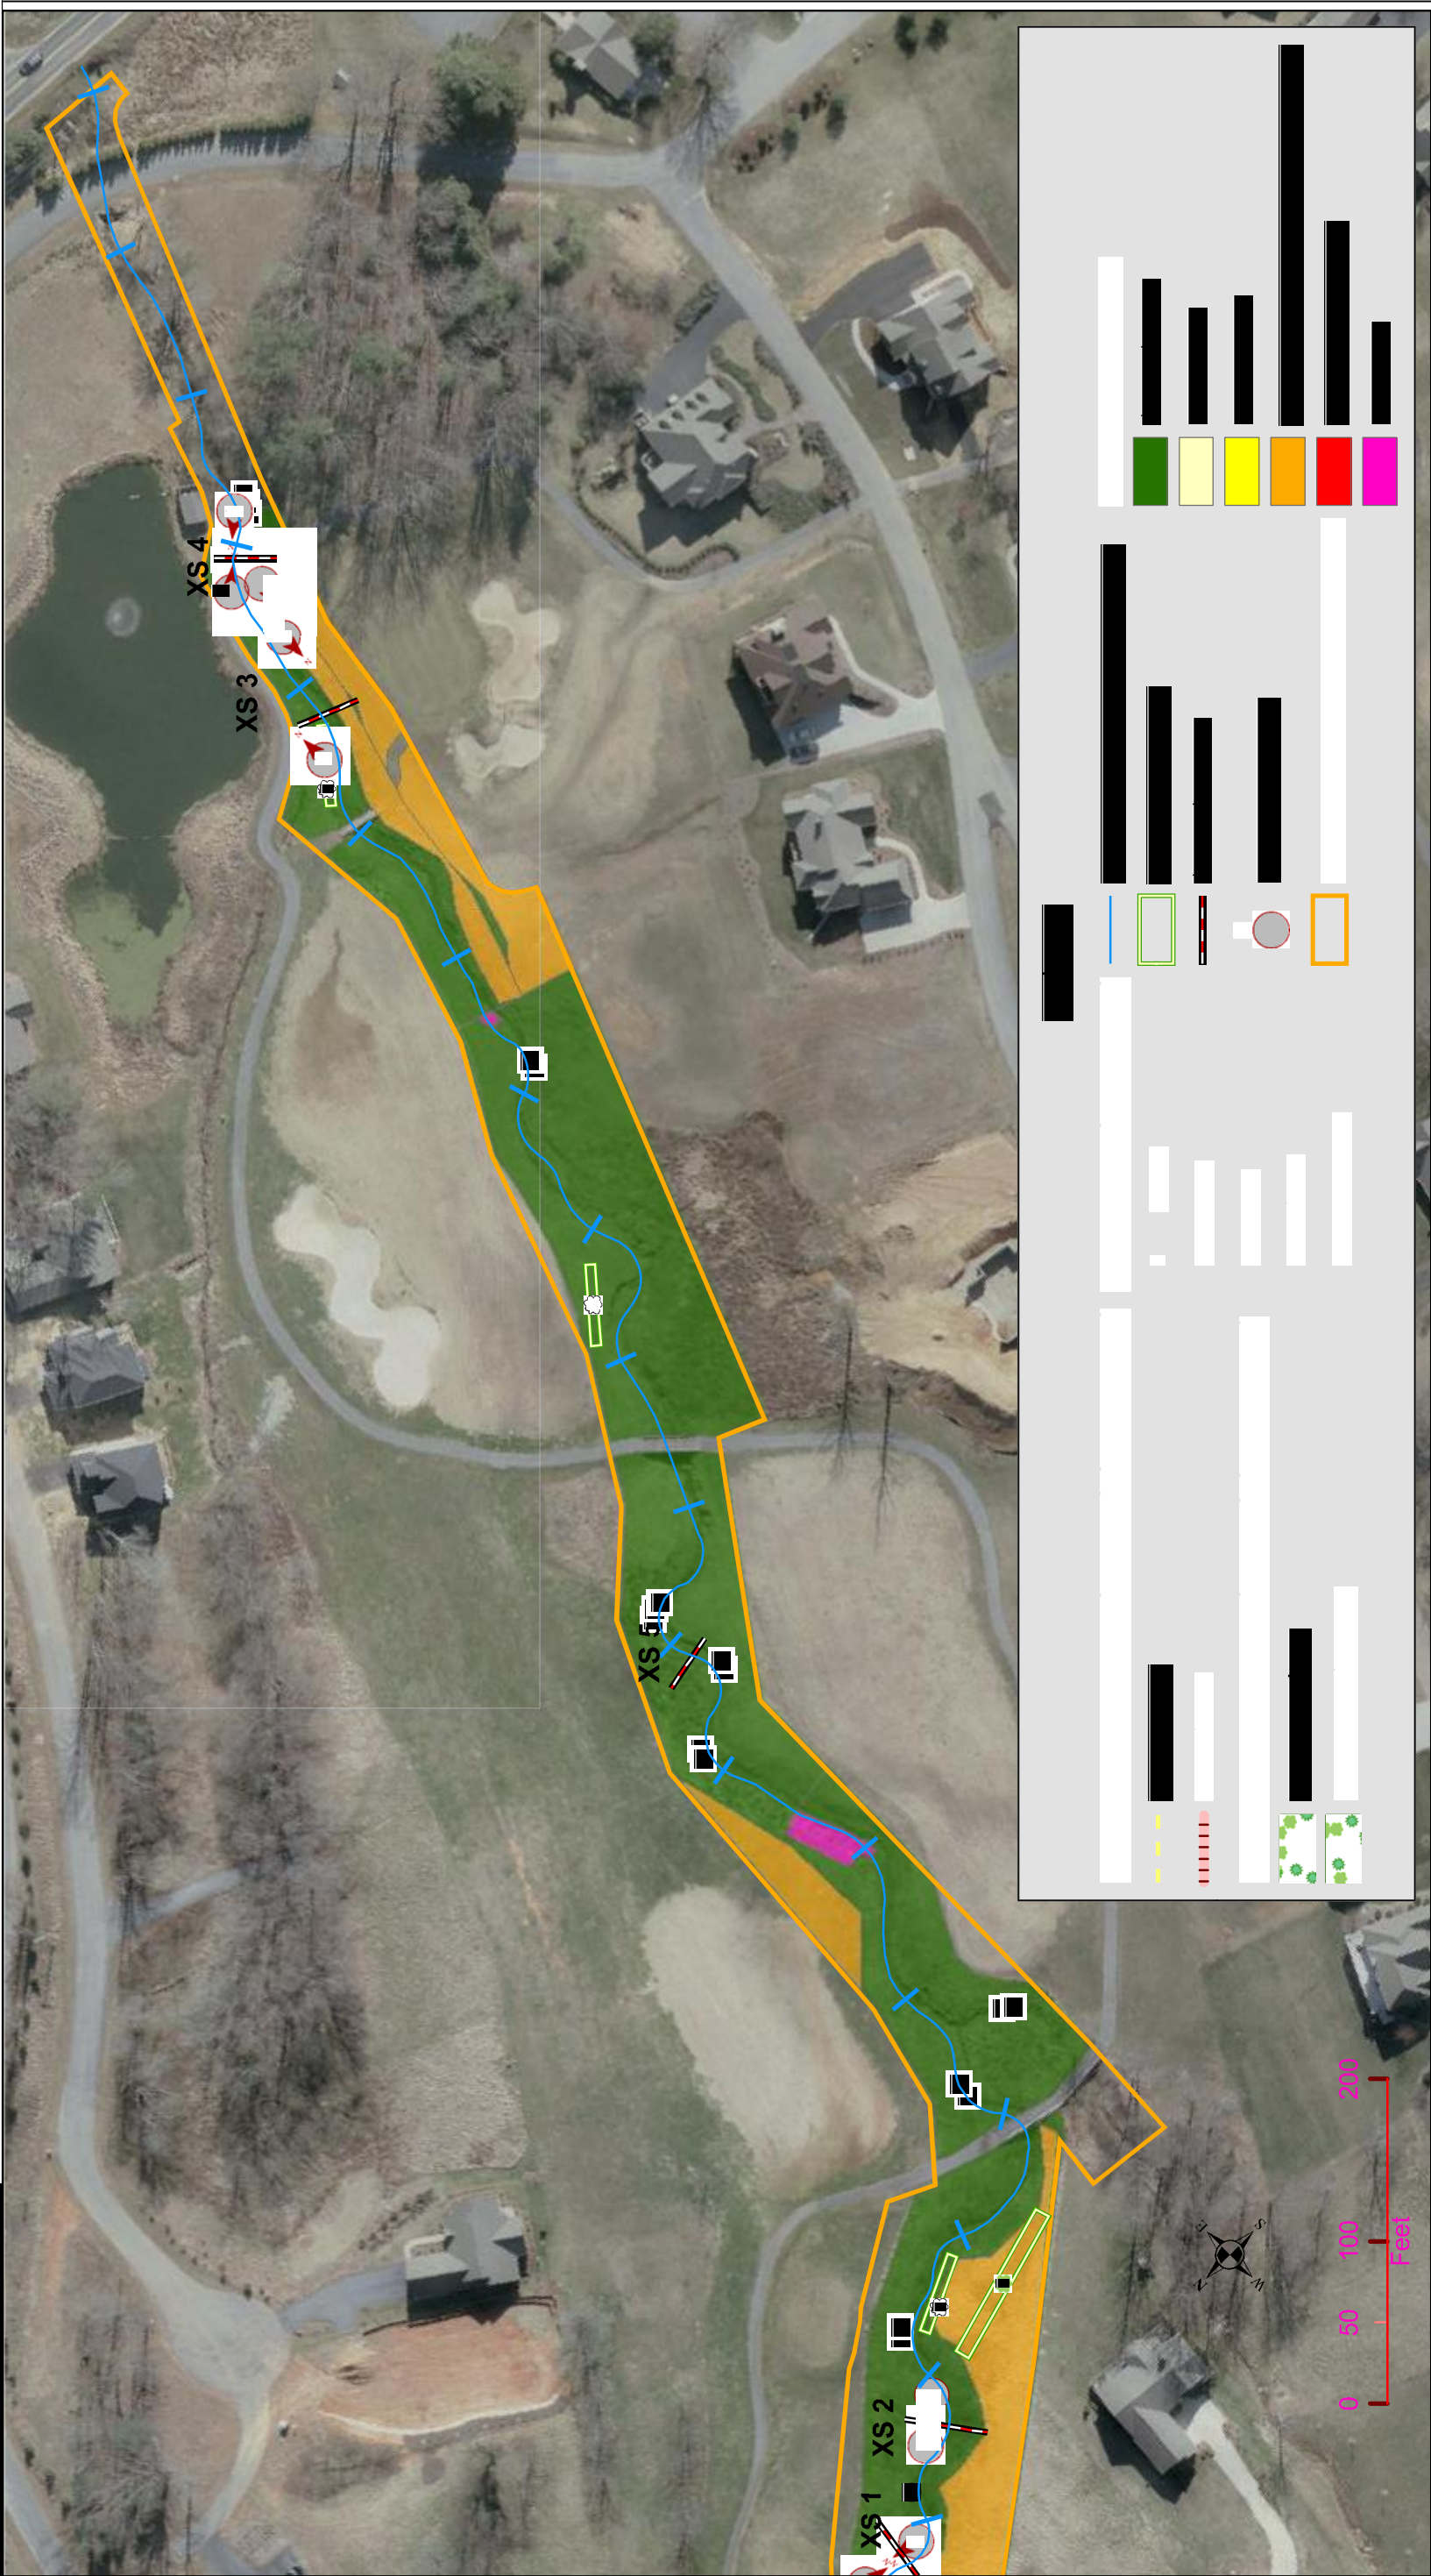
KHA assessed the site vegetation in October 2008. Throughout the reach, stream bank vegetation regions, primarily consisting of planted live stakes and successional volunteers such as Eastern Cottonwood (*Populus deltoides*), Tulip Poplar (*Liriodendron tulipifera*), and Sycamore (*Plantanus occidentalis*), were performing well with the exception of a few isolated stretches. The riparian zone was not performing as well. In several areas, especially below station 31+50, the riparian regions had been cleared. Vegetation plots VP1, VP2, and VP4 were observed as lacking woody vegetation, most likely a result of clearing and maintenance by landowners. Invasive and nuisance species were not observed in populations that presented an immediate threat to the existing communities. Appendix A provides a summary of vegetative problem areas. Figures 2-4 show the problem areas.

KHA assessed the stream channel during the spring and fall of 2008. During the winter of 2006, stream restoration contractors performed maintenance work on the lower 2,100 feet of the stream. The maintenance included reshaping the channel and repairing and installing stabilization structures. Overall, the channel appeared stable with isolated sections of instability. A couple of regions of bank scour were observed between stations 14+10 to 33+00. Most of the riffles appeared to be stable with a few shorter and steeper than design criteria. In the upper reach, some of the pools appeared to be steeper than design criteria and may be becoming unstable. Most of the in-stream structures such as rock vanes were functional. Some were difficult to identify due to the age of the reach. Monitoring Plan View Sheets 1 through 3 show the location of the stream problem areas and table B1 in appendix B summarizes the stream problem areas.

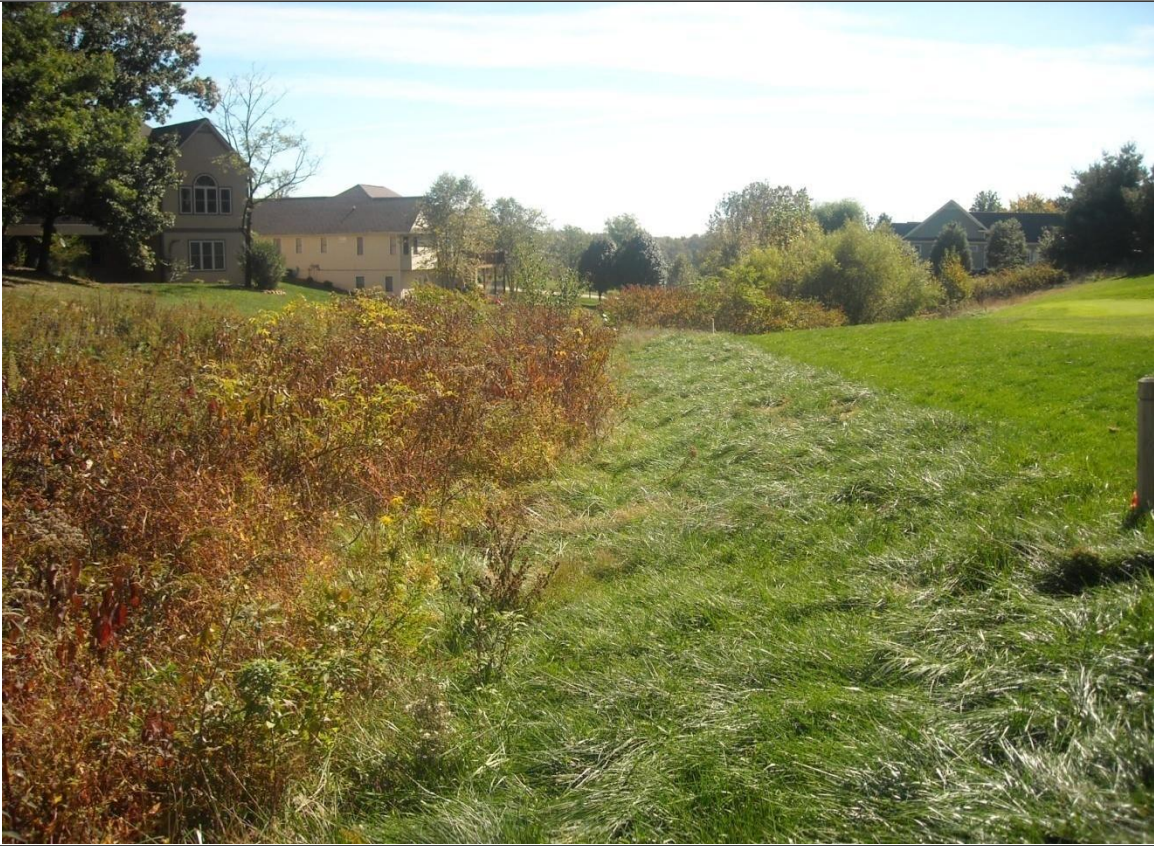
VP 1: Cleared buffer, no wooded species

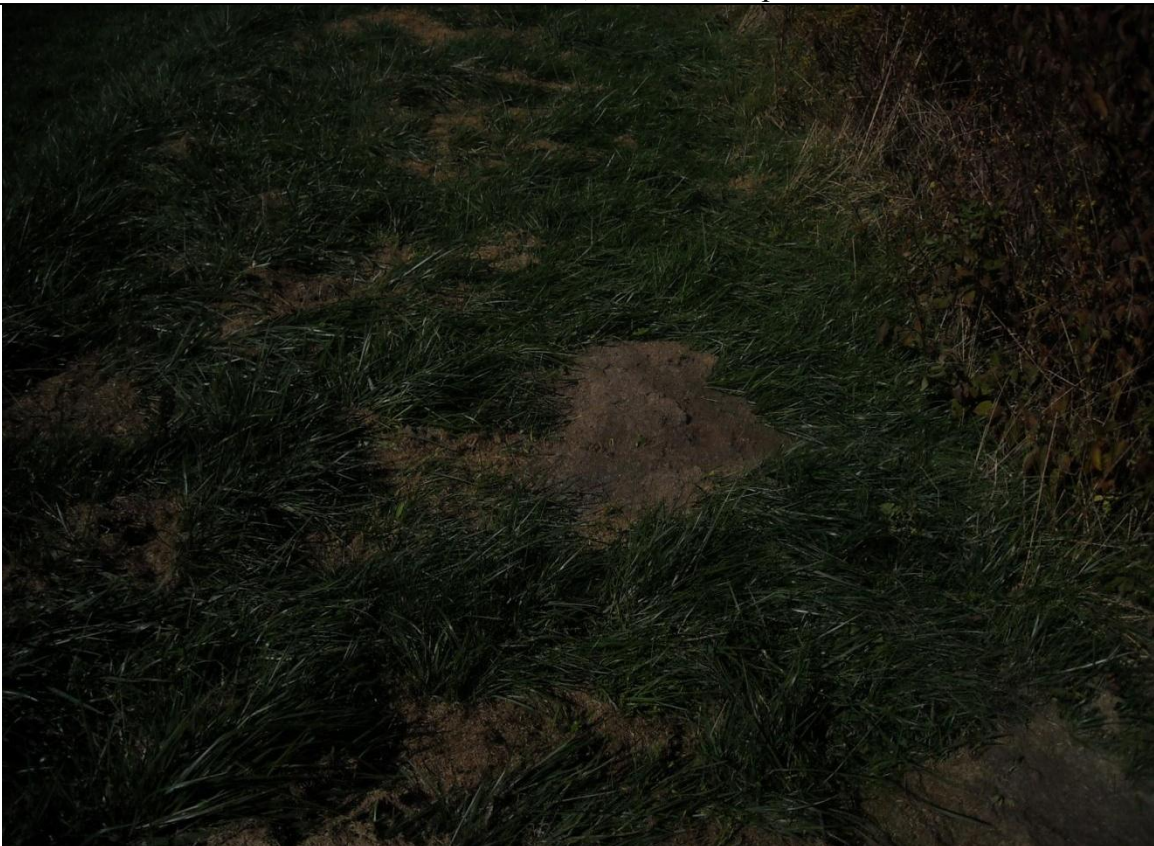
VP 2: Lawn clippings in easement

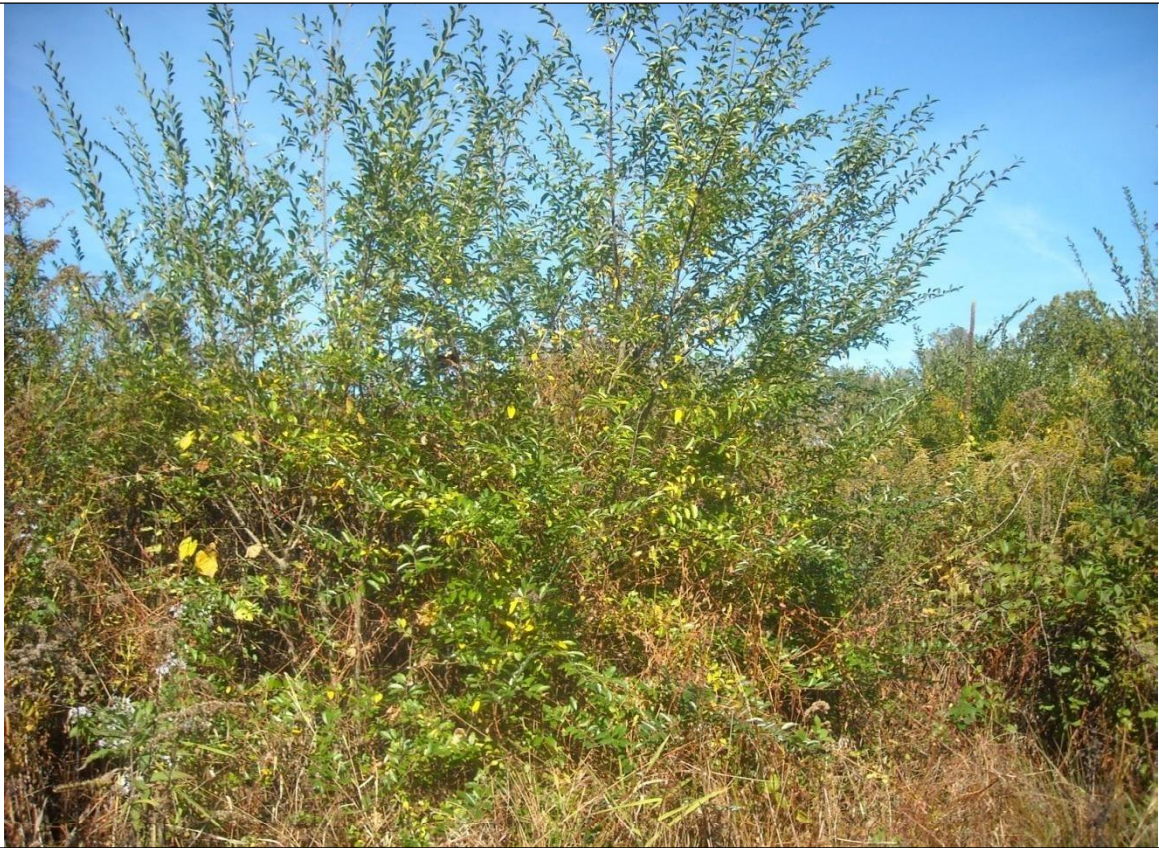
VP 3: Privet patch

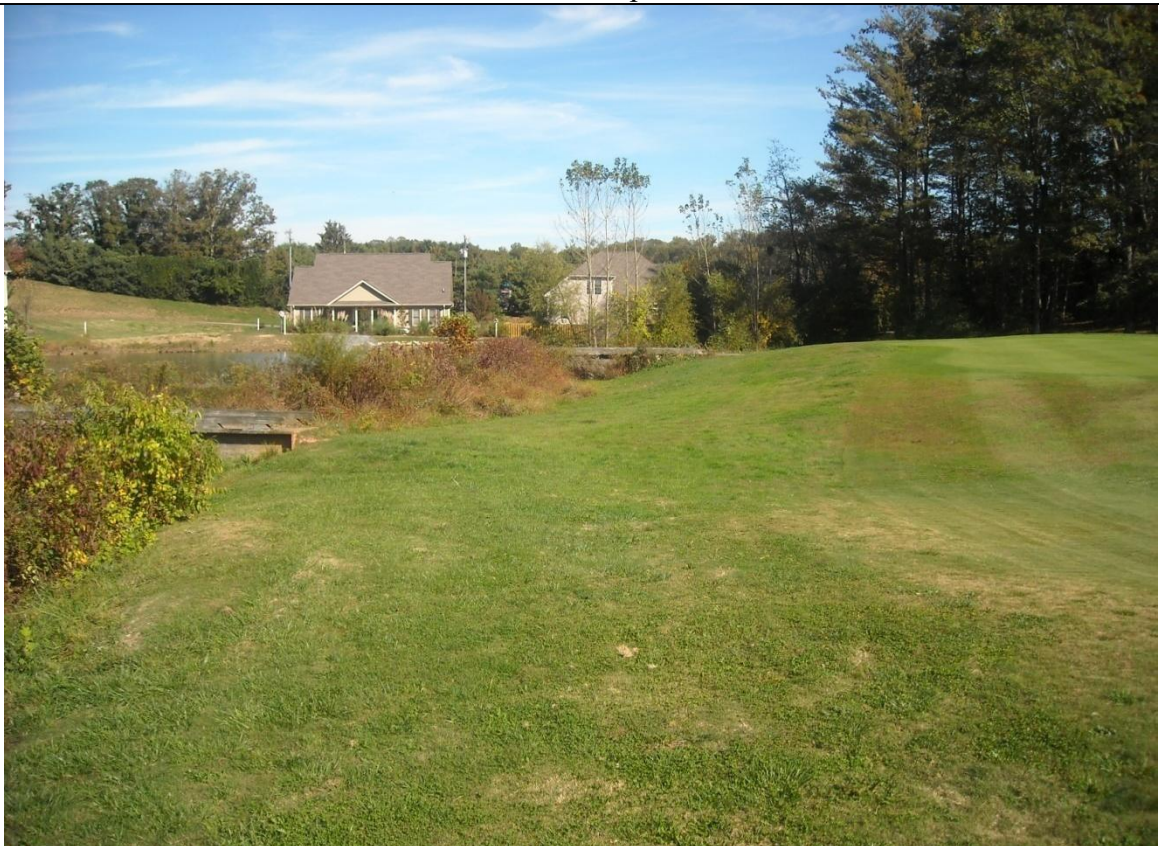
VP 4: Cleared and maintained to bank
