County Line Creek (High Vista) Monitoring Report Year 7 (2010)

Buncombe and Henderson Counties, North Carolina

Project ID No. 175

Submitted November 2010

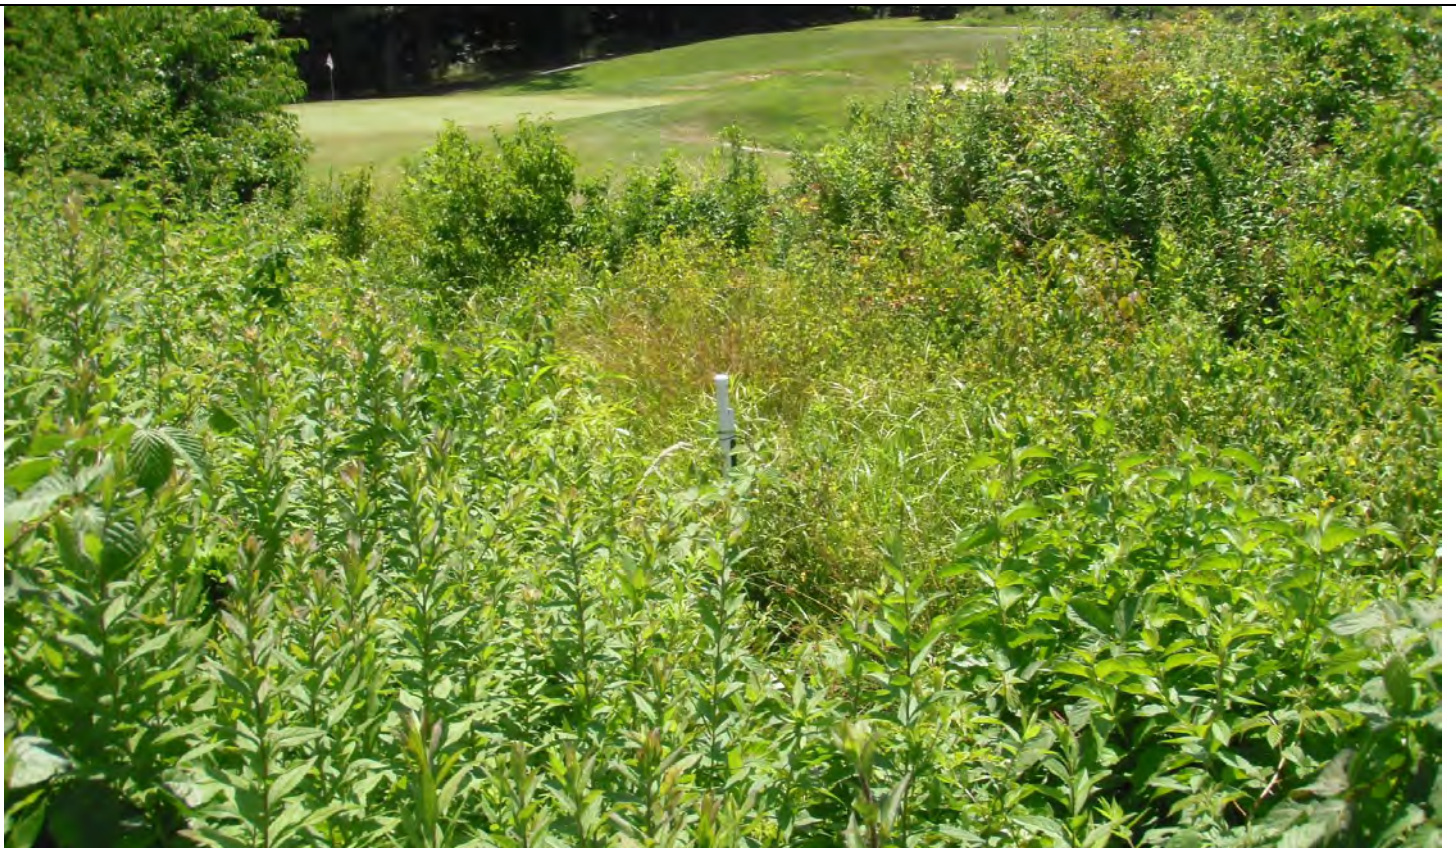
SP 1: Crest Gage

Table V. Verification of Bankfull Events			
County Line Creek (High Vista) Stream Restoration (EEP No. 00175)			
Date of Data Collection	Date of Occurrence	Method	Photo #
10/20/2009	N/A	Bankfull wracklines were not observed and the crest gauge did not indicate bkf event occurrence.	N/A
11/12/2009	Oct-Nov 2009	Bankfull wracklines were observed, indications that there had been a bankfull event.	N/A
7/7/2010	N/A	Crest Gage indicated a 1.75' bankfull event	SP1
