**Year 1 Monitoring Report**

**COWFORD PROJECT**

NCDMS Project #100095 (Contract #0007746)

**January 2023**

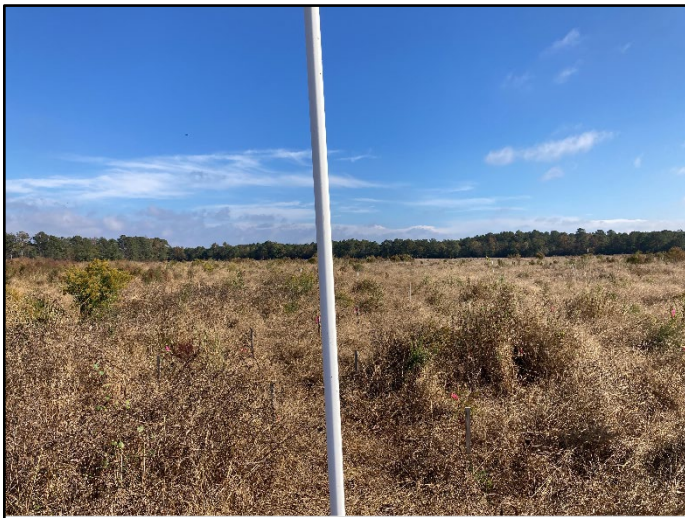
Vegetation Plot 3 (11/3/2022)

In MY1, random vegetation plot #3 captures a wetland depressional area. RES will continue to monitor vegetation success in wetland depression areas.

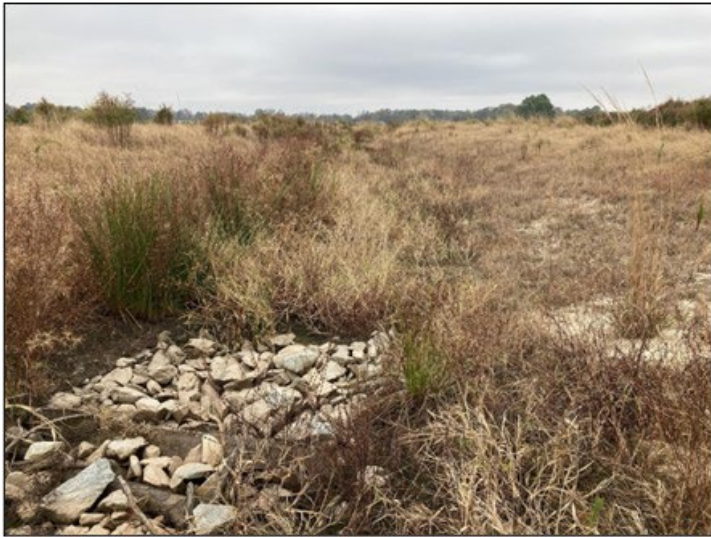
Headwater Valley (11/3/2022)

RES did not design a low flow (pilot) channel through the HWV reach and expects the reach to develop into a headwater system.

Setup of cross sections 1, 2, and 3 in the headwater valley took place on January 19<sup>th</sup>, 2022. Overall, the baseline cross sections and profile relatively match the proposed design. The flow gauge located in the headwater valley measured 55 consecutive flow days. The livestakes are becoming established within the channel and will provide opportunities for flow paths to develop in subsequent years. Additional headwater valley channel performance criteria are listed in **Appendix D**. Digital images can be found in **Appendix B**. Visual assessments and updated images will be documented in years to follow as indicators are established.

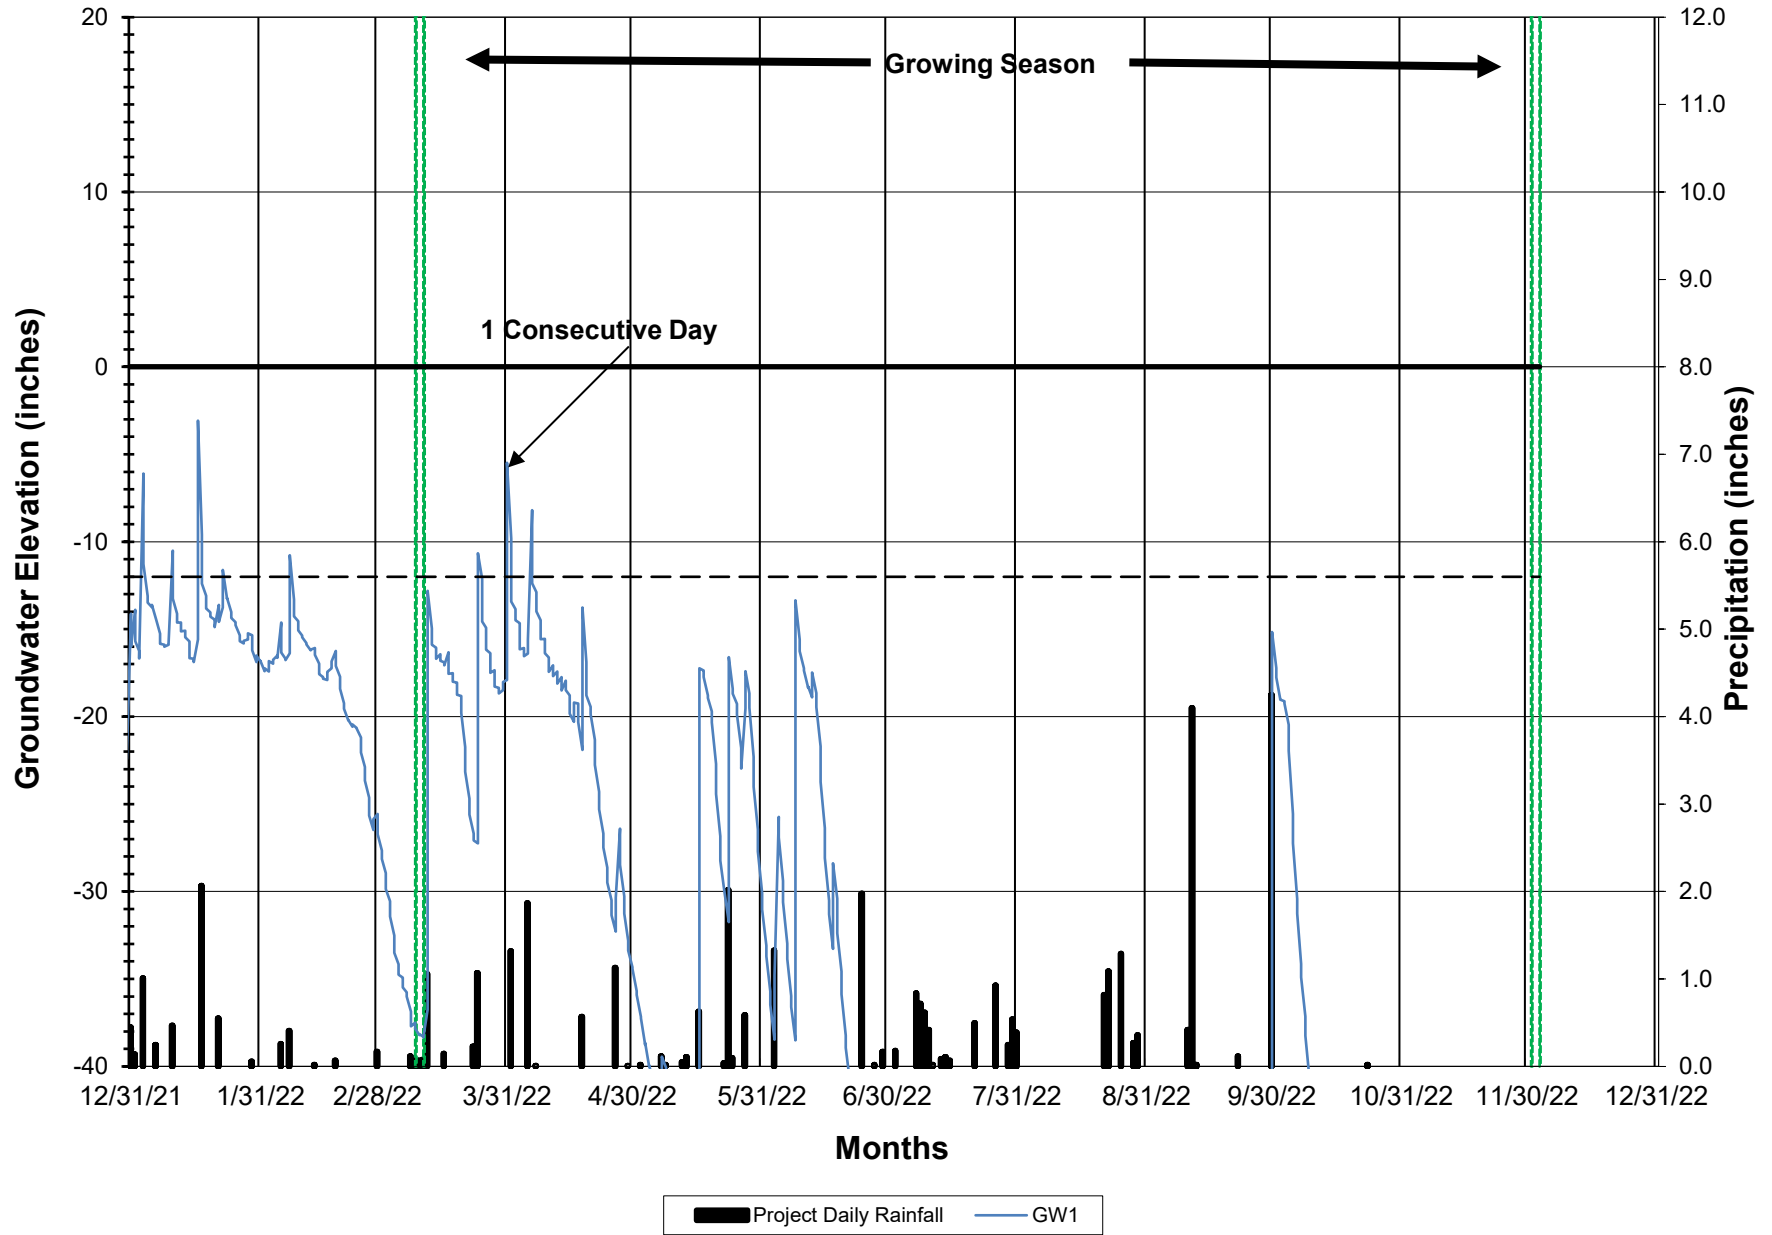
# 2022 Cowford GW1

A total of five groundwater wells with automatic recording pressure transducers were installed throughout the wetland areas on November 2<sup>nd</sup>, 2021, and April 28<sup>th</sup>, 2022. All five groundwater wells failed to meet success of 12-16 percent of the growing season (GW1 0%, GW2 1%, GW3 7%, GW4 4%, and GW5 5%) **Appendix E**. It is important to note that GW5 is located outside of the wetland crediting area. Although all five groundwater wells did not meet success, it was noted that due to extensive draining efforts that it may take at least a year for the site to become completely saturated and reach the target hydroperiods. Onslow county has experienced drought conditions for more than 70% of 2022 and rainfall amounts in February and June were below normal limits which could have attributed to lower hydroperiods. Therefore, RES expects the hydroperiods to increase in subsequent years as the wetlands continue to establish.
