Year 2 Monitoring Report

COWFORD PROJECT

NCDMS Project #100095 (Contract #0007746)
USACE Action ID: SAW-2019-00487
DWR Project #2019-0495

Onslow County, North Carolina
White Oak River Basin
HUC 03030001

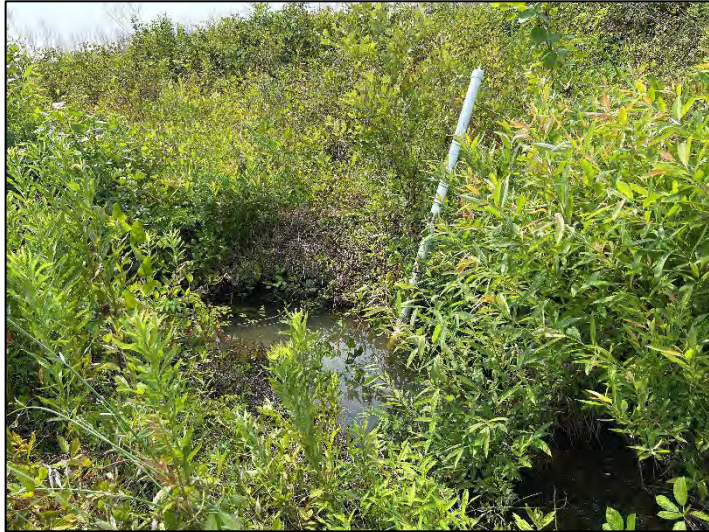
Stage Recorder KJ1-C (6/7/2023)

One stage recorder on KJ1-C, was installed on January 19th, 2022. One flow gauge, on KJ1-A, was installed on January 19th, 2022. The stage recorder is in place to document bankfull events, while the flow gauge is in place to track frequency and duration of stream flow events. The stage recorder on KJ1-C measured 10 bankfull events with the highest being 1.74 feet above the top of bank. The flow gauge on KJ1-A (HWV reach) measured 8 flow events with the longest flow event lasting 129 days. Gauge locations can be found on **Figure 2** and photos are in **Appendix B**.

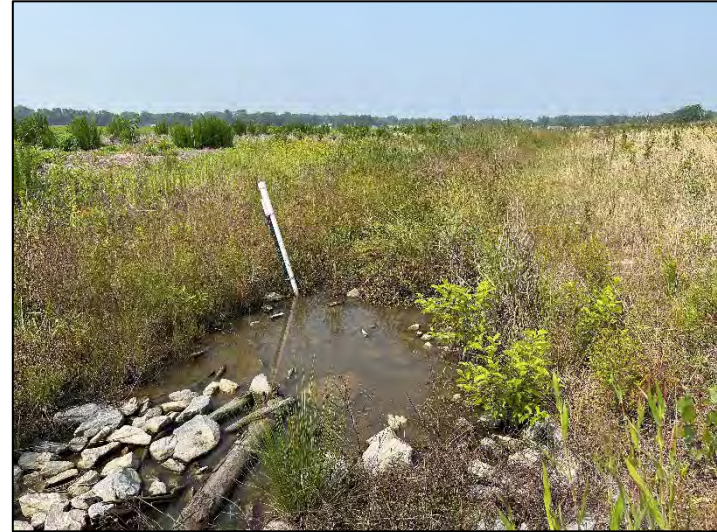
Flow Gauge KJ1-A (6/7/2023)

Setup of cross sections 1, 2, and 3 in the headwater valley took place on January 19th, 2022. Overall, the baseline cross sections and profile relatively match the proposed design. The flow gauge located in the headwater valley measured 160 consecutive flow days. The live stakes are becoming established within the channel and will provide opportunities for flow paths to develop in subsequent years. Additional headwater valley channel performance criteria are listed in **Appendix D**. Digital images can be found in **Appendix B**. Visual assessments and updated images will be documented in years to follow as indicators are established.

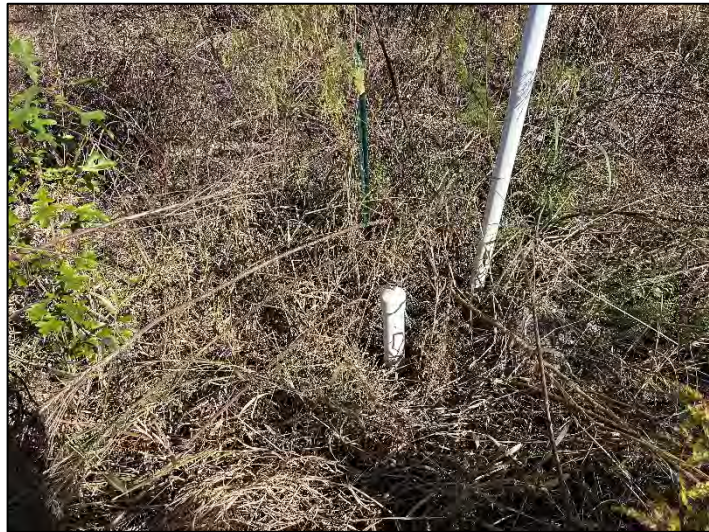
Wetland Gauge 1 (11/2/2023)

A total of five groundwater wells with automatic recording pressure transducers were installed throughout the wetland areas on November 2nd, 2021, and April 28th, 2022. All five groundwater wells failed to meet success of 12-16 percent of the growing season (GW1 2%, GW2 2%, GW3 6%, GW4 5%, and GW5 5%) **Appendix E**. It is important to note that GW5 is located outside of the wetland crediting area. Although all five groundwater wells did not meet success again in MY2, it was noted that due to historic draining efforts it may take more than a year for the site to become completely saturated and reach the target hydroperiods. Onslow county has experienced abnormally dry and moderate drought conditions in 2022 and 2023 (**Appendix E**). Rainfall amounts in December (2022), March, April, and October were below normal limits which could have attributed to lower hydroperiods. RES expects the hydroperiods to increase in subsequent years as the wetlands continue to establish. In addition, RES plans to install supplemental groundwater wells throughout the wetland crediting area to capture a more accurate representation of the wetland hydroperiod. These wells will be installed in the upcoming dormant season. RES has provided additional full calendar year hydroperiod data in **Appendix E**. Full calendar year hydroperiods are as follows: GW1 2%, GW2 2%, GW3 12%, GW4 9%, GW5 9%.
