**Cox Mitigation Project
Johnston County, North Carolina**

FINAL Year 5 Monitoring Report

December 2010

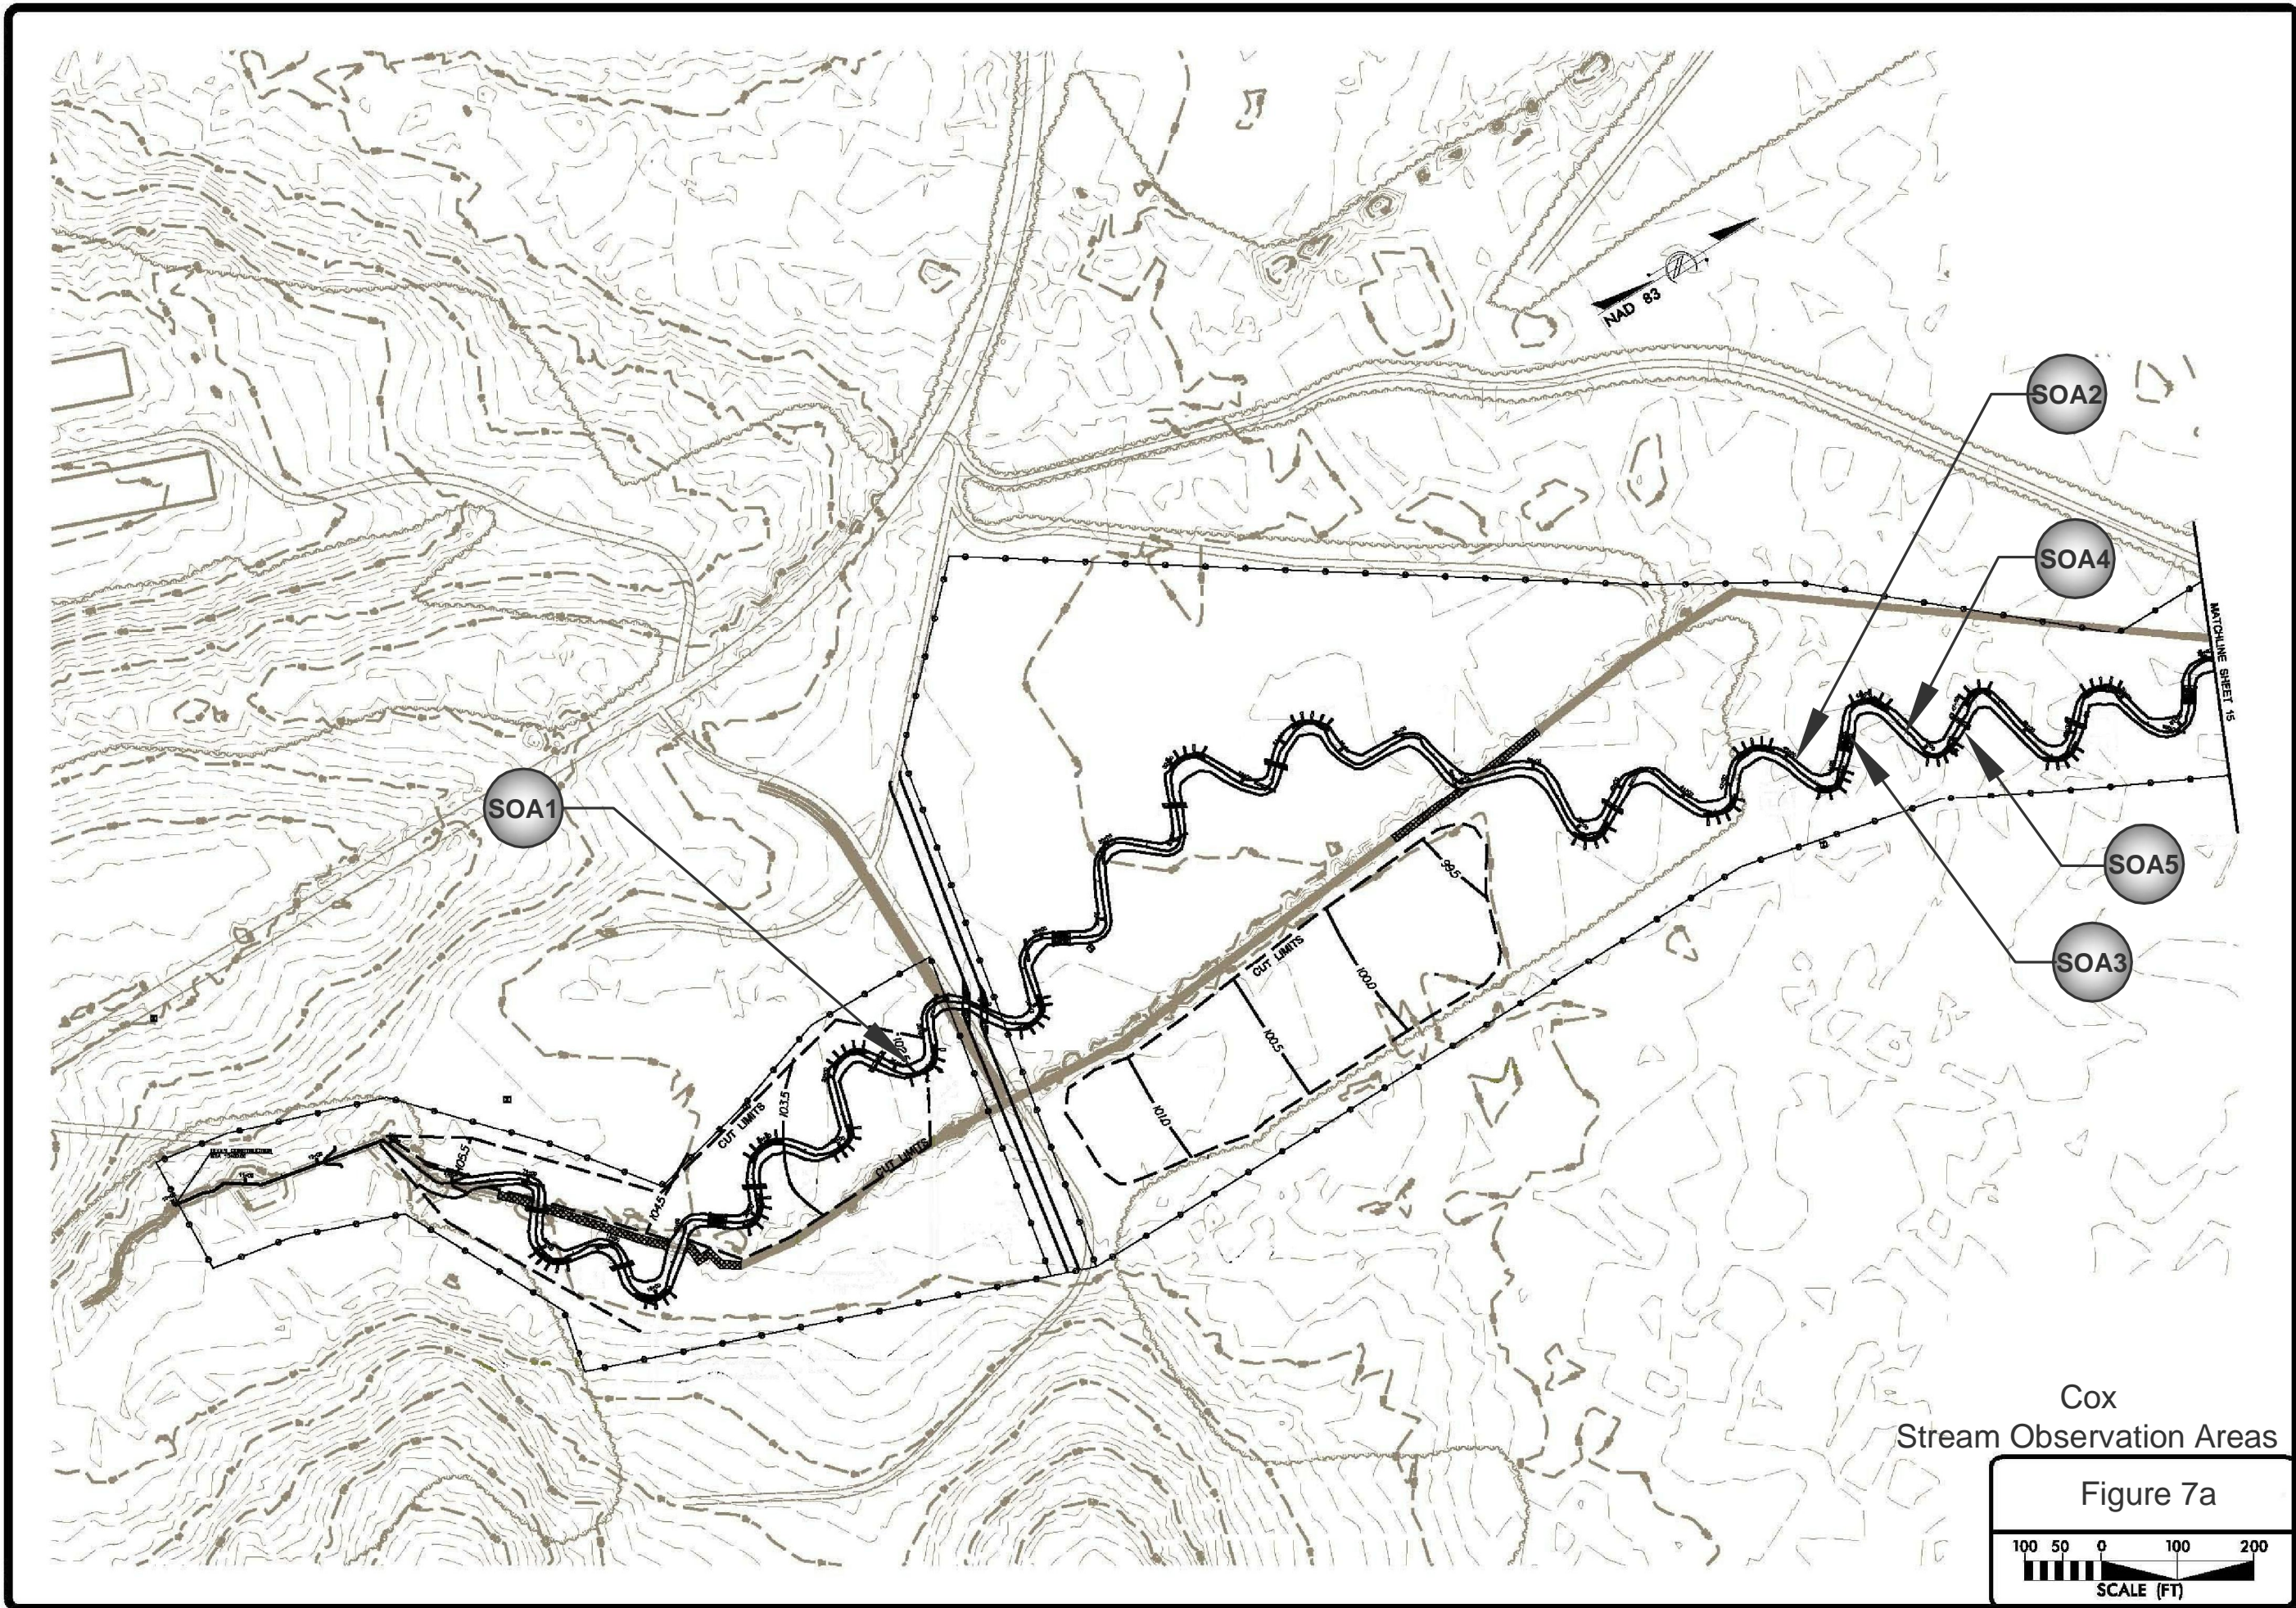
Figure 7a

indicated that most of the structures are stable and functioning properly. Vegetation has stabilized several areas of bank erosion and end cutting that were observed in previous monitoring years. Minor erosion is still occurring at a few structures, and several mid-channel bars were noted. **Table 9** details the stream areas of concern.

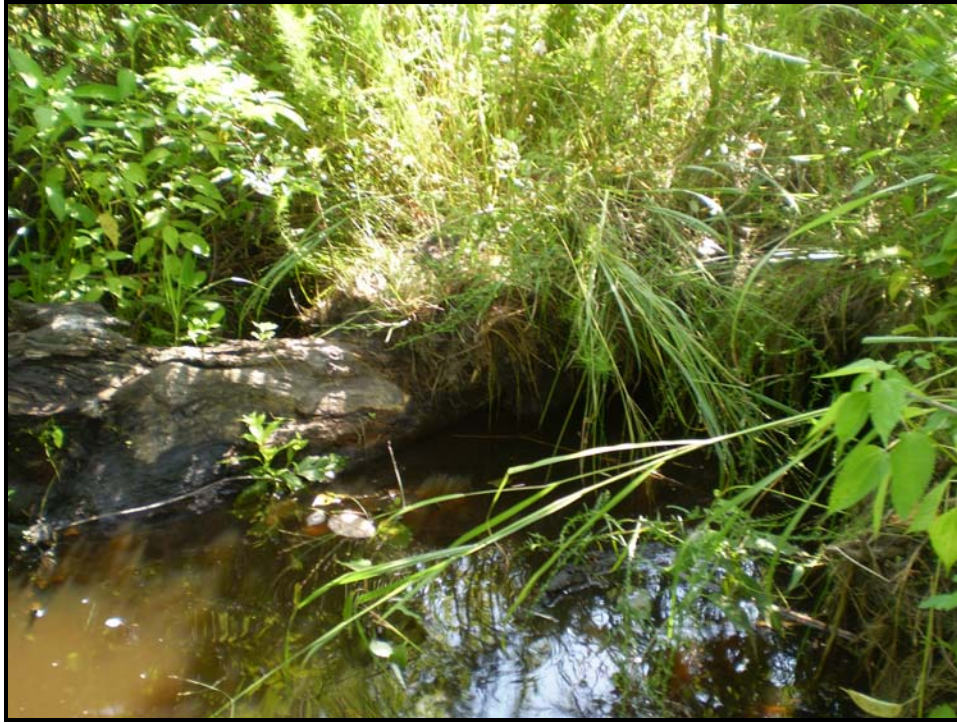
Feature	STA	Description/Recommendation	Photo Number
Root wads	24+25	Minor erosion on right bank behind root wads, vegetation is stabilizing banks, no repair needed	SOA 1
Channel	43+00	Mid-channel bar formation, no repair needed	SOA 2
Channel	44+35	Mid-channel bar formation, no repair needed	SOA 3
Channel	45+50	Vegetation in channel, no repair needed	SOA 4
Log weir	46+85	Log weir not functioning properly, causing minor erosion of banks, stream is stable and no repair is needed	SOA 5
Channel	74+90 to 75+00	Mid-channel bar formation, no repair needed	SOA 6

SOA 1 - Erosion on right bank behind root wads, Sta. 24+25.

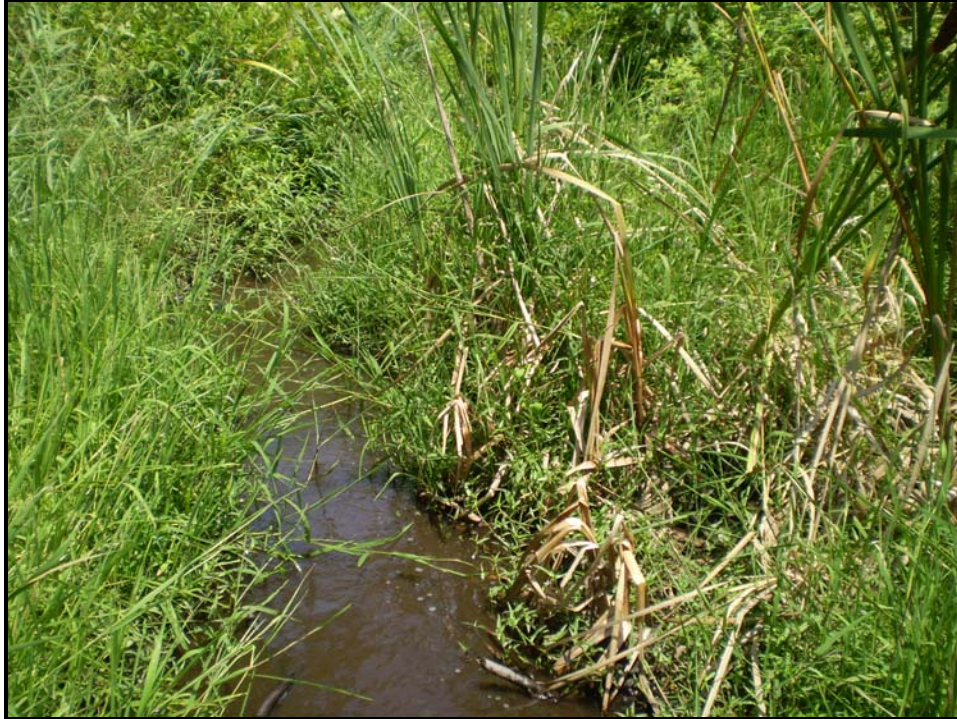
SOA 2 – Mid-channel bar formation, Sta. 43+00.

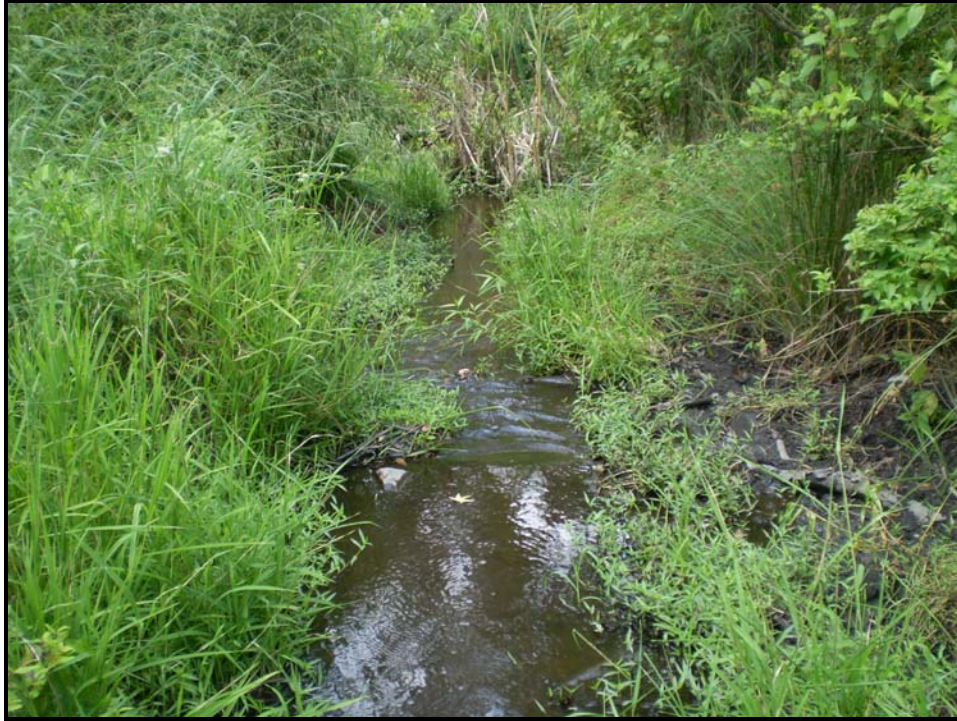
SOA 3 – Mid-channel bar formation, Sta. 44+35.

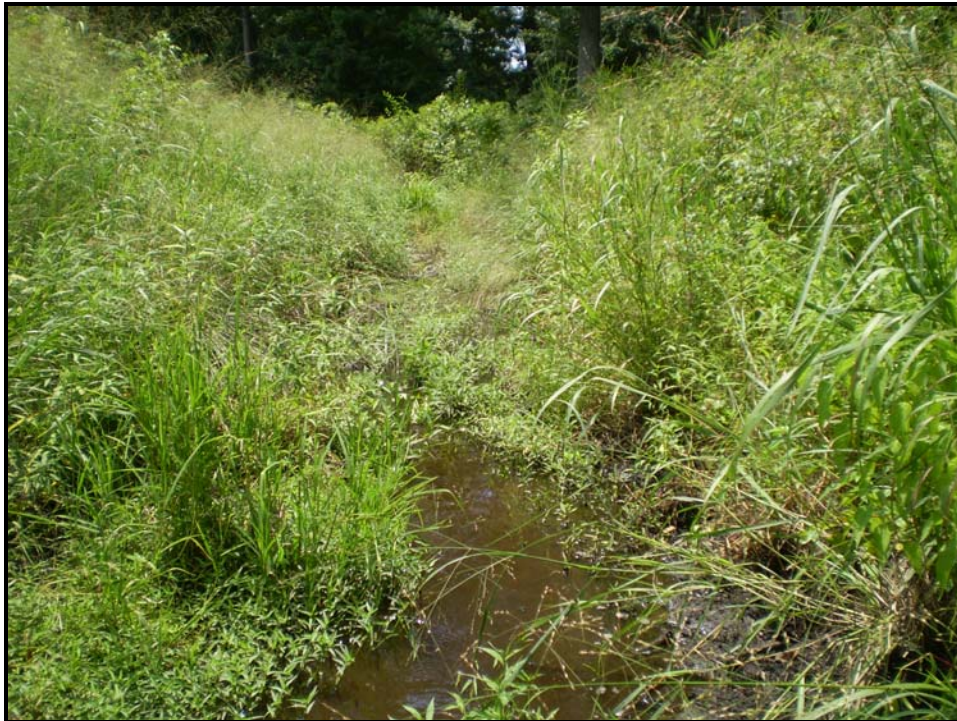
SOA 4 – Vegetation in channel, Sta. 45+50.

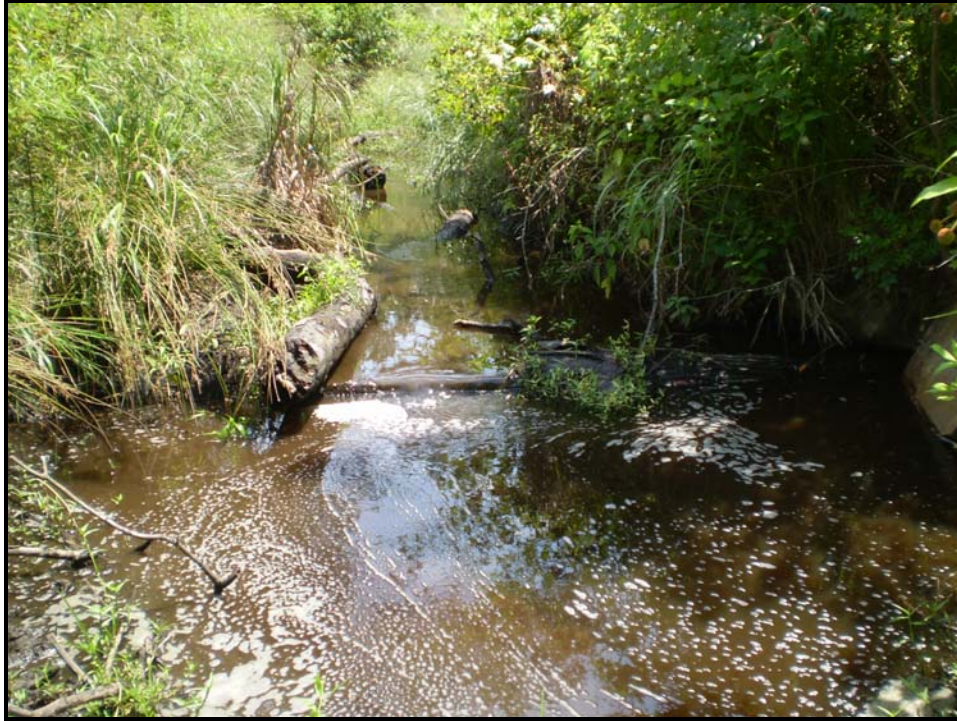
SOA 5 – Erosion on left and right banks at log weir, Sta. 46+85.

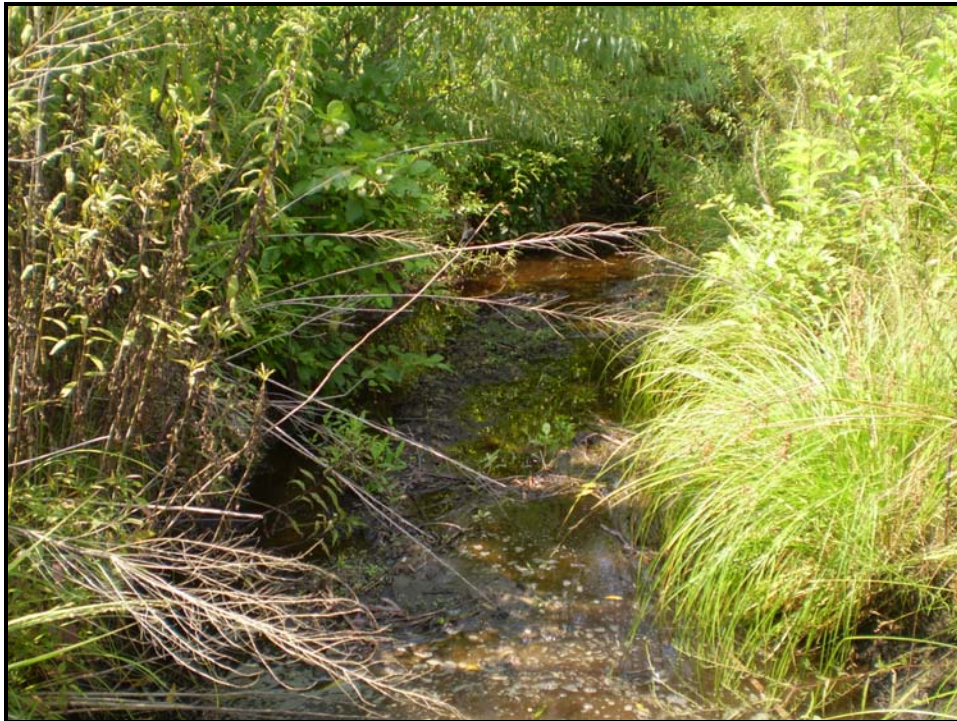
SOA 6 – Mid channel bar formation, Sta. 74+90 to 75+00.

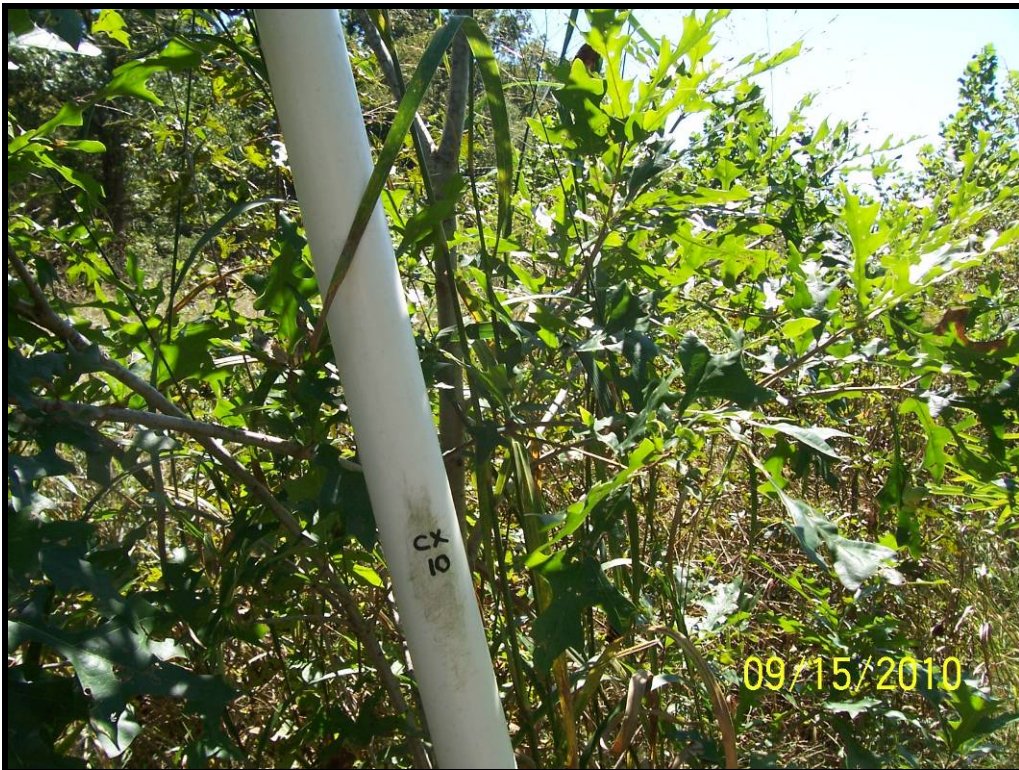
Cox Vegetation Monitoring Plot #10

Woody volunteer species were observed in high quantities in vegetation Plots 10 and 11. Sweetgum (*Liquidambar styraciflua*) is the most common volunteer, though red maple (*Acer rubrum*) and loblolly pine (*Pinus taeda*) were also observed. These areas are overpopulated with invasives due to the presence of seed trees in close proximity, as this is the narrowest part of the Site.
