MY1 MONITORING REPORT

CRANE STREAM AND WETLAND MITIGATION SITE

Lee County, North Carolina
Cape Fear River Basin
Cataloging Unit 03030002

Data Collection: January 2023-November 2023
Submission: February 2024

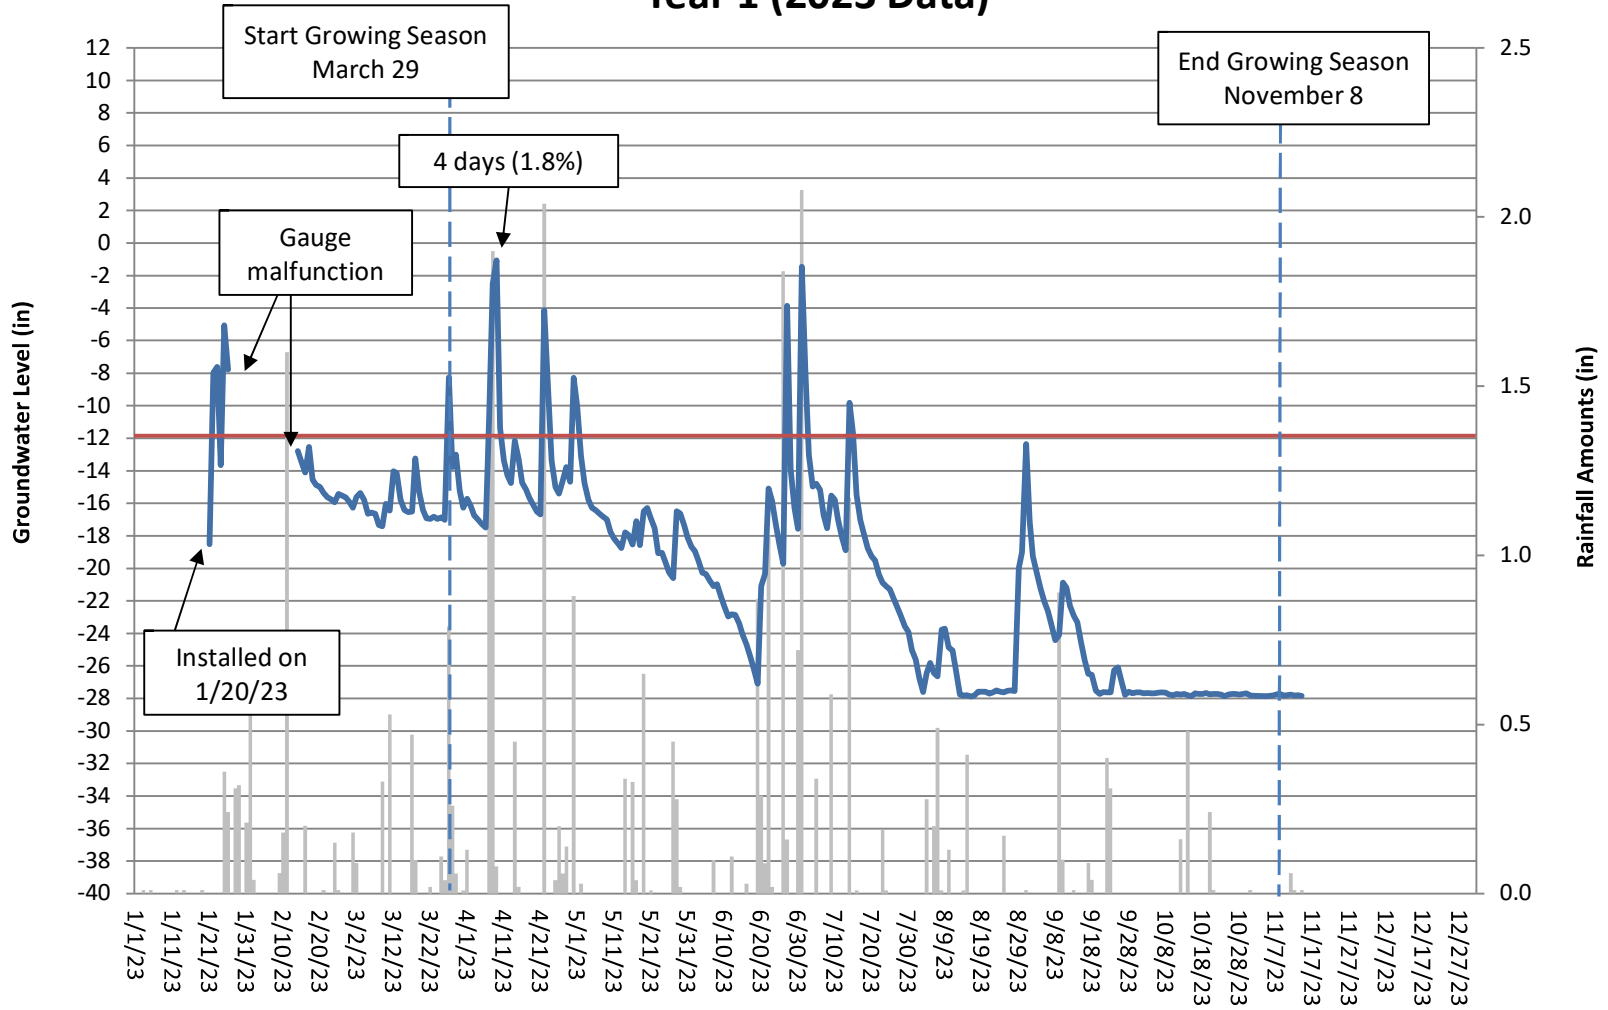
Crane Groundwater Gauge 1 Year 1 (2023 Data)

- Seven of the fifteen groundwater gauges met success criteria during MY1 (2023). Gauges 1, 4, 8, 9, 12, 13, and 14 did not meet success criteria with hydroperiods of 1.8%, 1.8%, 4.4%, 9.8%, 1.3%, 2.7%, and 6.2%, respectively. (Appendix D).

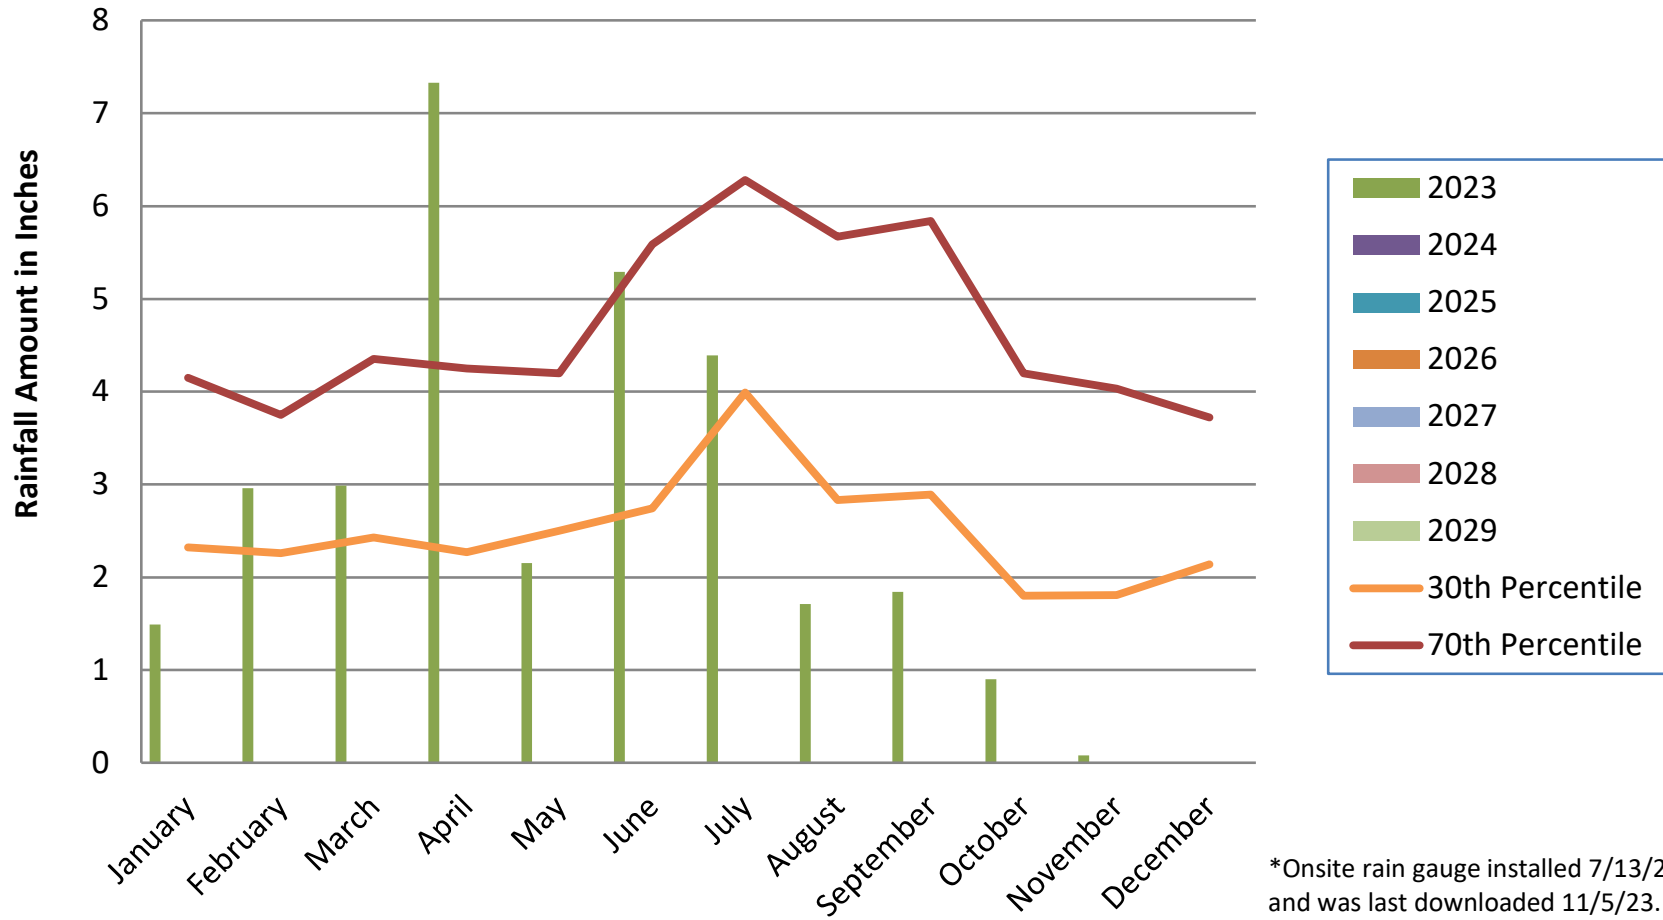
Figure D1: Crane 30-70 Percentile Graph for Rainfall

- When compared with 30-year 30-70th percentile rainfall, on-site rainfall amounts were low during February and March (Figure D1, Appendix D), with only 3.49 inches recorded during the nearly-2-month period between February 12 and April 6. Four of the seven gauges that did not meet success criteria dipped below 12 inches from the surface during this period before rising again with each precipitation event. Gauges 8, 9, and 14 dropped below 12 inches around April 18 for 4, 2, and 3 days respectively; otherwise, they would have exceeded the 12% hydroperiod required for wetland success. It is expected that with normal rainfall early in the growing season, the groundwater would be sufficiently recharged at the start of the growing season, and all gauges would have met hydrology success criteria.
