# MONITORING YEAR 7 ANNUAL/CLOSEOUT REPORT

# **CROOKED CREEK #2 RESTORATION PROJECT**

Union County, NC DEQ Contract 6617 DMS Project Number 94687 USACE Permit No. SAW-2011-02201

Submission Date: February 27, 2023

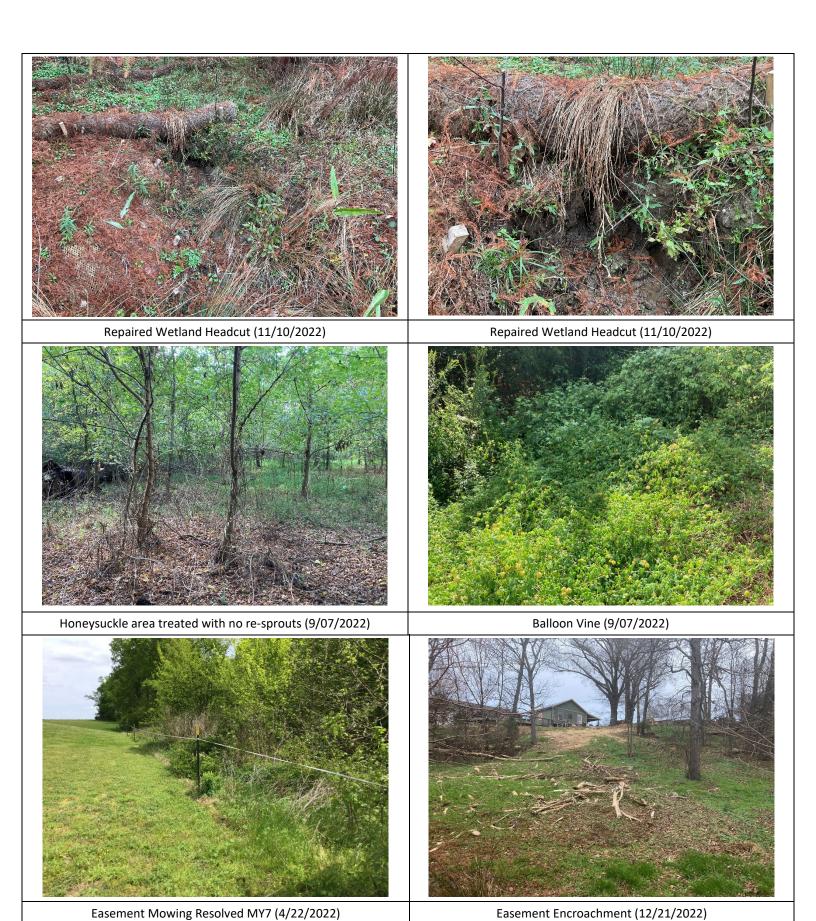
Area of Concern Photographs
Monitoring Year 7

Previous mowing within the easement during MY5 and MY6 has been resolved with additional easement signs and a clear marker line connecting the easement signs with white tape. However, a new area of encroachment involving clearing into the easement from an adjacent landowner occurred during MY7 and DMS is actively corresponding with the landowner to rectify the encroachment and the area is circled on the MY7 CCPV maps. Refer to Appendix 2 for the vegetation condition assessment table, Area of concern photographs and the CCPV maps for MY7 areas of concern.

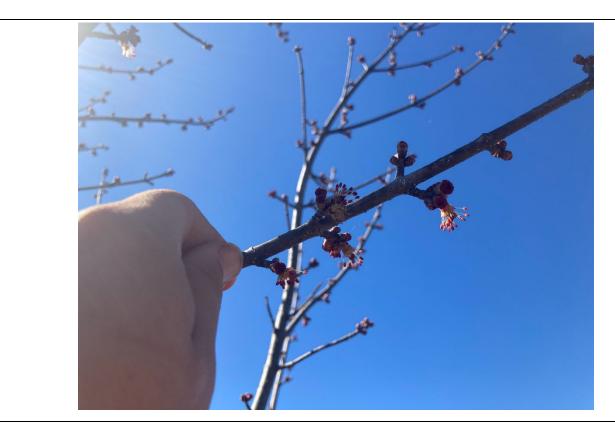
**Bud burst documentation** (3/1/2022)- photo taken at Deep Meadow Mitigation Site approximately 9 miles away from Crooked Creek Mitigation Site
