MONITORING YEAR 1 ANNUAL REPORT

CROOKED CREEK #2 RESTORATION PROJECT

Union County, NC
NCDEQ Contract D09126S
DMS Project Number 94687

Data Collection Period: Aug. 2016 – Sept. 2016
Draft Submission Date: November 18, 2016
Final Submission Date: December 12, 2016

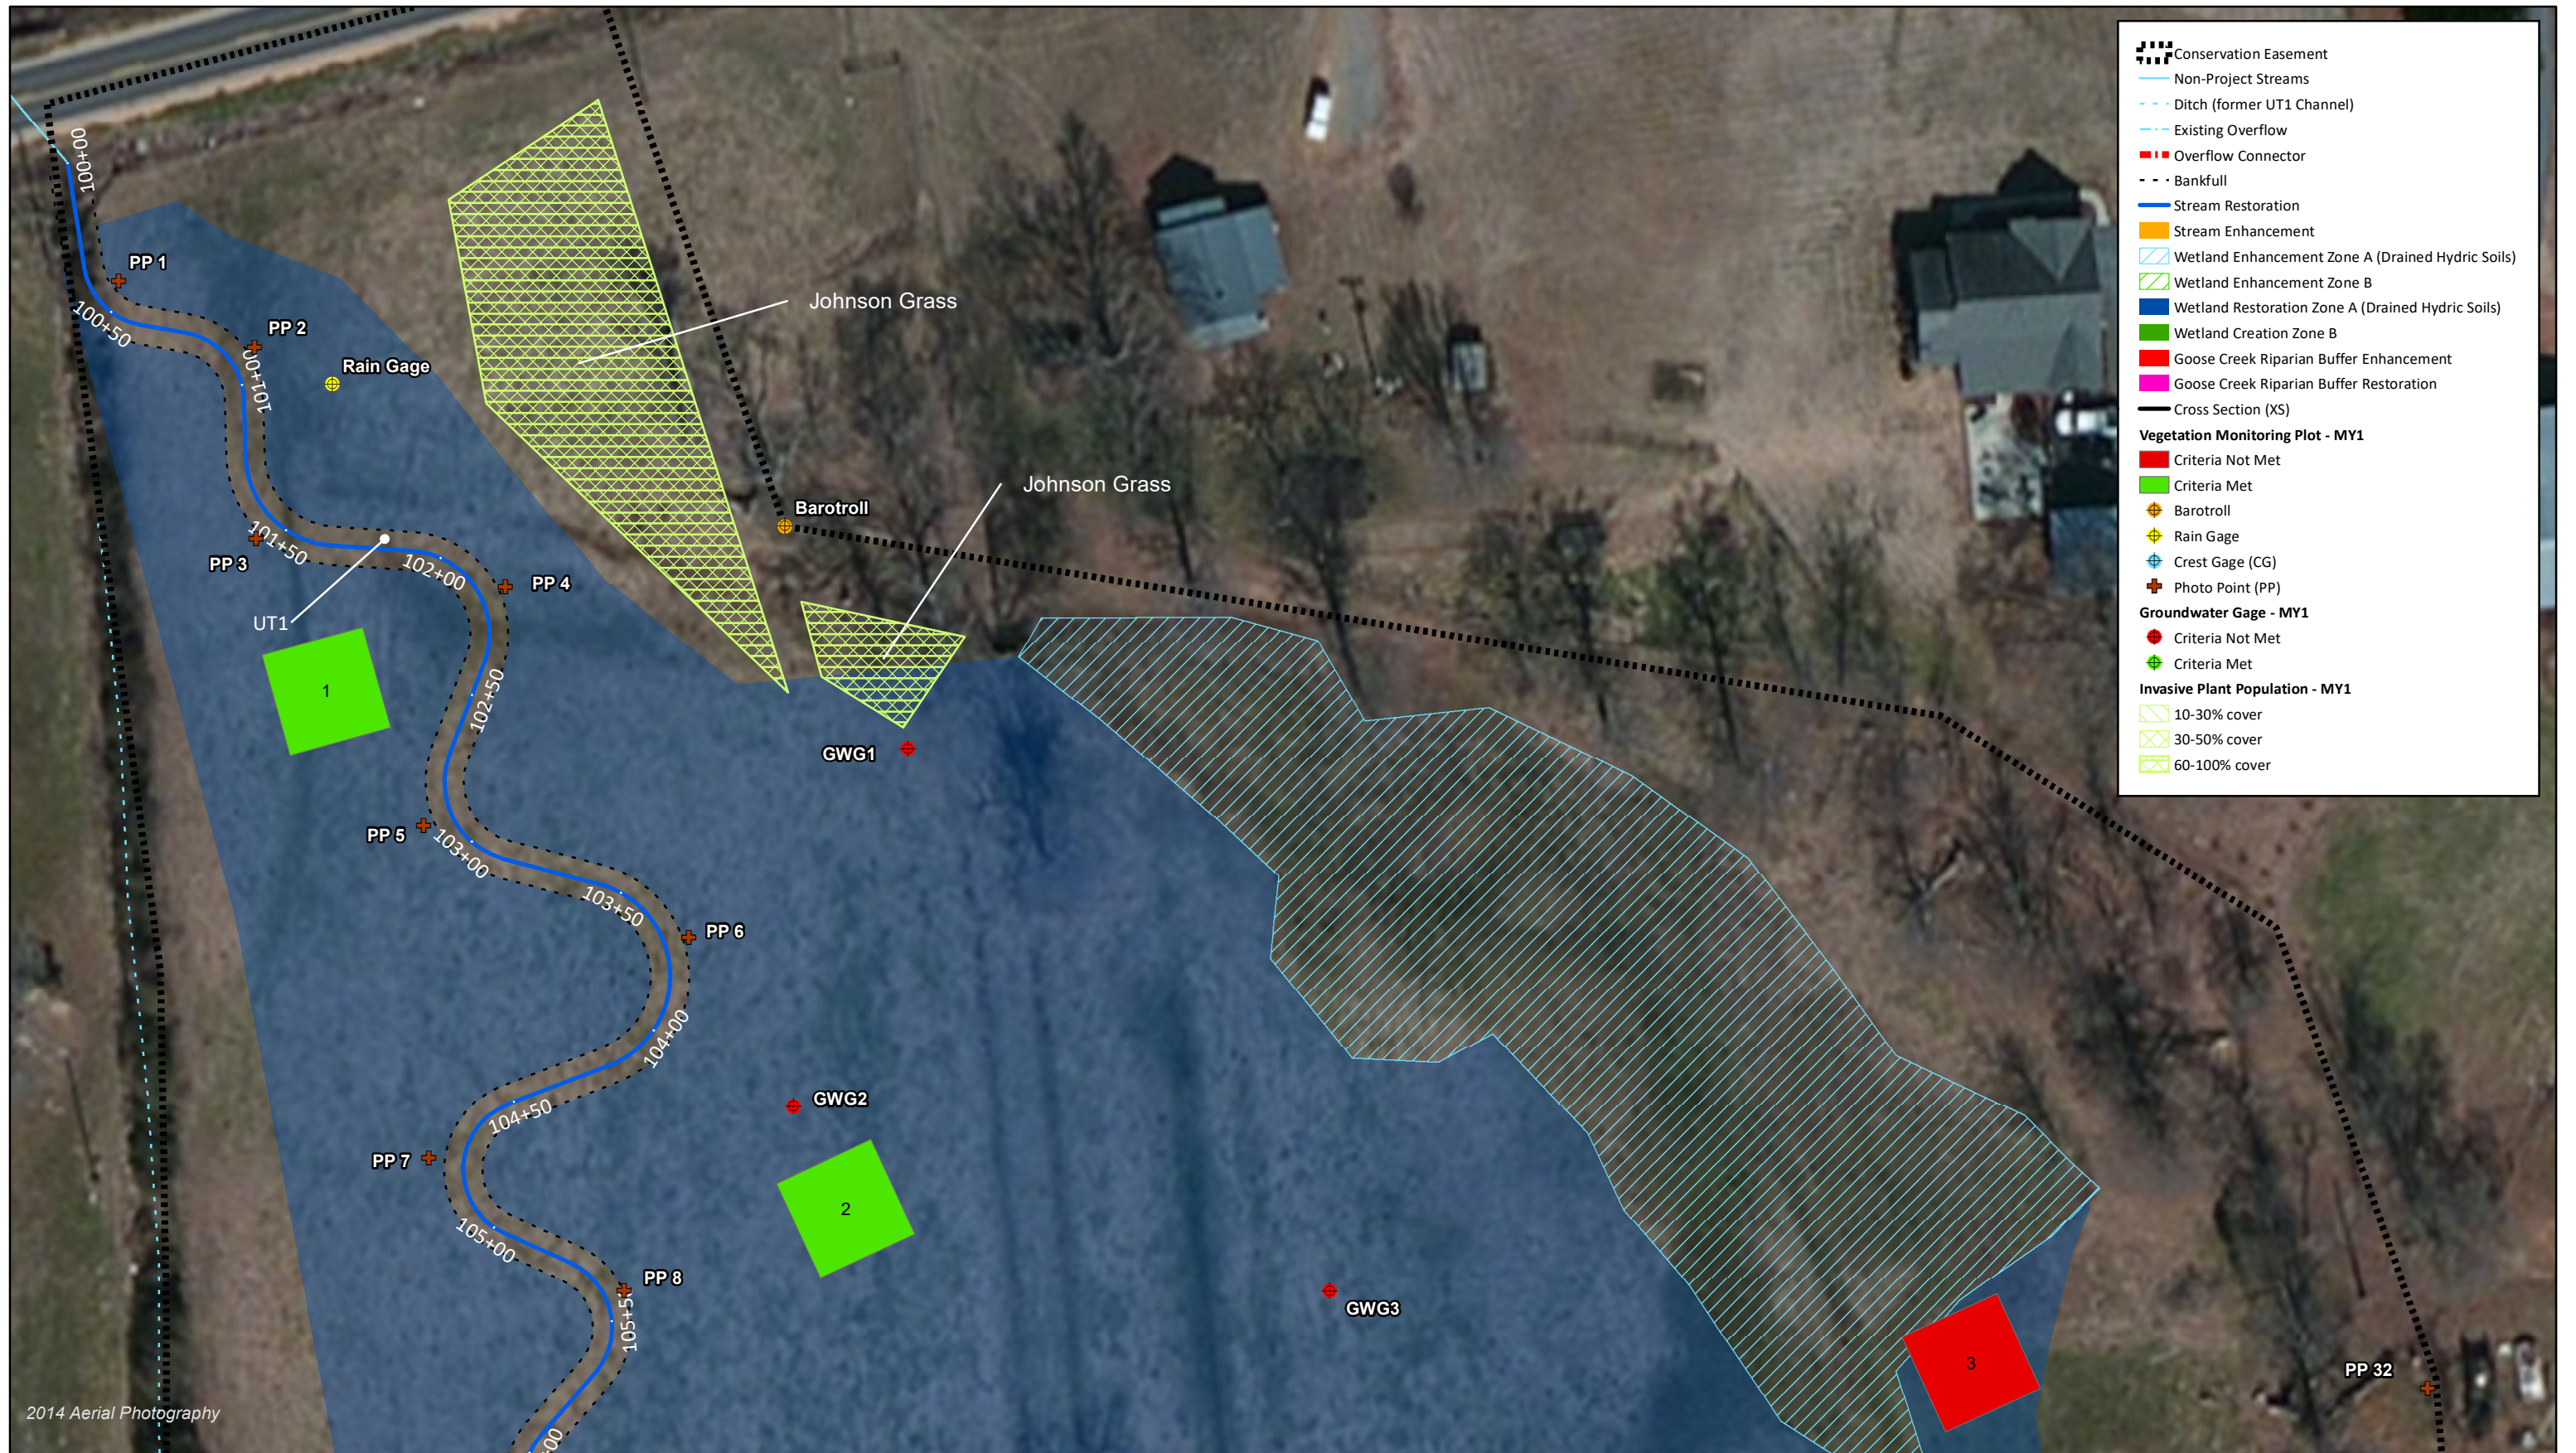
Figure 3.1 Integrated Current Condition Plan View (Sheet 1)
 Crooked Creek #2 Restoration Project
 DMS Project No. 94687
 Monitoring Year 1 - 2016
 Union County, NC

The majority of the floodplain contains dense, native herbaceous cover; however, the competition for water could potentially impact the planted stems in drought conditions. Morning glory vines, and other invasive plants are impacting planted stems near photo point 33, which is located at the center, northern border of the easement. Despite herbicide treatment along the fence line, the vines have intruded further into the easement. The treated areas of Chinese privet on Crooked Creek Reach A and Reach B are showing increasing dominance of this species once again. Refer to Appendix 2 for the vegetation condition assessment table, Integrated Current Condition Plan View (CCPV), and reference photographs.

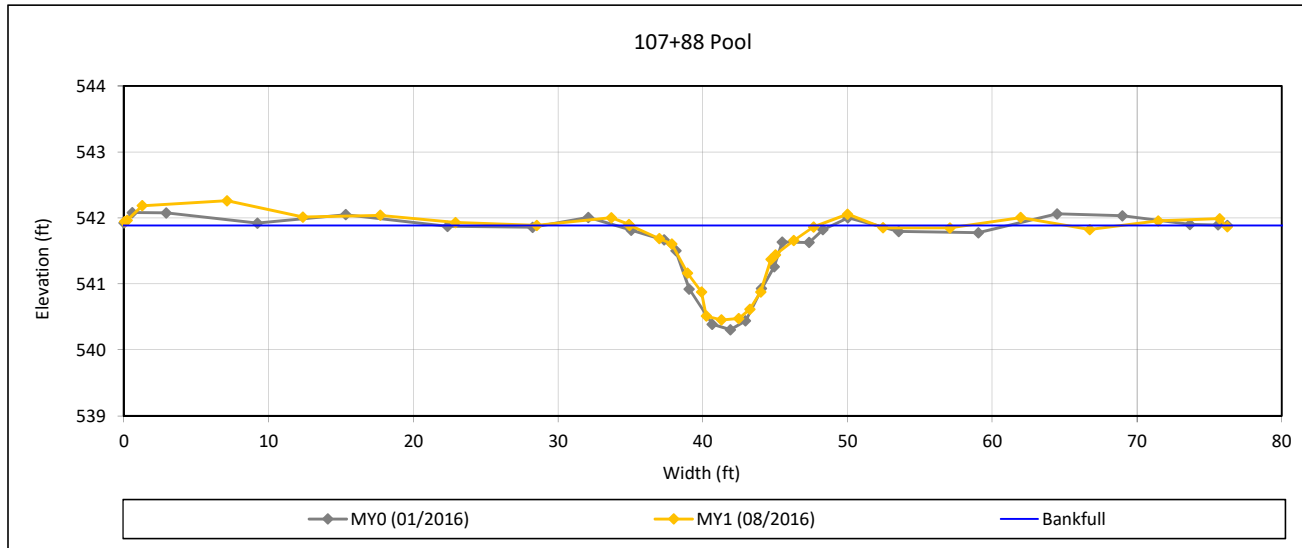
Cross Section 1-UT1

8.5	x-section area (ft.sq.)
12.7	width (ft)
0.7	mean depth (ft)
1.4	max depth (ft)
13.3	wetted perimeter (ft)
0.6	hydraulic radius (ft)
18.9	width-depth ratio

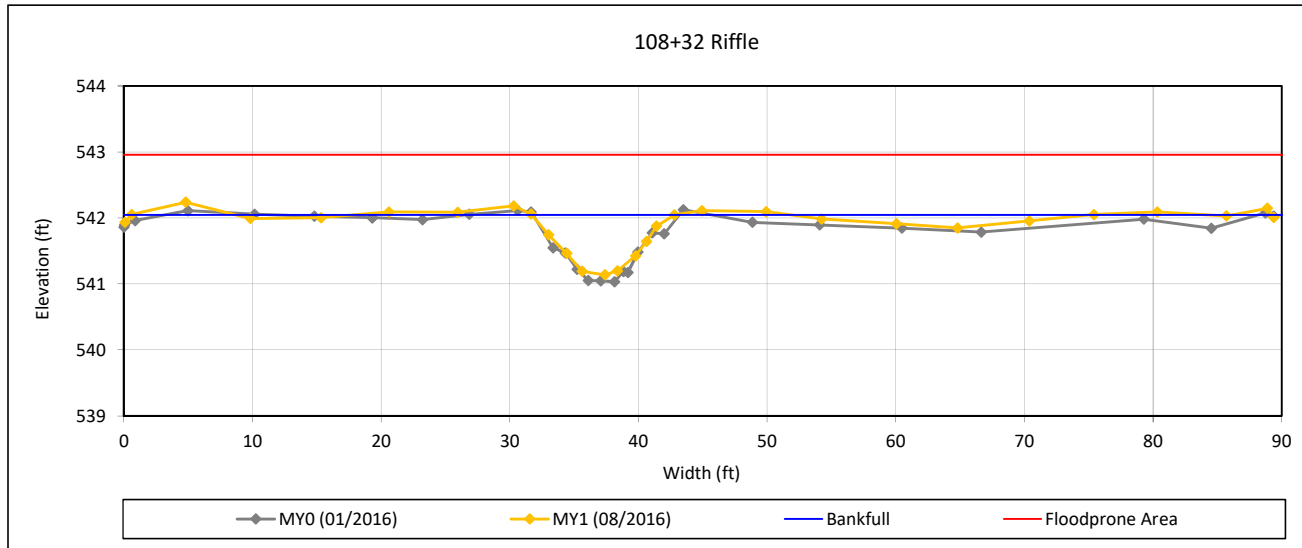
Cross Section 2-UT1

5.9	x-section area (ft.sq.)
11.1	width (ft)
0.5	mean depth (ft)
0.9	max depth (ft)
11.3	wetted perimeter (ft)
0.5	hydraulic radius (ft)
20.8	width-depth ratio
150.0	W flood prone area (ft)
13.5	entrenchment ratio
1.0	low bank height ratio

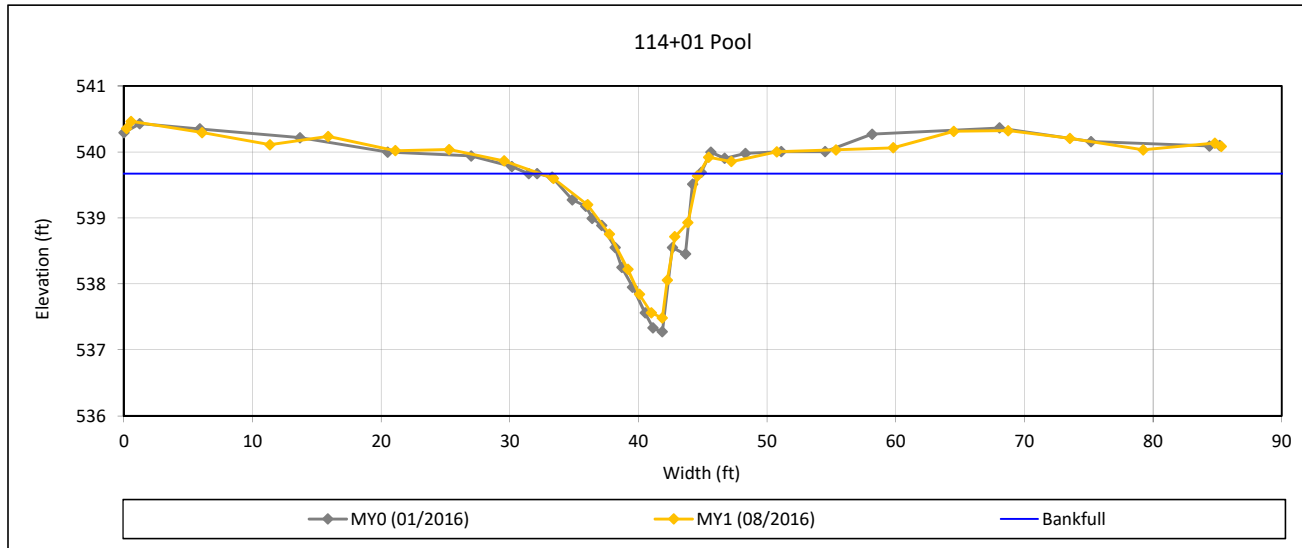
Cross Section 3-UT1

11.4	x-section area (ft.sq.)
12.3	width (ft)
0.9	mean depth (ft)
2.2	max depth (ft)
13.6	wetted perimeter (ft)
0.8	hydraulic radius (ft)
13.4	width-depth ratio

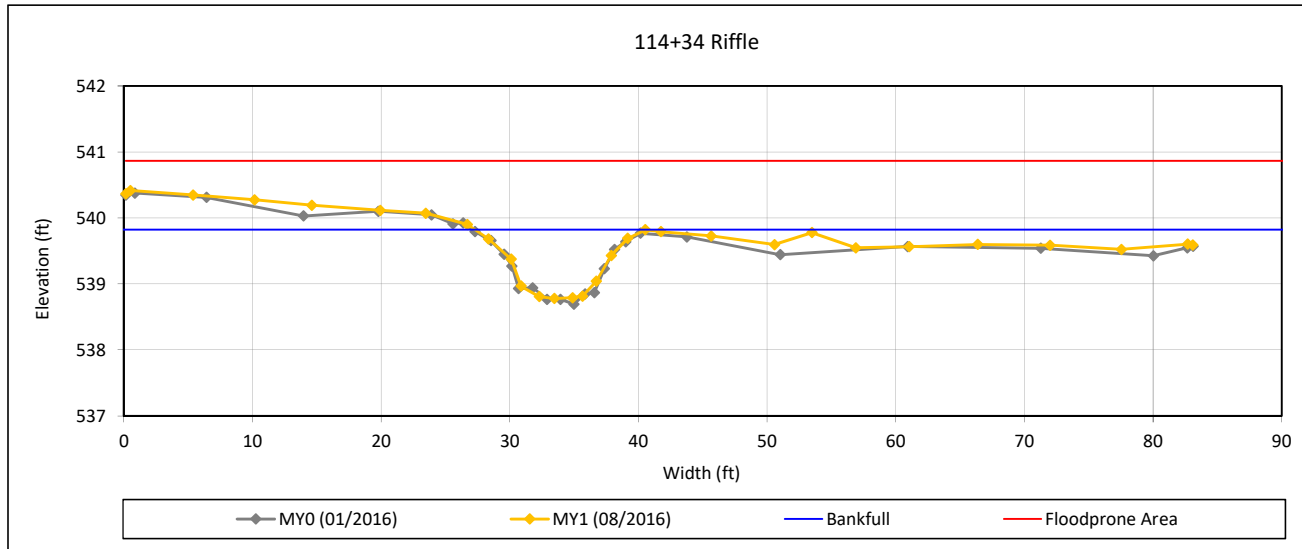
Cross Section 4-UT1

7.8	x-section area (ft.sq.)
11.9	width (ft)
0.7	mean depth (ft)
1.0	max depth (ft)
12.1	wetted perimeter (ft)
0.6	hydraulic radius (ft)
18.0	width-depth ratio
150.0	W flood prone area (ft)
12.6	entrenchment ratio
1.0	low bank height ratio
