MONITORING YEAR 2 ANNUAL REPORT

CROOKED CREEK #2 RESTORATION PROJECT

Union County, NC
DEQ Contract D09126S
DMS Project Number 94687

Data Collection Period: April – November 2017
Draft Submission Date: November 30, 2017
Final Submission Date: December 20, 2017

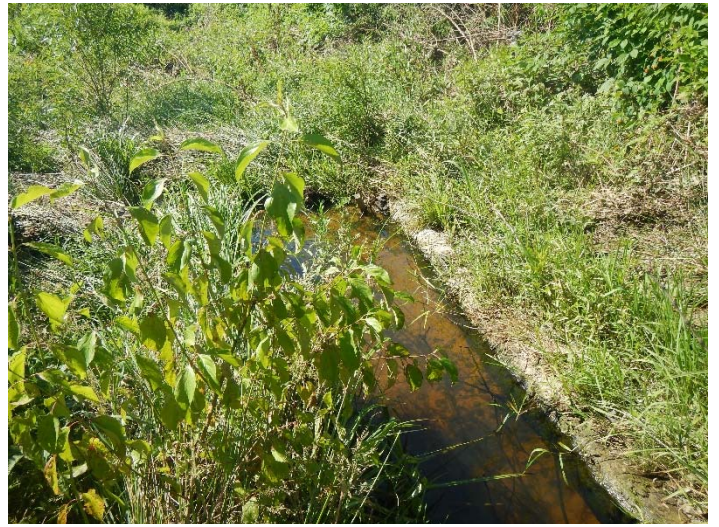
Photo Point 1 – UT1 looking upstream (06/28/2017)

Dense herbaceous ground cover has entered the UT1 streambed which hinders the movement of sediment during bankfull events. The streambed is difficult to locate due to this herbaceous coverage, especially when the stream is dry.

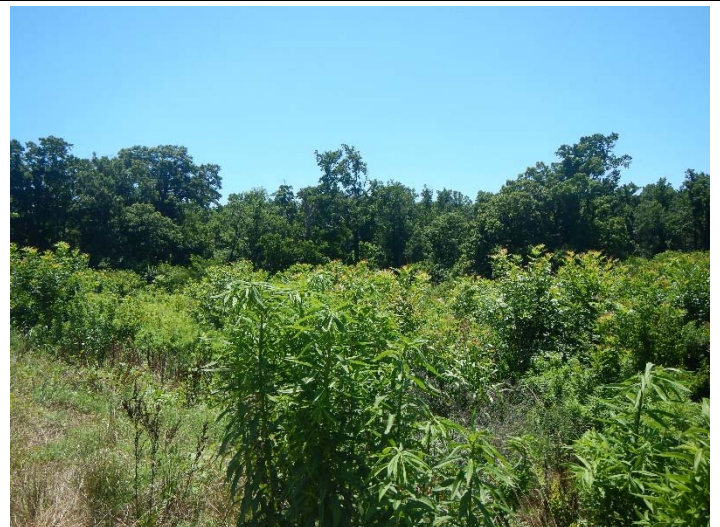
Photo Point 33 – Wetland Zone A & B facing W (06/28/2017)

An herbicide treatment was applied along the fence line around photo point 33. However, the invasive vine species, such as Chinese lantern, Japanese honeysuckle and morning glory, continue to impact the stem growth within the site. Several invasive species were noted throughout the site and include Chinese lantern (*Physalis spp.*), Chinaberry (*Melia azedarach*), Chinese privet (*Ligustrum sinense*), Japanese honeysuckle (*Lonicera japonica*), Johnson grass (*Sorghum halepense*), and morning glory (*Ipomoea sp.*). The native invasive cattail (*Typha latifolia*) has colonized into Vegetation Plot 5, which may impact planted woody stem survival, along with the dense herbaceous coverage of rice cutgrass (*Leersia oryzoides*). Invasive maintenance will need to continue to enable the planted stems to grow within the site.
