MONITORING YEAR 3 ANNUAL REPORT

CROOKED CREEK #2 RESTORATION PROJECT

Union County, NC

DMS Project Number 94687

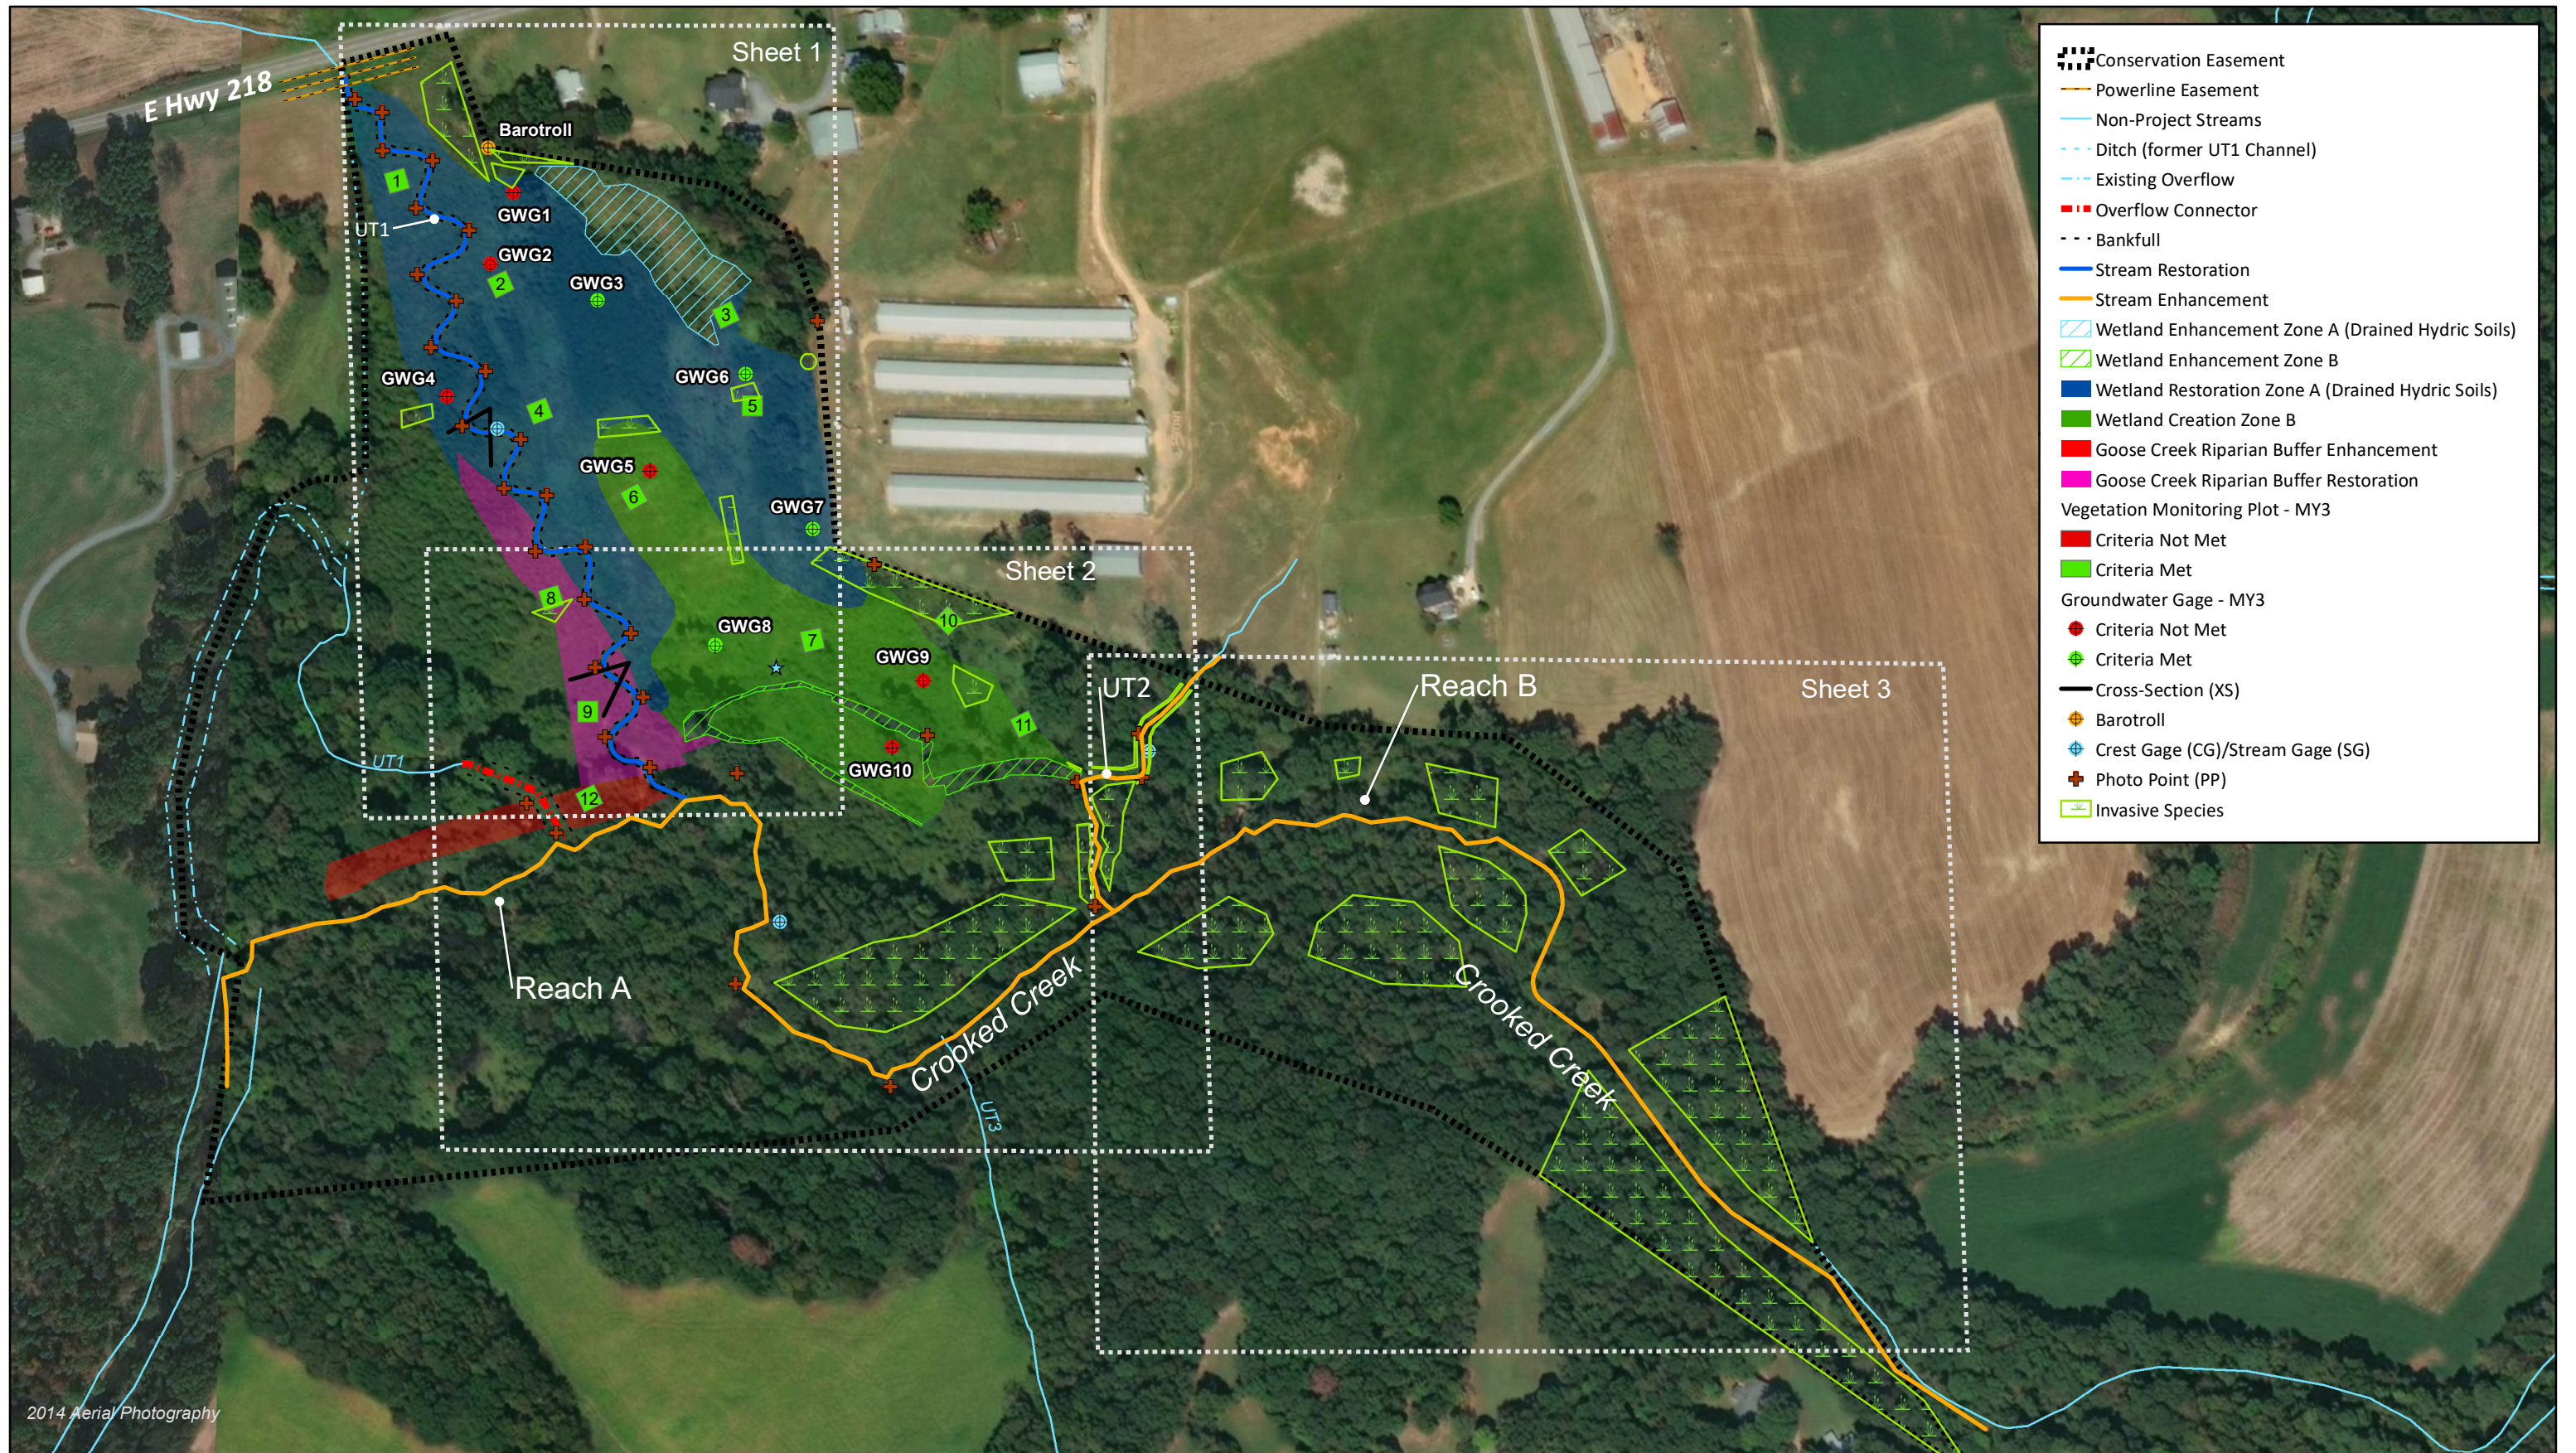
Figure 3.0 Integrated Current Condition Plan View
 Crooked Creek #2 Restoration Project
 DMS Project No. 94687
 Monitoring Year 3 - 2018
 Union County, NC

As mentioned in prior monitoring reports, the UT1 streambed continues to be inundated with dense herbaceous vegetation and now contains sections of cattail. This instream vegetation has created large debris jams of urban litter, which is hindering normal baseflow conditions and sediment transport process. The MY3 pebble count data indicates that UT1 has illustrated an increase in fine sediment deposition from base line. Refer to Appendix 2 for the visual assessment.

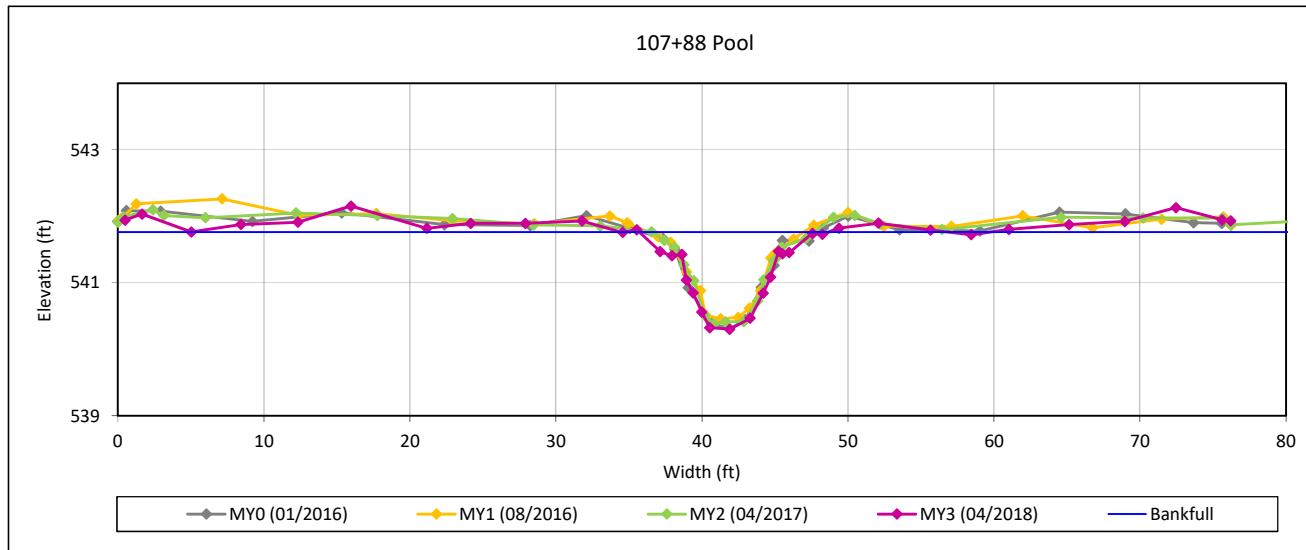
Cross-Section 1-UT1

8.7	x-section area (ft.sq.)
13.3	width (ft)
0.7	mean depth (ft)
1.5	max depth (ft)
14.0	wetted perimeter (ft)
0.6	hydraulic radius (ft)
20.4	width-depth ratio

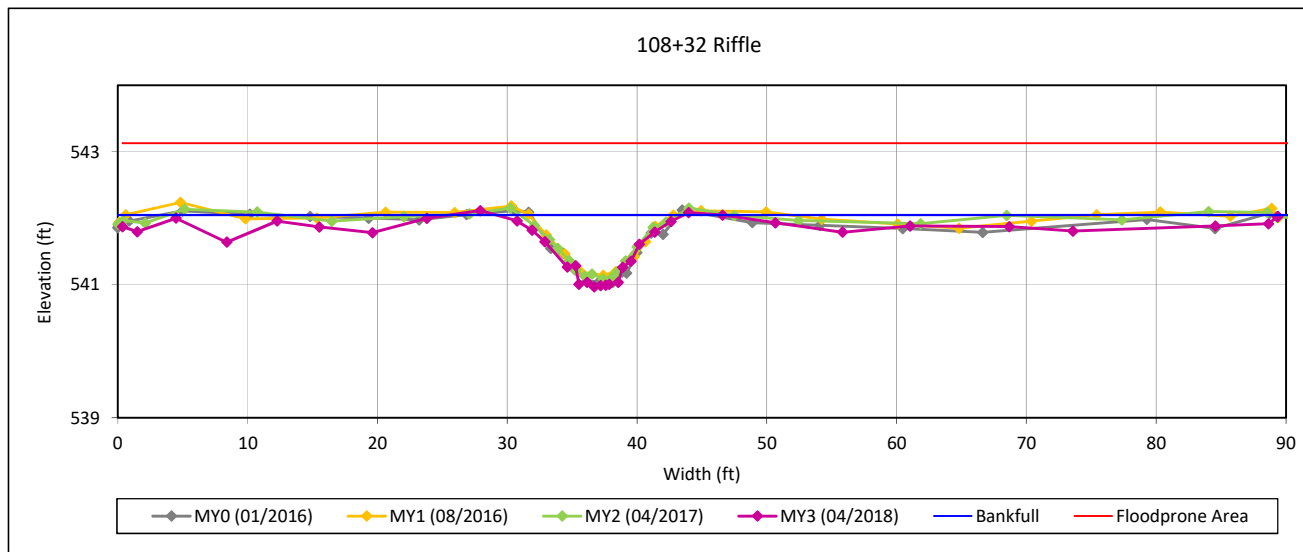
Cross-Section 2-UT1

7.3	x-section area (ft.sq.)
14.6	width (ft)
0.5	mean depth (ft)
1.1	max depth (ft)
14.9	wetted perimeter (ft)
0.5	hydraulic radius (ft)
29.1	width-depth ratio
150.0	W flood prone area (ft)
10.3	entrenchment ratio
1.0	low bank height ratio

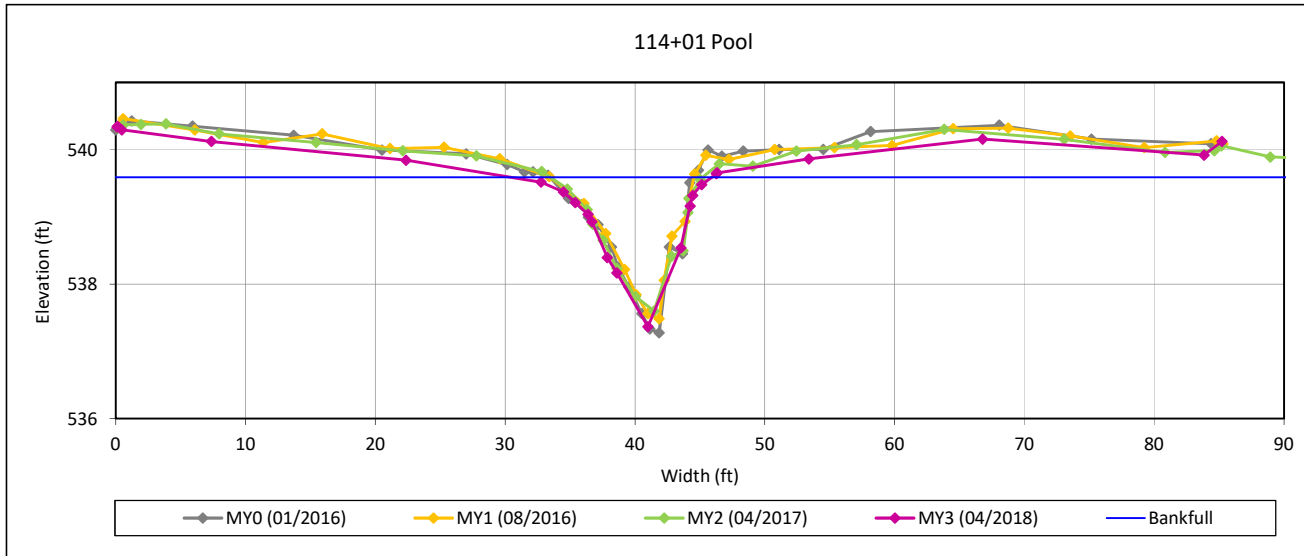
Cross-Section 3-UT1

- 12.6 x-section area (ft.sq.)
- 15.4 width (ft)
- 0.8 mean depth (ft)
- 2.2 max depth (ft)
- 16.3 wetted perimeter (ft)
- 0.8 hydraulic radius (ft)
- 18.9 width-depth ratio

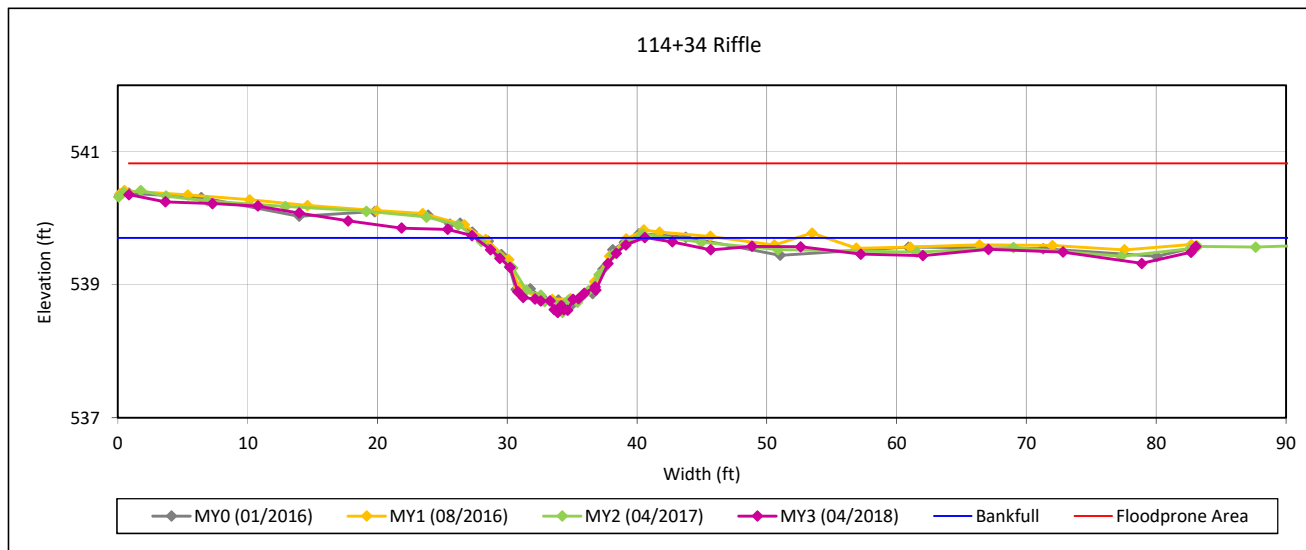
Cross-Section 4-UT1

7.5	x-section area (ft.sq.)
13.0	width (ft)
0.6	mean depth (ft)
1.1	max depth (ft)
13.4	wetted perimeter (ft)
0.6	hydraulic radius (ft)
22.6	width-depth ratio
150.0	W flood prone area (ft)
11.5	entrenchment ratio
1.0	low bank height ratio
