MONITORING YEAR 4 ANNUAL REPORT

CROOKED CREEK #2 RESTORATION PROJECT

Union County, NC

DMS Project Number 94687

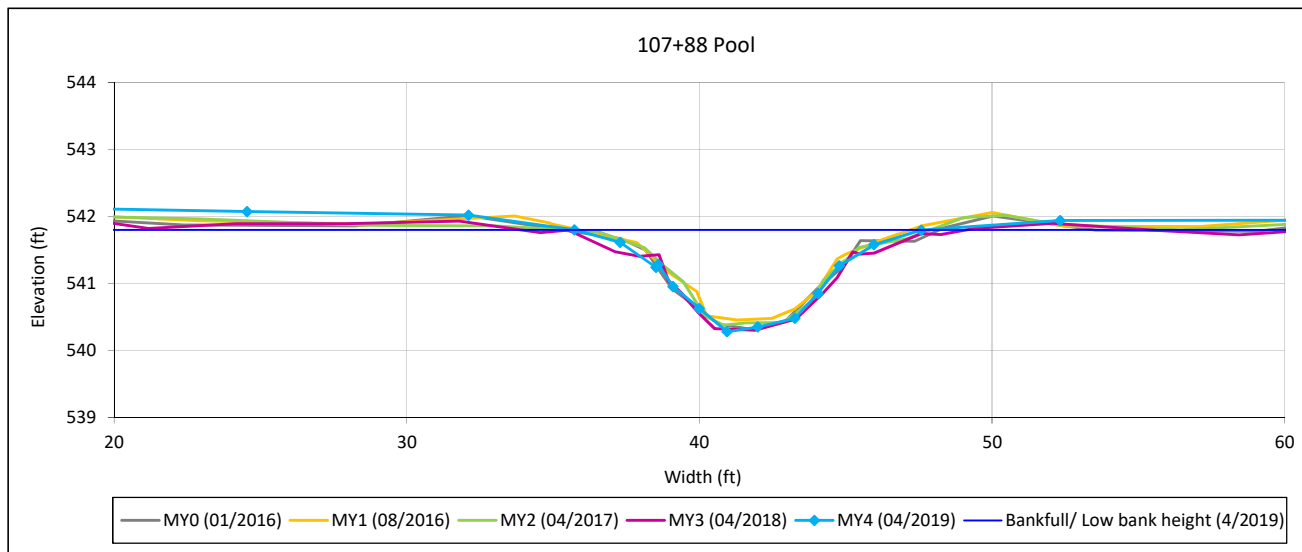
Cross-Section 1-UT1

- 8.4 x-section area (ft.sq.)
- 10.2 width (ft)
- 0.8 mean depth (ft)
- 1.5 max depth (ft)
- 10.8 wetted perimeter (ft)
- 0.8 hydraulic radius (ft)
- 12.5 width-depth ratio

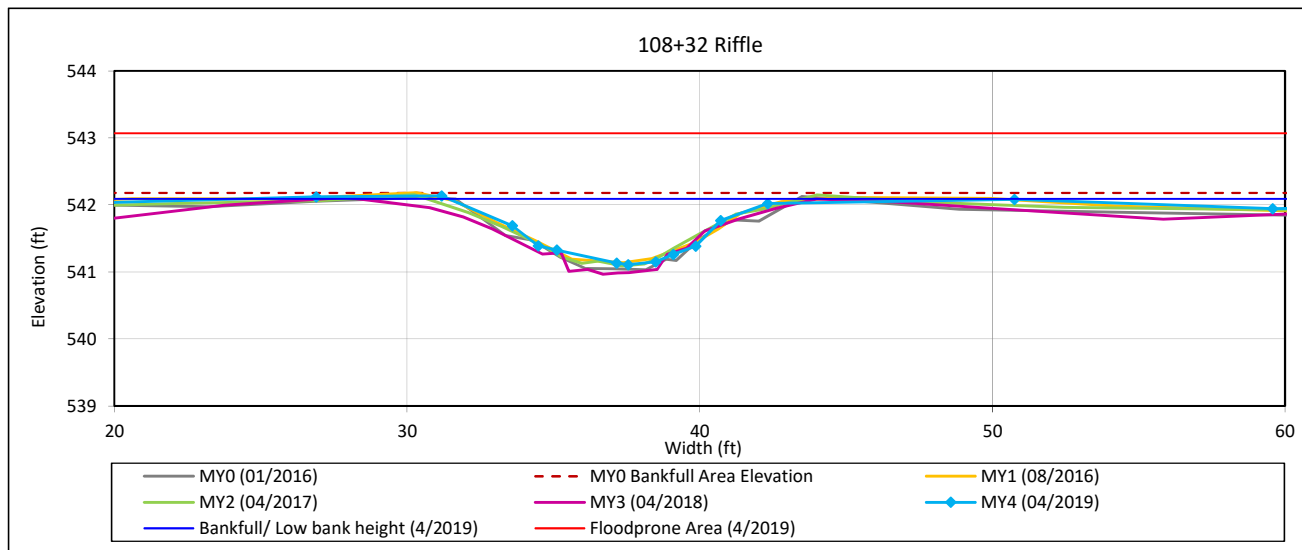
Cross-Section 2-UT1

- 6.3 x-section area (ft.sq.)
- 10.9 width (ft)
- 0.6 mean depth (ft)
- 1.0 max depth (ft)
- 11.1 wetted perimeter (ft)
- 0.6 hydraulic radius (ft)
- 18.8 width-depth ratio
- 89.3 W flood prone area (ft)
- 8.2 entrenchment ratio
- 0.9 low bank height ratio

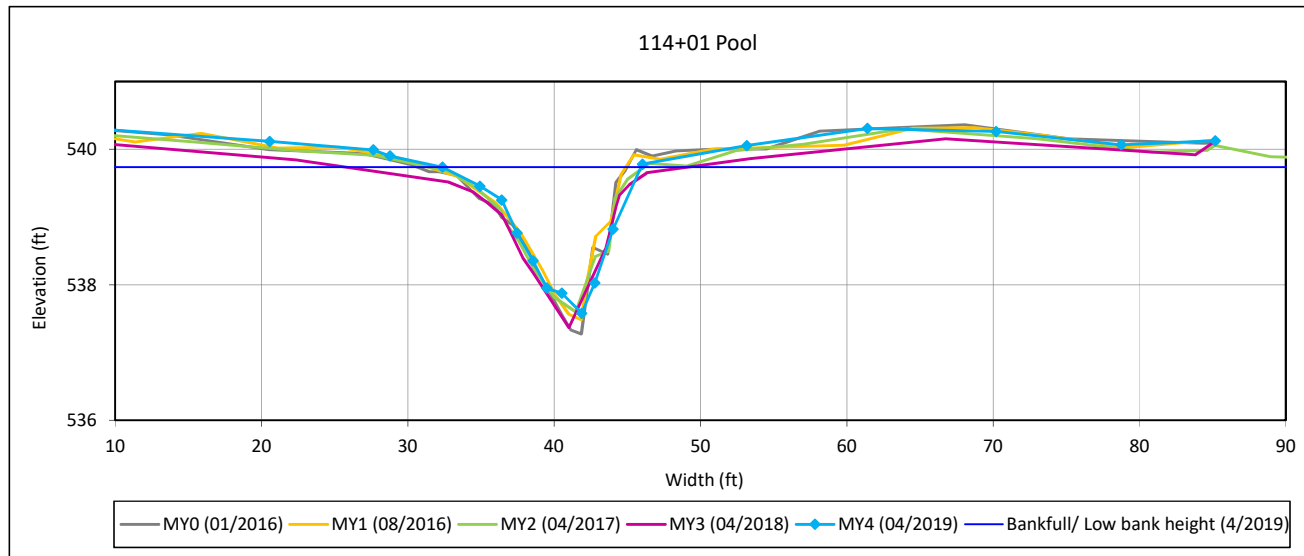
Cross-Section 3-UT1

- 13.3 x-section area (ft.sq.)
- 13.6 width (ft)
- 1.0 mean depth (ft)
- 2.2 max depth (ft)
- 14.4 wetted perimeter (ft)
- 0.9 hydraulic radius (ft)
- 13.8 width-depth ratio

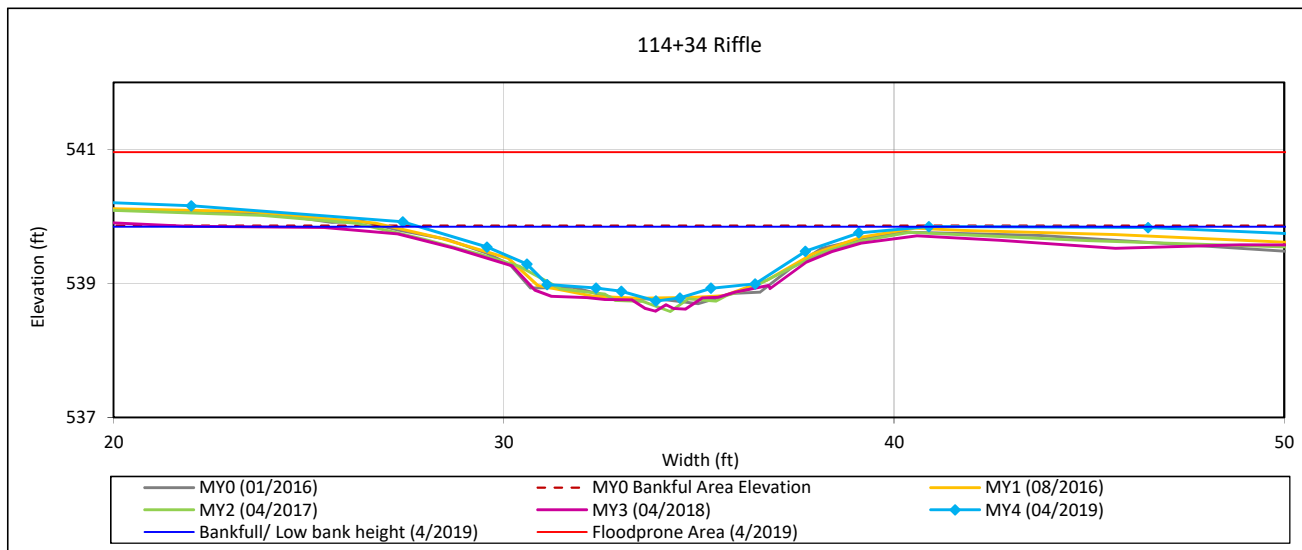
Cross-Section 4-UT1

- 7.4 x-section area (ft.sq.)
- 13.1 width (ft)
- 0.6 mean depth (ft)
- 1.1 max depth (ft)
- 13.4 wetted perimeter (ft)
- 0.6 hydraulic radius (ft)
- 23.2 width-depth ratio
- 83.0 W flood prone area (ft)
- 6.3 entrenchment ratio
- 1.0 low bank height ratio

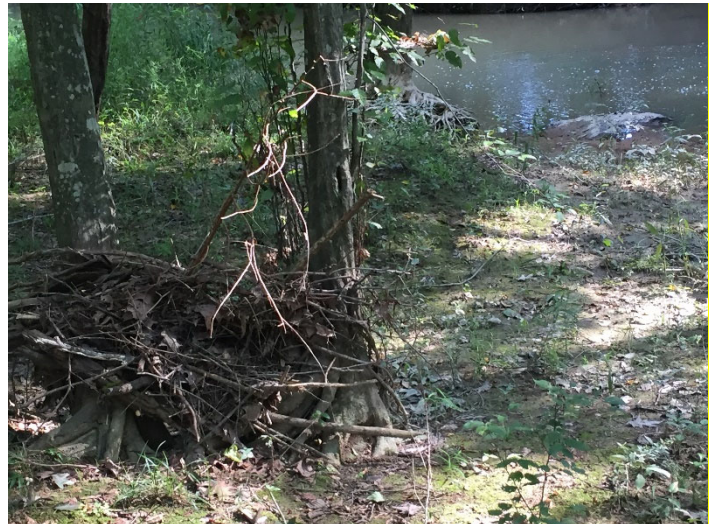
Bankfull Flow – Crooked Creek (4/5/2019)
