# **MONITORING YEAR 5 ANNUAL REPORT**

## **CROOKED CREEK #2 RESTORATION PROJECT**

DMS Project Number 94687

Data Collection Period: March – November 2020

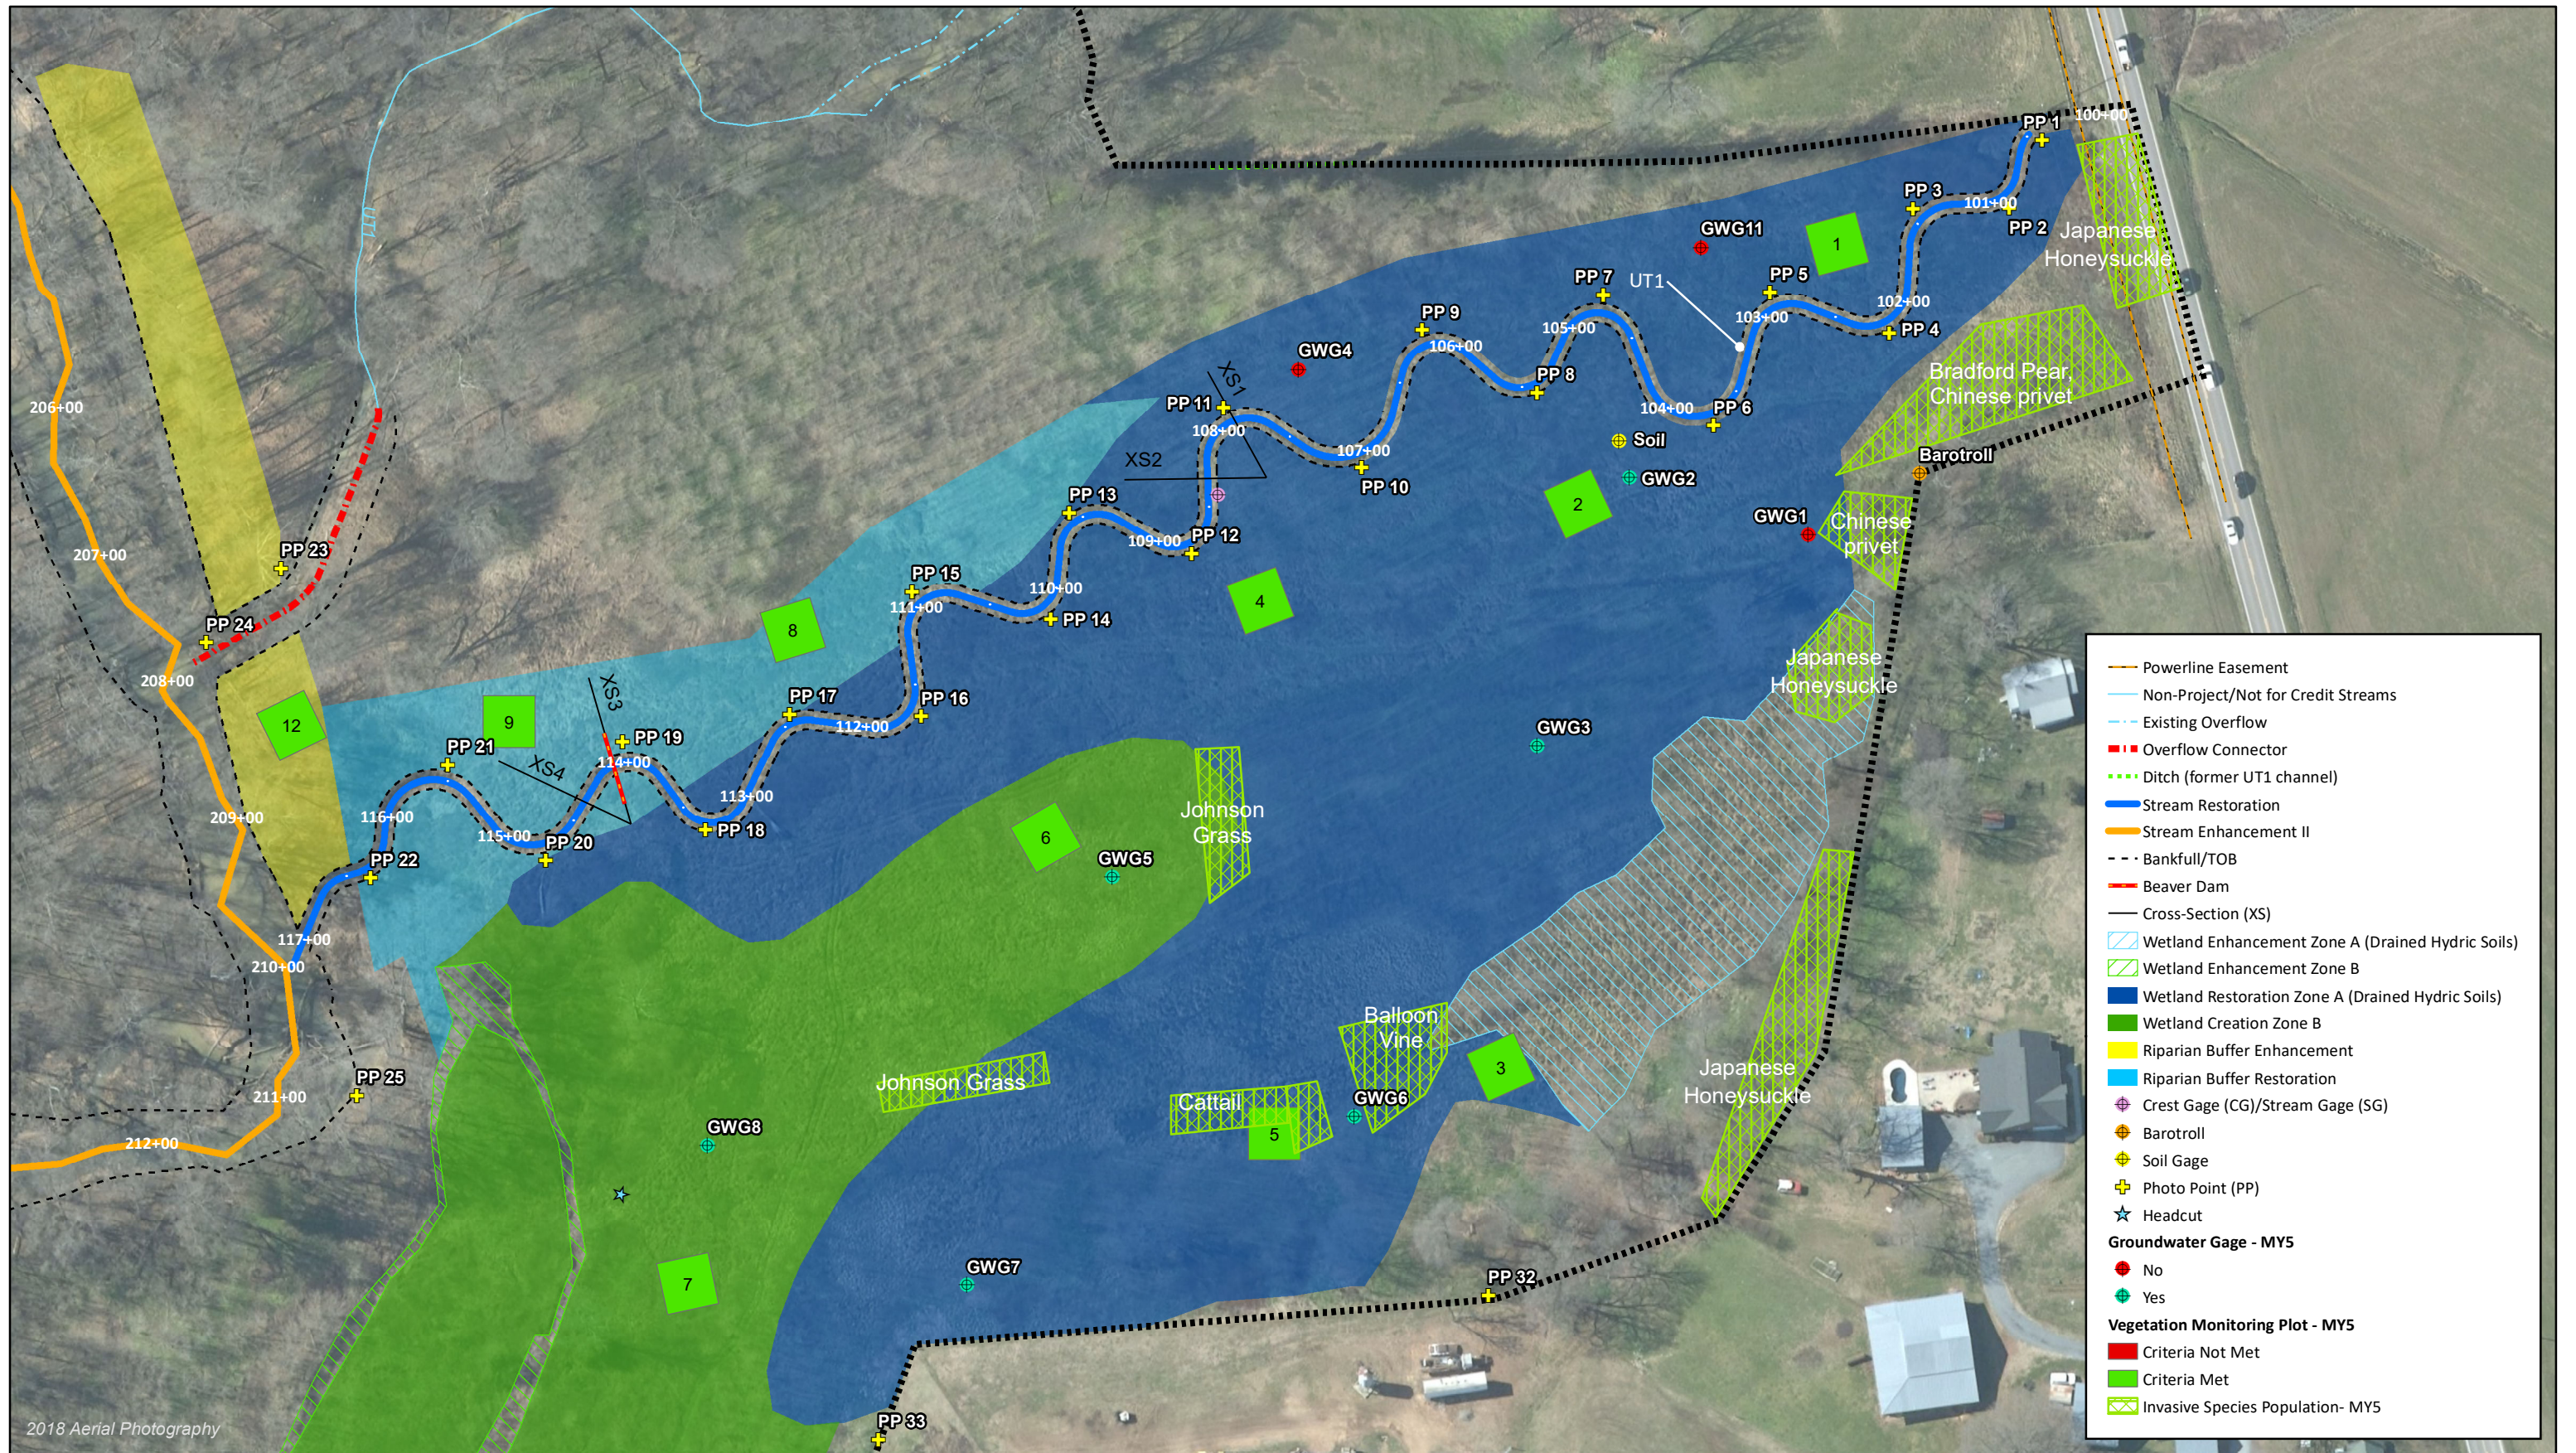
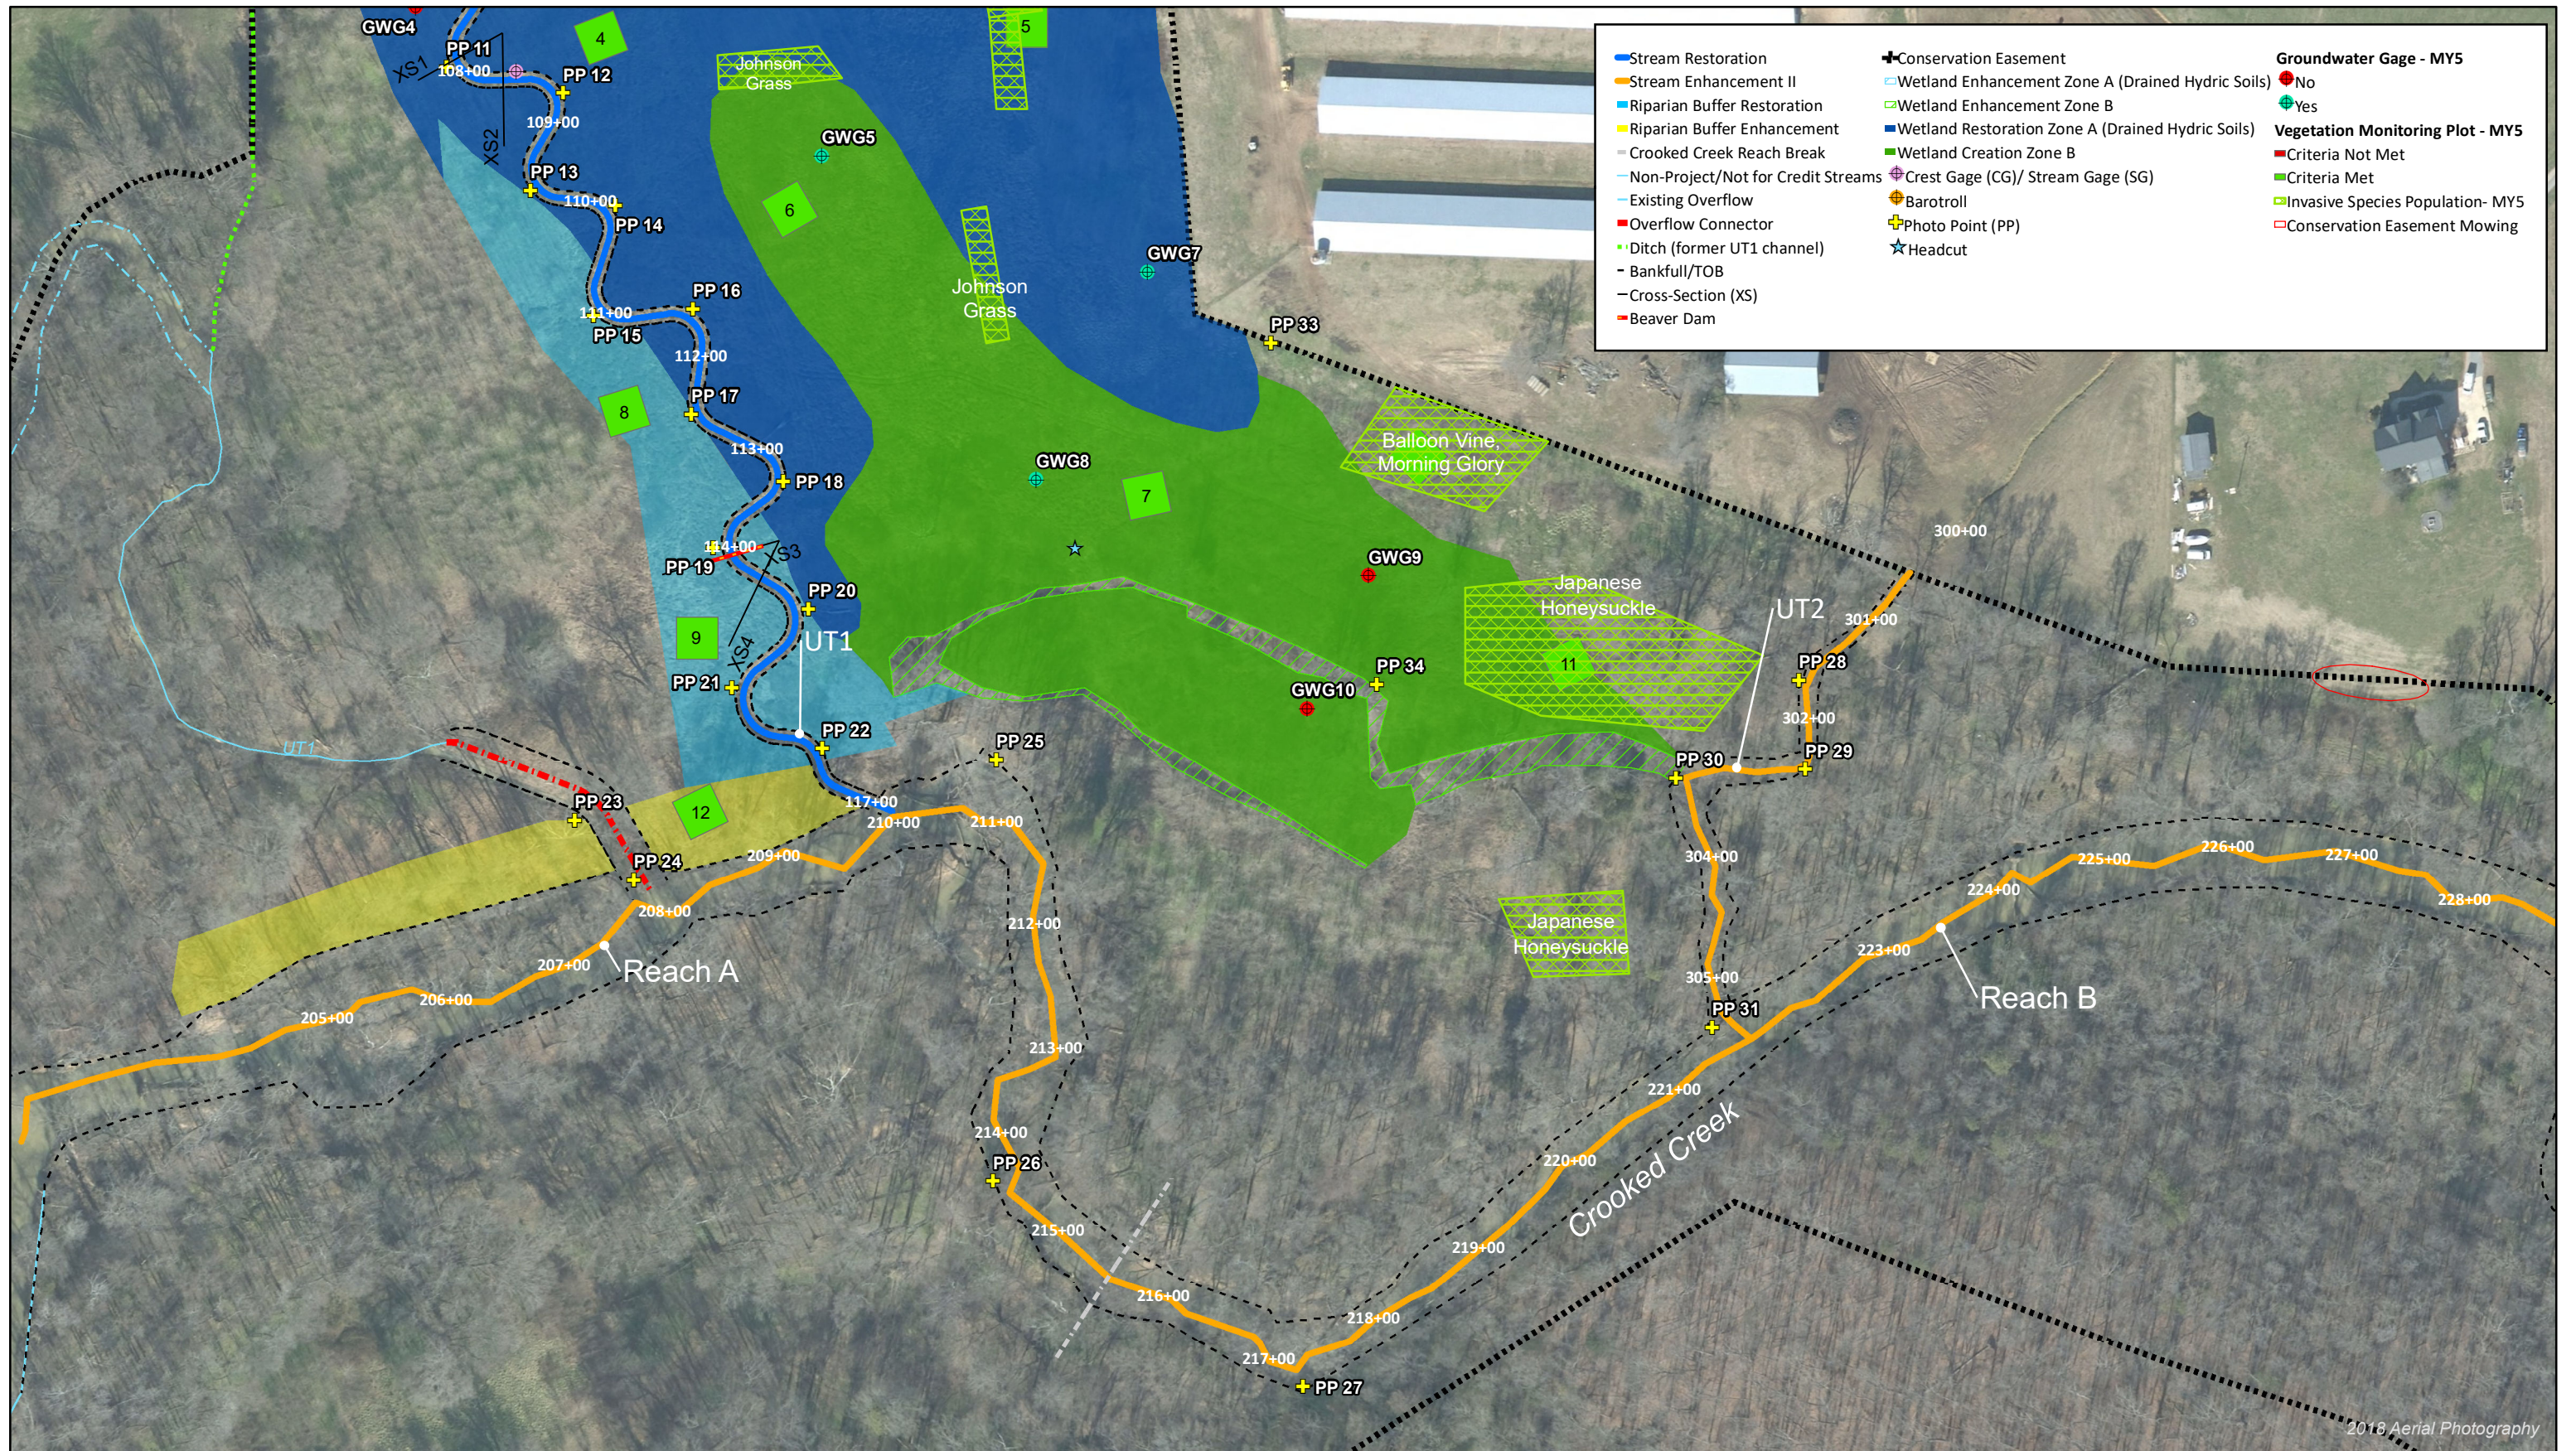
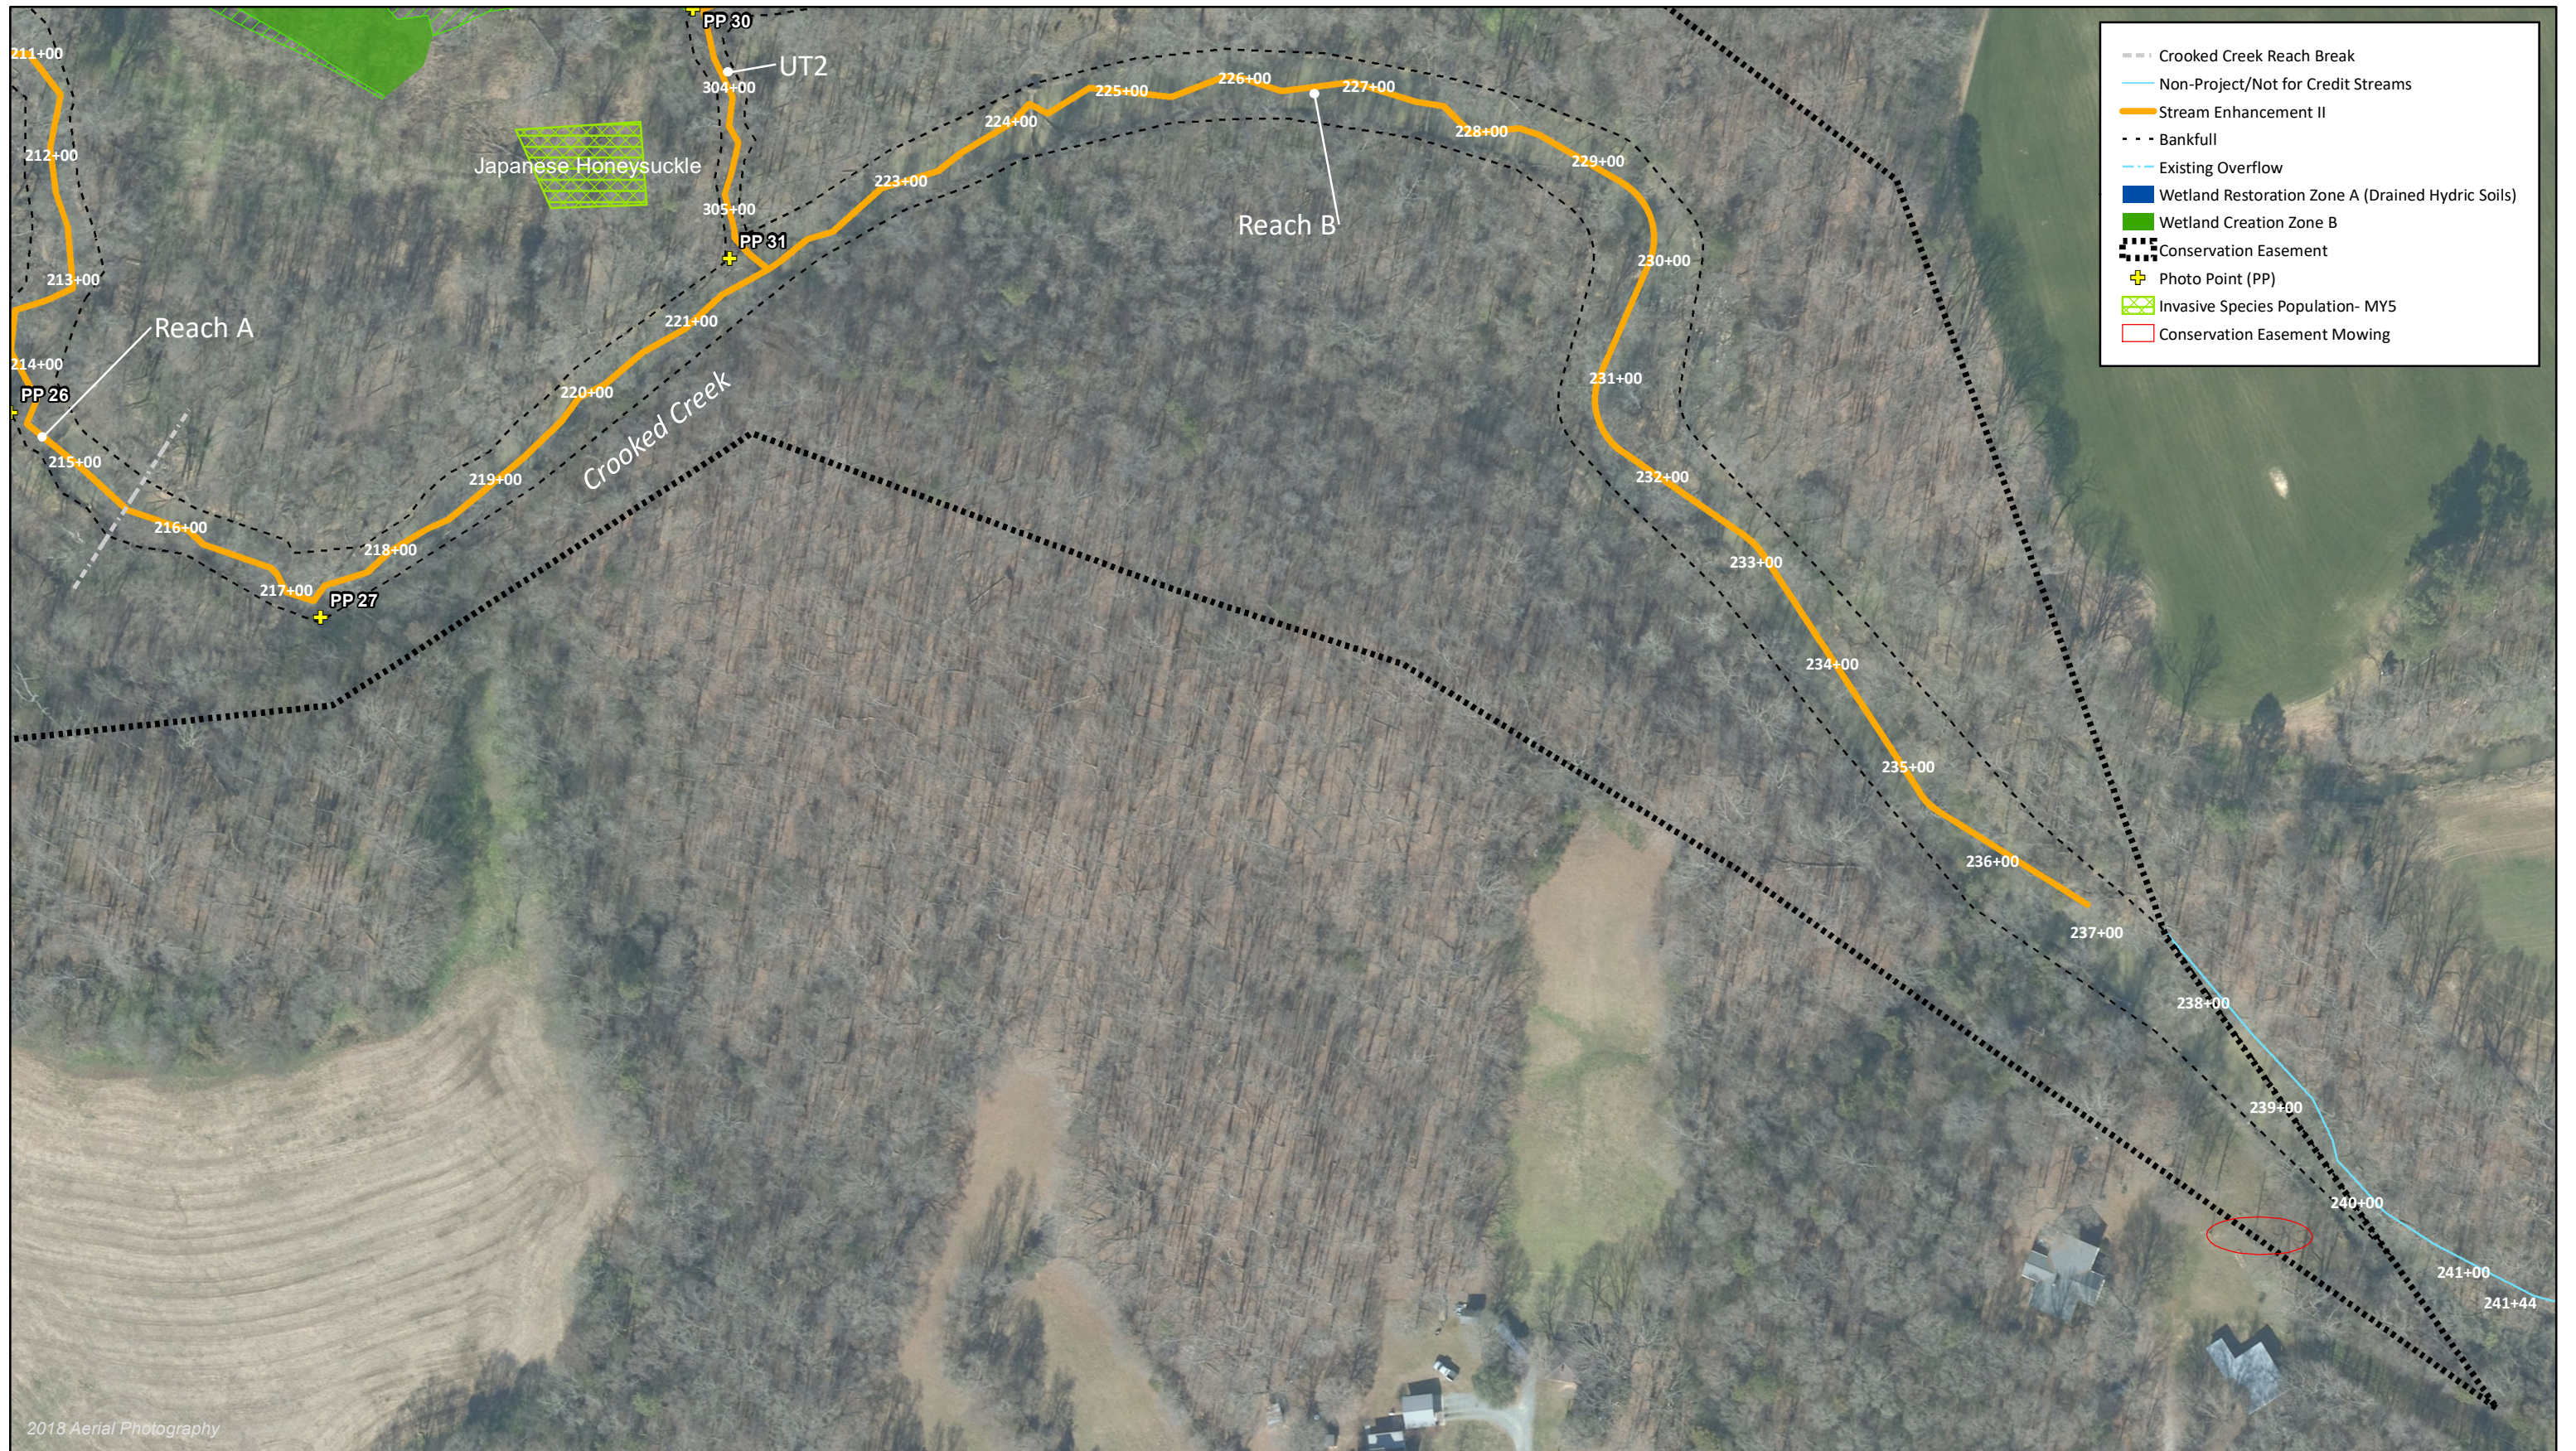
Refer to Appendix 2 for the vegetation condition assessment table and CCPV maps for MY5 vegetation areas of concern and conservation easement mowing locations.

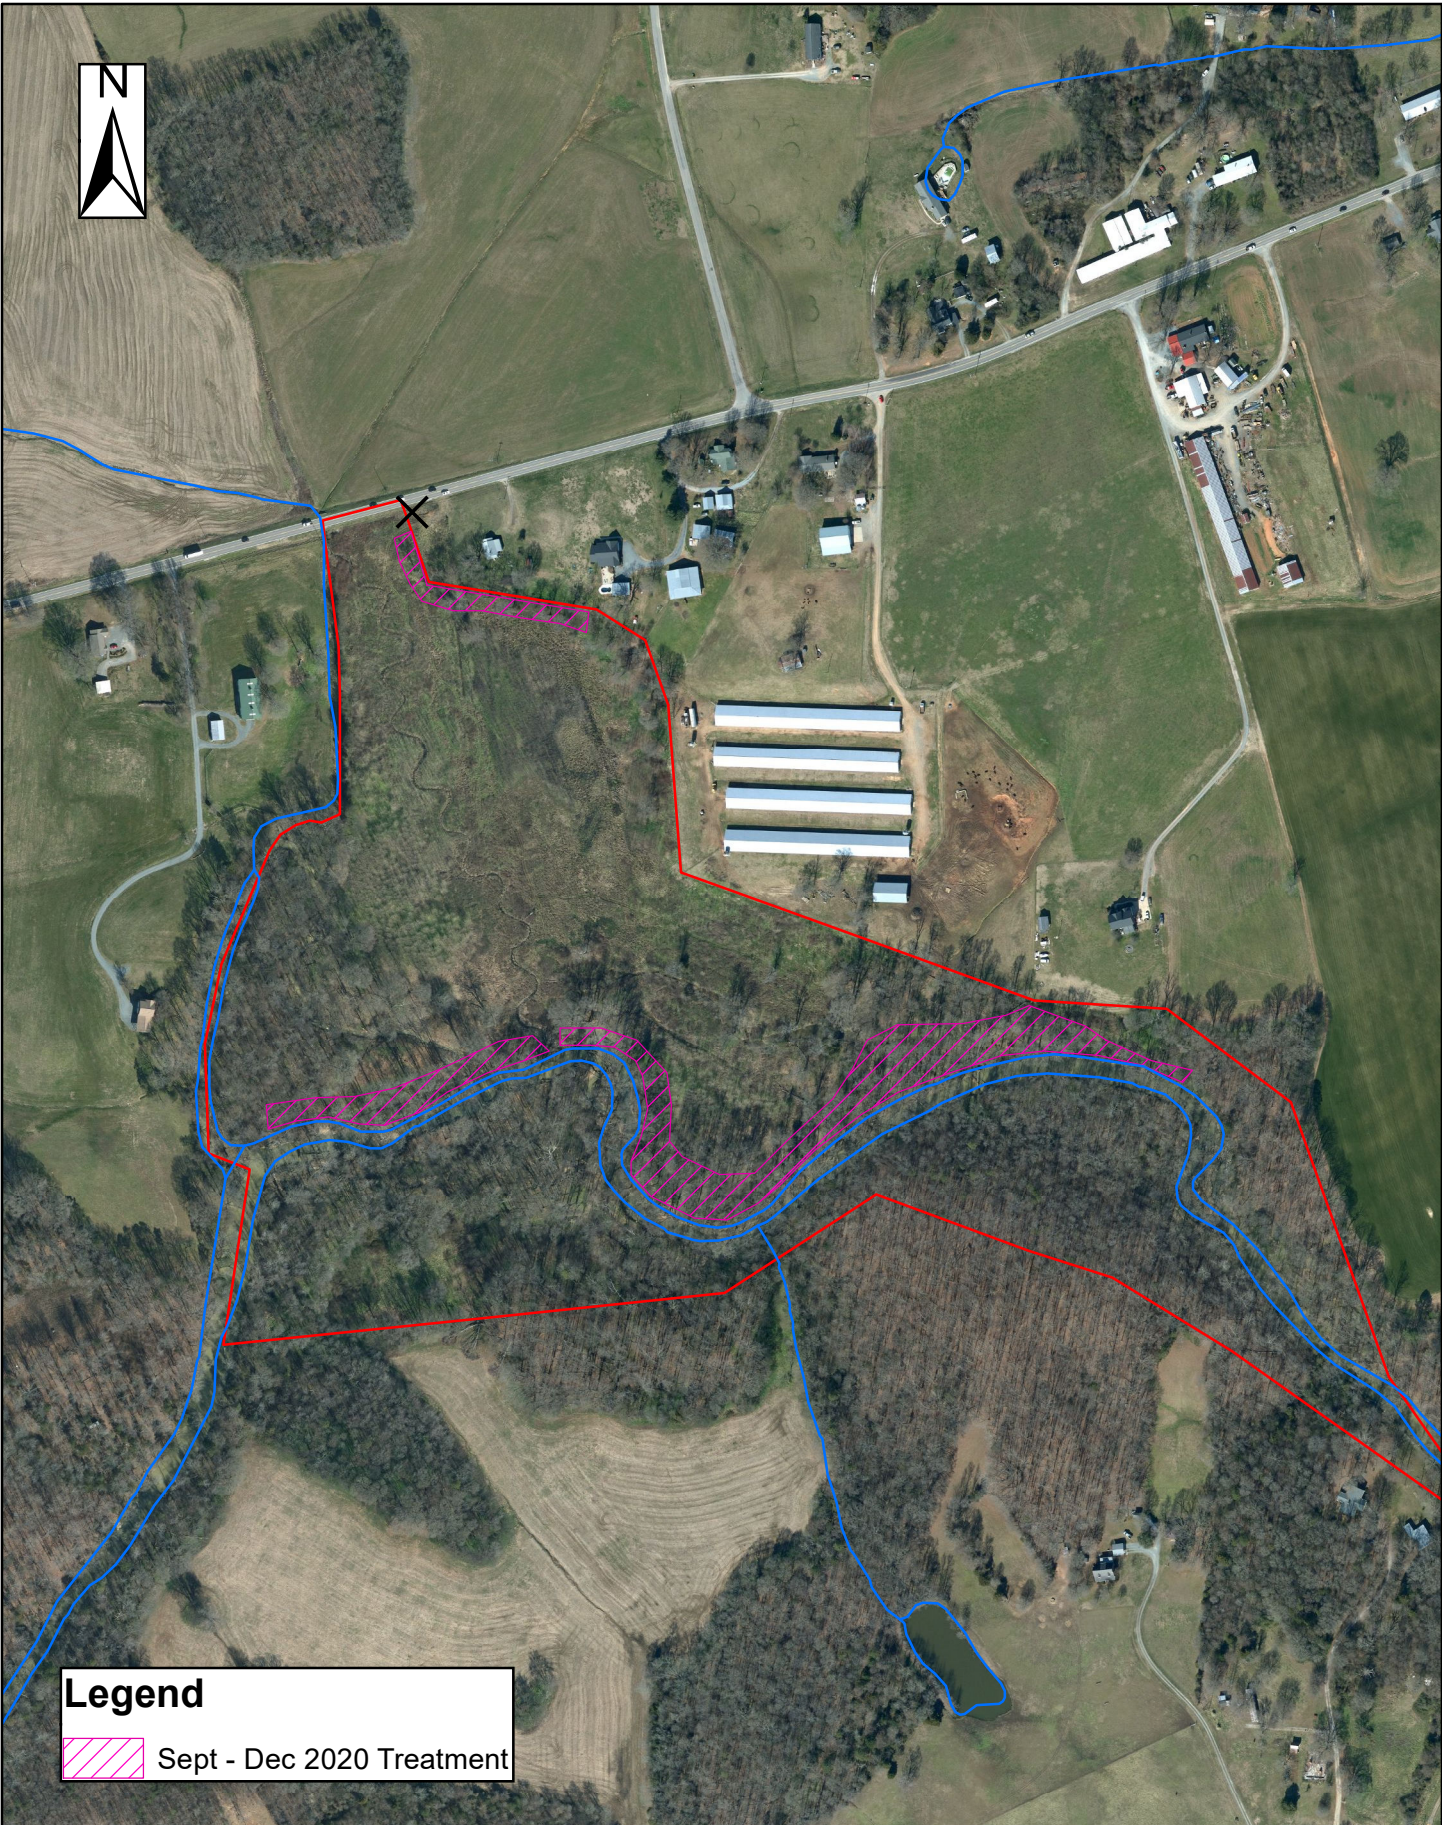
Jason York and Drew Powers applied 10 gallons of 3% Rodeo (glyphosate) as a foliar spray on privet (*Ligustrum spp.*) along the northern bank of Crooked Creek. Approximately 60 feet from the banks were treated. Other invasive plants treated included Sacred Bamboo (*Nandina domestica*), Burning Bush (*Euonymus alata*), Japanese Honeysuckle (*Lonicera japonica*), and Callery Pear (*Pyrus calleryana*). Privet and Callery Pear were also treated with 20% Garlon 4 in Bark Oil Blue as a basal bark application near the northern most easement boundary. No stems were treated that were tall enough to fall on the adjacent fence line. Attached is a map showing the approximate area that was treated.

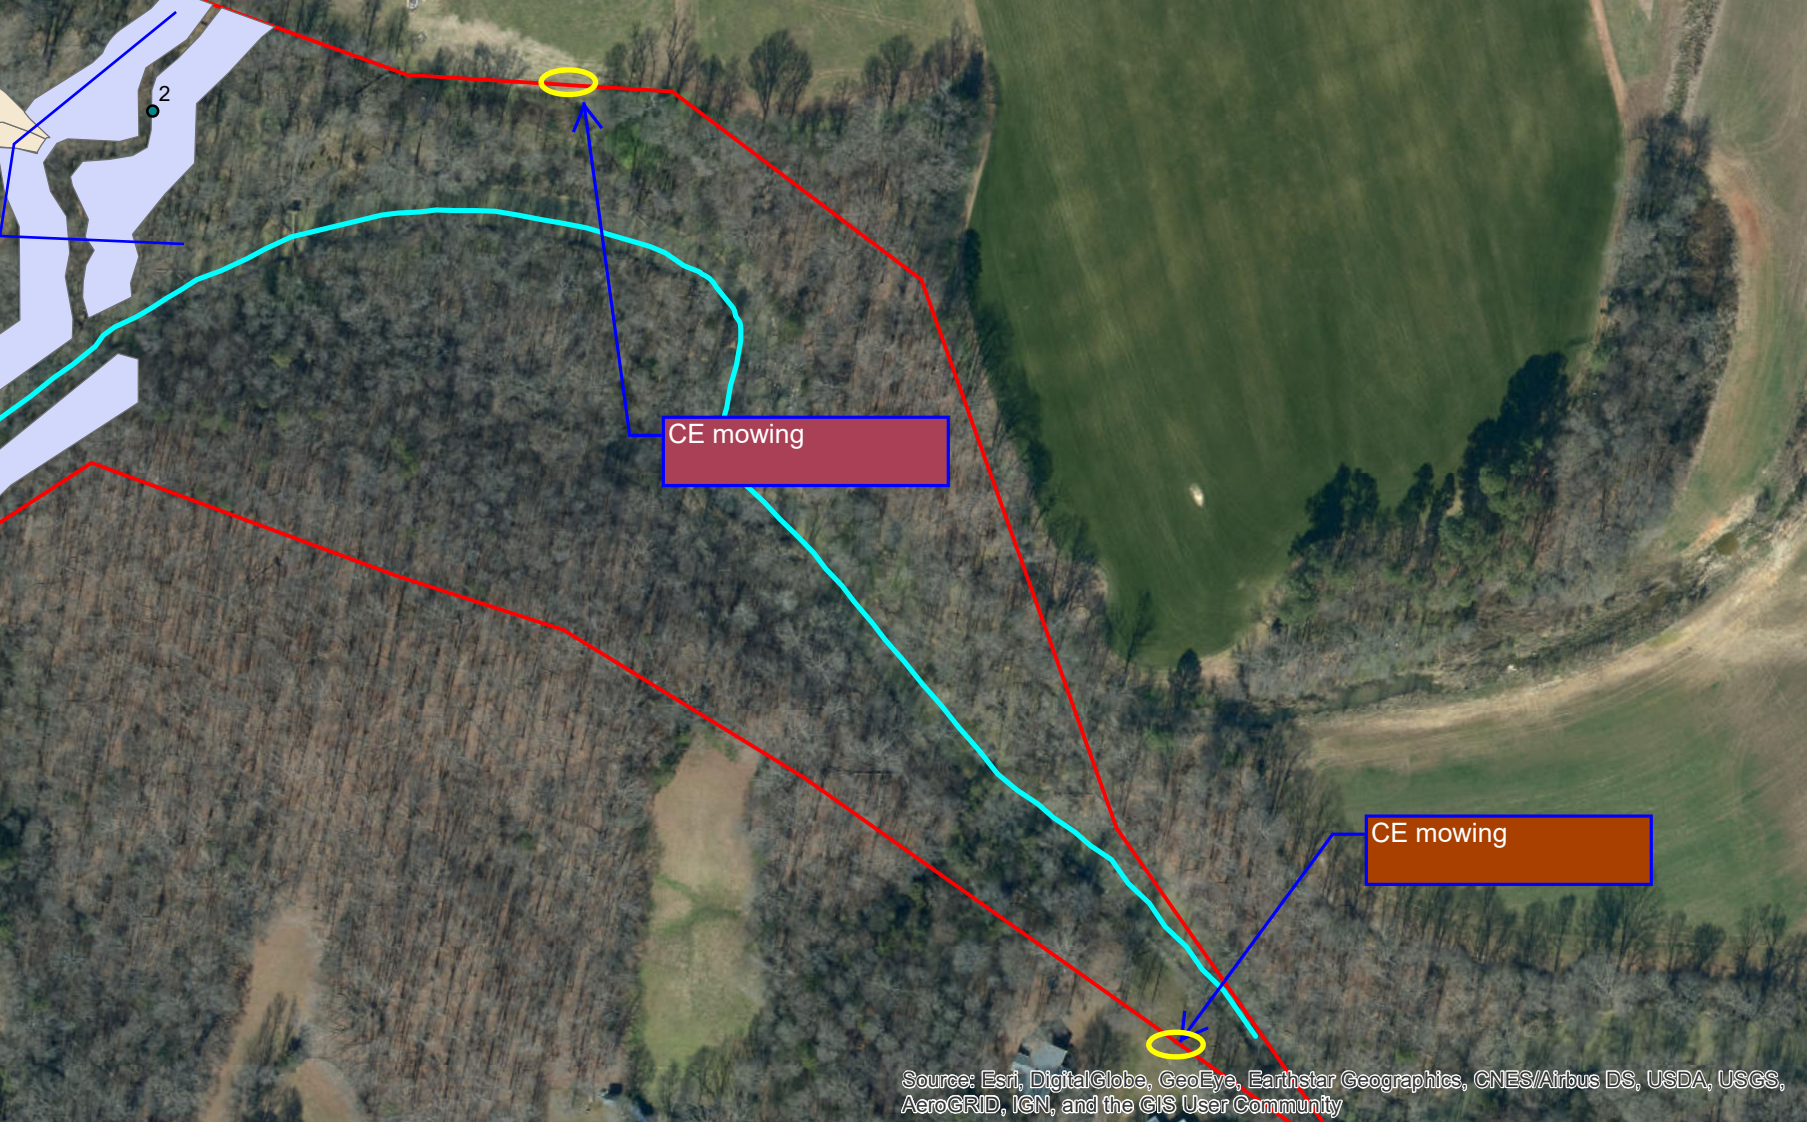
## **APPENDIX 9. Easement Encroachment Areas**

CE mowing
