**MONITORING YEAR 1
ANNUAL REPORT**
Final

CROSS CREEK RANCH SITE

Montgomery County, NC
Yadkin River Basin
HUC 03040104

DMS Project No. 100138
NCDEQ Contract No. 7879-01
DMS RFP No. 16-007879 / Issued: May 6, 2019
USACE Action ID No. 2020-00051
DWR Project No. 2020-0016
Data Collection Dates: February 2022 – November 2022

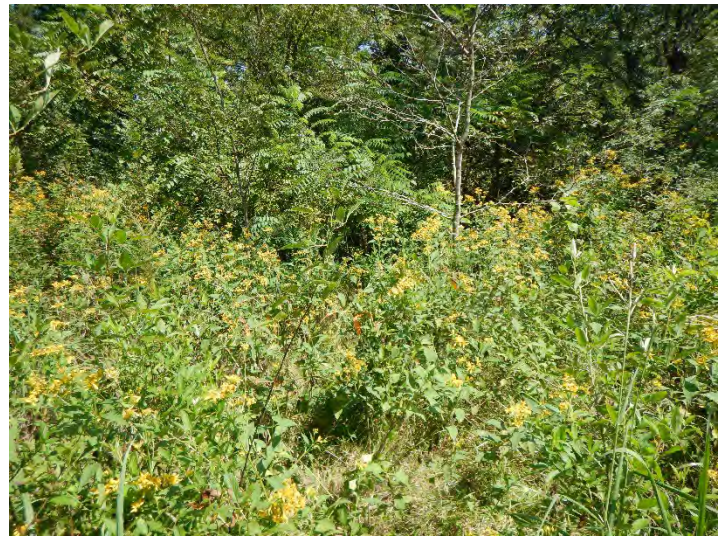
RANDOM VEG PLOT 27 (09/15/2022)

The primary cause for live stake mortality represented by random vegetation plots 27 and 28 along Clarks Creek is likely competition with fescue. These areas will be evaluated and treated in 2023 with ring-sprays to limit fescue competition.
