**Cross Creek Stream Restoration
Year One Monitoring Report
Cumberland County, North Carolina**

NCEEP Project Number 105
SCO Number 01-05460-01
EEP Project Manager: Melonie Allen

December 2006

**CROSS CREEK STREAM RESTORATION
YEAR ONE MONITORING REPORT**

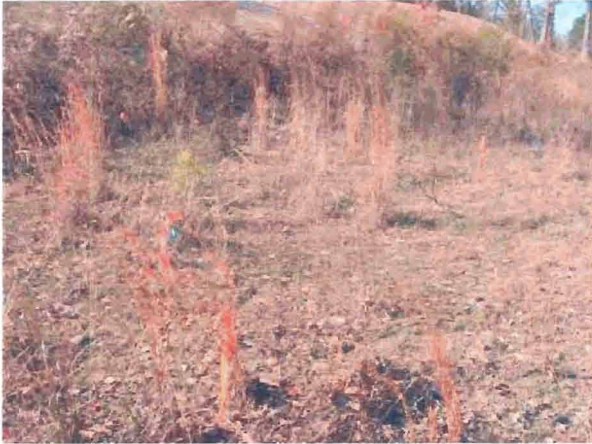
Table VIII. Vegetation Problem Areas Cross Creek Stream Mitigation Site/Project No. 105			
Feature/Issue	Station # /Range	Probable Cause	Photo
Invasive Species	Vegetation Plot 103	Kudzu, Mimosa	VPA.5
	Vegetation Plot 104	Chinese Privet	VPA.6
Establishment Failure	Approximately 18+70	Lack of Vegetation	VPA.1
	Approximately 17+30	Lack of Vegetation	VPA.2
	Approximately 21+60	Lack of Vegetation	VPA.3
Direct Damages	NA	Beaver Damage	VPA.4

VPA1. Vegetation failure near Station 18+70

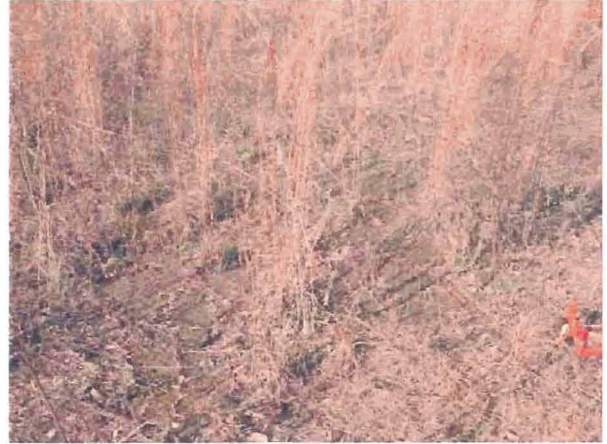
VPA2. Vegetation failure near Station 17+30

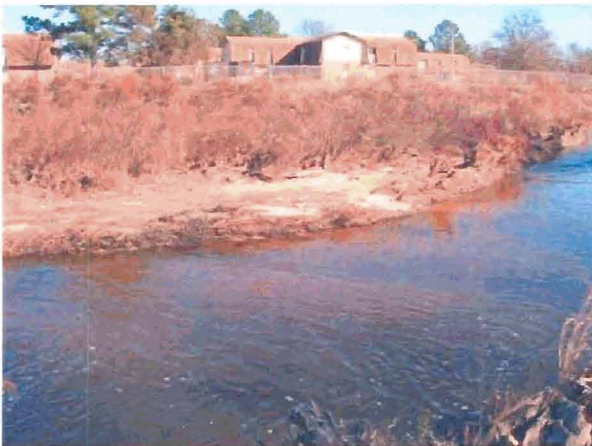
VPA3. Vegetation failure near Station 21+60

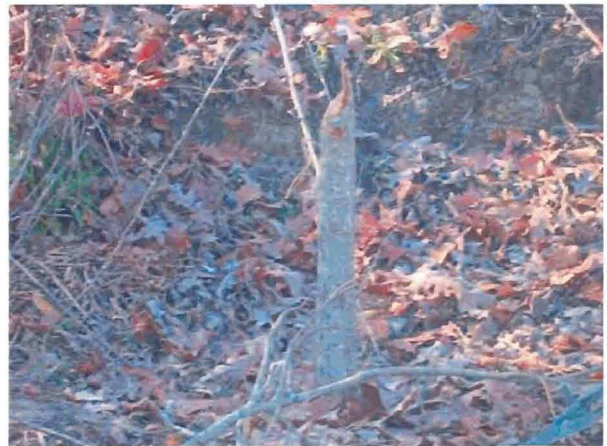
VPA4. Evidence of beaver damage.

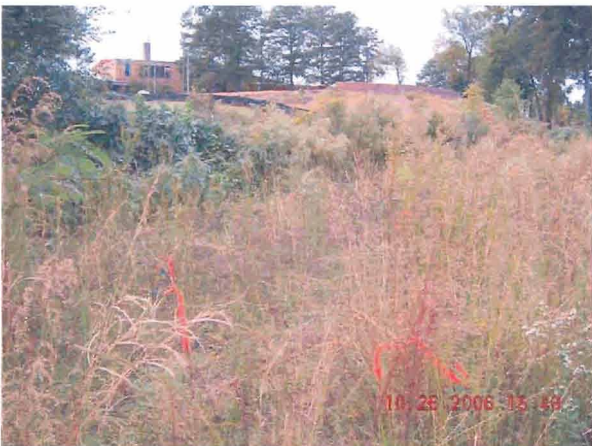
VPA5. Invasive Species. Kudzu and Mimosa

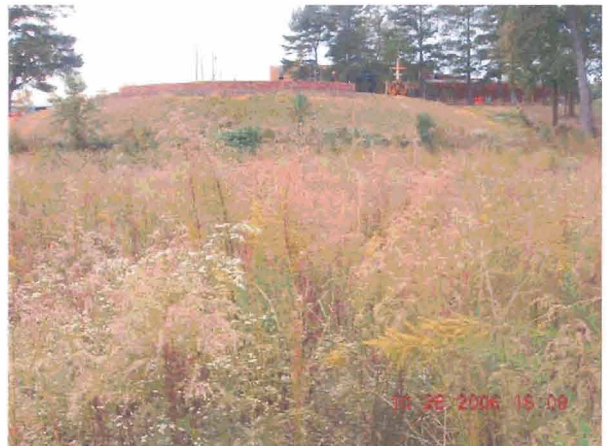
VPA6. Invasive Species. Kudzu and Privet

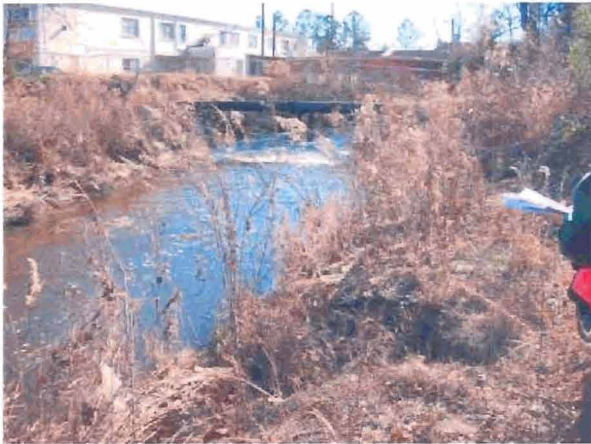
Table IX. Stream Problem Areas			
Cross Creek Stream Mitigation Site/Project No. 105			
Feature/Issue	Station # /Range	Probable Cause	Photo #
Bank Scour	14+50	Minimal vegetation, stress on bank.	SPA1
	15+80	Widening and deepening (“bowling”) of stream caused by turbulence from sill.	SPA2
	18+50	Widening and deepening (“bowling”) of stream caused by turbulence from sill.	SPA3
	23+00	Improperly applied level spreader; discharge from 48” pipe is probably much greater than anticipated.	SPA4
	21+50	Combination of shear stress on outside meander and erosion from discharge of 48” pipe.	SPA5
	LCC 10+70	Bank erosion caused by direction of flow towards bank and insufficient resistance of the bank to that flow .	SPA8
Engineered structures - improper function	Level Spreader	Channelization and erosion caused by discharge from 48” pipe.	SPA5
Aggradation/Bar Formation	LCC 10+50	Possible shift in channel location	SPA6

SPA 1. Station 14+50 Erosion on right bank above utility pipe.

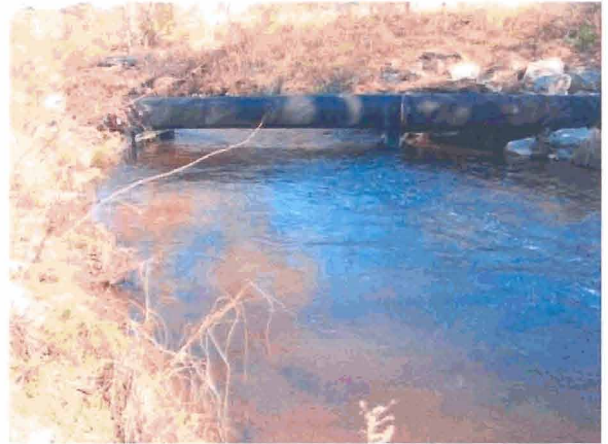
SPA 2. Station 15+80 Bowling effect caused by pool formation below utility pipe.

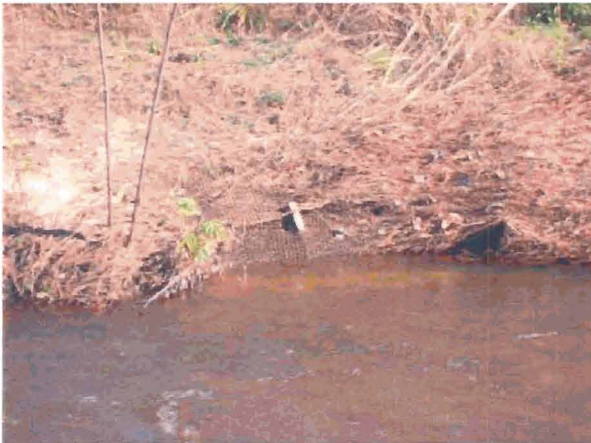
SPA 3. Station 18+50 Bowling effect caused by pool formation below sill.

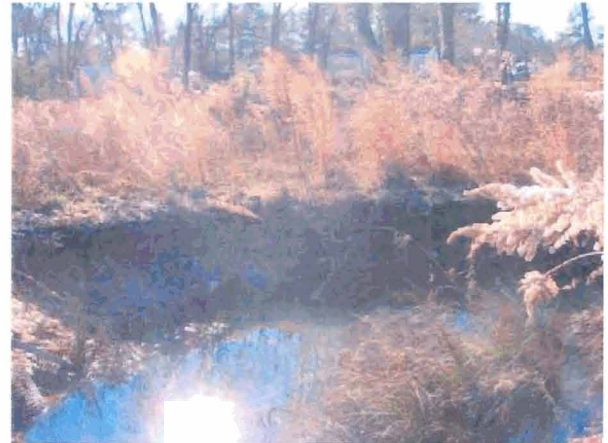
During the initial Year 1 Monitoring, some bank scour was noted in a few locations and bar formation was noted on Little Cross Creek at station 11+00. The level spreader was also discovered functioning improperly and channelization erosion occurring immediately down-slope from the spreader. Specific problem areas are detailed in the following table.

SPA 4. Station 23+00 Erosion due to failed level spreader.

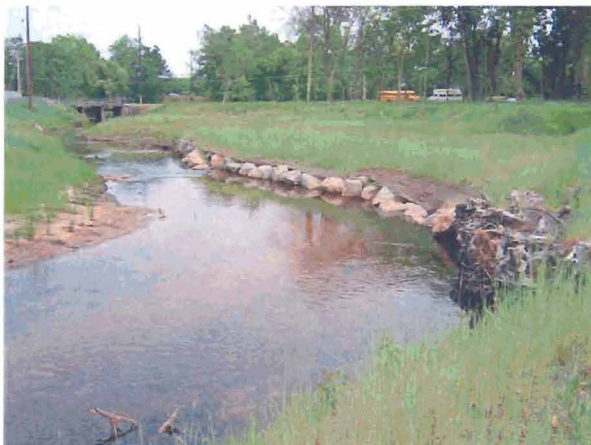
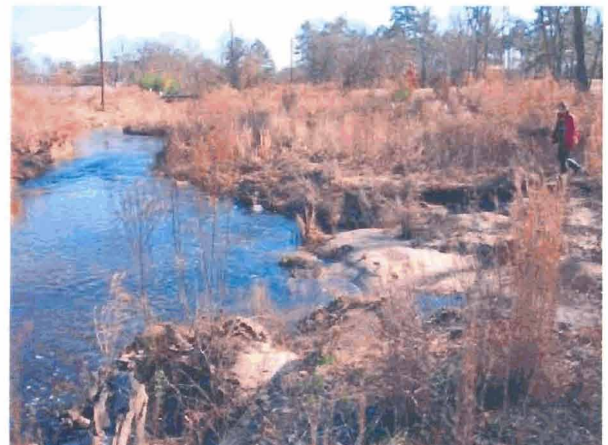
Overall, the project is doing well with a few minor erosion areas and some areas of minimal vegetation. Repairs are recommended for the only major erosion area of the site, near Station 21+50. The other problem areas need to be watched and if the problems worsen over time, then solutions need to be discussed to assess the reason for the problem and potential options to fix the areas. Vegetative problem areas are described in Table VI and stream problem areas are described in Table IX.

SPA 5. Station 21+50 As-built outside meander with toe revetment.

SPA 5. Station 21+50 Current state of outside meander; bank failure occurring.

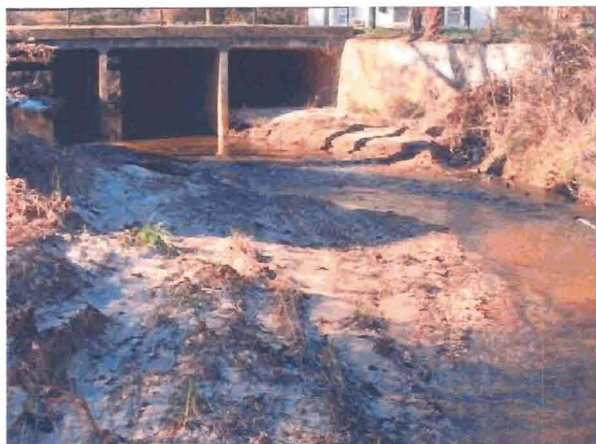
SPA 6. Station 10+50 on Little Cross Creek (LCC). Deposition causing point bar formation.

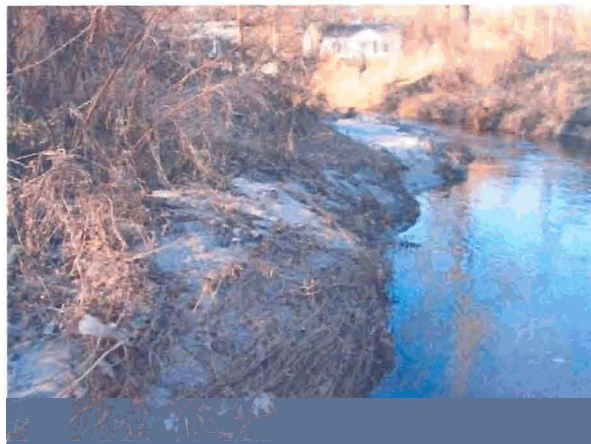
SPA 7. Station 10+70 on LCC Deposition on left bank.

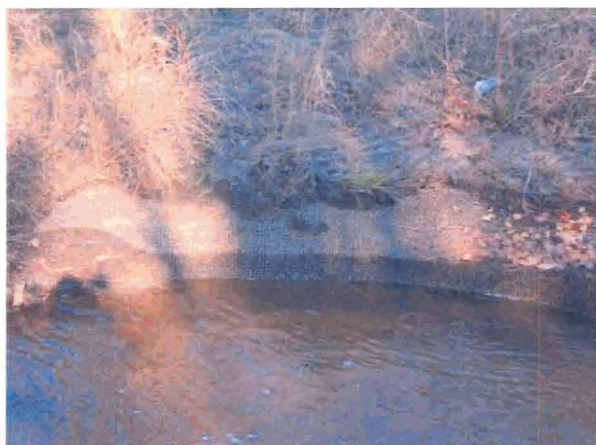
SPA 8. Station 12+00 on LCC. Undercut matting on left bank.

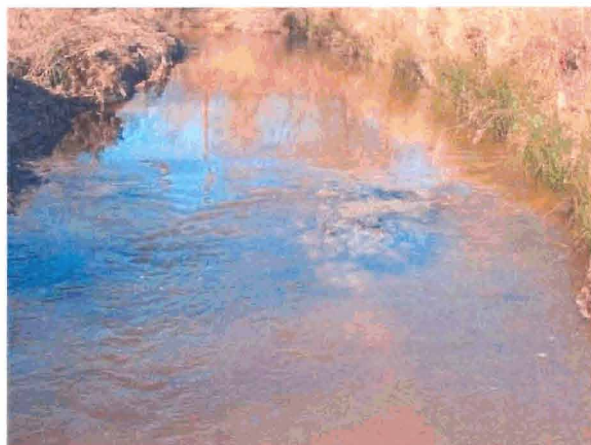
LCC 12+40	Deposition on bank caused by design of over-widened channel.	
	LCC 14+20	Transverse bar formation causing perpendicular flow into outside bank, and concomitant bank erosion.	SPA9
	LCC 15+20	Transverse bar formation causing perpendicular flow into outside bank, and concomitant bank erosion.	SPA10
	LCC 15+70	Point bar formation caused by aggradation due to design of over-widened channel.	SPA11

SPA 9. Station 14+20 on LCC. Transverse bar formation and concomitant erosion on left bank.

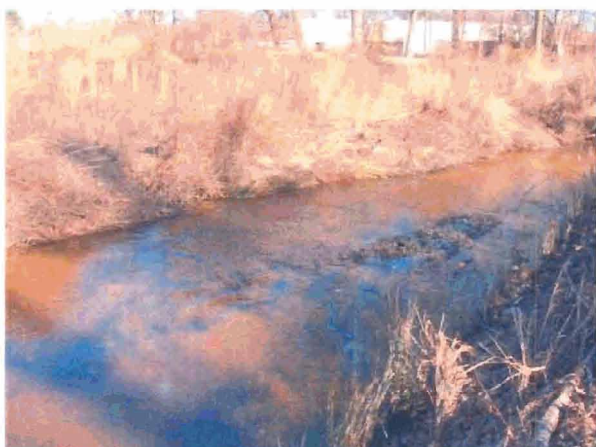
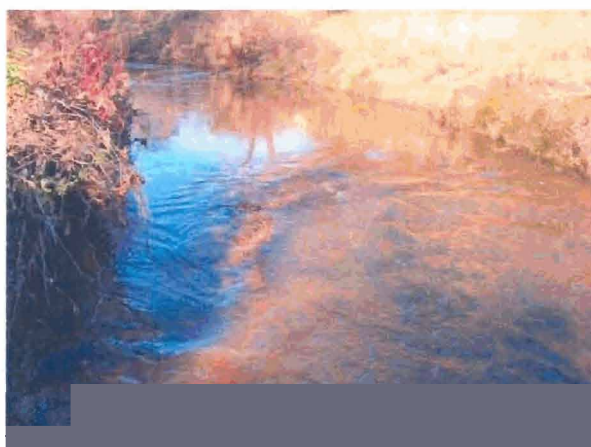
SPA 10a. Station 15+20 on LCC. Looking downstream at bar formation in stream.

SPA 10b. Station 15+20 on LCC. Looking downstream at bar formation in stream.

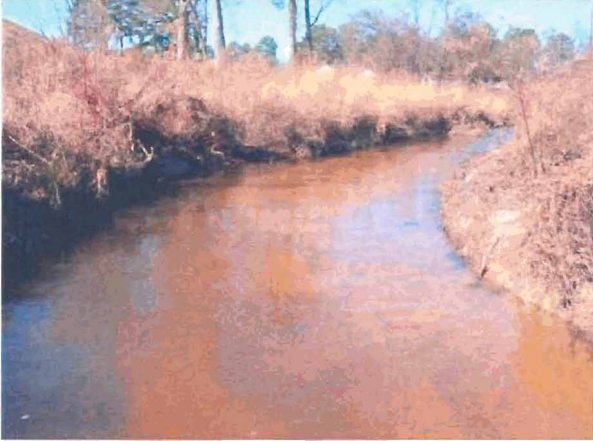
SPA 11. Station 16+00 on LCC. Aggradation causing point bar formation above structure. Looking upstream.
