CROSS CREEK STREAM RESTORATION
MONITORING REPORT (YEAR 2 OF 5)

Cumberland County, North Carolina
NCEEP Project Number 105

Status of Plan: Final
Submission Date: March 2008

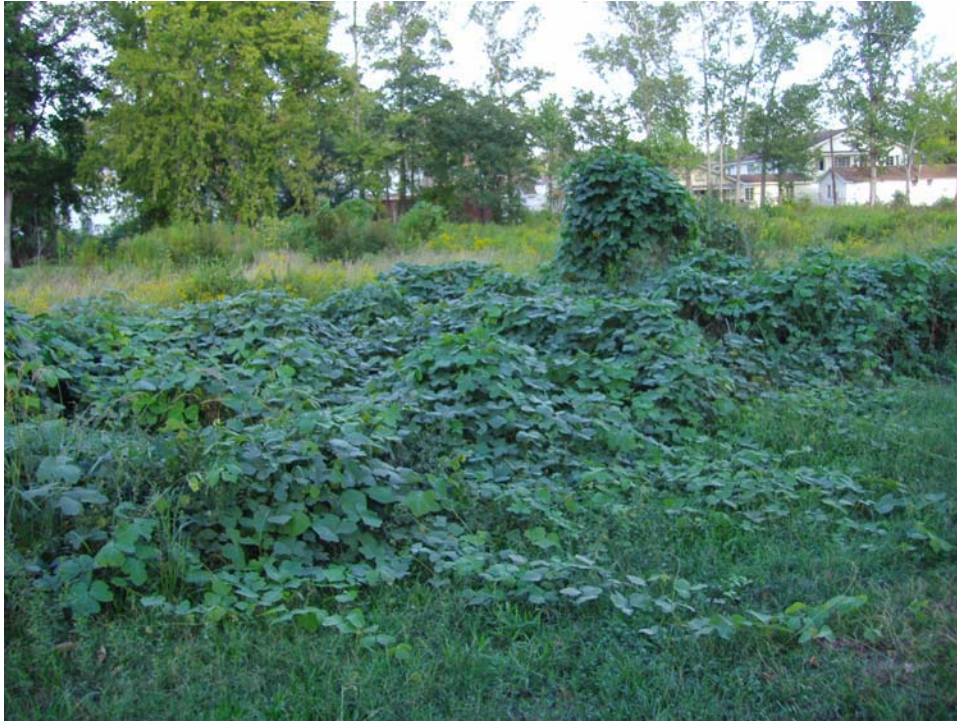
Photo 1: Kudzu invasion near Veg Plot 107 (10/1/07)

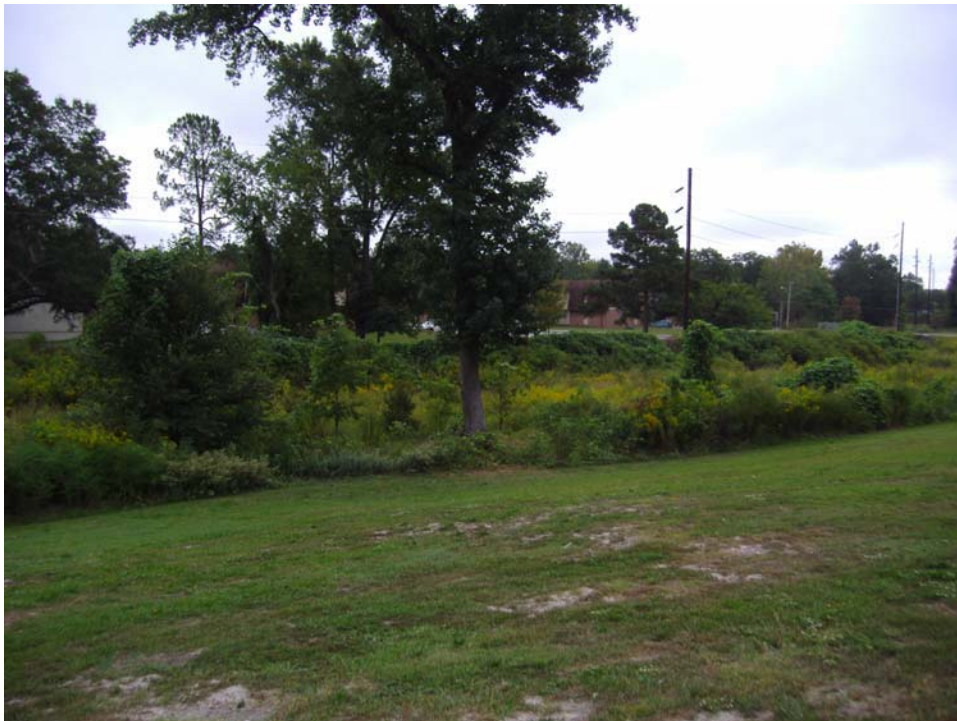
Photo 2: Kudzu on either side of the channel near Veg Plot 102 (10/2/07)

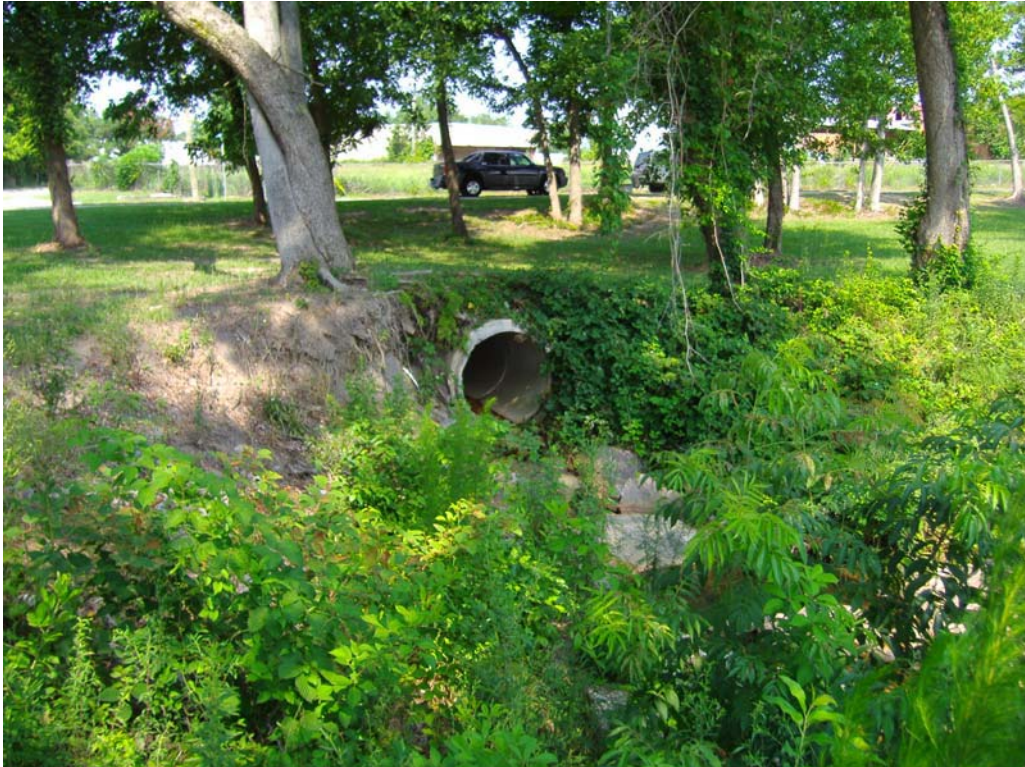
The major problem areas for this project are a failure of a stormwater channel plunge pool [Stream Problem Area (SP) 9] and a failure of a wetland pond (SP 10). This pond lies adjacent to the stormwater channel in the lower reach of Cross Creek (Photo 1 in Appendix B3 of Appendix B and Appendix D. Integrated Problem Areas Plan View). The stormwater channel has produced massive erosion and bank migration (Appendix B3. Photo 2). Failure has occurred at the confluence of the stormwater channel and Cross Creek in the form of a blow hole. Sediment is being deposited directly into the main reach from erosion of the stormwater channel (Appendix B3. Photo 3). The original design for this feature called for a plunge basin, field observation indicates that this was either improperly designed or not constructed properly. The channel cannot currently hold the velocities and flow capacity of the discharge from the stormwater pipe. The grade that the stormwater channel approaches the stream channel is too steep. The failure of the stormwater channel has in turn caused failure to the wetland pond (Appendix B3. Photos 4 and 5). Currently, the wetland is receiving overflow from the stormwater channel and the increased flow has caused erosion and channel migration in the wetland much like that in the stormwater channel. A failure at the wetland pond’s outlet to the main reach and overbank flow has also occurred.

Photo 1. (SP 9) Stormwater outlet pipe entering into the design plunge basin (7/4/07)

It is strongly recommended that this area of the restoration project be re-designed. The flow exiting the stormdrain (and the energy associated with that flow) is too great for the current design. A flow splitter is

recommended to divert large storms around the facility and into a bypass channel. The bypass channel should be designed to convey large flows and should utilize grade control structures for stabilization and for the benefit of the receiving stream reach. Redesigning this area will decrease downstream velocities and restore habitat in the wetland area. See Exhibit Table B1 as well as accompanying photos provided in Appendix B.

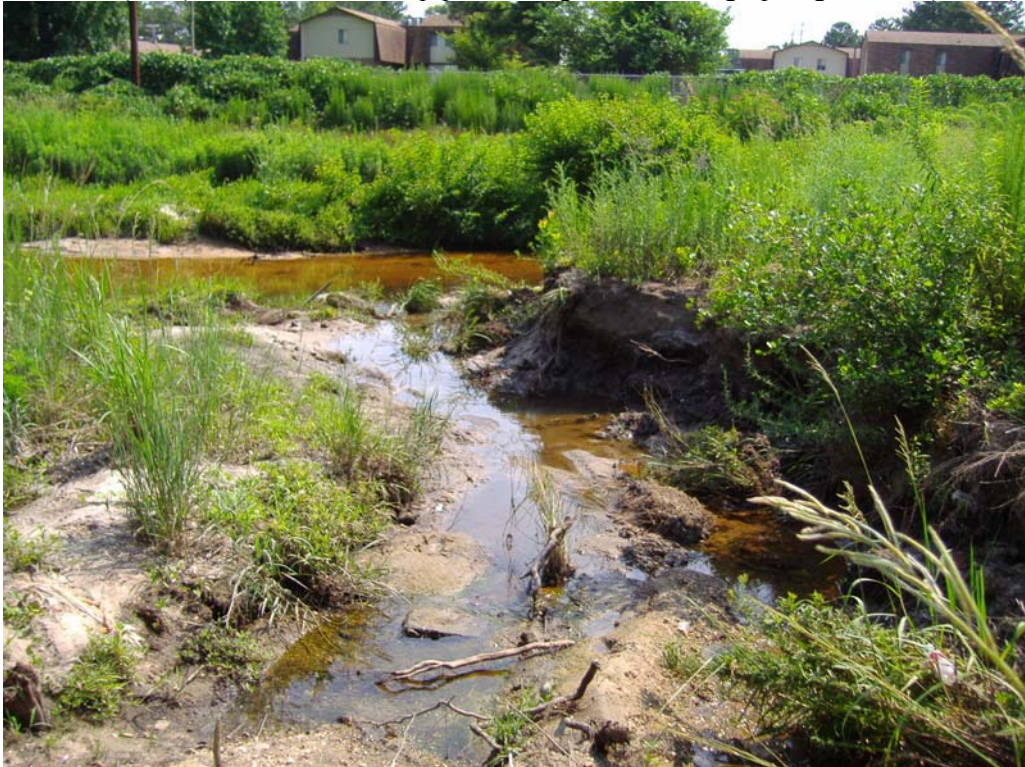
Photo 2. (SP 9) Bank erosion and migration of the design trapezoidal plunge basin (7/4/07)

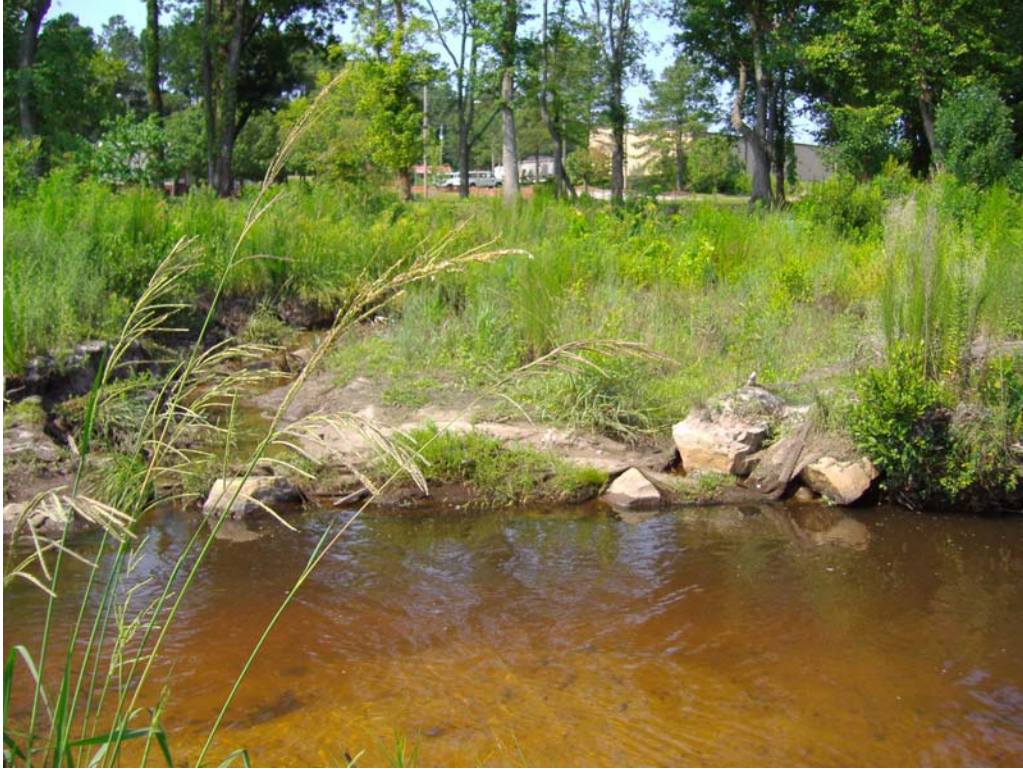
Photo 3. (SP 9) Outlet failure of the stormwater channel into the main reach (7/4/07)

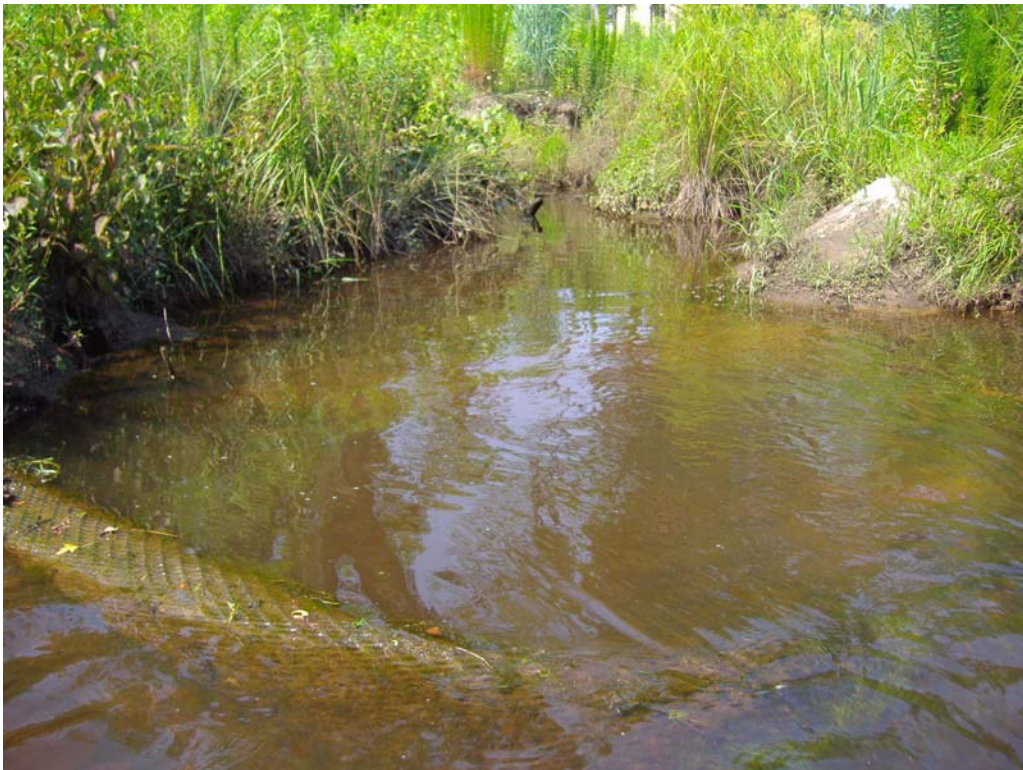
Photo 4. (SP 10) Outlet failure of the wetland pond into the main reach (7/4/07)

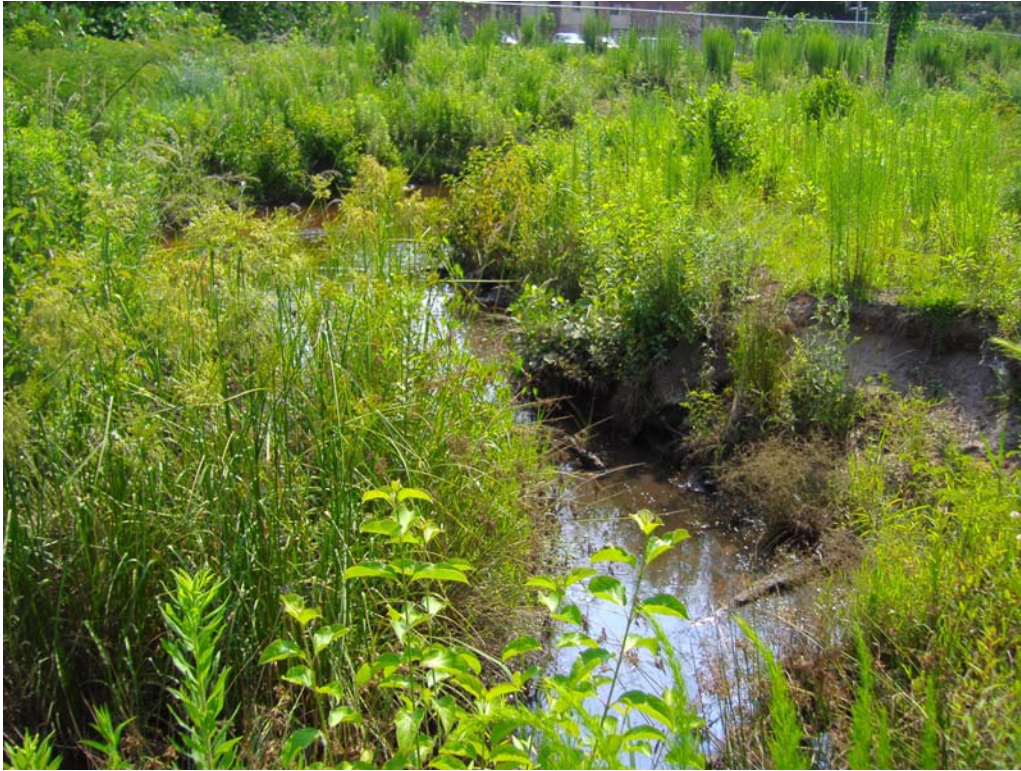
Photo 5. (SP 10) Bank erosion, migration, and failure of the wetland pond (7/4/07)

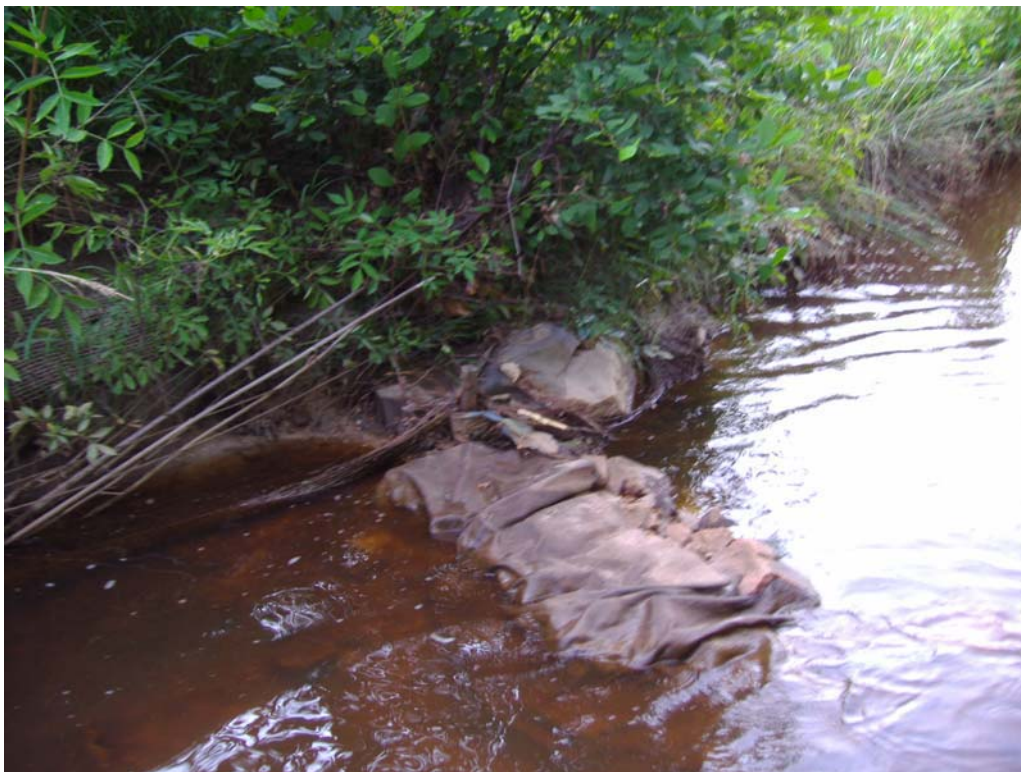
Photo 6. (SP 2-4, 16) Example of poorly built structure leading to structural failure and causing erosion on the banks (7/4/07)

Minor problem areas (SP 1-8, 11-18) were also found across the project and they can be defined into four subcategories: structure failure, root wad failure, toe scour, and bank erosion. These problem areas can be remediated by additional plantings and/or minor hand grading. See Exhibit Table B1 and representative photos in Appendix B as well as the map in Appendix D for more information.

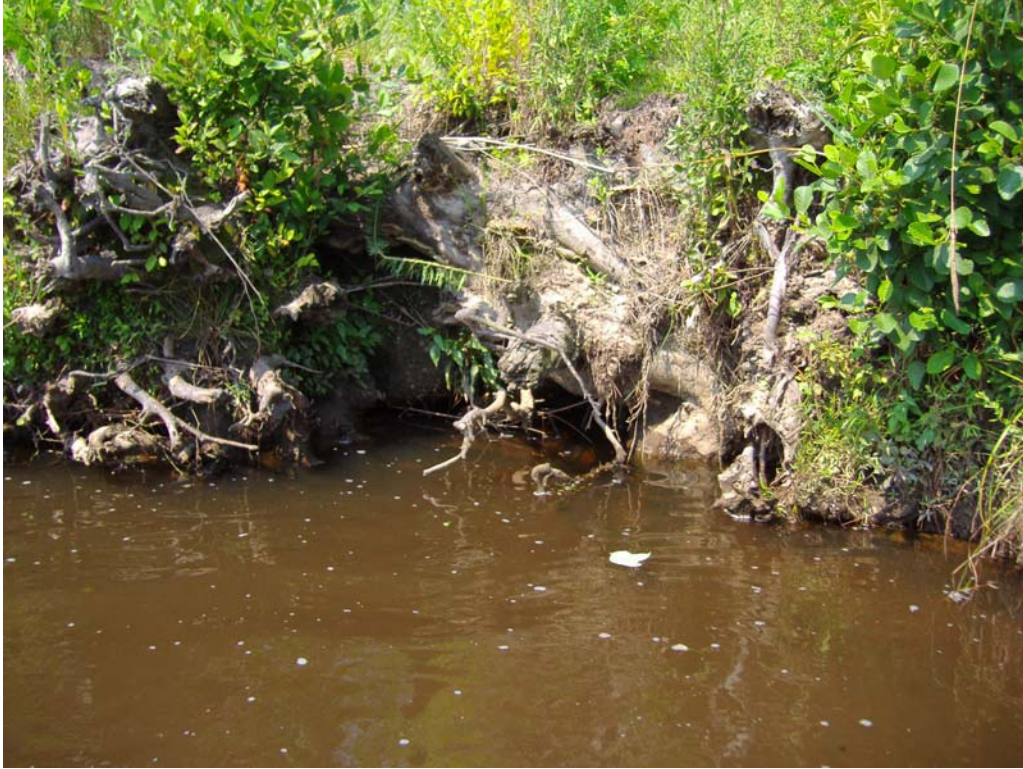
Photo 7. (SPA 7, 11, 19) Example of root wad failure - scouring around a root wad structure (7/4/07)

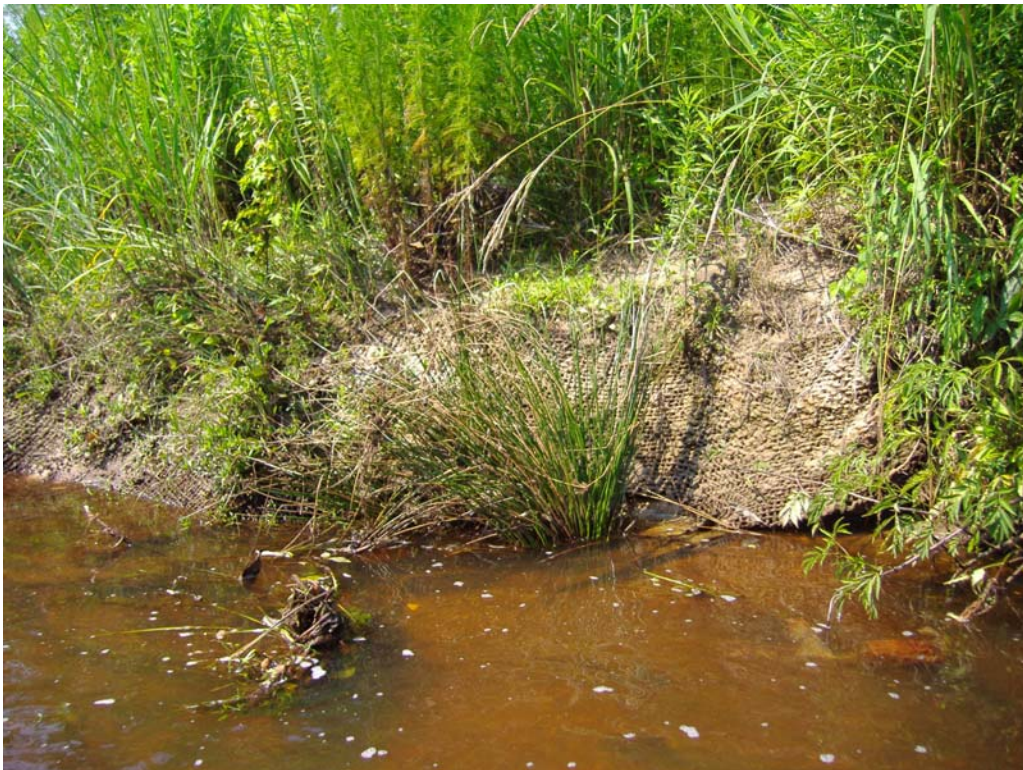
Photo 8. (SPA 1, 13, 18) Example of toe scouring around meandering bends (7/4/07)

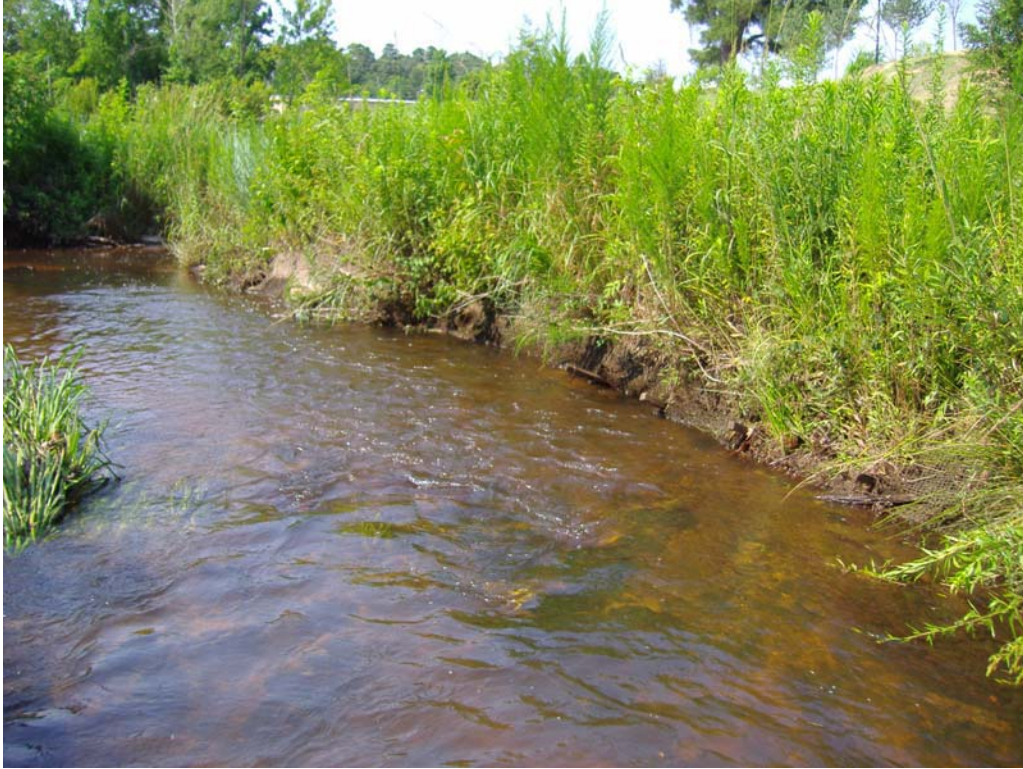
Photo 9. (SPA 5, 6, 8, 12, 14, 15, 17) Example of bank erosion (7/4/07)
