**CROSS CREEK STREAM RESTORATION  
MONITORING REPORT (YEAR 5 OF 5)**  
Cumberland County, North Carolina  
EEP Project No. 105

Status of Plan: Final  
Submission Date: November 2010

Stantec Consulting Services, Inc.  
801 Jones Franklin Road, Suite 300  
Raleigh, NC 27606

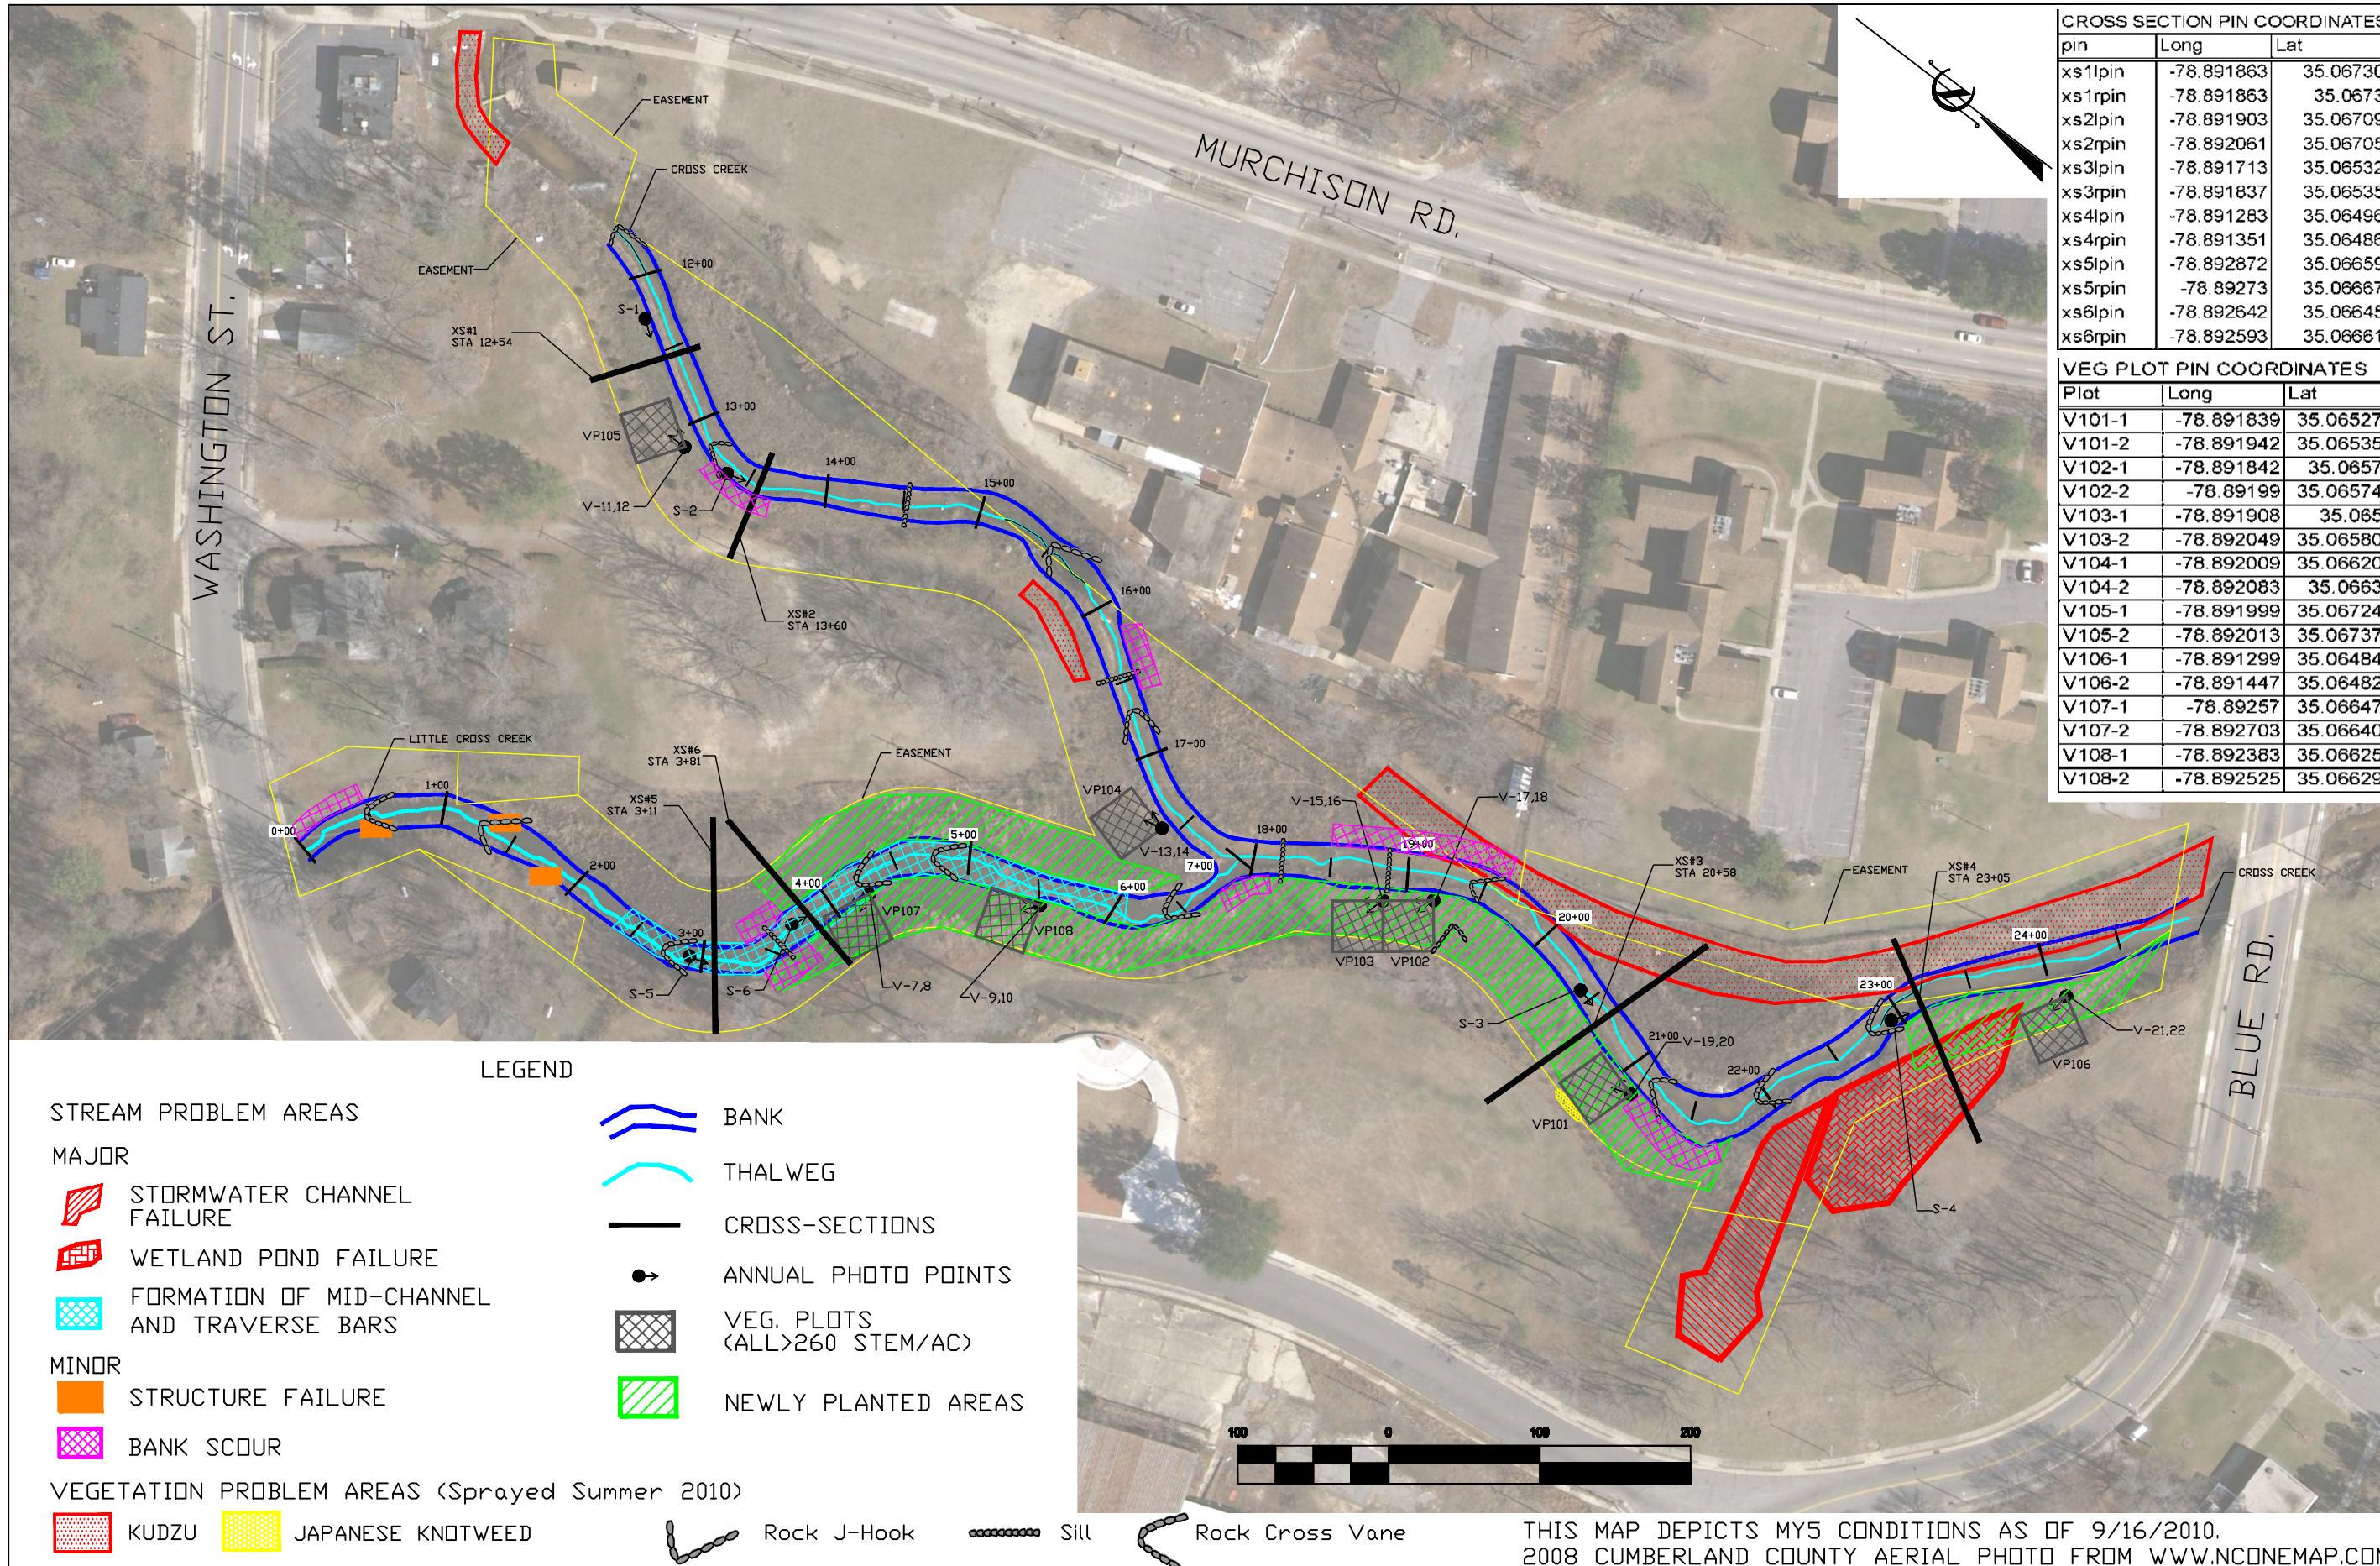
CROSS CREEK STREAM RESTORATION  
EEP PROJECT NUMBER 105  
MONITORING REPORT - MYS  
CURRENT CONDITION PLAN VIEW

Mid-channel bar formations were observed in Little Cross Creek, indicating that the stream may not possess sufficient capacity at this time. Colonization by beavers in this area in more recent years may be a contributing factor as well. EEP indicated that a wildlife control contractor has been dispatched to remove the beavers from the site. The stormwater plunge pool and wetland pond area continued to remain unstable and had contributed bank sediments to the channel below. Cross Creek upstream of the confluence with Little Cross Creek appeared to remain relatively stable with no major changes from last year.

The stormwater plunge pool area and wetland pond were continuing to experience mass bank wasting, causing deposition of sediment into the main channel. The energy associated with the flow from the culvert is too great for the plunge pool as it is currently constructed. As a result of this a scour hole has developed. The wetland pond located on the right bank near station 21+60 is continuing to experience bank erosion. The wetland pond erosion is related to the excess energy associated with the culvert/plunge pool area described above. EEP is establishing a repair contract for this area. Many of the project structures are not functioning as intended and the project has exhibited some minor bank erosion that manifested earlier in the project's history, but Stantec believes that the restoration is generally stable and other than the stormwater outfall area designated for repair, the stability of the project has generally
