# MONITORING YEAR 2 ANNUAL REPORT

## CROSS CREEK RANCH SITE

Montgomery County, NC

DMS Project No. 100138

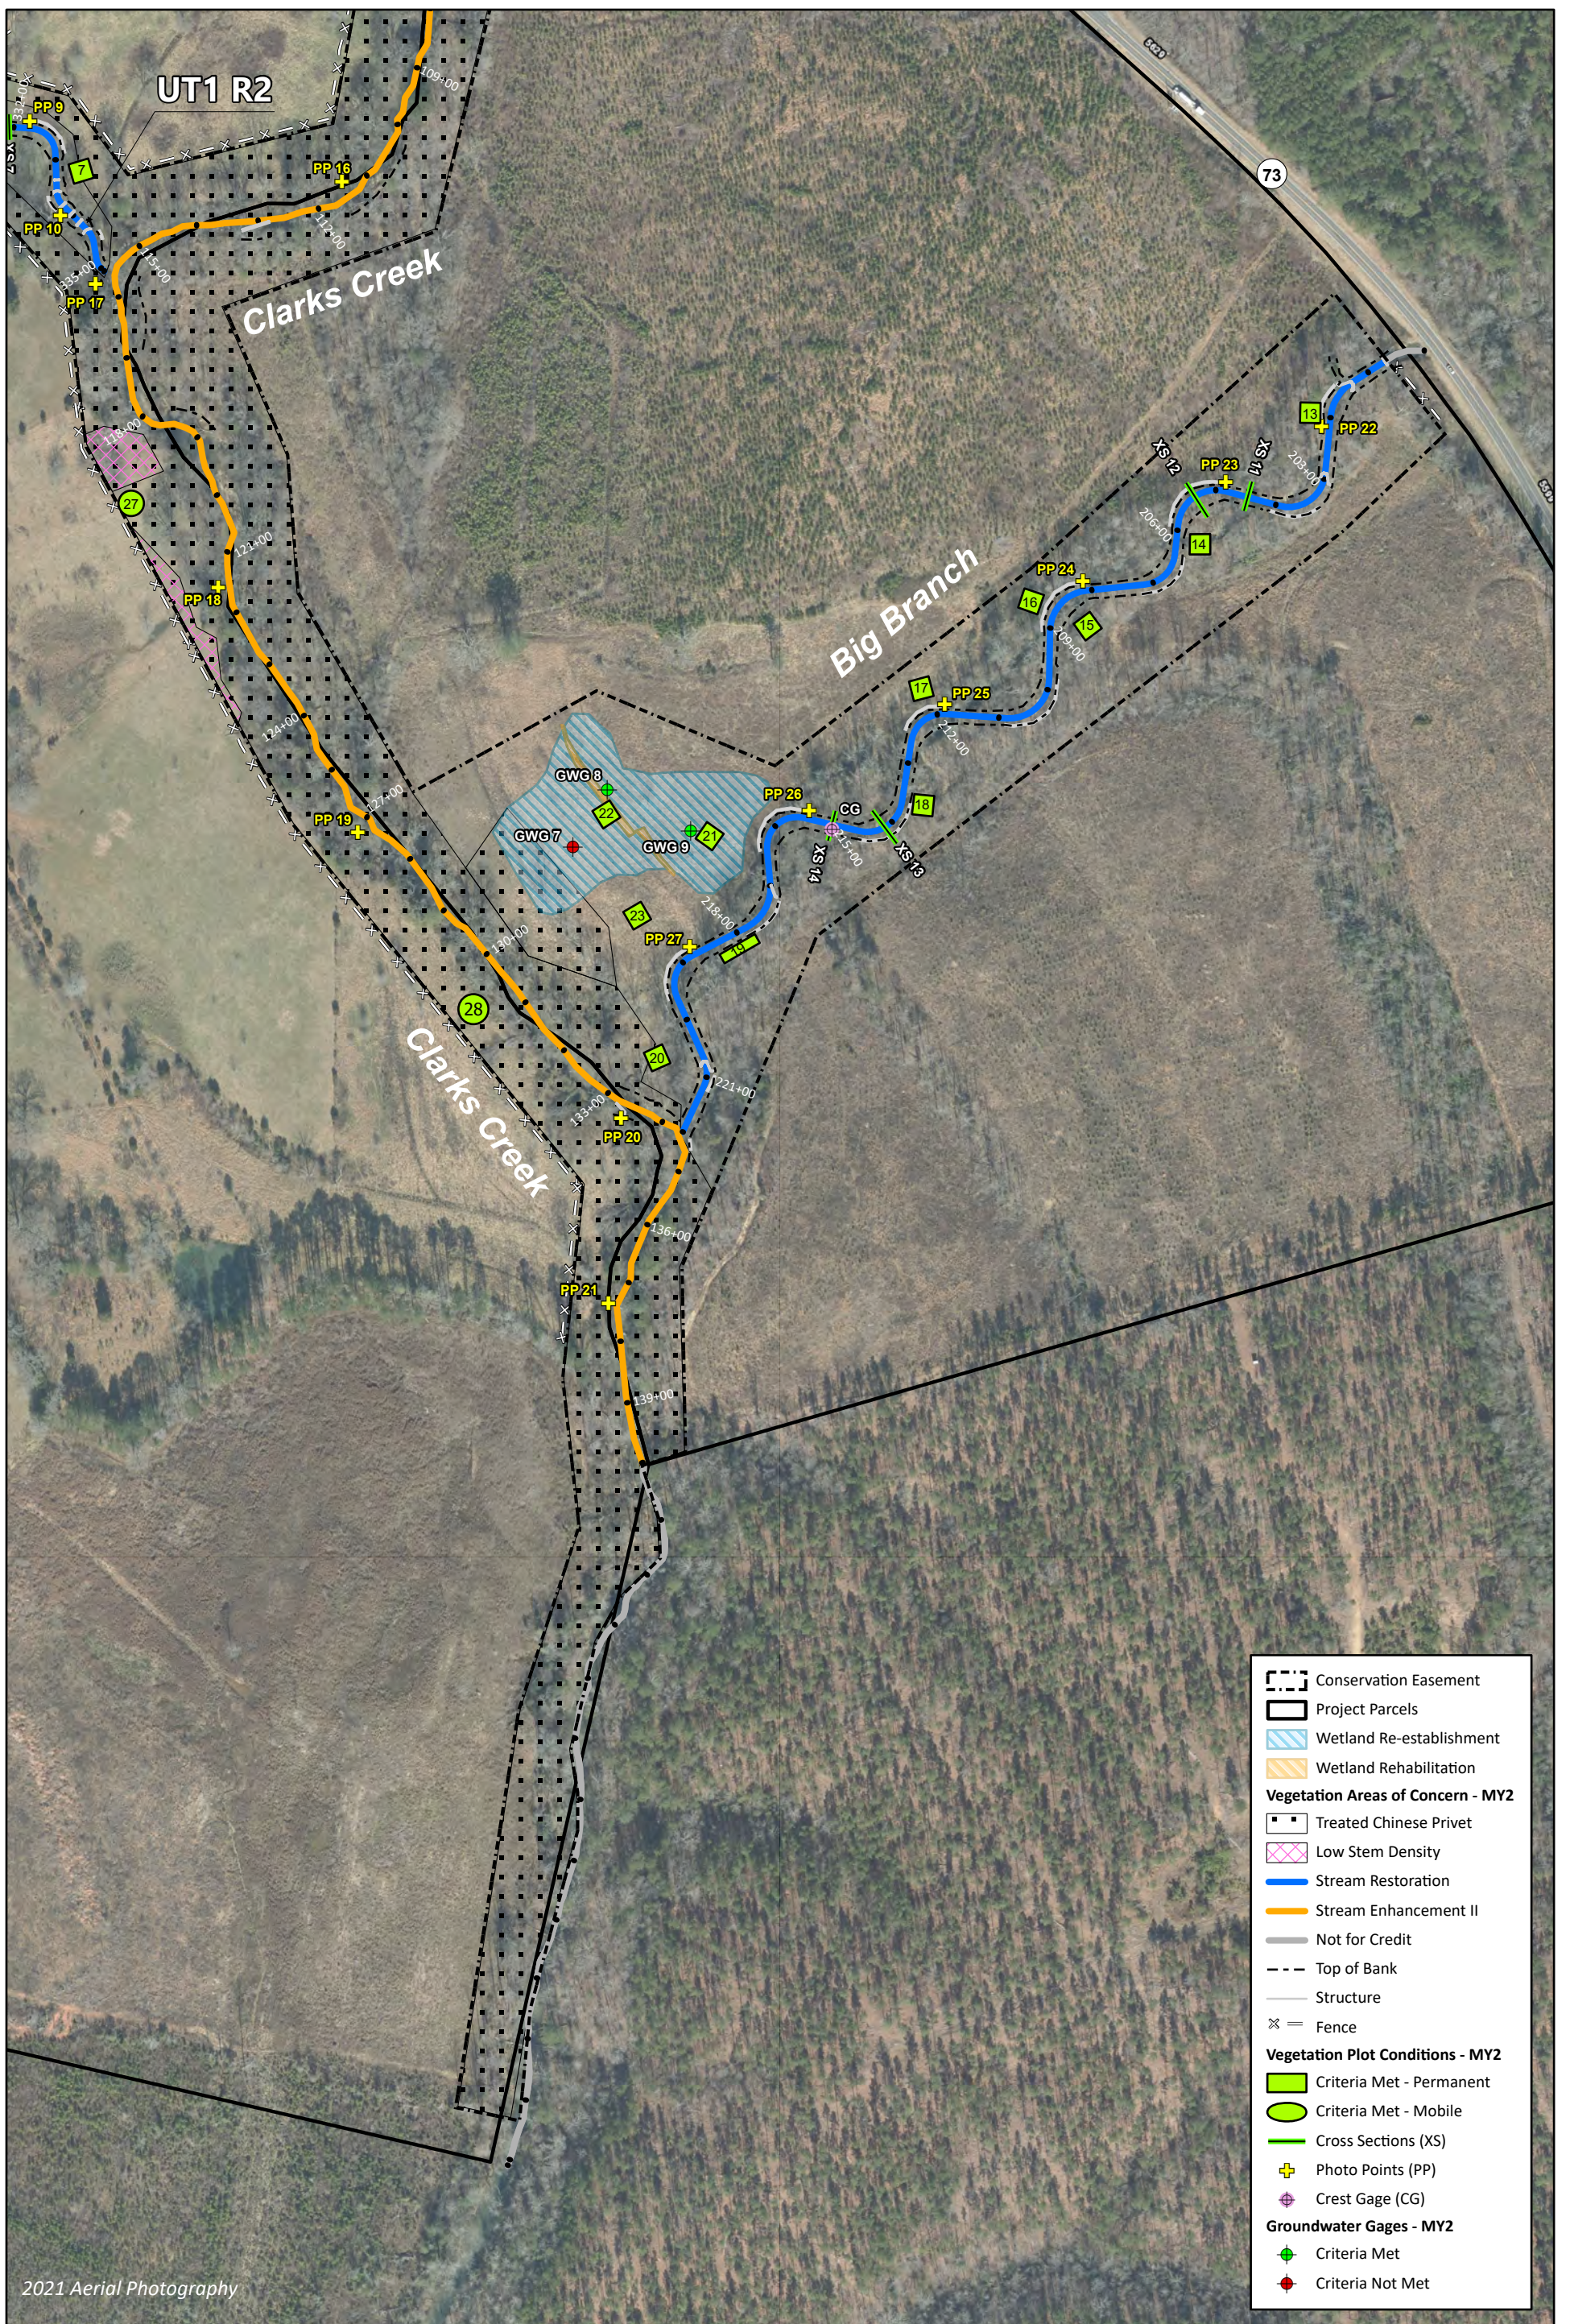
Figure 1b. Current Condition Plan View  
 Cross Creek Ranch Site  
 DMS Project No. 100138  
 Monitoring Year 2 - 2023  
 Montgomery County, NC

Low planted stem density areas have been observed on the upstream portion of UT3 and along Clarks Creek, equating to 0.7 acres in total. These areas will continue to be observed for new growth in MY3. Refer to Appendix A for the Vegetation Condition Assessment Table and Figures 1b-c for a mapped representation of low stem density areas on the Site.

During construction, dense areas of Chinese privet (*Ligustrum sinense*) along Clarks Creek were mechanically removed; thereby, greatly decreasing the privet population along Clarks Creek. In February 2023, a foliar chemical treatment was applied to privet populations along UT1. This treatment was deemed successful when observed in the fall of 2023. These areas will be re-evaluated and re-treated, if necessary. In addition, previously untreated areas of dense Chinese privet along UT3 are scheduled for treatment in early 2024. Due to the nature of treating dense tracts of Chinese privet or any invasive species, Wildlands recognizes that multiple treatments are typically needed throughout the monitoring period for effective invasive plant control. Refer to the Vegetation Condition Assessment Table in Appendix A for information on additional vegetative areas of concern and to Figures 1a-c for the treated and untreated areas of Chinese privet.
