# CROWNS WEST STREAM RESTORATION PROJECT

## ANNUAL MONITORING REPORT FOR 2007 (YEAR 1)

Contract Number D06003-2

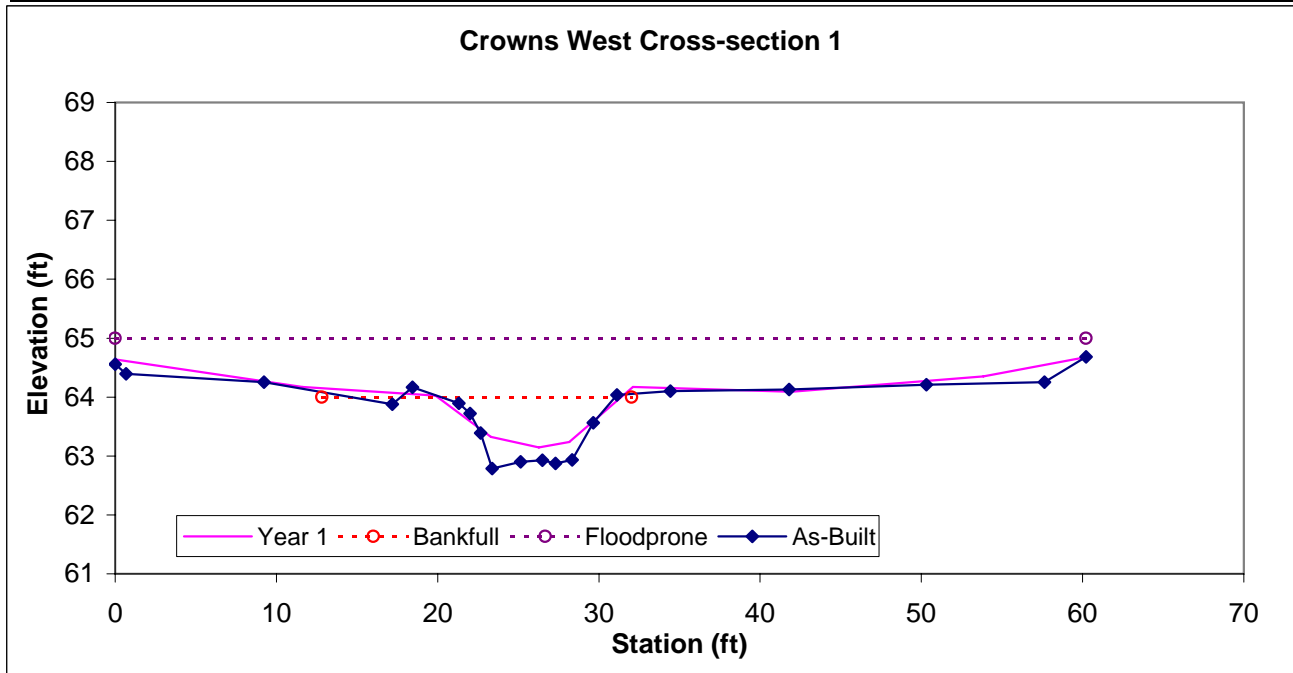
**Permanent Cross-section 1**  
(Year 1 Data - Collected Aug. 2007)

Feature	Stream Type	BKF Area	BKF Width	BKF Depth	Max BKF Depth	W/D	BH Ratio	ER	BKF Elev	TOB Elev
Riffle	Cc	8.4	19.2	0.44	1	44.11	0.9	3.1	64	63.88

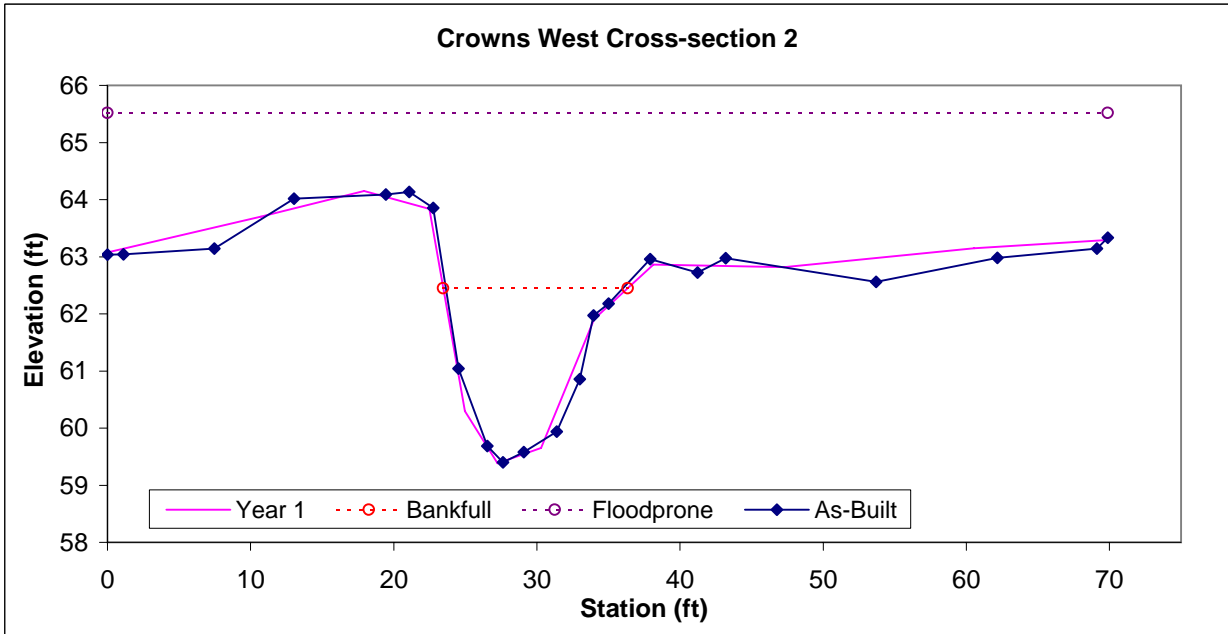
**Permanent Cross-section 2**  
(Year 1 Data - Collected Aug. 2007)

Cross-sections 2, 5, 6, and 9 are located across pools found at the apex of meander bends. Based on the cross-section data, none of these sections show the development of point bar features on the inside bank of the meander bend. Due to below average rainfall for 2007 the pools on the project site did not experience enough sustained water and flow in the channel to develop point bar features. Cross-section 2 did not experience significant change during Year 1. However, cross-sections 5 and 6 exhibited shallower pools, while cross-section 9 showed a deeper pool than was measured in the as-built condition.

Feature	Stream Type	BKF Area	BKF Width	BKF Depth	Max BKF Depth	W/D	BH Ratio	ER	BKF Elev	TOB Elev
Pool		23.3	12.88	1.81	3.07	7.11	1.1	5.4	62.45	62.86

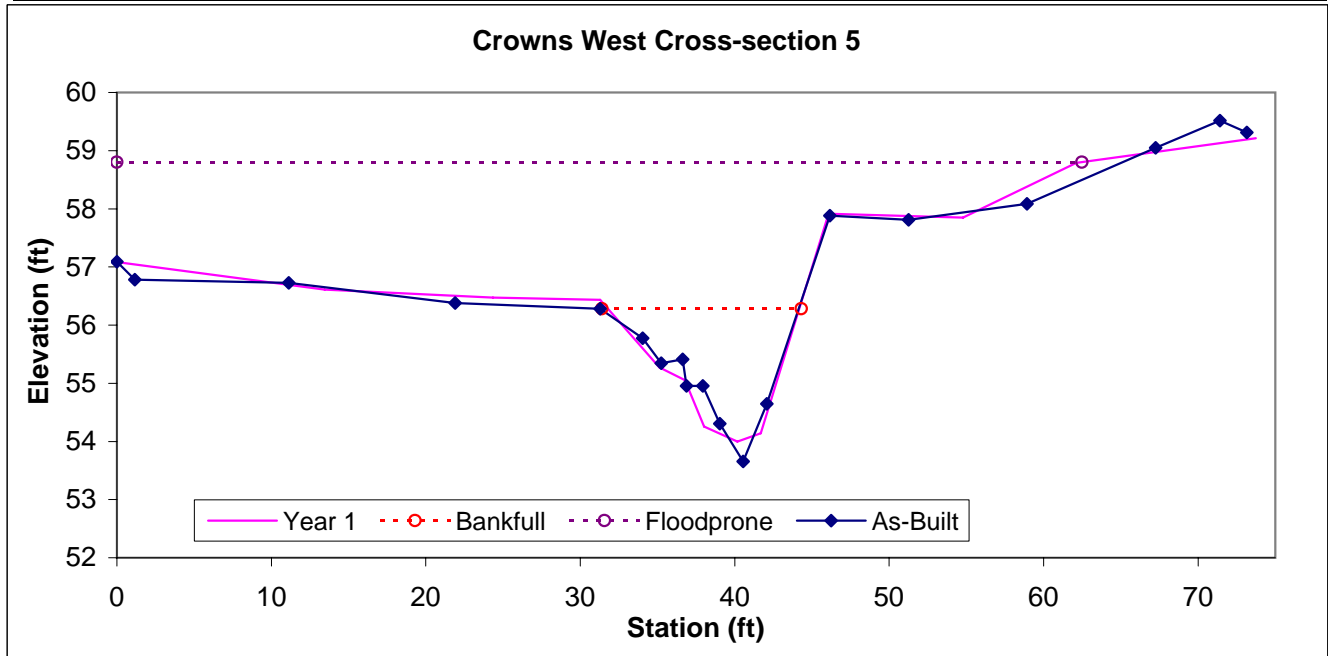
**Permanent Cross-section 5**  
(Year 1 Data - Collected Aug. 2007)

Feature	Stream Type	BKF Area	BKF Width	BKF Depth	Max BKF Depth	W/D	BH Ratio	ER	BKF Elev	TOB Elev
Pool		17.7	12.92	1.37	2.4	9.42	1	4.8	56.28	56.32

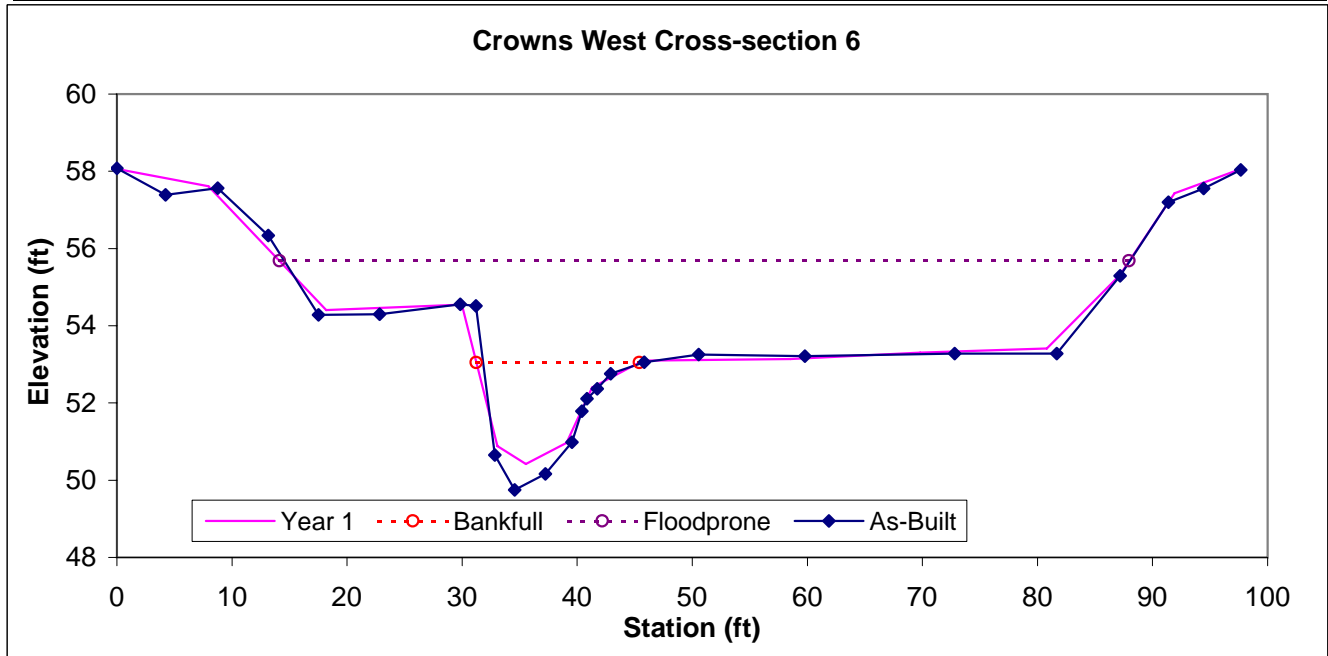
**Permanent Cross-section 6**  
 (Year 1 Data - Collected Aug. 2007)

Feature	Stream Type	BKF Area	BKF Width	BKF Depth	Max BKF Depth	W/D	BH Ratio	ER	BKF Elev	TOB Elev
Pool		20.6	14.17	1.45	2.63	9.75	1	5.2	53.05	53.1

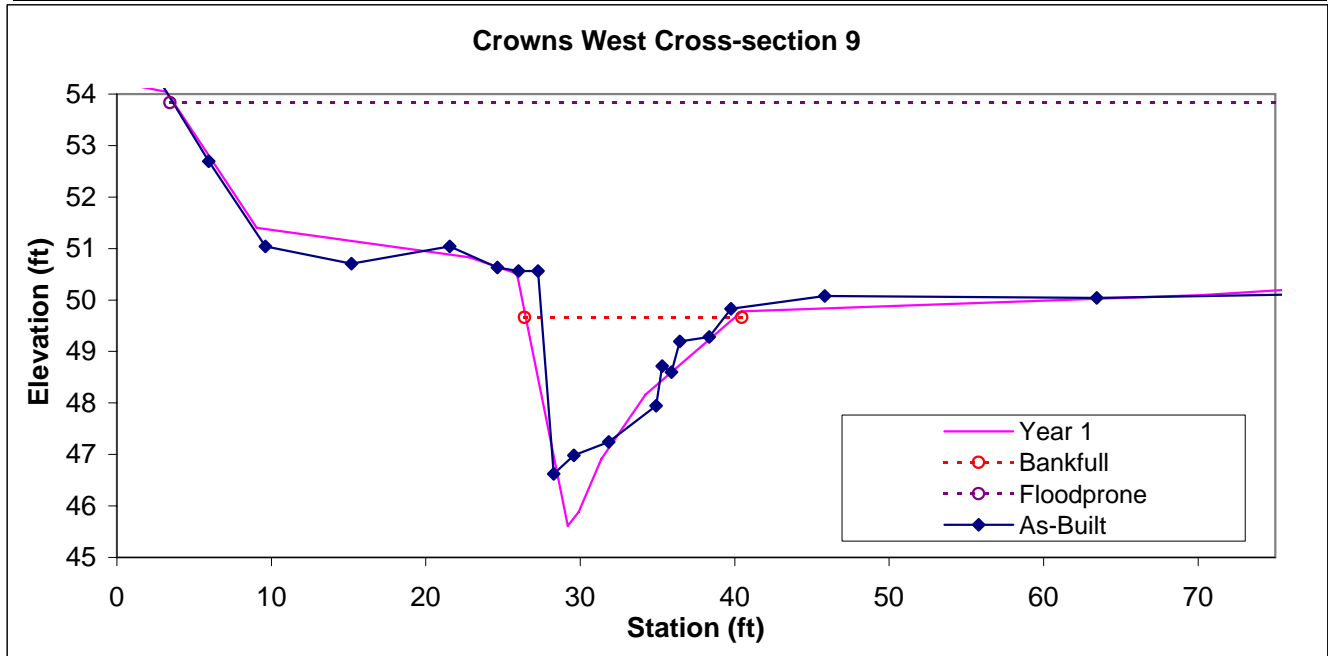
**Permanent Cross-section 9**  
(Year 1 Data - Collected Aug. 2007)

Feature	Stream Type	BKF Area	BKF Width	BKF Depth	Max BKF Depth	W/D	BH Ratio	ER	BKF Elev	TOB Elev
Pool		25.11	14.08	1.78	4.17	7.9	1	8.2	49.83	49.66

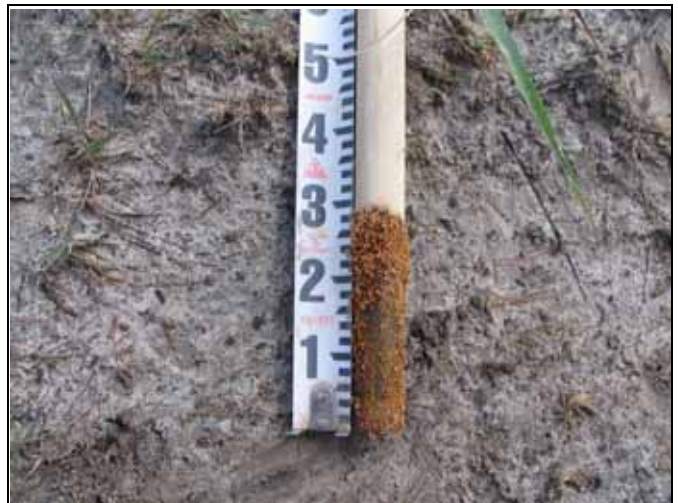
The on-site crest gauge documented the occurrence of at least one bankfull flow event during Year 1 of the post-construction monitoring period, as shown in Table 6. Inspection of conditions during a site visit revealed visual evidence of out-of-bank flow, confirming the crest gauge reading. The largest on-site stream flow documented by the crest gauge during Year 1 of monitoring was approximately 0.40 feet (4.8 inches) above the bankfull stage and was the result of overbank flooding of M2.

Crest gauge after bankfull event, 0.28 inches
