CROWNS WEST STREAM RESTORATION PROJECT

ANNUAL MONITORING REPORT FOR 2008 (YEAR 2)

Contract Number D06003-2

December 2008

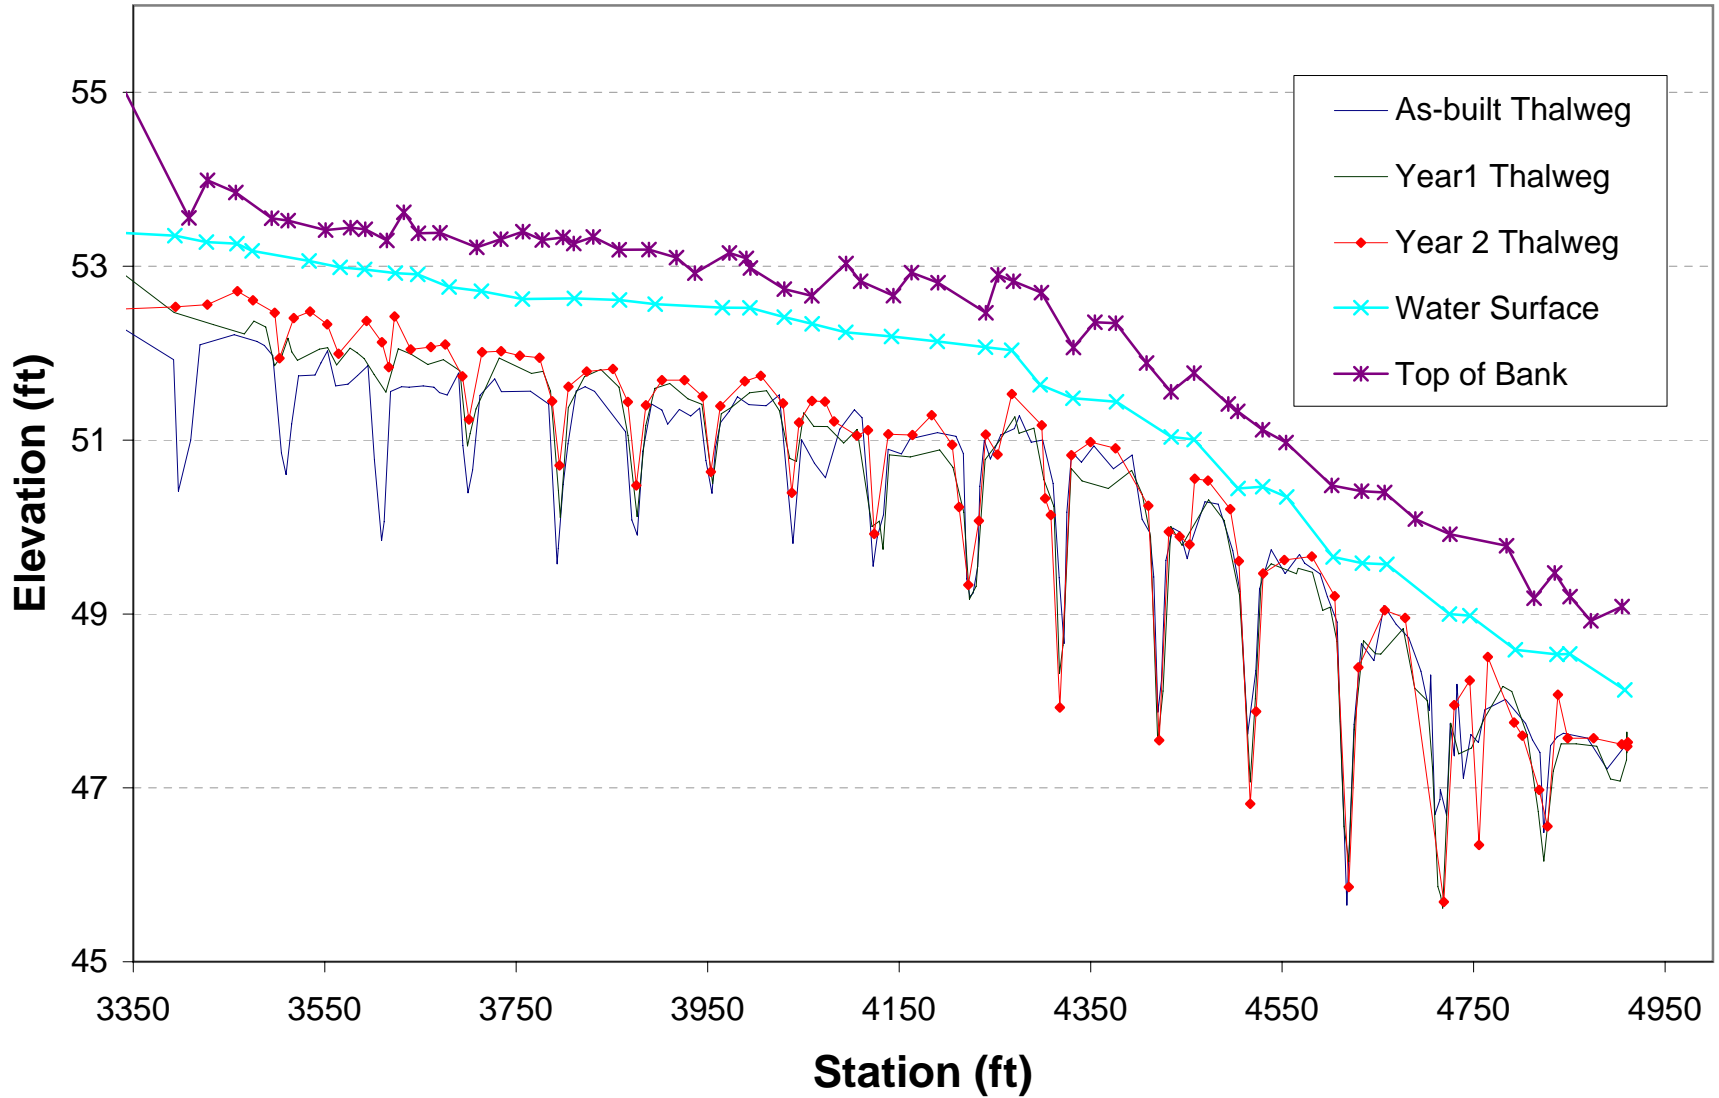
Crowns West Profile Station 33+50 to 50+00

The Year 2 profile for M2 shows that the riffles at the beginning of the reach, (stations 33+95 to 45+05) have slightly aggraded since Year 1. The aggradation in these riffle areas was found to be generally 0.1 – 0.3 feet in depth. The Year 2 profile for M2 shows that the pools between stations 33+95 to 38+75 have also aggraded slightly since Year 1. The maximum measurement recorded in the pool areas is 2 feet in depth. It is noted that this area of concern is downstream of the Haw Branch Road culvert. The longitudinal profile for reach M2 shows that the riffles and in-stream structures are stable on the downstream portion of the reach. The longitudinal profile for the upstream portion of reach M2 will be closely monitored during Year 3.

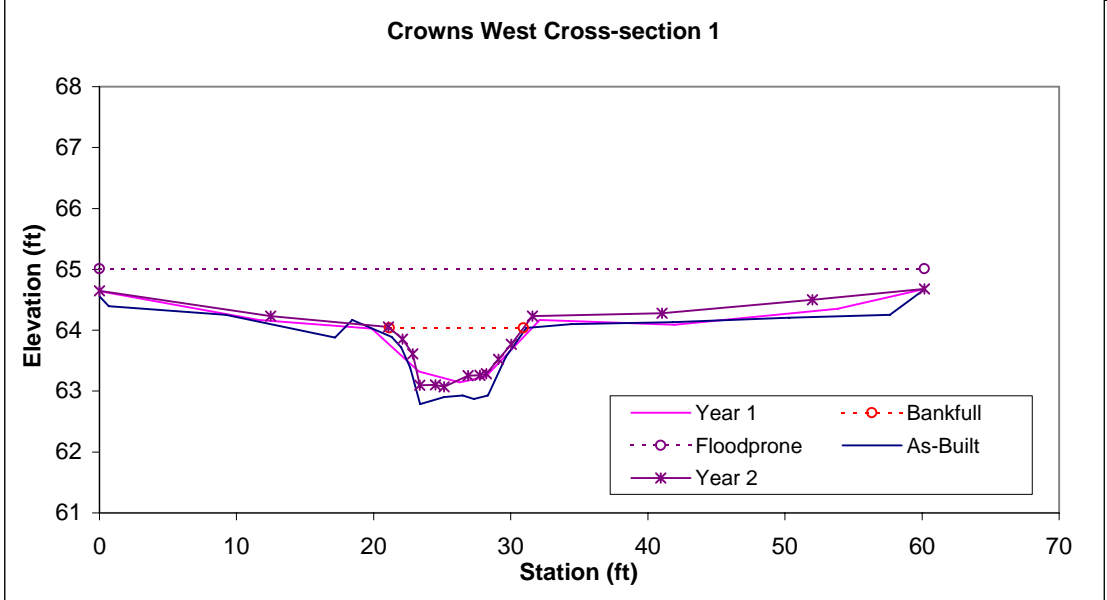
Permanent Cross-section 1
(Year 2 Data - Collected August 2008)

Cross-sections 1, 3, 4, 7 and 8 are located across riffles found between meander bends. Cross-section 1 has aggraded since the as-built survey, however, it has remained stable since monitoring during Year 1. The channels in cross-sections 3, 7 and 8 have remained relatively stable since the as-built survey. However, the floodplains of cross-sections 7 and 8 have experienced sediment deposition on the floodplain, composed mostly of fine sand. Visual on-site observations of areas east of Haw Branch Road have documented the deposition of sediment on the floodplain, which occurred during a large out-of-bank flow event during the year. This is considered to be a natural system response and no areas of concern have been noted due to the deposition.

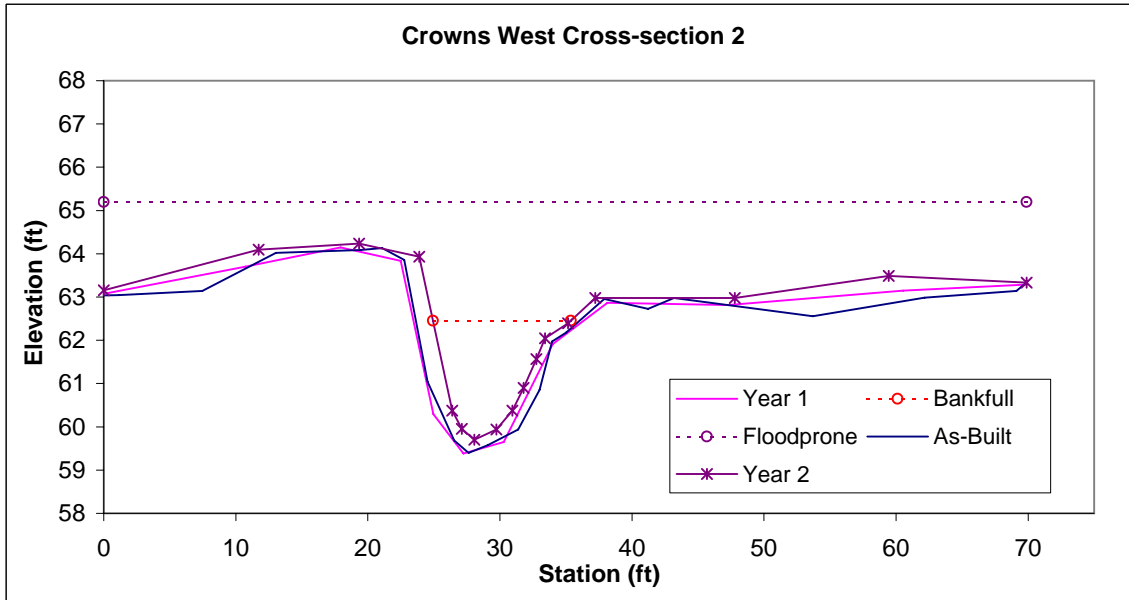
Permanent Cross-section 2
(Year 2 Data - Collected August 2008)

Cross-sections 2, 5, 6, and 9 are located across pools found at the apex of meander bends. Based on the cross-section data, the pools at cross-sections 2 and 6 have filled some since Year 1 monitoring. Cross-sections 5 and 9 have remained relatively stable since Year 1. The pool cross-sections are showing slow development of point bar features on the inside bank of the meander bends.

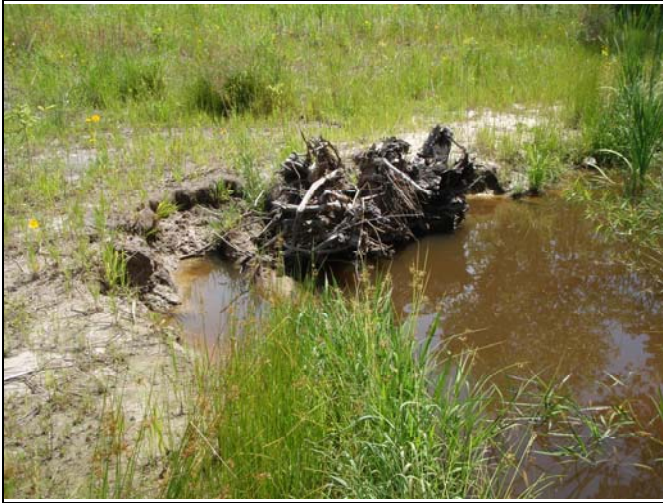
Problem Area 1, Station ~31+50

During Year 2 monitoring, the Site experienced several stream restoration-related problems. These problems were repaired in November 2008 and are currently functioning properly. The stream problem areas were located on reaches M1 and M2. All problem areas were located in pools where erosion occurred around root wads that were installed in sandy soils. The areas were repaired during November 2008 and will be monitored closely during the coming years.
