CROWNS WEST STREAM RESTORATION PROJECT

ANNUAL MONITORING REPORT FOR 2009 (YEAR 3)

Contract Number D06003-2

December 2009

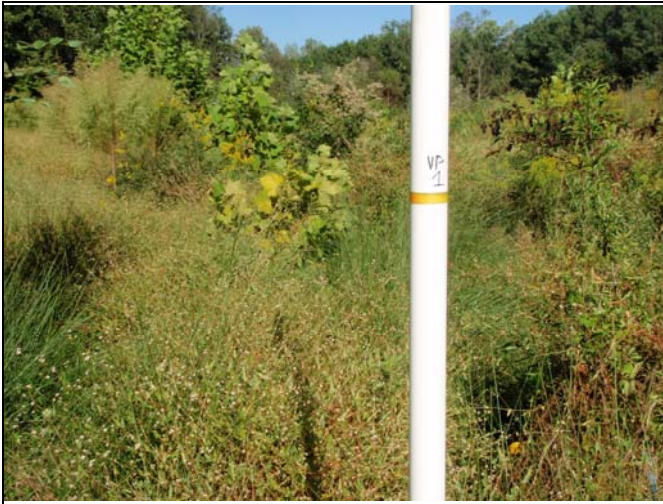
Vegetation Plot 1

During monitoring Year 3, vegetation plot 1 encountered two different problems that may threaten future survivability of the plot and the surrounding area. These problems are weedy species occurring within the vegetation plot and saturated soils due to beaver dams. The strong presence of arrowleaf tearthumb (*Polygonum sagittatum*) and an unknown vine species in this area is affecting the survivability of the smaller planted stems. Two beaver dams in the area have caused the soils to become saturated for an extended period, which has caused planted stems, mostly sycamores, to begin to lean. The beaver dams will be removed during the winter of 2009/2010.

Two beaver dams on the upstream portion of M1 have caused the soils to become saturated for an extended period, which has affected planted stems, mostly sycamores, to lean more than 45 degrees. The two dams are located between stations 10+00 and 13+00 and will be removed in the winter of 2009/2010.

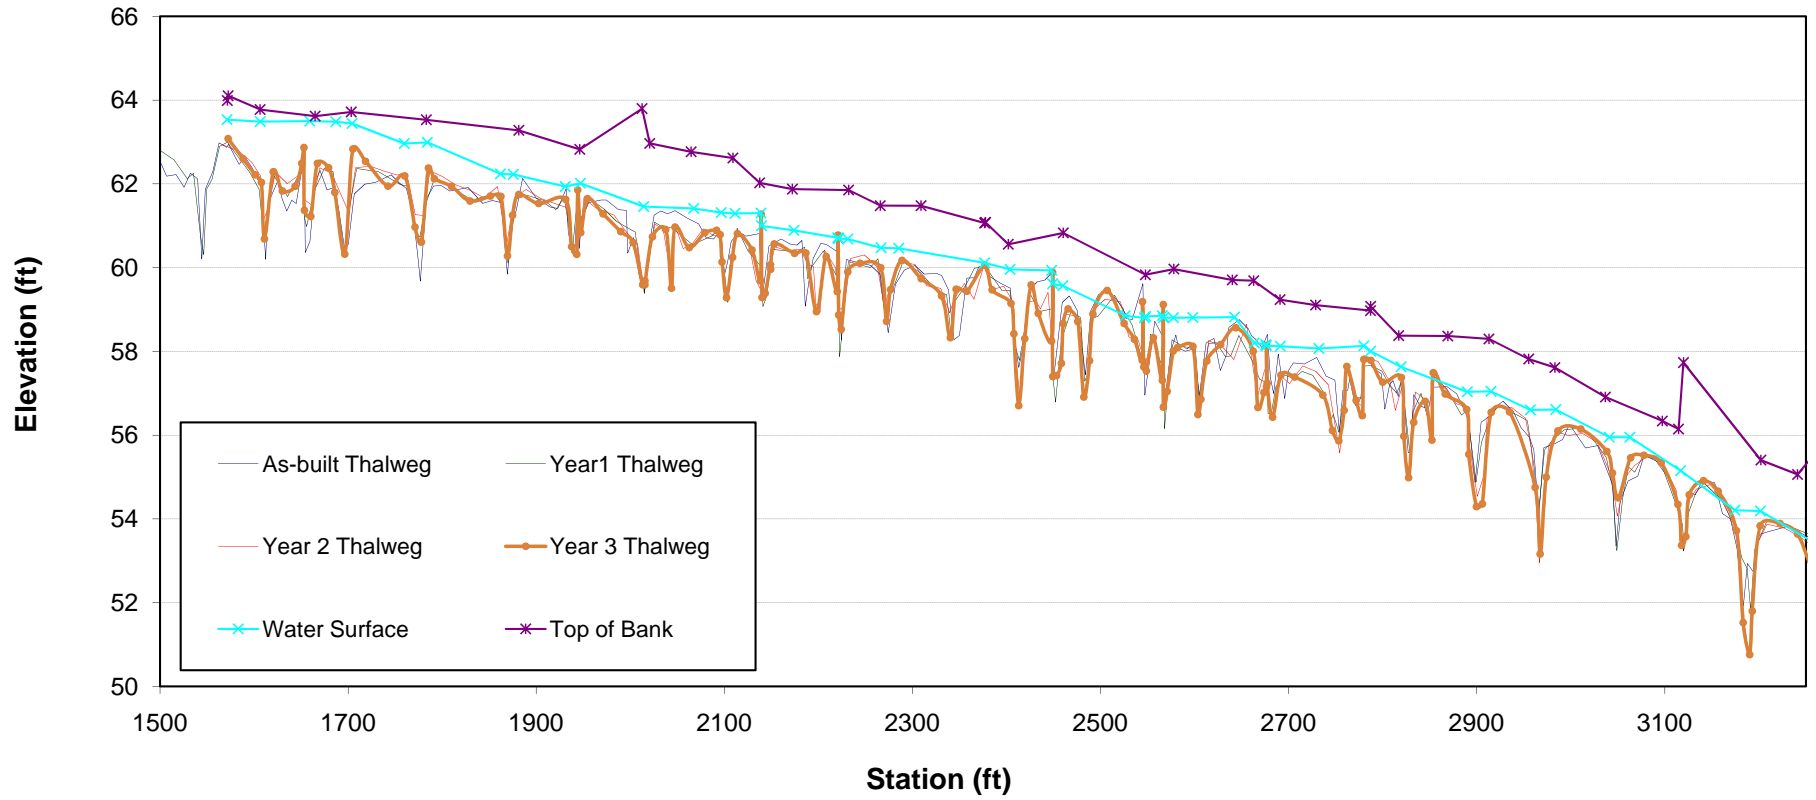
Crowns West Profile Station 15+00 to 32+50

The longitudinal profile for Year 3 was surveyed in August 2009 and was compared to data collected during the as-built condition survey, and Years 1 and 2 of monitoring. The results of the Year 3 longitudinal profile show that the pools and riffles in M1 have maintained elevations and pool depths, similar to those documented during the as-built survey, and Year 1 and Year 2 monitoring. The longitudinal profile shows that the riffles and in-stream structures throughout reach M1 are stable.

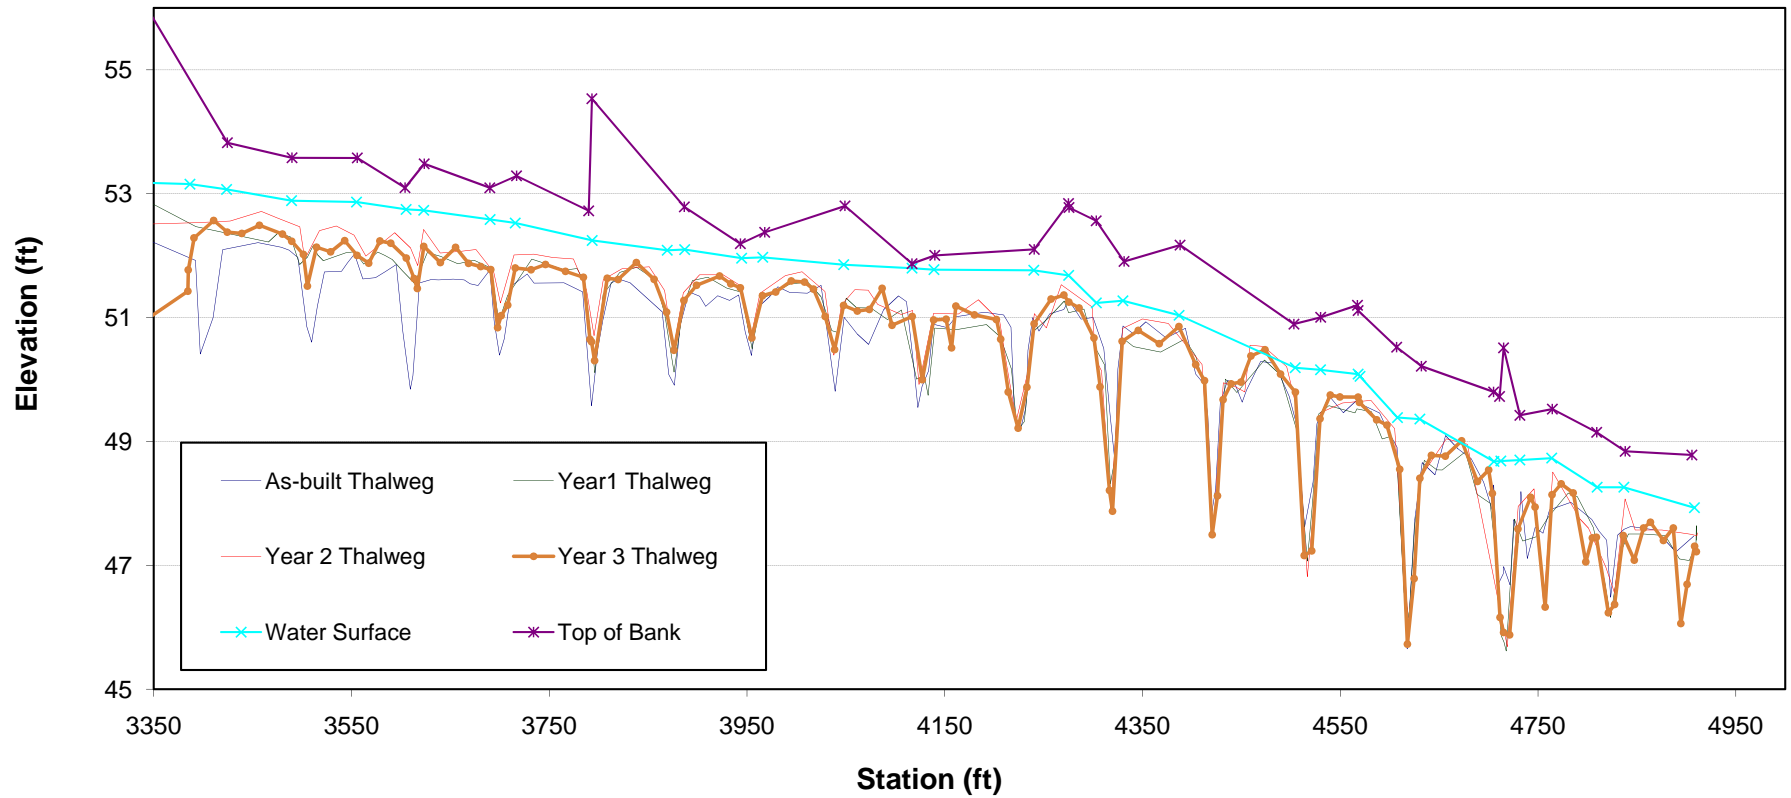
Crowns West Profile Station 33+50 to 50+00

The Year 3 profile for M2 shows that the riffles at the beginning of the reach, (stations 33+95 to 45+05) have aggraded slightly since as-built conditions, but are showing a tendency to aggrade in drier years (i.e. Year 2) and scour back out in wetter year (i.e. Year 3). This is considered to be a normal pattern of stream bed dynamics within sandbed streams. The Year 2 profile for M2 shows that the pools have remained deep since Year 1. The maximum depth measured in the M2 pool areas is approximately 3 feet in depth. The longitudinal profiles of reaches M1 and M2 are presented in Appendix B. The longitudinal profile for the Site shows that the riffles and in-stream structures are stable on the downstream portion of the reach

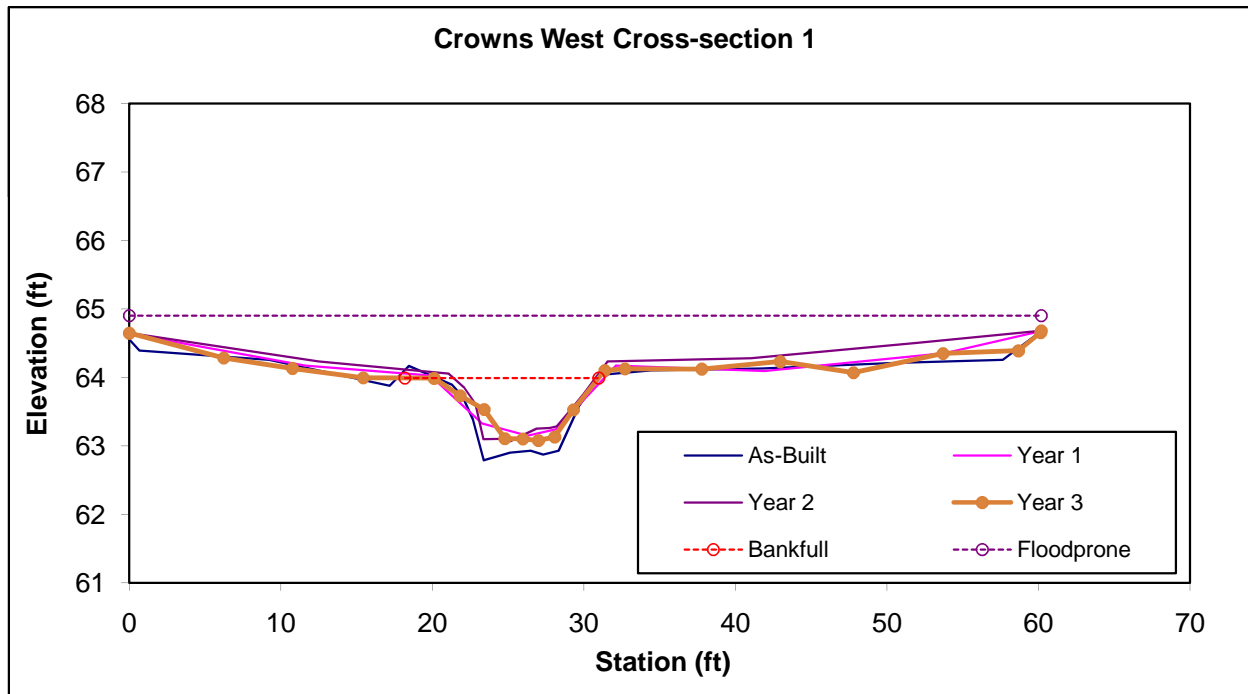
Permanent Cross-section 1
(Year 3 Data - Collected August 2009)

Cross-sections 1, 3, 4, 7 and 8 are located across riffles found between meander bends. Cross-section 1 has aggraded slightly since the as-built survey but has remained relatively stable through Year 3. The channels in cross-sections 3, 4, 7 and 8 have remained relatively stable since the as-built survey. The floodplains of cross-sections 7 and 8 remained stable through Year 3 monitoring. It is noted that Year 2 and Year 3 visual on-site observations of areas east of Haw Branch Road have documented the deposition of sediment on the floodplain. This is considered to be a natural system response and no areas of concern have been noted due to the deposition.

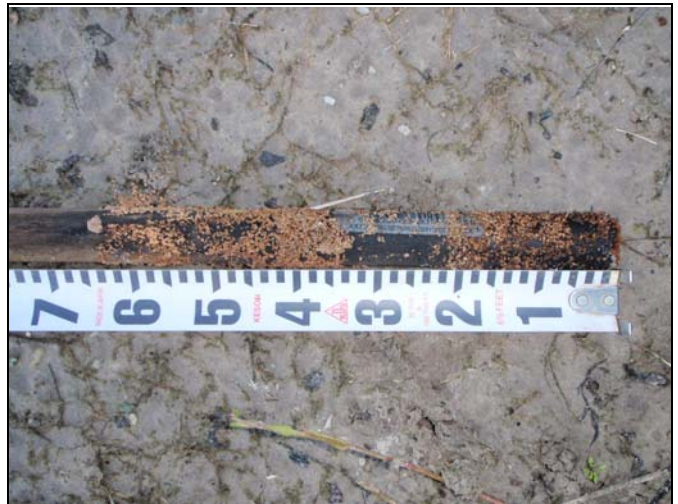
The on-site crest gauge documented the occurrence of at least three bankfull flow events during Year 3 of the post-construction monitoring period. Inspection of conditions during site visits revealed visual evidence of out-of-bank flows. The largest on-site stream flow documented by the crest gauge during Year 3 of monitoring was approximately 1.03 feet (12.36 inches) above the bankfull stage.

Crest Gauge after Bankfull – 0.63 feet

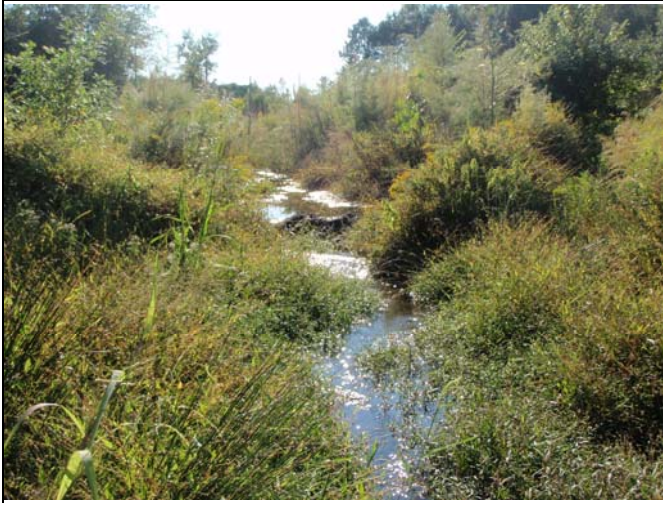
Beaver Dam above Photo Point 1

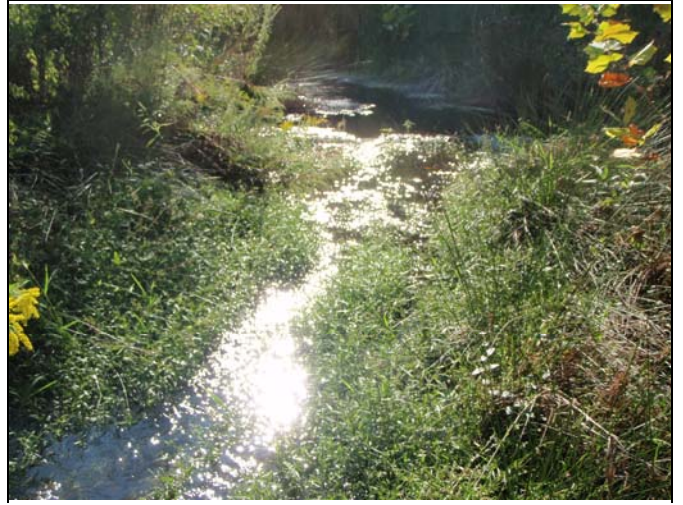
Beaver Dam below Photo Point 1
