CROWNS WEST STREAM RESTORATION PROJECT

ANNUAL MONITORING REPORT FOR 2010 (YEAR 4)

Contract Number D06003-2

December 2010

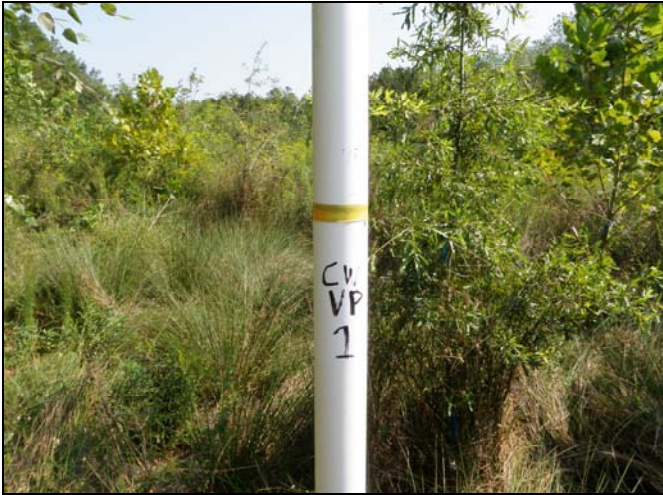
Vegetation Plot 1

During monitoring Year 3, two problems were observed in vegetation plot 1 that threatened survivability of the plot. These problems were weedy species occurring within the vegetation plot and saturated soils due to beaver dams. The strong presence of arrowleaf tearthumb (*Polygonum sagittatum*) and an unknown vine species in this area was affecting the survivability of the smaller planted stems. Another problem in this area was the presence of two beaver dams that had caused the soils to become saturated for extended periods. This had caused planted stems, mostly sycamores, to become unstable. These trees were observed to be leaning following Year 3 monitoring.

The beaver dams observed in the vegetation plot 1 area were scheduled to be removed in the winter of 2009/2010. Dwayne Huneycutt of Baker met with Mark Batchlor of the United States Department of Agriculture (USDA) on the Site in February 2010. It was noted during the site visit, that the beaver dams observed in the fall of 2009 were not present within the conservation easement. According to Mr. Batchlor of the USDA, it is likely that the beaver have moved off-site. No beaver dams or visible beaver activity were noted in September 2010. This upstream portion of the Site will be closely observed for future beaver activity during Year 5 of monitoring.

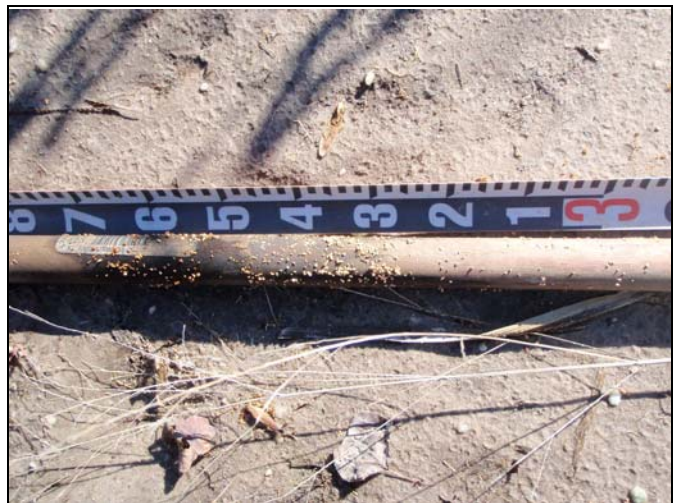
The on-site crest gauge documented the occurrence of at least two bankfull flow events during Year 4 of the post-construction monitoring period, as shown in Table 6. Inspection of conditions during site visits revealed visual evidence of out-of-bank flow, confirming the crest gauge readings. The highest on-site stream flow documented by the crest gauge during Year 4 of monitoring was approximately 3.72 feet (44.64 inches) above the bankfull stage and was the result of overbank flooding of M2. Photographs documenting bankfull evidence observed during Year 4 are presented in Appendix B.

Crest Gauge after Bankfull - 3.72 feet

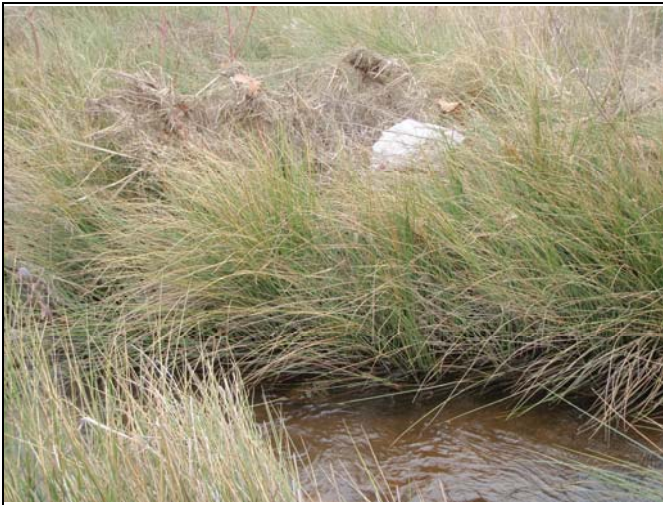
Bankfull evidence noted on stream bank
February 9, 2010

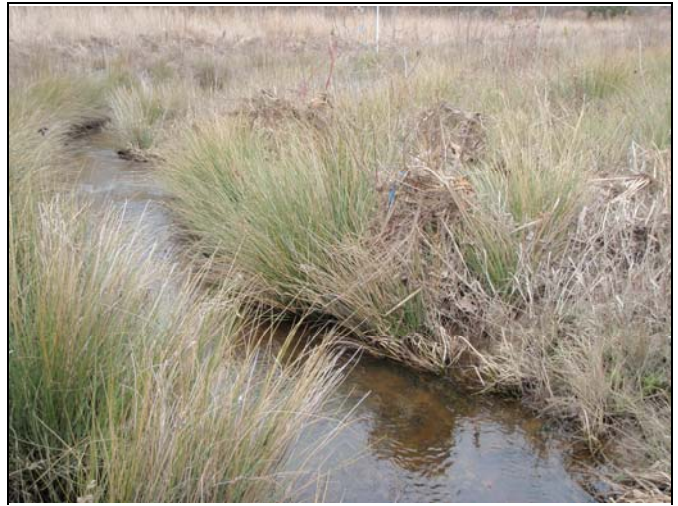
Bankfull evidence noted on stream bank
February 9, 2010
