CROWNS WEST STREAM RESTORATION PROJECT

ANNUAL MONITORING REPORT FOR 2011 (YEAR 5)

Contract Number D06003-2

December 2011

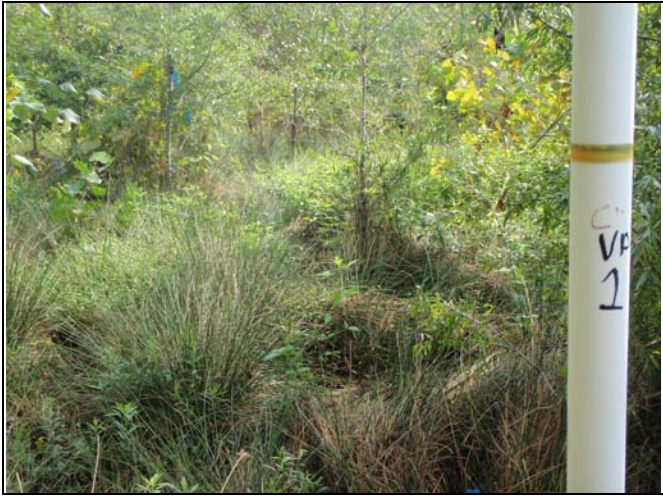
During monitoring Year 3, two vegetative problems were observed in Vegetation Plot 1 that threatened survivability of the plot. These problems were weedy species occurring within the vegetation plot and saturated soils due to nearby beaver dams. The strong presence of arrowleaf tearthumb (*Polygonum sagittatum*) and an unknown vine species in this area were affecting the survivability of the smaller planted stems. Another issue in this area was the presence of two nearby beaver dams that had caused the soils to become saturated for extended periods. This had caused planted stems, mostly sycamores, to become unstable. These trees were observed to be leaning following Year 3 monitoring at approximately 45 degrees.

Following Year 5 monitoring, this upstream portion of the Site was fairly dry and no beaver activity was observed in the area. The soils in the vicinity of vegetation plot 1 are no longer saturated since the beaver activity has ceased, and the planted stems were observed to be thriving and no additional stems were found to be leaning.

The beaver dams observed in the Vegetation Plot 1 area were scheduled to be removed in the winter of 2009/2010. Dwayne Huneycutt of Baker Engineering met with Mark Batchlor, a representative with the United States Department of Agriculture (USDA), on the Site in February 2010. Mr. Huneycutt and Mr. Batchlor noted during this site visit, that the beaver dams observed in the fall of 2009 were not active and were breached and/or destroyed. According to Mr. Batchlor, it was likely that the beaver had moved off-site. No beaver dams or visible beaver activity were noted in September 2010 or September 2011.

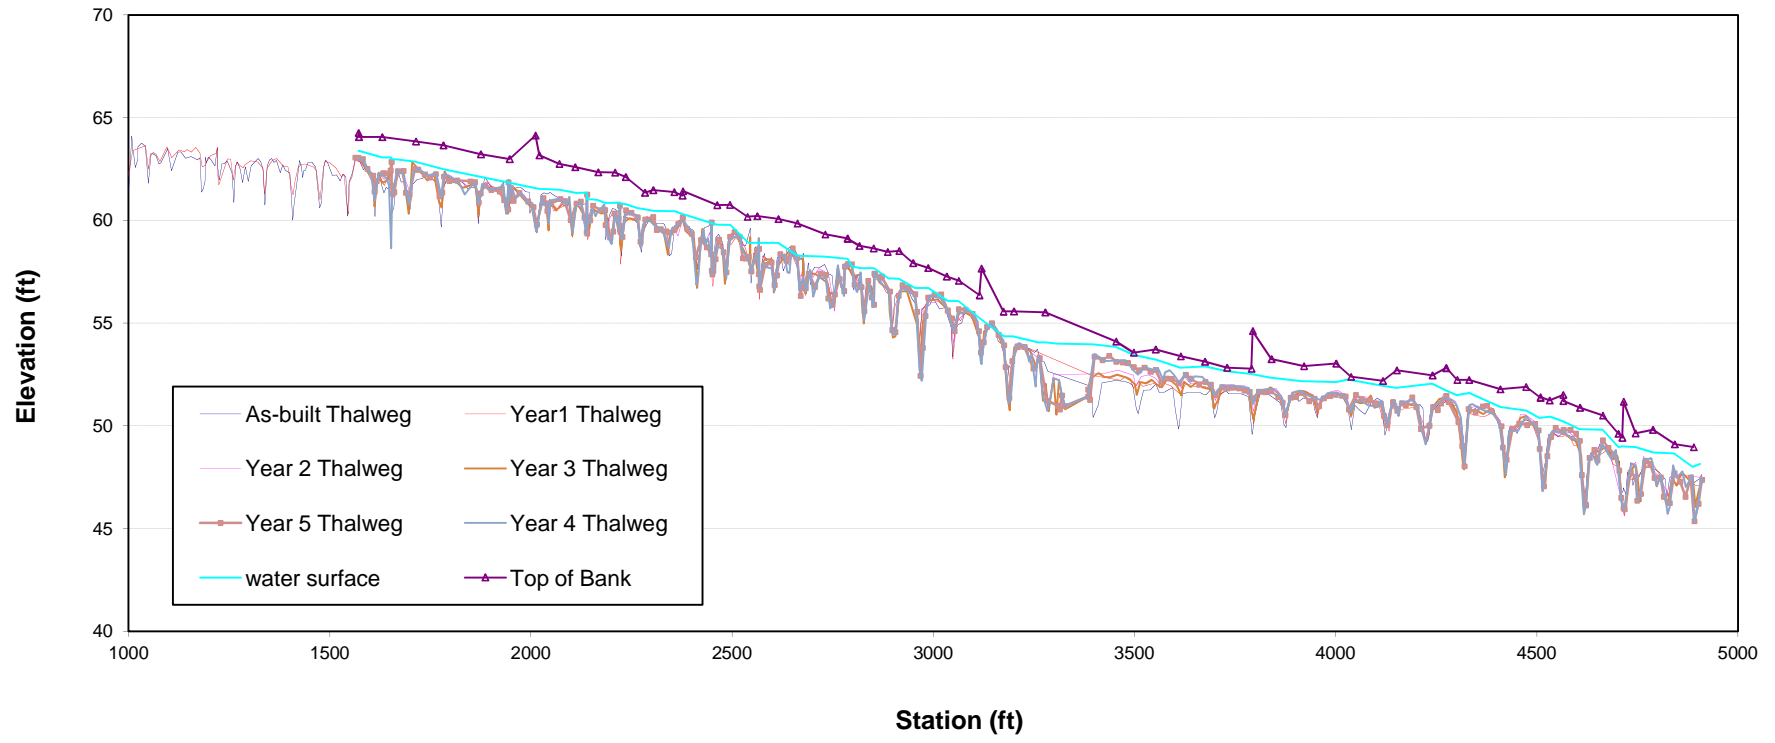
Crowns West Profile Station 10+00 to 45+00

The longitudinal profiles of reaches M1 and M2 are presented in Appendix B and Table B.3. The longitudinal profile for Year 5 was surveyed in November 2011 and was compared to data collected during the as-built condition survey, and Years 1, 2, 3 and 4 of monitoring. The results of the Year 5 longitudinal profile show that the pools and riffles in M1 have maintained elevations and pool depths, similar to those documented

The Year 5 profile for M2 shows that the riffles and pools at the beginning of the reach, (stations 33+95 to 42+50) have aggraded slightly since as-built conditions. This section of M2 is showing a tendency to aggrade in drier years (Year 2 and 4) and scour in wetter years (Year 3 and 5). This is considered to be a normal pattern of stream bed dynamics within sandbed streams.

Overall, the Year 5 longitudinal profile shows that there have been some minor adjustments to the stream profile since construction and as-built conditions. These adjustments within the channel are noted to be progressing towards a more stable condition. However, the channel is stable and functioning as designed.

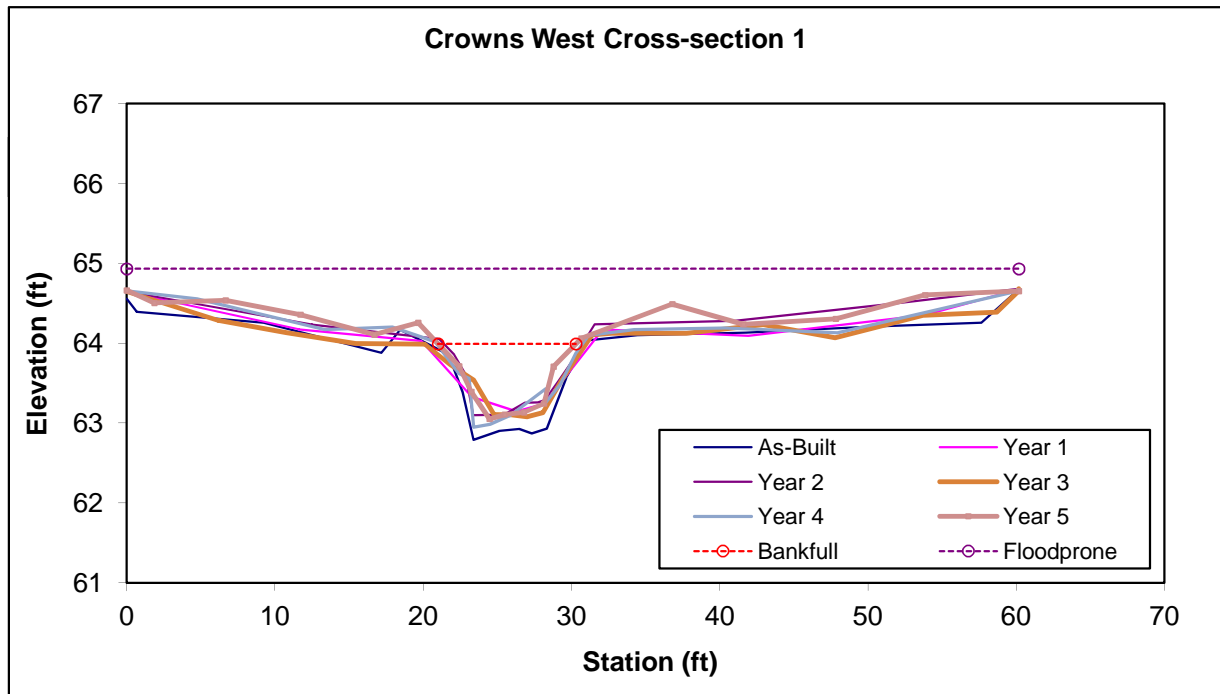
Permanent Cross-section 1
(Year 5 Data - Collected November 2011)

Cross-sections 1, 3, 4, 7 and 8 are located across riffles found between meander bends. Cross-section 1 has aggraded slightly since the as-built survey but has remained relatively stable throughout the five-year monitoring period. Stream dimension in cross-sections 3, 4, 7 and 8 have remained relatively stable since as-built conditions. The floodplains of cross-sections 7 and 8 on the downstream portion of the Site have remained stable through Year 5 monitoring. It was noted during Years 2 and 3 that visual on-site observations of areas on reach M2 documented deposition of sediment on the floodplain. This is considered to be a natural system response and no significant areas of concern have been noted due to this deposition.

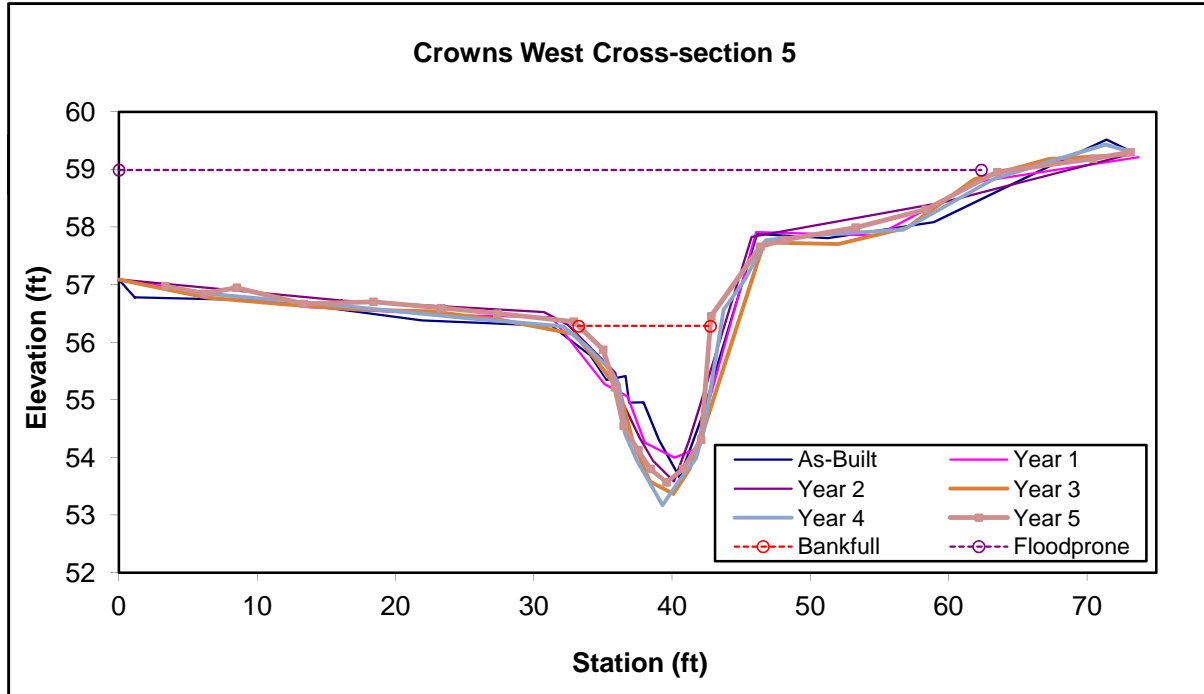
Permanent Cross-section 5
(Year 5 Data - Collected November 2011)

Cross-sections 2, 5, 6, and 9 are located across pools found at the apex of meander bends. Based on the cross-sectional data, the pool at cross-section 6 has filled slightly since Year 1 monitoring, but has remained relatively stable through Years 2, 3, 4 and 5. It was noted during Year 4, that cross-sections 2, 5 and 9 have remained at or below the as-built thalweg elevations in the maximum pool depths. All pools are remaining deep and are stable.

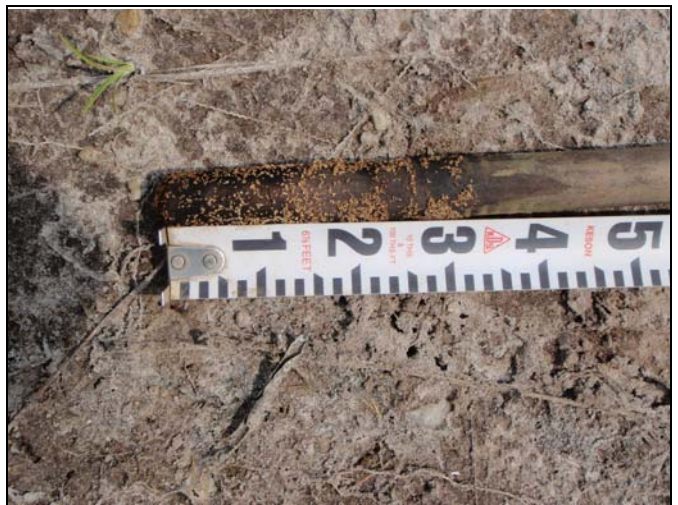
The crest gauge on the Site has documented at least one bankfull event per year during Year 5 of the post-construction monitoring period, as shown in Table 6 and Table 7. Inspection of conditions during site visits revealed visual evidence of out-of-bank flow, confirming the crest gauge readings. The highest on-site stream flow documented by the crest gauge during Year 5 of monitoring was approximately 0.67 feet above the bankfull stage and was the result of overbank flooding of M2. Photographs documenting bankfull evidence observed during Year 5 are presented in Appendix B.

Crest Gauge after Bankfull – 0.31 feet. Bankfull event occurred on or about May 14, 2011
