**CUTAWHISKIE CREEK STREAM AND WETLAND RESTORATION SITE  
2012 ANNUAL MONITORING REPORT (YEAR 5)**

**HERTFORD COUNTY, NORTH CAROLINA  
NCEEP CONTRACT NO. D06066-A (IMS NO. 92547)**

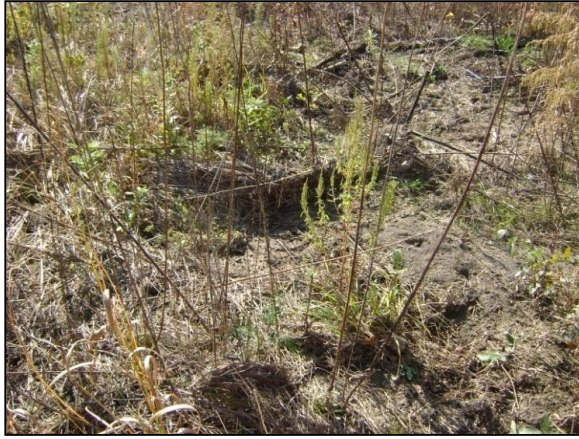
Photo 1. Floodplain wrack line

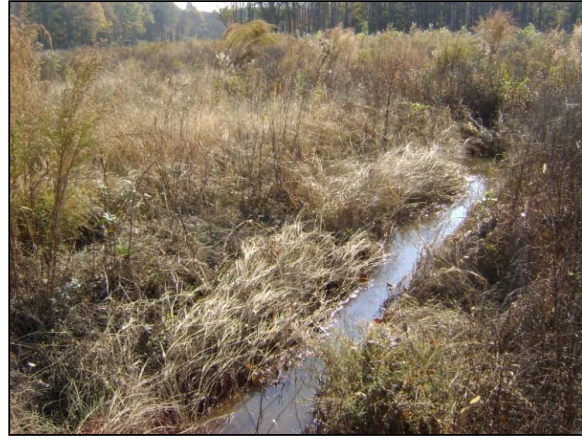
Photo 2. Water in channel near bankfull. Streamside vegetation matted down along the banks.

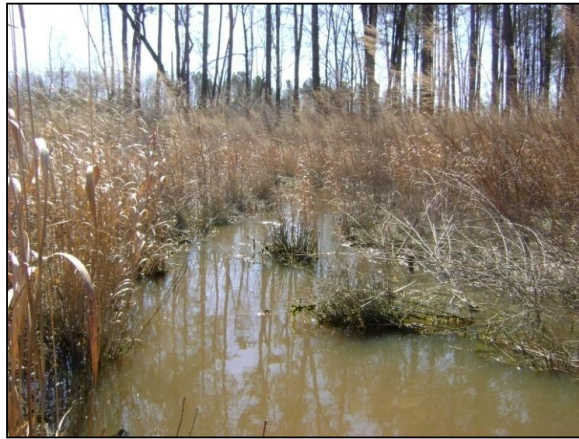
Photo 1. UT to Cutawhiskie Creek following a bankfull event. Water still persists above the top of bank and on the floodplain.

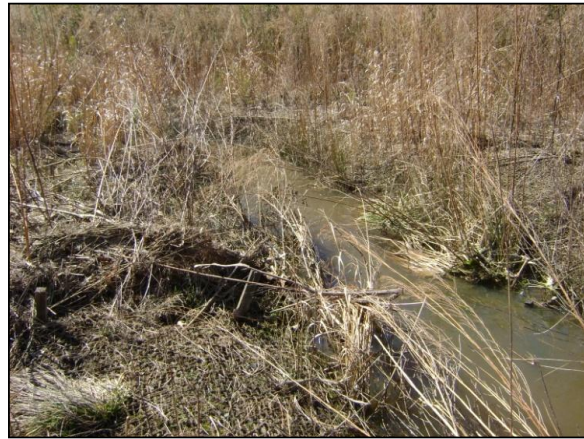
Photo 2. Floodplain wrack line.

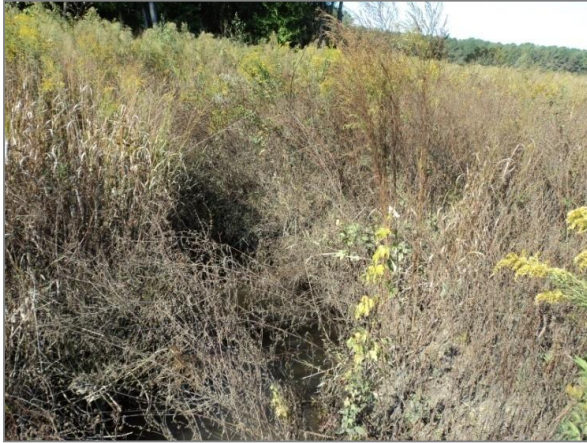
Photo 3. Hurricane Nicole produced 8-10 inches of rain over the region during an 8 hour period. Evidence of a large bankfull event was seen while checking monitoring gauges. Herbaceous vegetation adjacent to the channel showed signs of being matted down from water flow. Wrack lines were found pressed against erosion matting stakes and woody vegetation.

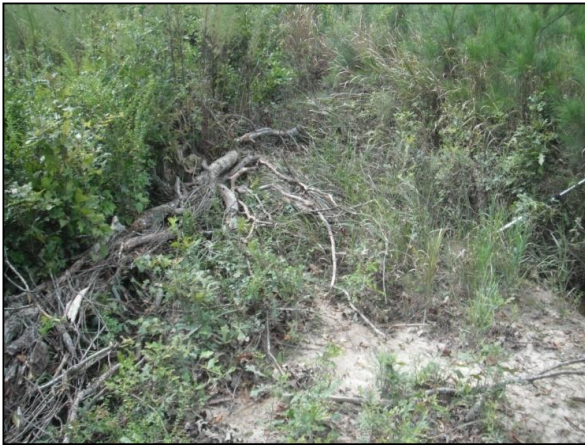
Photo 1. Hurricane Irene produced 5-7 inches of rain over the region during a 24 hour period. Evidence of a large bankfull event was seen while checking monitoring gauges. Herbaceous vegetation adjacent to the channel showed signs of being matted down from water flow. Wrack lines were found pressed against erosion matting stakes and woody vegetation.

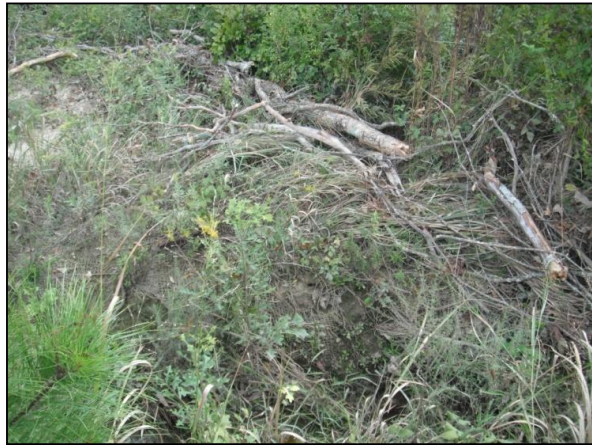
Photo 2. Floodplain wrack line looking from across channel.

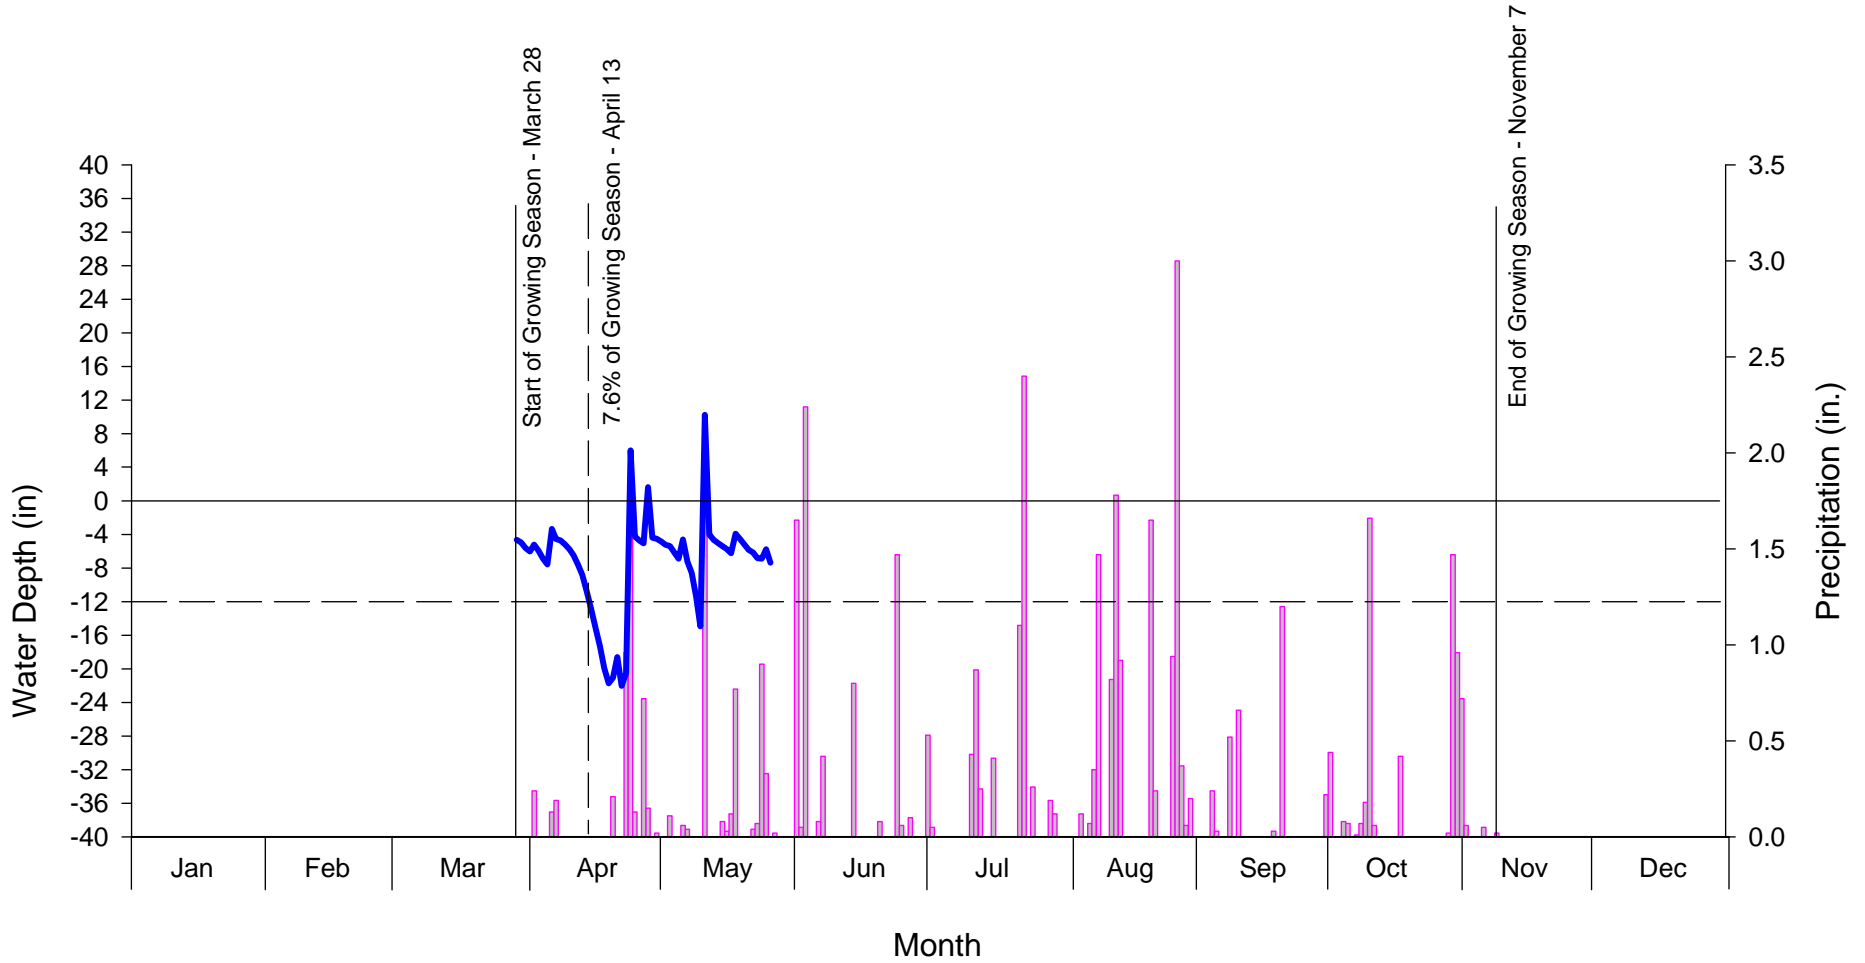
# Cutawhiskie Creek Year-5 Monitoring - 2012 Monitoring Gauge 2: N47BAB81

Note:  
Data missing after May 25 due to gauge malfunction.

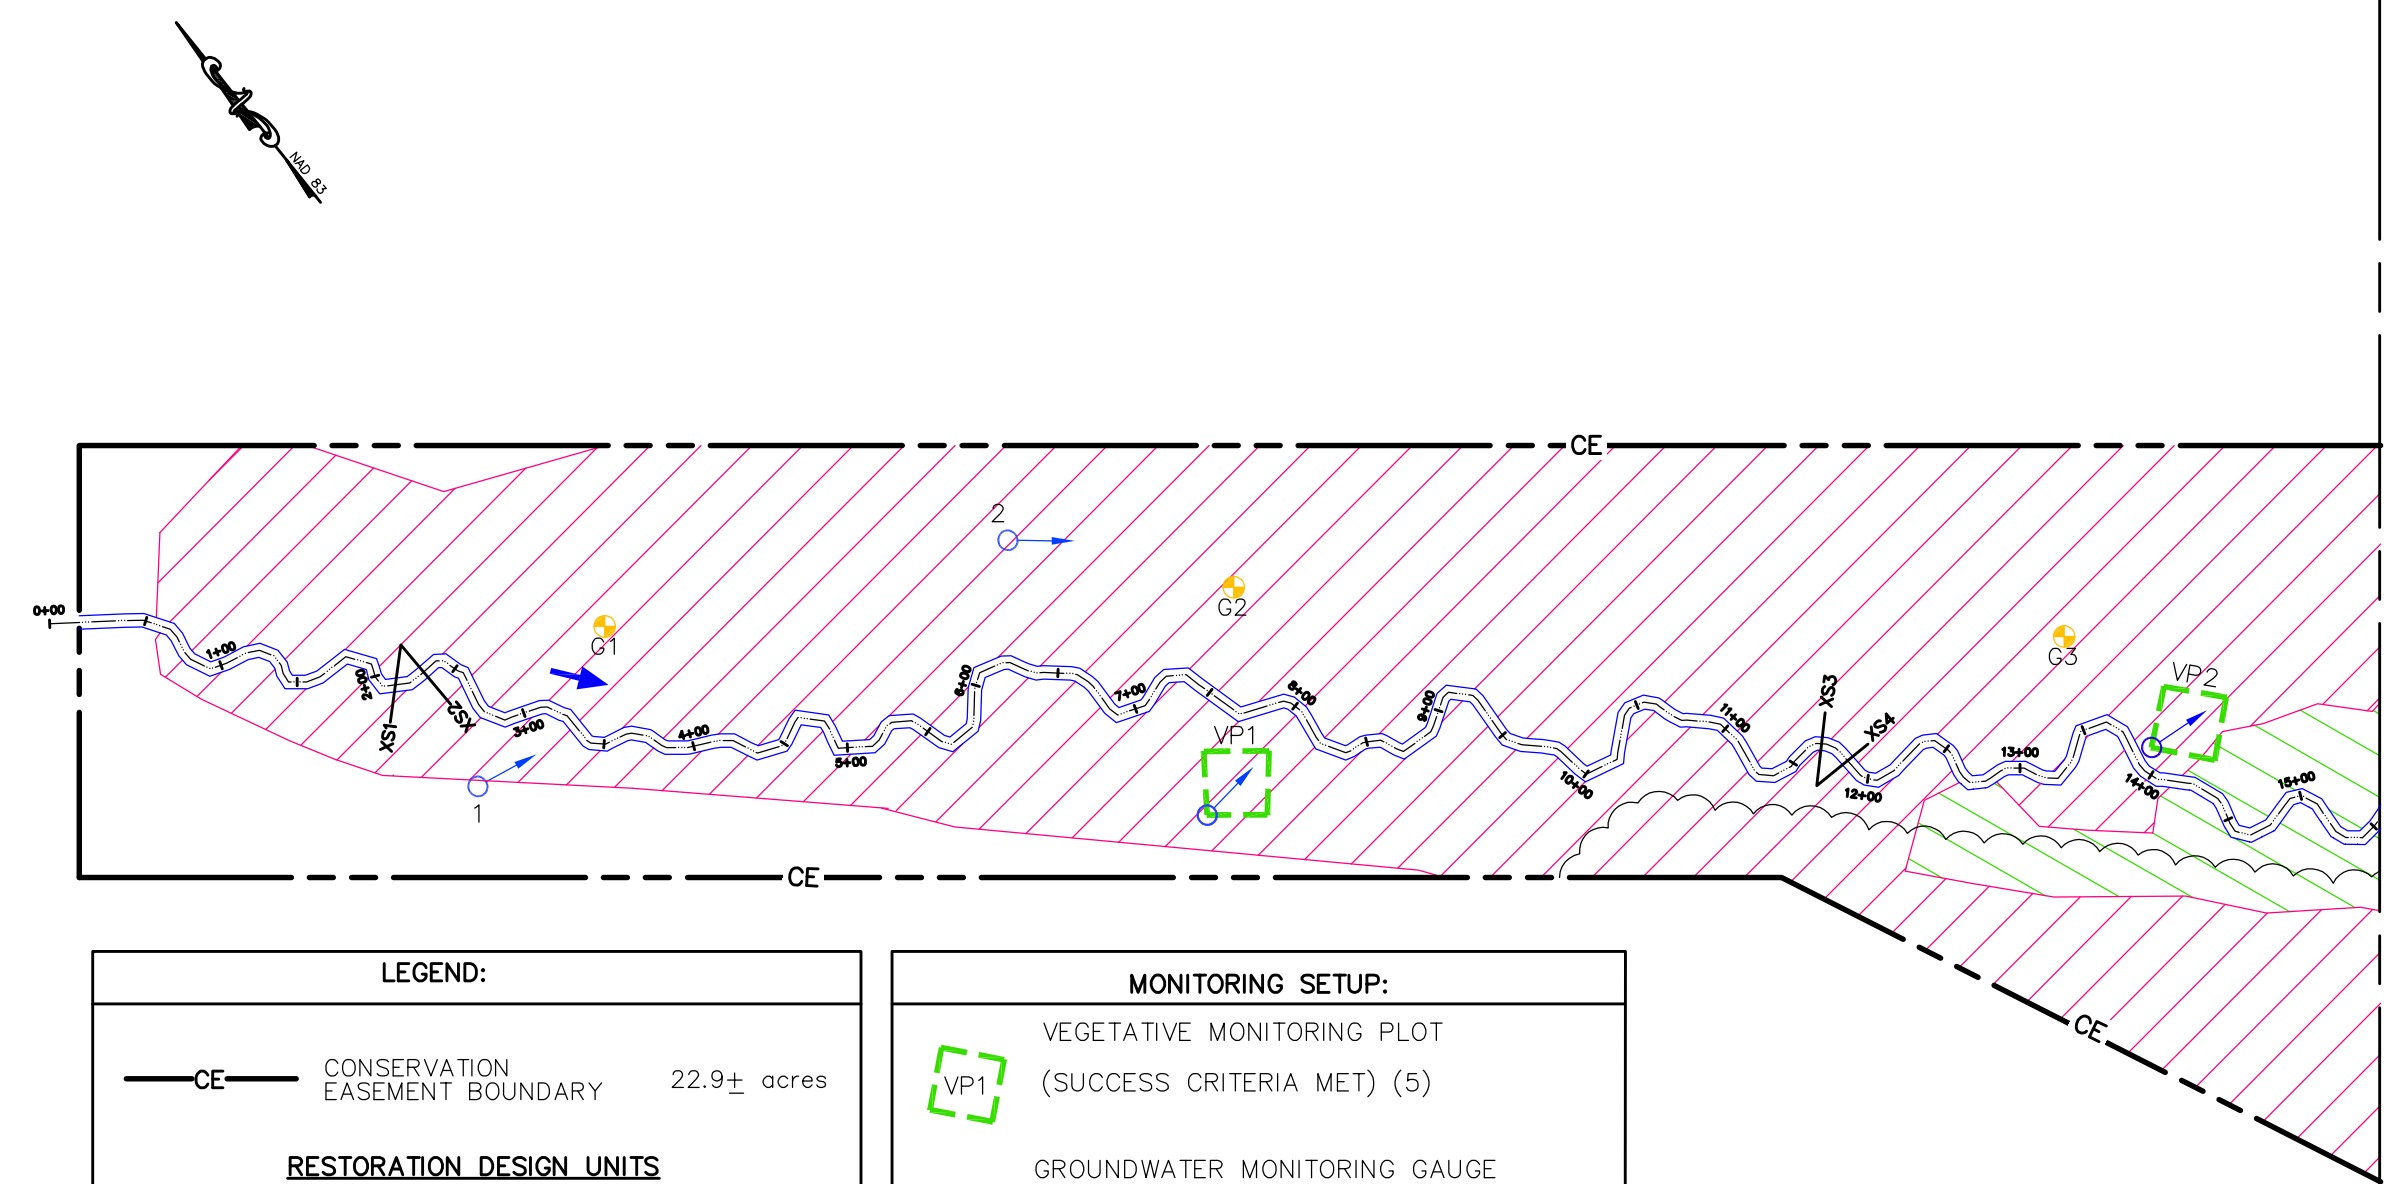
FIGURE  
**2A**

Chinese privet (*Ligustrum sinense*), an exotic invasive, was found growing densely along the lower reach of the stream channel. During the summer of 2012, the Prime Contractor (Restoration Systems LLC) continued their plan to manage exotic species Chinese privet on the Site. Dense thickets of Chinese privet

were sprayed along the southwestern Site boundary (Figure 2A and 2B, Appendix D) as well as solitary specimens located along Cutawhiskie Creek.

NOTE:  
 NO STREAM OR VEGETATION PROBLEM AREAS WERE IDENTIFIED DURING YEAR-5 MONITORING.
