MY00 FINAL MONITORING REPORT

**Dales Creek Restoration Site
Buncombe County, North Carolina
French Broad River Basin - 06010105**

DMS Project #100128

Monitoring Data Collected: 2022

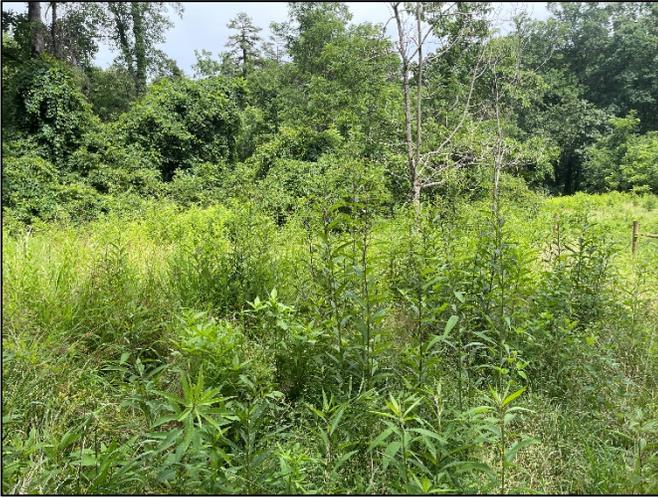
Vegetation Plot 1 – MY-00 – 7/14/22*

*Photo taken 7/14/22, plot data collected 5/2/22

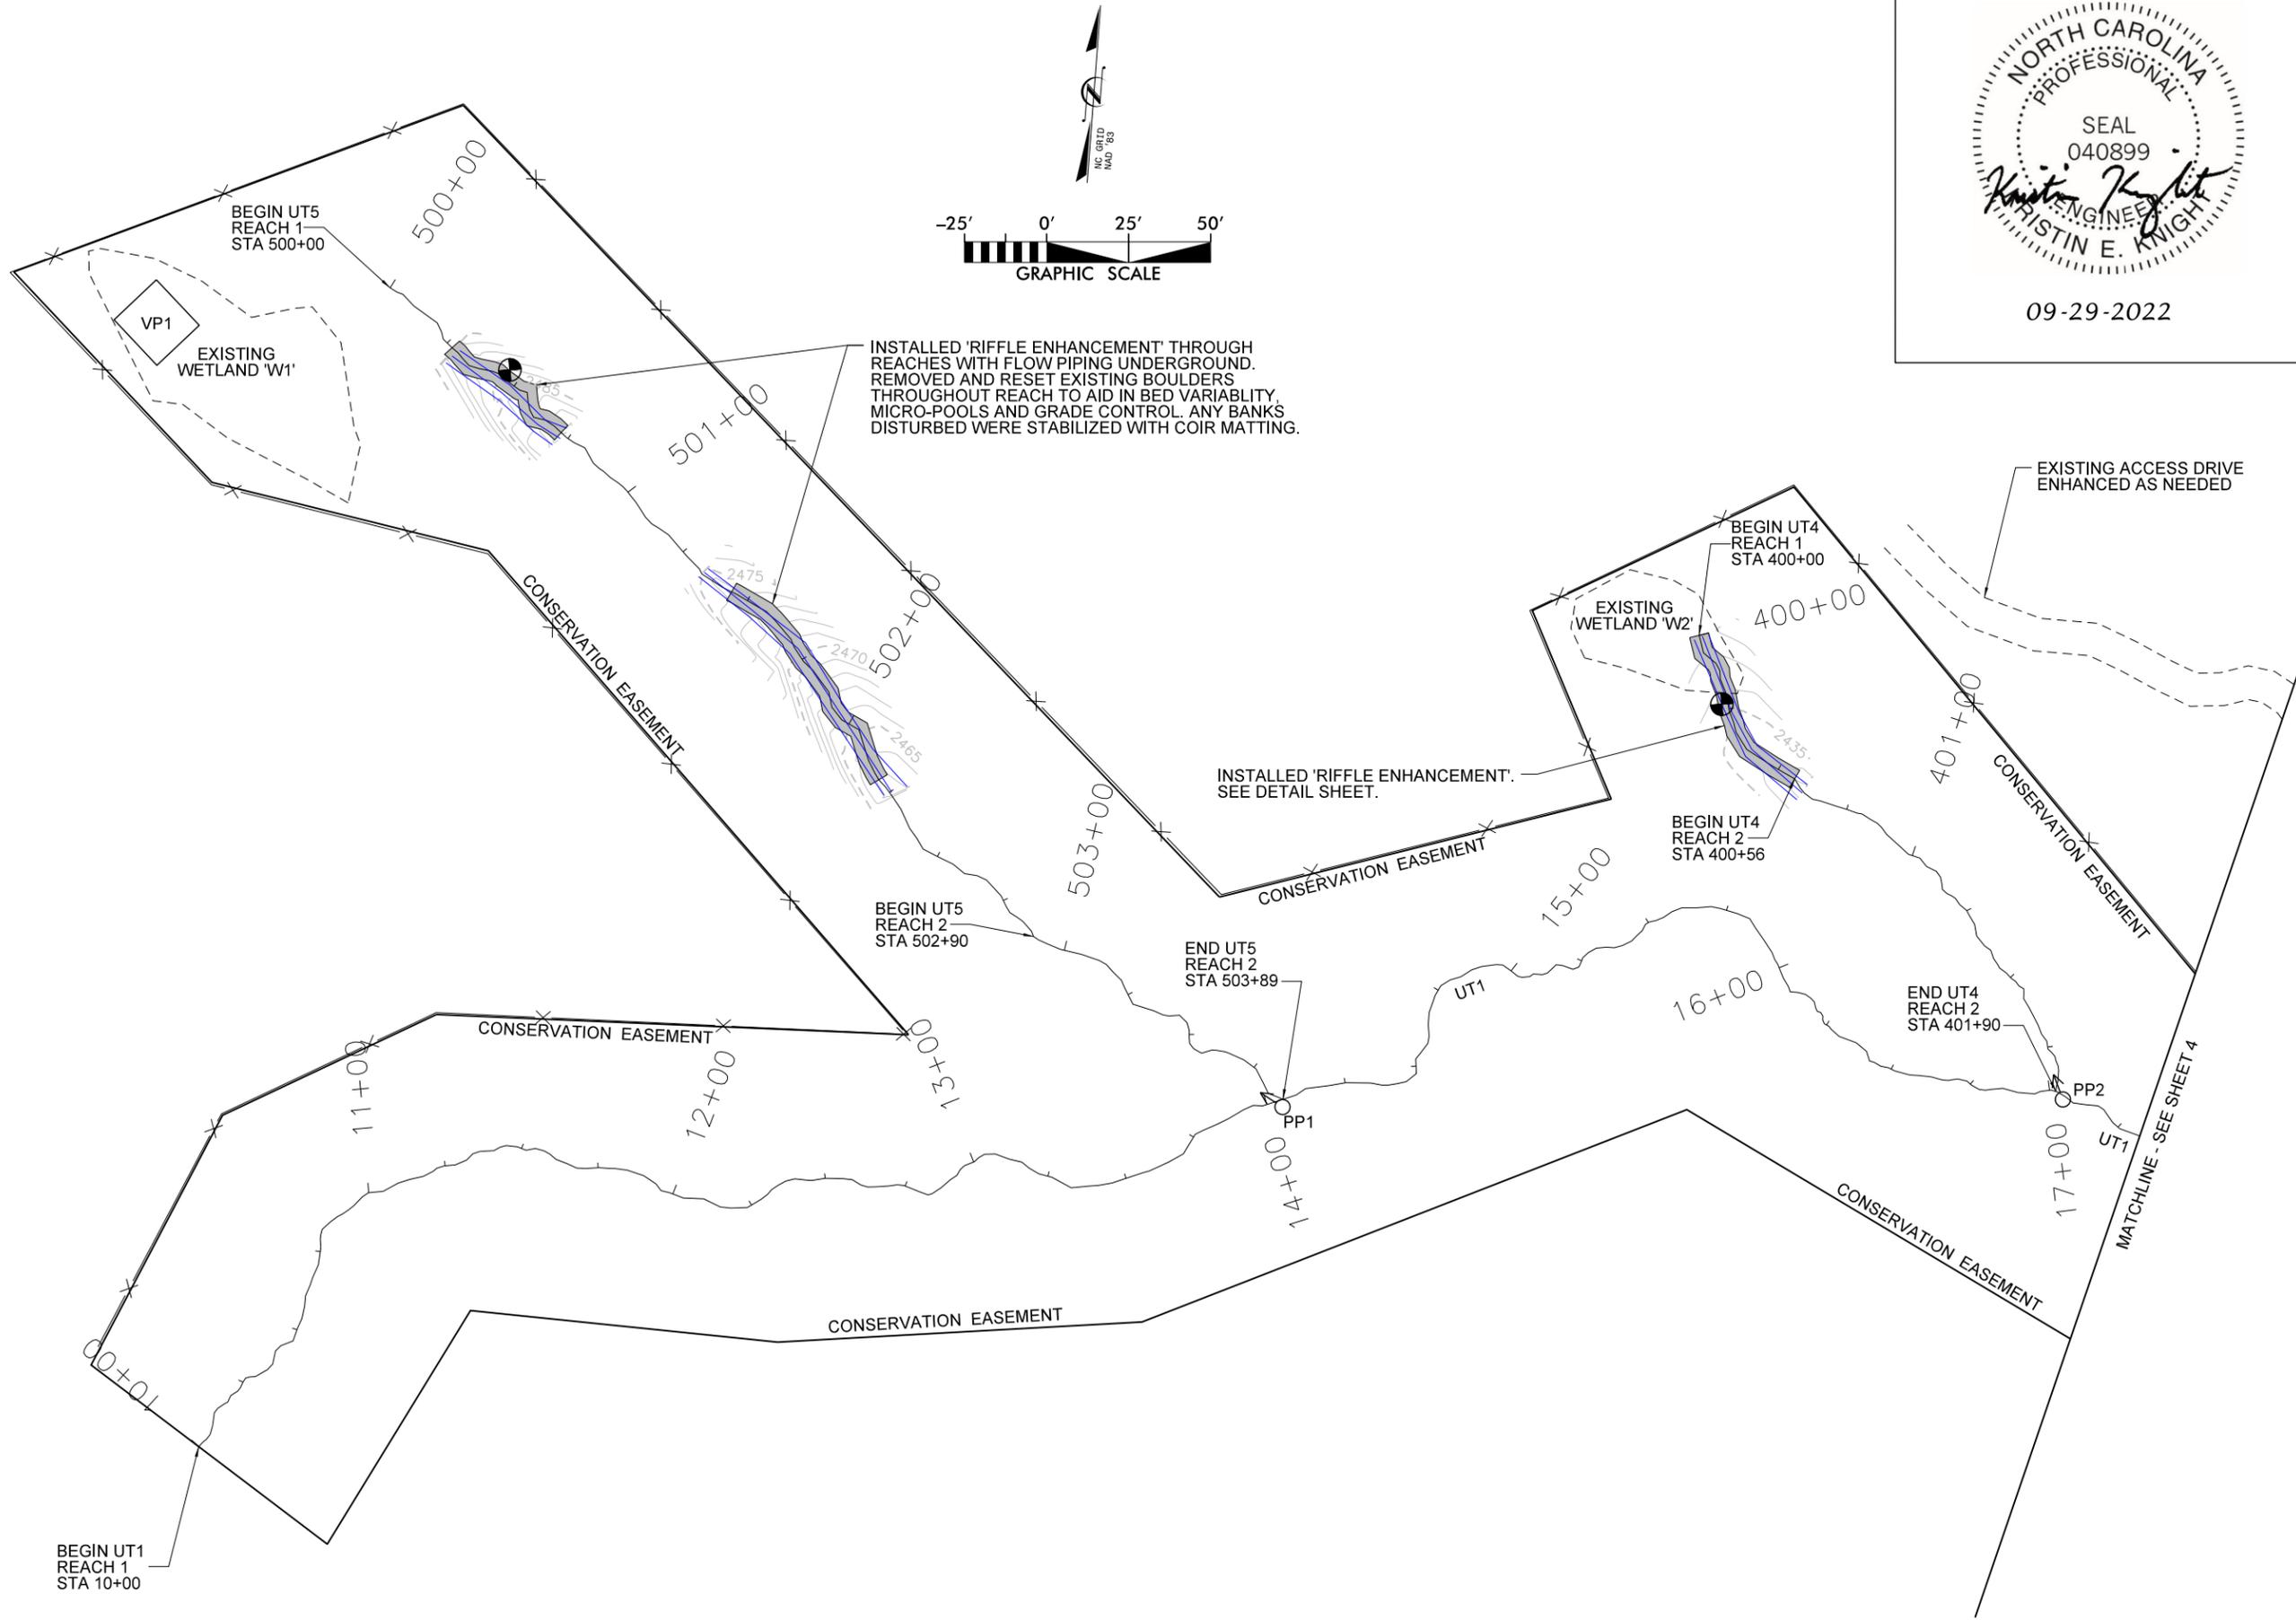
SITE PLAN

INSTALLED 'RIFFLE ENHANCEMENT' THROUGH REACHES WITH FLOW PIPING UNDERGROUND. REMOVED AND RESET EXISTING BOULDERS THROUGHOUT REACH TO AID IN BED VARIABILITY, MICRO-POOLS AND GRADE CONTROL. ANY BANKS DISTURBED WERE STABILIZED WITH COIR MATTING.

INSTALLED 'RIFFLE ENHANCEMENT'. SEE DETAIL SHEET.
