MY01 MONITORING REPORT

Dales Creek Restoration Site
Buncombe County, North Carolina
French Broad River Basin - 06010105

DMS Project #100128

Monitoring Data Collected: 2022

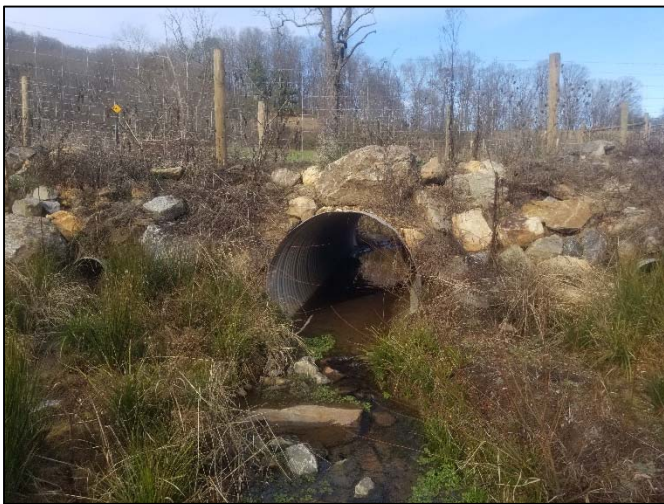
Culvert on T1 – 12/20/22

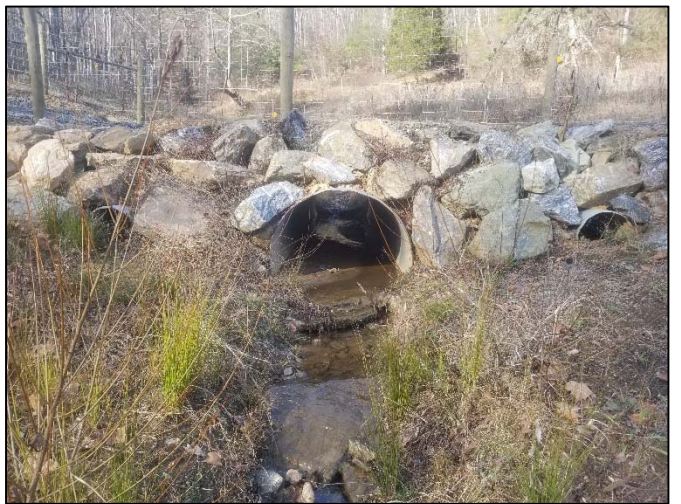
Culvert on T3 – 12/20/22

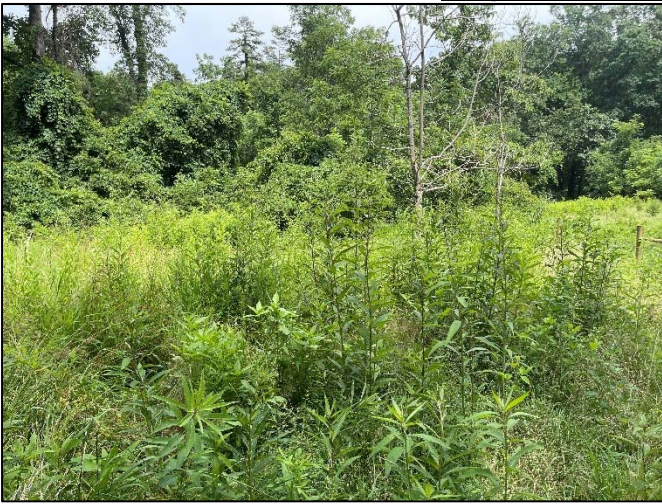
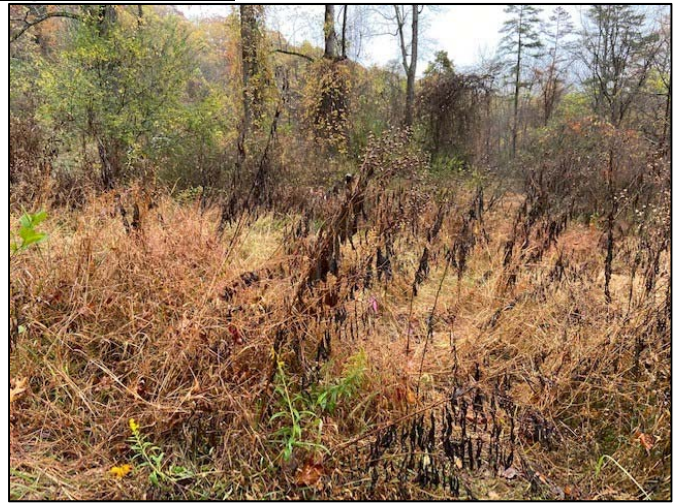
Vegetation Plot 1 – MY-00 – 7/14/22

The site was planted in April 2022. The MY01 vegetation monitoring was conducted on November 2, 2022. Five out of the six vegetation monitoring plots have met all of the success criteria. The plot that did not meet all of the success criteria, was Plot 1, which only had 2 native hardwood species. This plot is located in an area with many mature trees in close proximity to it and KCI expects that native volunteer species will colonize the plot in future monitoring years to correct this low level of diversity. Several invasive species were present on site during 2022. These species were treated on August 23, 2022 with herbicide. KCI will continue to monitor the invasives on site and treat as necessary.

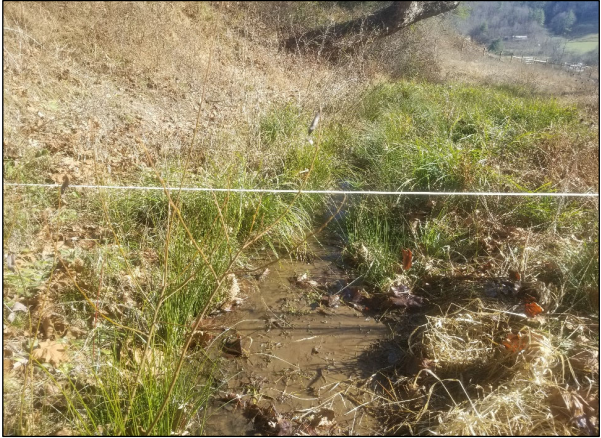
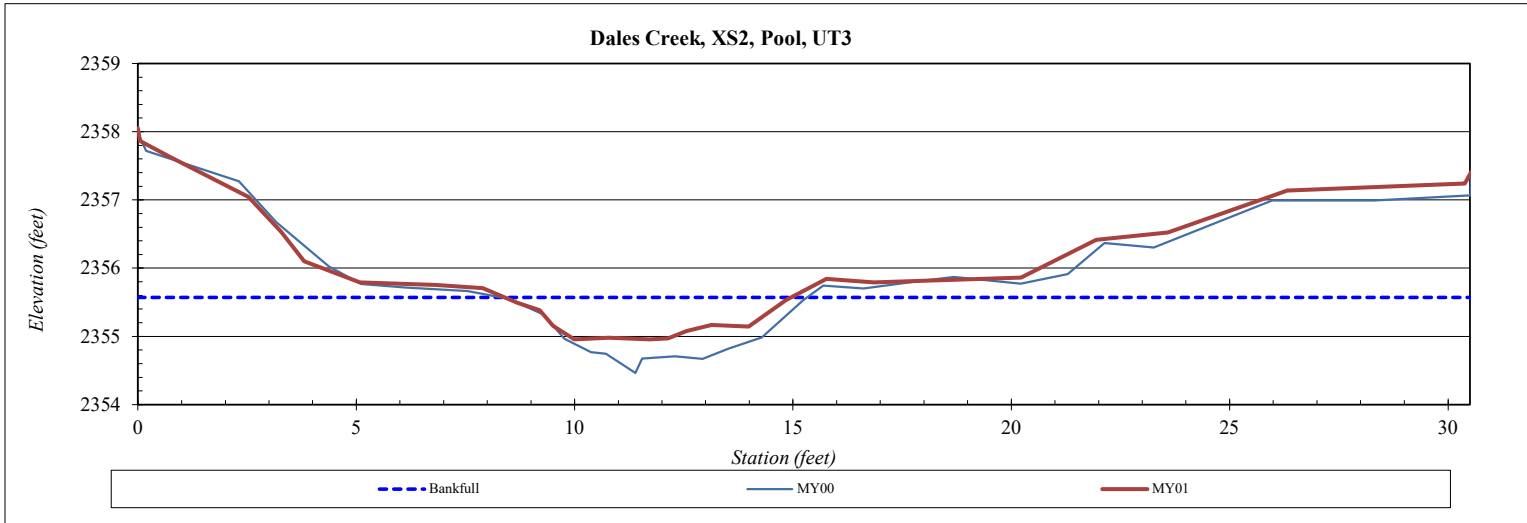
River Basin:	French Broad
Site:	Dales Creek
XS ID	XS2
Drainage Area (sq mi):	0.02
Date:	4/28/2022
Field Crew:	TS, KB

The MY01 cross-section survey was completed on December 20, 2022. The survey found the stream functioning as designed. Small amounts of aggradation (approximately 0.3') were seen in XS2 and XS3. This has led to an entrenchment ratio of 2.1 in XS3. These slight changes are part of the stream settling after construction and do not represent a threat to project success. KCI expects that as the stream continues to settle and this sediment moves through the system, that all of the cross-section measurements will be within the desired ranges.

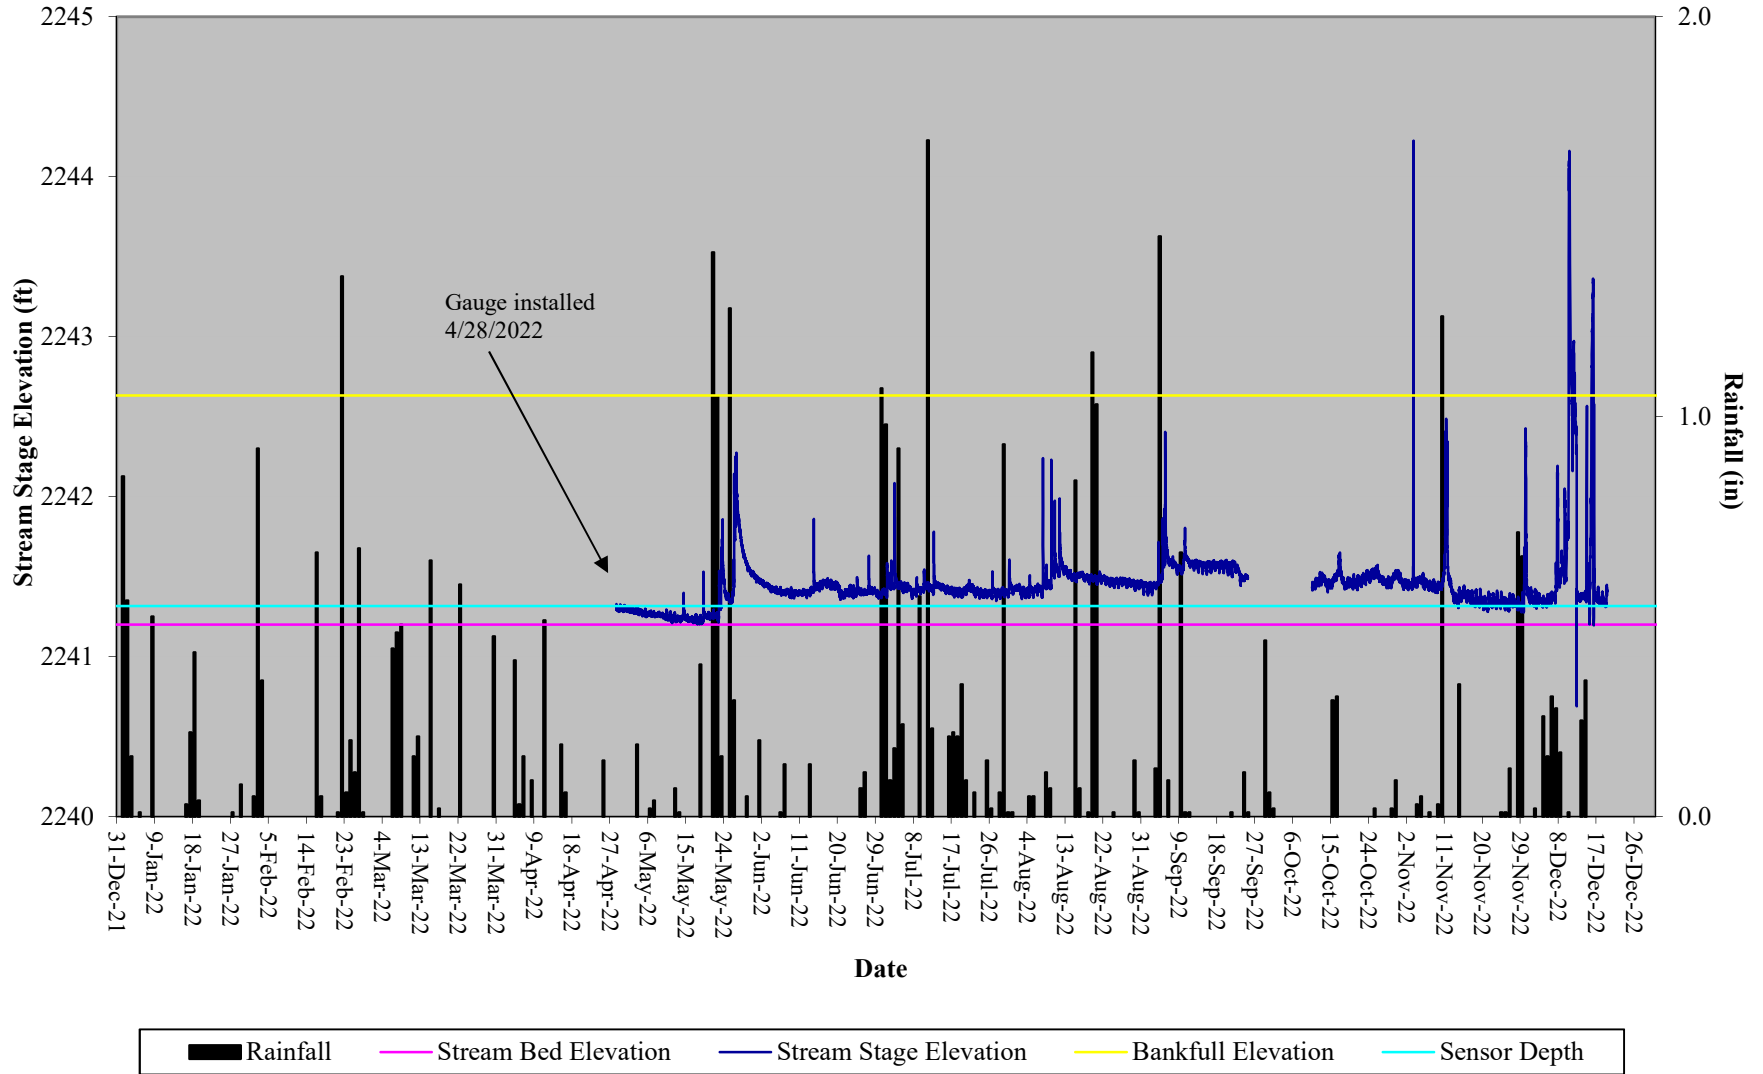
DalesCreek Restoration Site Hydrograph Stream Gauge UT1-4

During 2022, the stream gauge on T1 recorded 3 bankfull events. None of the flow gauges recorded any days of flow in 2022. Based on on-site assessment and observations, KCI does not believe that this data is accurate. Due to the size of the streams and their relative steepness, it would appear that, although the streams were flowing, it was at a level too low for the gauges to record. Before the beginning of the 2023 growing season, KCI will reinstall the gauges as needed and install cameras in their vicinity to provide supplemental data.
