# MY02 MONITORING REPORT

Dales Creek Restoration Site  
Buncombe County, North Carolina  
French Broad River Basin - 06010105

DMS Project #100128

Monitoring Data Collected: 2023

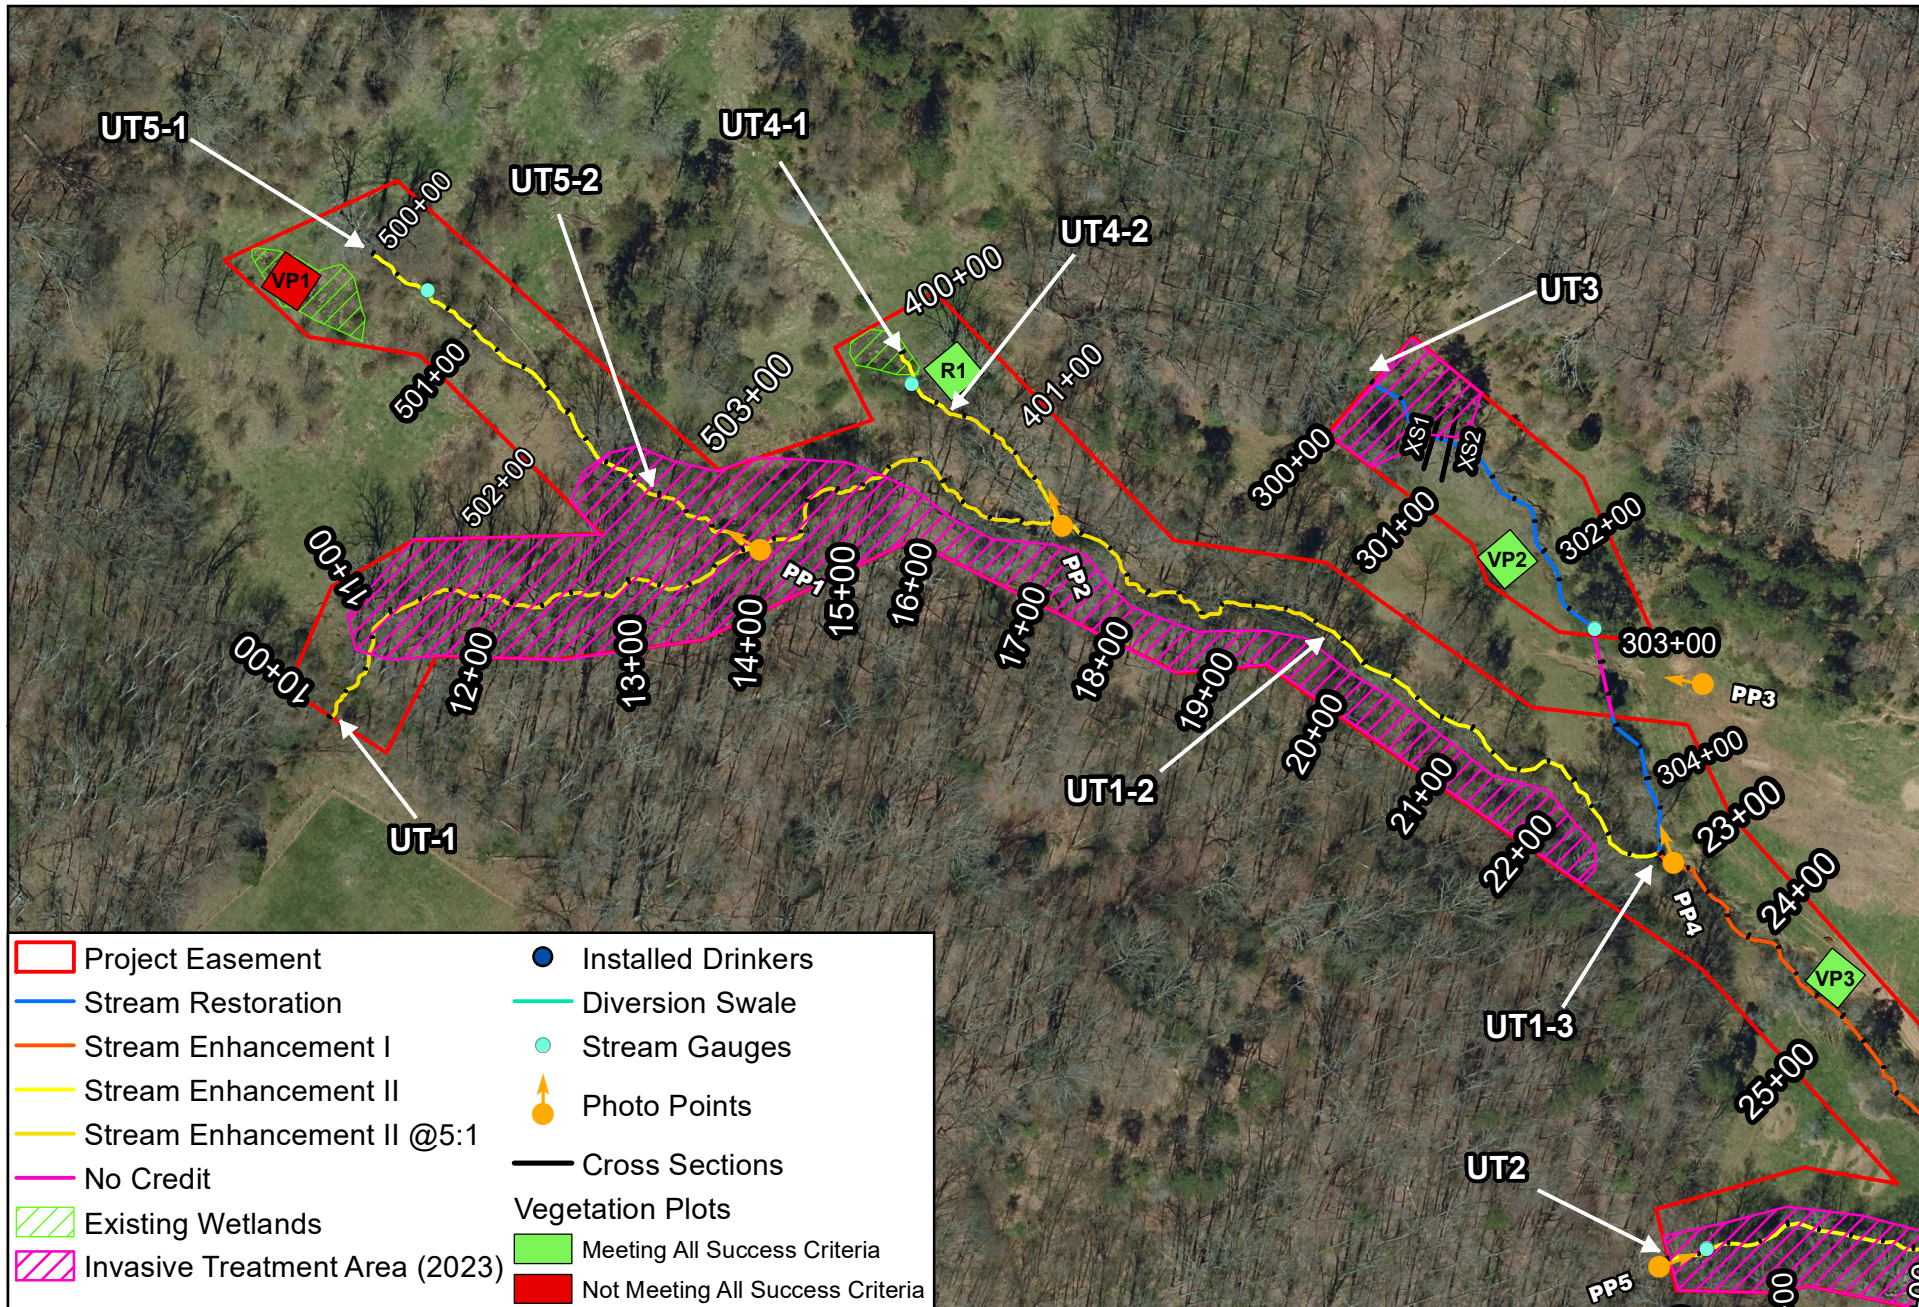
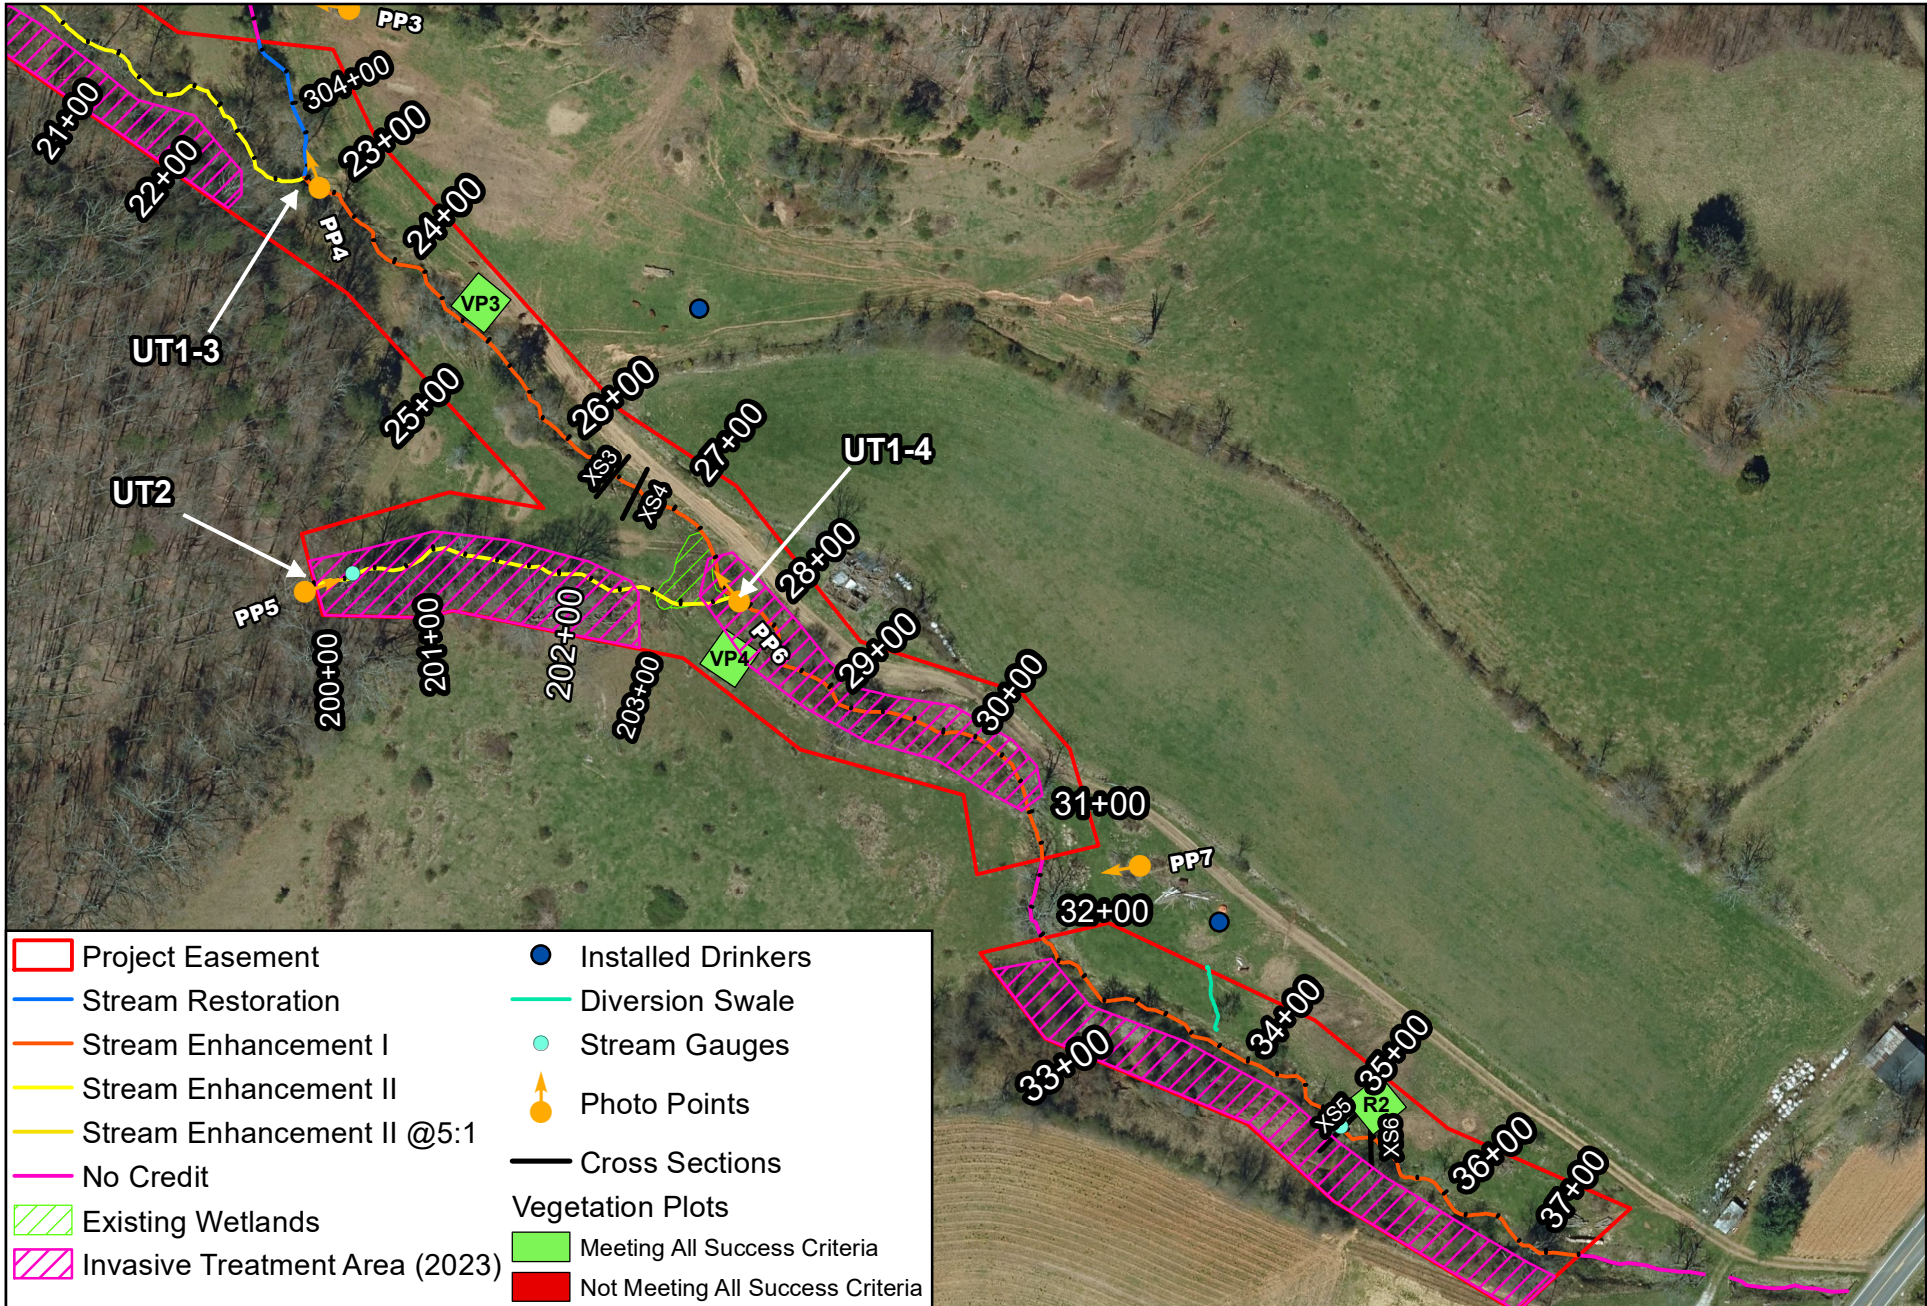
**CURRENT CONDITIONS PLAN VIEW  
DALES CREEK RESTORATION SITE  
BUNCOMBE COUNTY, NC**

The site boundaries were inspected on December 11, 2023. No areas of encroachment or trespass were noted. The fence is intact, and signs are present at regular intervals around the boundary. All of the stream reaches on site (including the E2 reaches UT1-1, UT1-2, UT2 and UT4) were also inspected during this site visit. While no areas of stream instability were noted during this inspection, one area of hillslope erosion adjacent to the stream was identified. This area is located on the left side of UT1-1, just upstream from the confluence with UT2. KCI is evaluating this area to determine if further stabilization is necessary.

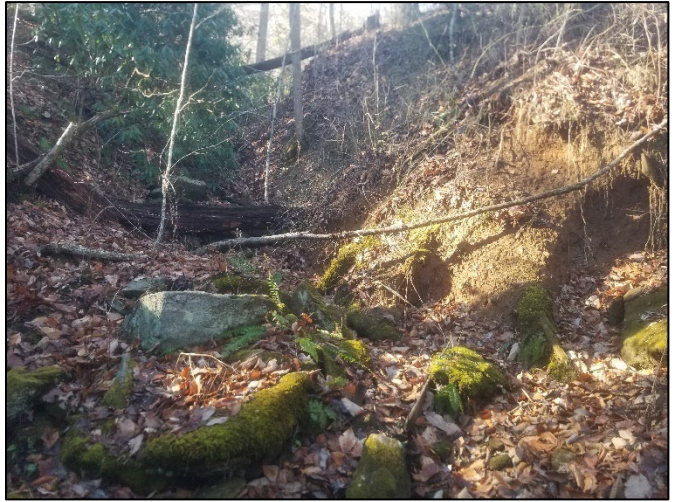
PP2 – MY-02 – 12/11/23

1. During a site visit in 2023 DMS observed an area (along UT1 near Photo Point 2) of steep hillslope erosion, fallen trees, and active spring flow at the base of the bank and into this project E2 reach. Attached to this comment email is a short video. DMS recommends inspecting this area next time KCI visits the site, and if needed, reporting on this area moving forward to assess its stability and if/how it is changing year to year.  
*KCI Response: KCI was first alerted to this issue by DMS near the beginning of 2023. The area in question has been reviewed several times since then and although the hillslope erosion and fallen trees were noted, we were unable to identify the area of spring flow (likely due to the lower than normal amounts of rainfall that the site experienced this year). A site visit is planned for early spring 2024, and will be coordinated so that it occurs shortly after a rainfall and the spring is flowing. Once KCI has had a chance to thoroughly assess this area we will develop a plan of action to ensure that this area does not pose a threat to the project.*
