# **Year 1 Monitoring Report for Stream Restoration of Davis Branch and Unnamed Tributary**

Union County, NC  
SCO # D06054-F

**Submitted:** December 2009

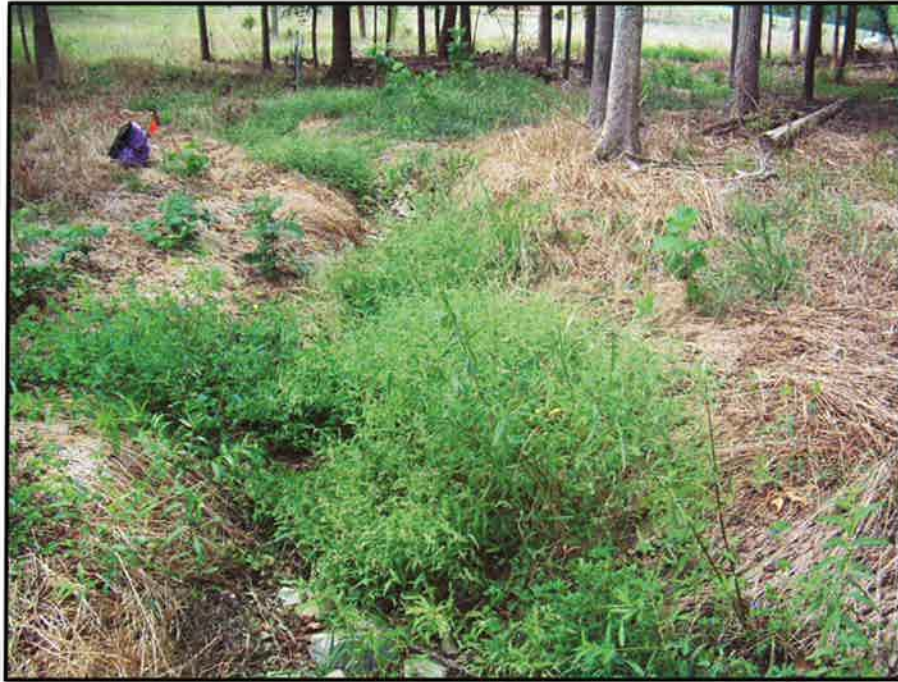
#### **VPA 1**

**Example of the patchy herbaceous vegetation growing along the stream corridor of UT1. The herbaceous vegetation is sparse anywhere the existing large trees were preserved, and is likely a natural condition for the woodland areas.**

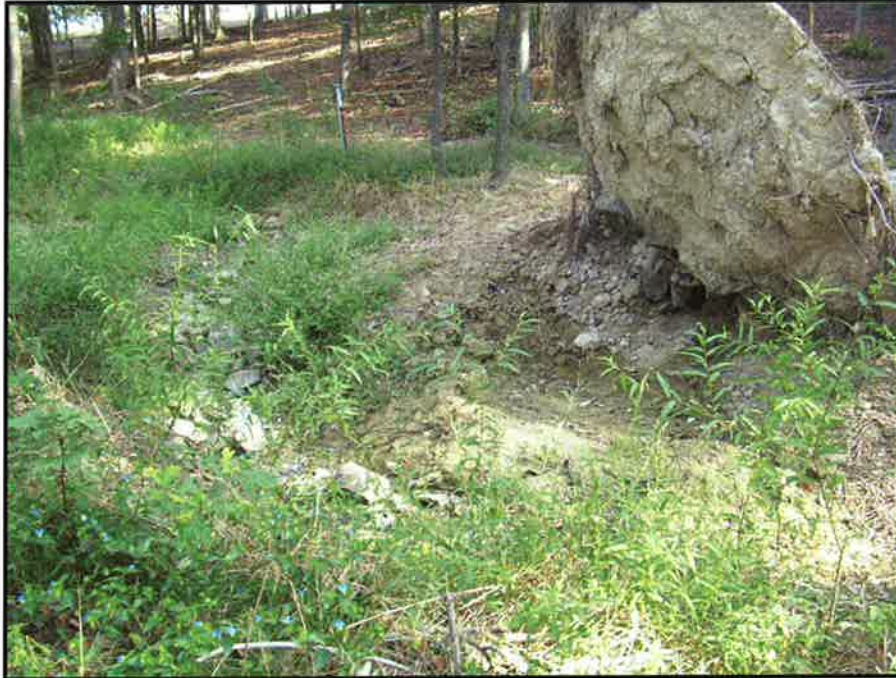
One area of concern is located along the restored portion of the Davis Branch mainstem where a large tree had fallen in the riparian corridor. While the bulk of the tree fell away from the stream channel, a large hole was formed where the root mass previously existed near the edge of the stream. No erosion was witnessed here in Year 1, and the area has subsequently been repaired. This location is noted as a problem area of low concern that will be watched over time to monitor the develop of bank scour that may occur near the former hole.

**SPA 1**  
**Large tree fall on Davis Branch near station 18+75.**  
(EMH&T, Inc. 9/19/09)

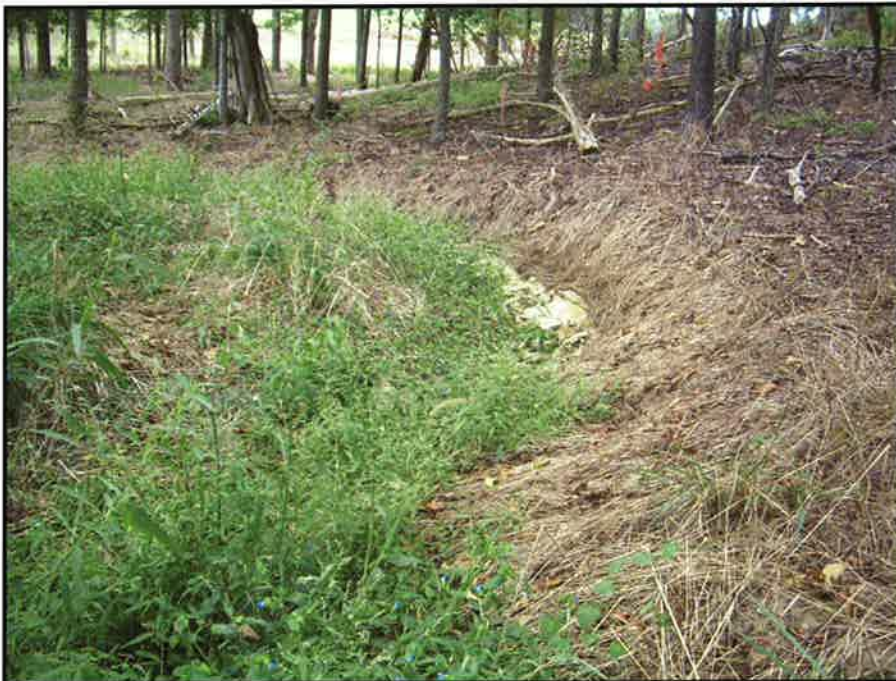
The other type of problem area is isolated to a few outside meander bends along the project streams. The banks of the outside bends have little established vegetation to stabilize the slopes. These areas are considered low concern at this time, as the bends are not actively eroding beyond the minor sloughing of loose soil. No remedial maintenance is scheduled at this time. These areas are noted in order that they be watched to catch any erosion problems that may occur before vegetation becomes fully established along these slopes. Actively monitoring these areas will allow developing problems to be caught early and managed without the need for mechanical intervention. If erosion problems arise, the outside meander bends could be stabilized using vegetative methods such as seeding and live stakes, or with a natural fiber (coconut) geotextile.

**SPA 2**  
**Bare banks along an outer meander bend on UT1 near station 5+50. Concern for stability if vegetation does not develop.**  
(EMH&T, Inc. 9/19/09)

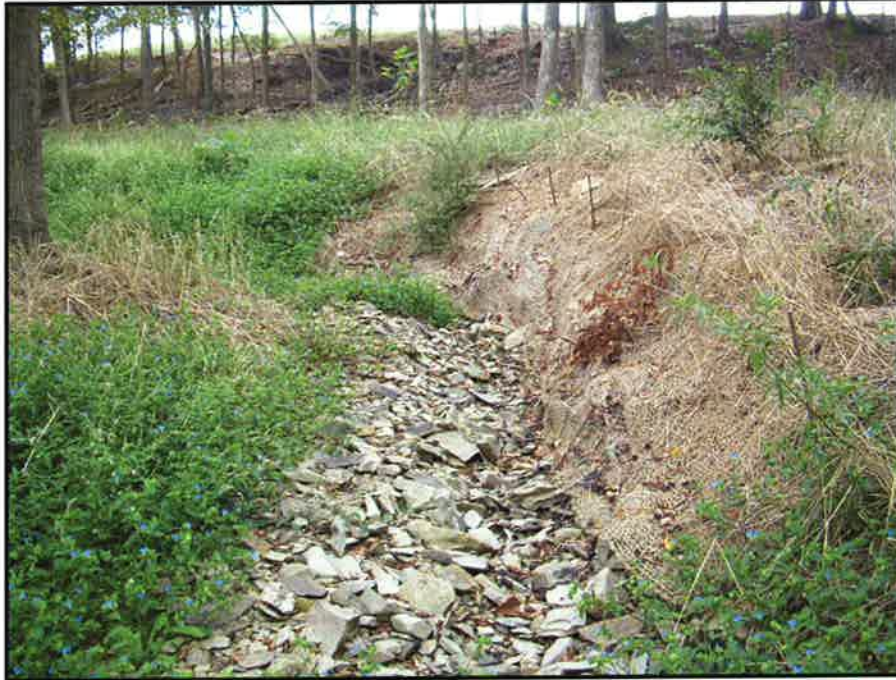
**SPA 3**

**Bare banks along an outer meander bend on Davis Branch near station 29+90. Concern for stability if vegetation does not develop.**

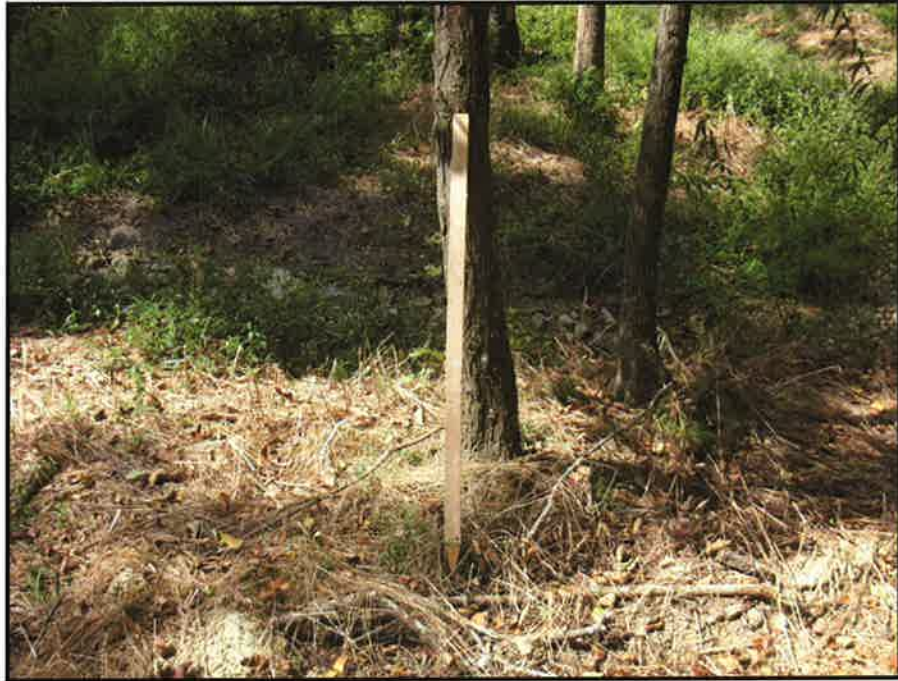
On September 20, 2009, the crest gage on UT1 registered a bankfull event at a level of 5.0 inches above the bottom of the crest gage. The crest gage on the Davis Branch mainstem reach also documented the bankfull event, with a height of 3.5 inches above the bottom of the crest gage. These crest gages are set at or above the bankfull elevation of each stream channel. Photographs of the crest gages are shown in Appendix B.

**BF 1**  
**Crest Gage on the mainstem of Davis Branch.**  
(EMH&T, Inc. 9/20/09)

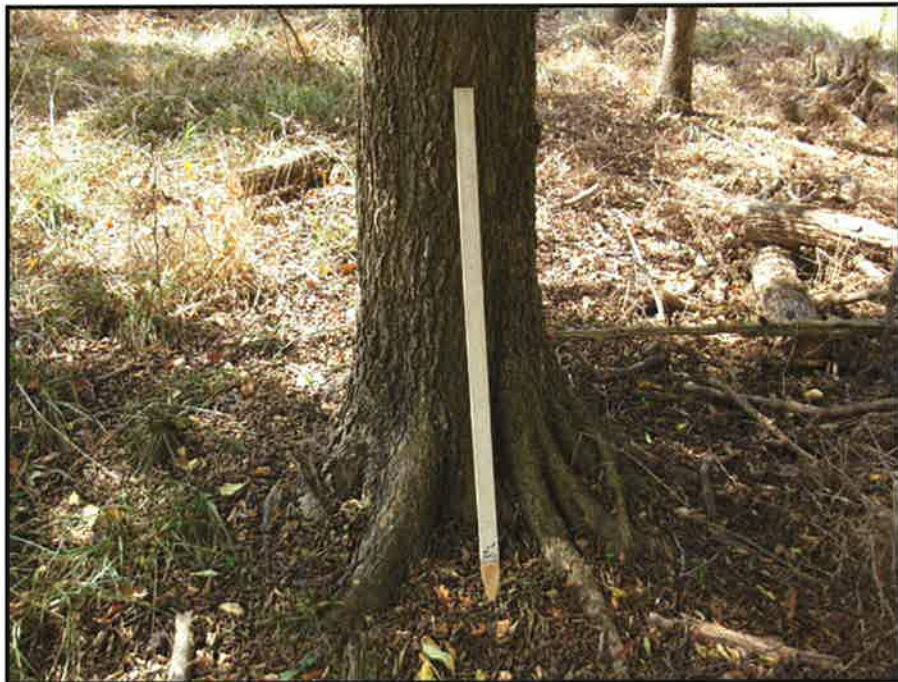
**BF 2**  
**Crest Gage 4 on UT1 of Davis Branch.**  
(EMH&T, Inc. 9/20/09)
