Year 2 Monitoring Report for Stream Restoration of Davis Branch and Unnamed Tributary

Union County, NC
SCO # D06054-F

Submitted: January 2011

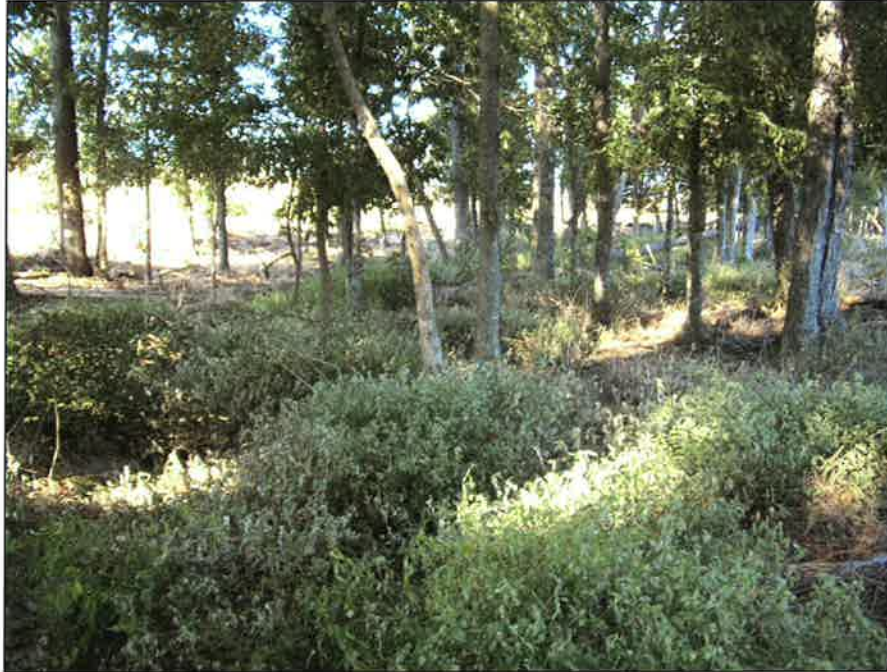
VPA 1

Example of the patchy herbaceous vegetation growing along the stream corridor of UT1. The herbaceous vegetation is sparse anywhere the existing large trees were preserved, and is likely a natural condition for the woodland areas.

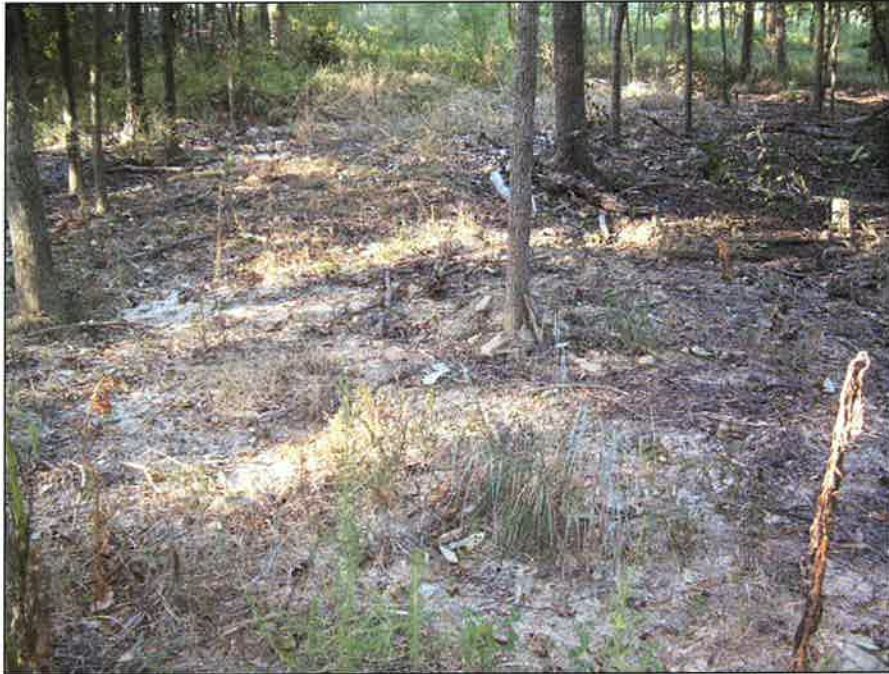
Table X. Stream Problem Areas			
Davis Branch Stream Restoration / EEP Project No. D06054-F			
Feature Issue	Station Numbers	Suspected Cause	Photo Number
Other	8+00 Mainstem	Bare banks - concern for future stability if vegetation does not develop	SPA 1
	11+00-13+00 Mainstem	Bare banks (patchy distribution along this section) - concern for future stability if vegetation does not develop	SPA 2
	29+90 Mainstem	Bare banks - concern for future stability if vegetation does not develop	
	7+25, 5+50 UT1 PI/II	Bare banks - concern for future stability if vegetation does not develop	
	3+50 – 0+50 UT1 PI/II	Bare banks (patchy distribution along this section) - concern for future stability if vegetation does not develop	SPA 3

The other type of problem area is isolated to a few meander bends along the project streams. The banks of the outside bends have little established vegetation to stabilize the slopes. These areas are considered low concern at this time, as the bends are not actively eroding beyond the minor sloughing of loose soil. Additionally, vegetation in 2010 is beginning to infiltrate the bare areas. This is resulting in an increased root density which provides better stabilization for the stream banks. No remedial maintenance is scheduled at this time. These areas are noted in order that they be watched to catch any erosion problems that may occur before vegetation becomes fully established along these slopes. Actively monitoring these areas will allow developing problems to be caught early and managed without the need for mechanical intervention. If erosion problems arise, the outside meander bends could be stabilized using vegetative methods such as seeding and live stakes, or with a natural fiber (coconut) geotextile.

Bare banks along stream channel bend on Davis Branch near station 8+00. Concern for stability if vegetation does not develop.

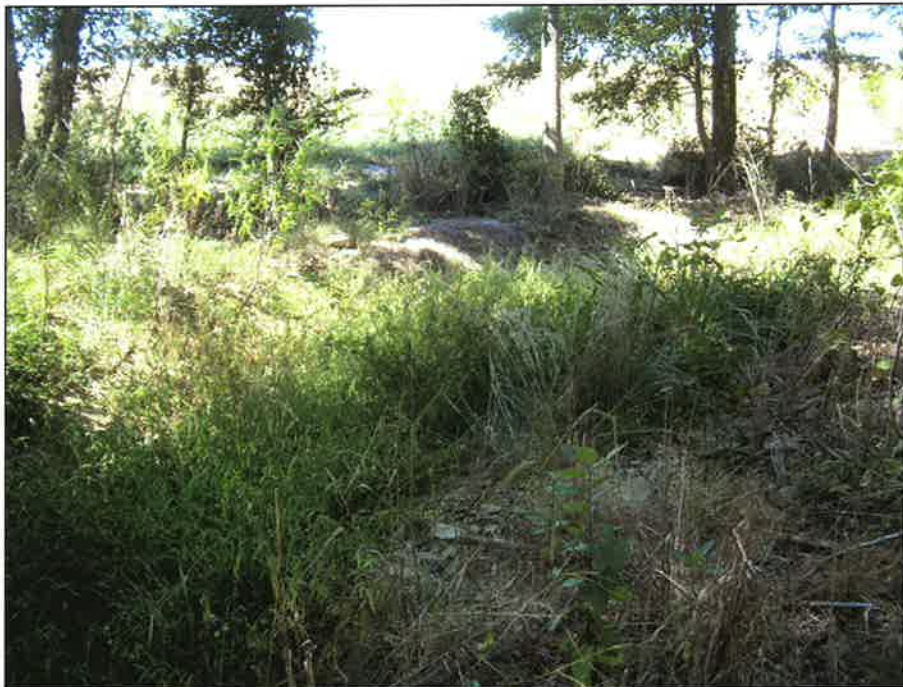
SPA 2

Bare banks along a meander bend on Davis Branch near station 13+00. Concern for stability if vegetation does not develop.

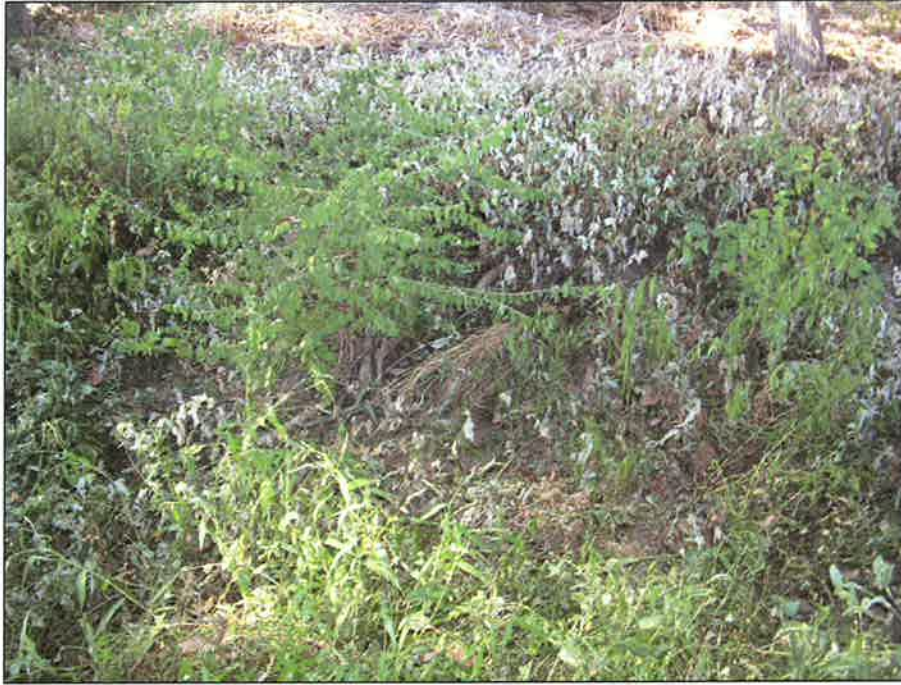
SPA 3

Bare banks along UT1 near station 3+00. Concern for stability if vegetation does not develop.
