Subject: Year 3 Monitoring Report for Stream Mitigation of Davis Branch
SCO# D06054-F

Year 3 Monitoring Report for Stream Restoration of Davis Branch and Unnamed Tributary

Union County, NC
SCO # D06054-F

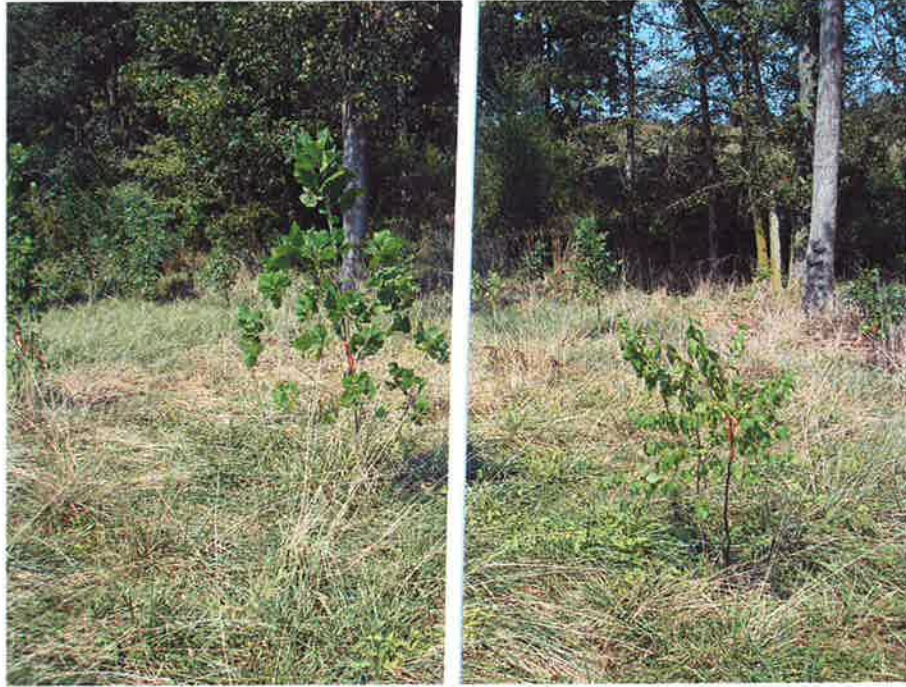
The average stem density of planted species for the site far exceeds the minimum criteria of 320 stems per acre after three years. One plot (plot 3) has a stem density below the minimum. Some plots showed woody stem mortality due to the dry summer and the rocky soil of the riparian corridor. A substantial number of recruit stems have been found across the site, increasing the total stem density by approximately 27%. The number of recruit stems for the individual plots was large enough to bring all plots, except plot 3, into compliance with the three year minimum criteria.

Vegetation Plot 3
Monitoring Year 3
(EMH&T, 9/14/11)

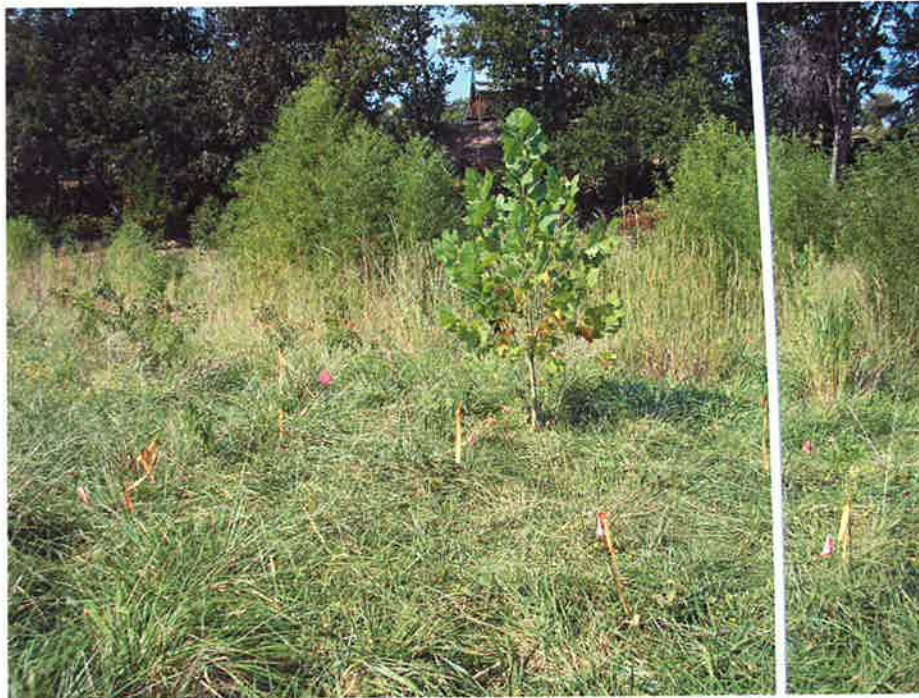
Vegetation Plot 8 - note that flagging tape signifies the location of a bare root planting
Monitoring Year 3
(EMH&T, 9/14/11)

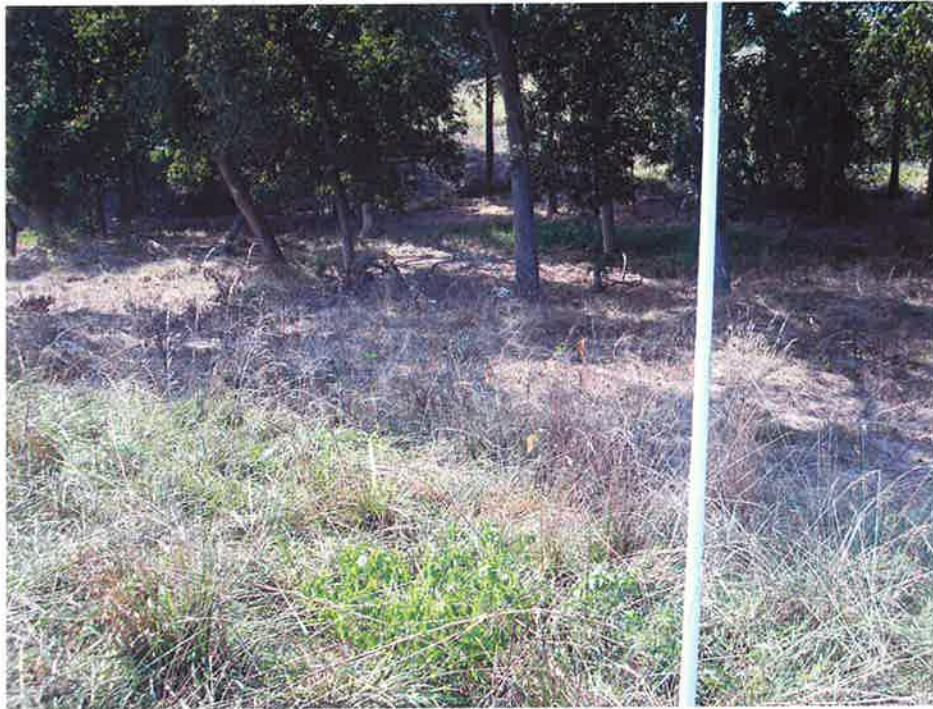
Vegetation Plot 9 – note that flagging tape signifies the location of a bare root planting
Monitoring Year 3
(EMH&T, 9/14/11)

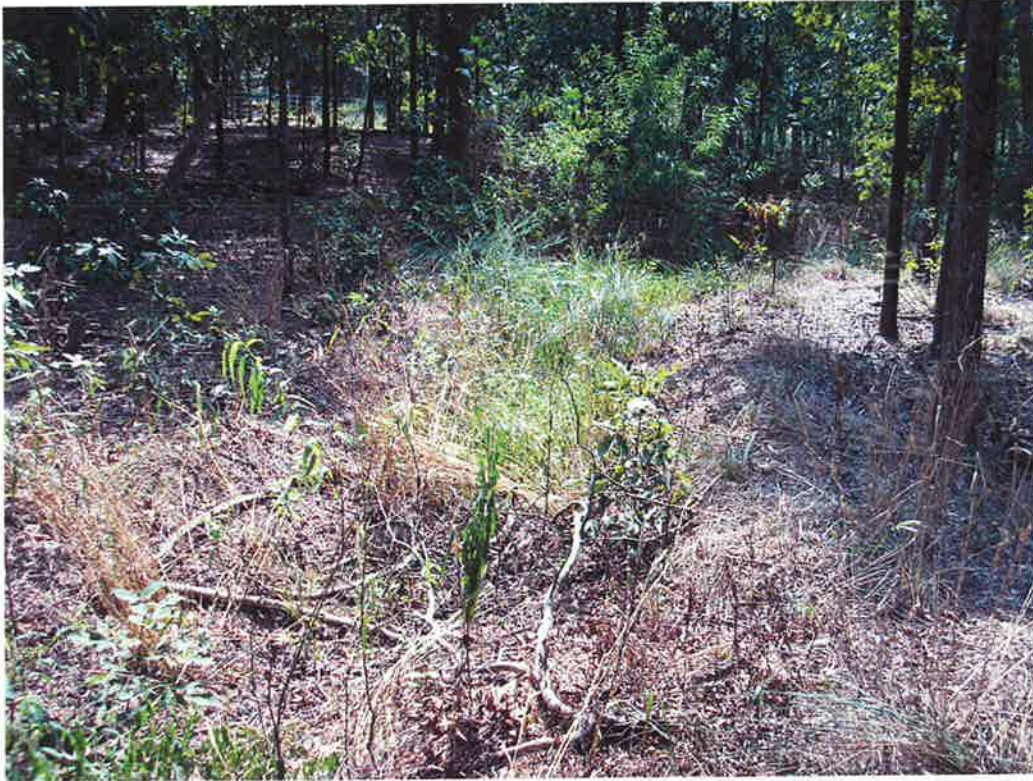
As depicted on the Vegetation Problem Area map in Appendix A, there is a minor area of the riparian corridor along the right bank of the mainstem that is exhibiting denudation in 2011. This area is situated between stations 8+00 and 10+00. It is labeled as a vegetation problem area of low concern because there is no evidence that denudation is currently affecting stream stability. The lack of vegetation in this area appears to be attributed to a natural condition. It is situated in the understory of a secondary growth forest where there is competition for light during certain portions of the day. It is expected that shade tolerant recruits will establish along this section of stream in future years.

Table VII. Vegetative Problem Areas Davis Branch Stream Restoration / EEP Project No. D06054-F			
Feature/Issue	Station # / Range	Probable Cause	Photo #
Bare Banks	8+00 – 10+00; Mainstem	<u>Unknown</u> : could be shade competition or poor, rocky soil	VPA 1

Example of the patchy herbaceous vegetation growing along the stream corridor near the upstream terminus of Davis Branch (approximately at station 8+00). The herbaceous vegetation is sparse everywhere the existing large trees were preserved, and is likely a natural condition for the woodland areas.

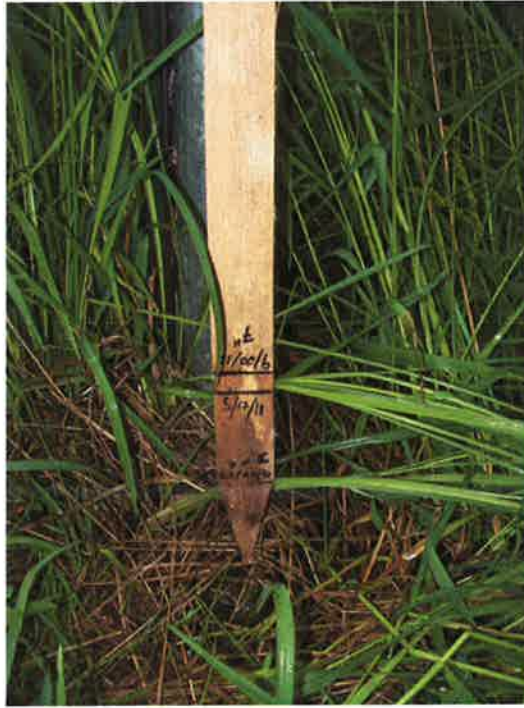
On September 14, 2011, the crest gage on UT1 was observed and indicated a bankfull event at a level of 6 and 5/8 inches above the bottom of the crest gage. The crest gage on the Davis Branch mainstem reach also documented the bankfull event, with a height of 6 and 3/8 inches above the bottom of the crest gage. These crest gages are set at or above the bankfull elevation of each stream channel. Photographs of the crest gages are shown in Appendix B.

BF 3
Crest Gage on the mainstem of Davis Branch (Year 3).
(EMH&T, 9/14/11)

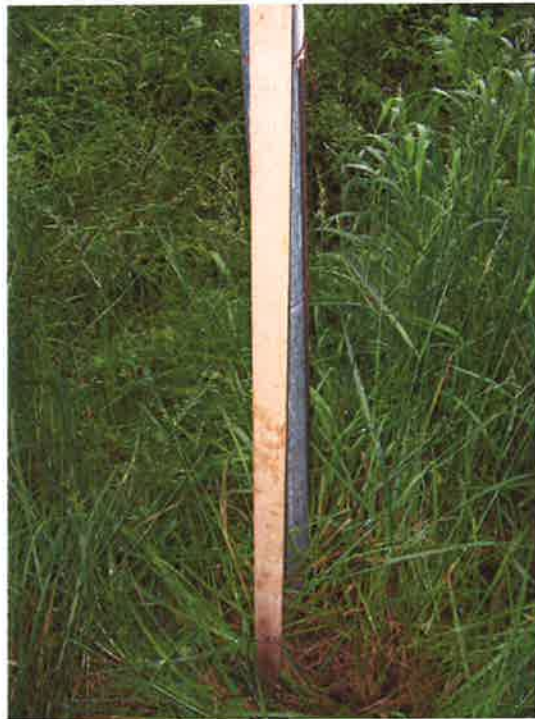
BF 6
Crest Gage 4 on UT1 of Davis Branch (Year 3).
(EMH&T, 9/14/11)

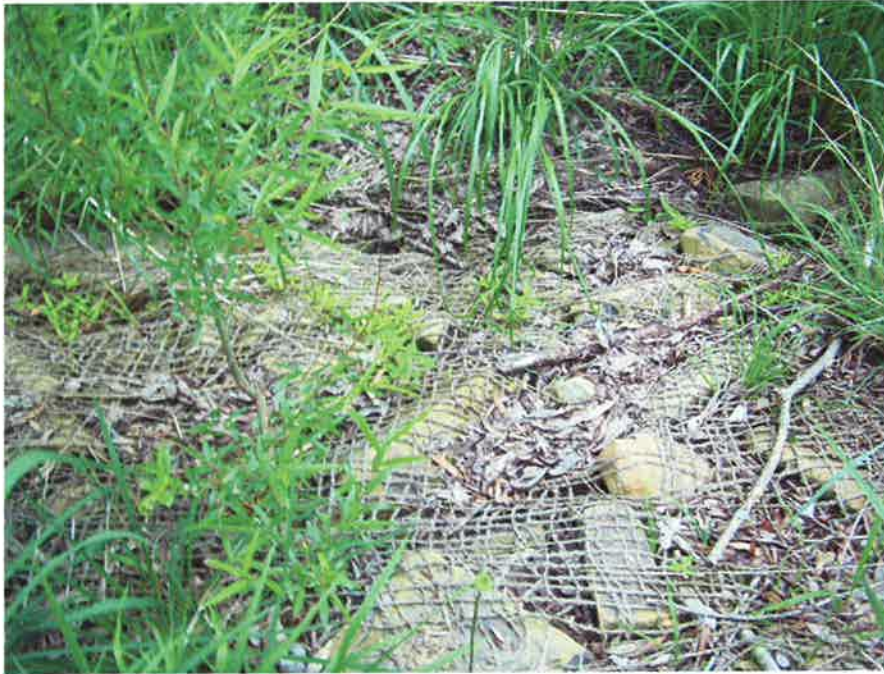
Table X. Stream Problem Areas			
Davis Branch Stream Restoration / EEP Project No. D06054-F			
Feature Issue	Station Numbers	Suspected Cause	Photo Number
Erosion/Bare Banks	8+00-10+00; Mainstem	Bare banks - concern for future stability if vegetation does not develop	SPA 1
	18+00-19+00, 21+00-22+00, and 23+50; Mainstem	Bank erosion (along meander bends) - concern for future stability if vegetation does not develop	SPA 2 & SPA 3

Stream problem areas in Year 3 were isolated to a few meander bends along the Davis Branch mainstem. In these places, the right and left banks of the meander bends have little established vegetation to stabilize the slopes. These areas are considered of low concern at this time, as the bends are not in a state of extreme erosion. Additionally, vegetation is continuing to infiltrate many of the bare areas. This is resulting in an increased root density which provides better stabilization for the stream banks. No remedial maintenance is scheduled at this time. These areas are noted in order that they be watched to catch any erosion problems that may occur before vegetation becomes fully established along these slopes. Actively monitoring these areas will allow developing problems to be caught early and managed without the need for mechanical intervention. If erosion problems arise, the outside meander bends could be stabilized using vegetative methods such as seeding and live stakes, or with a natural fiber (coconut) geotextile.

**Bare banks along stream channel bend on Davis Branch near station 8+25.
(EMH&T, 9/14/11)**

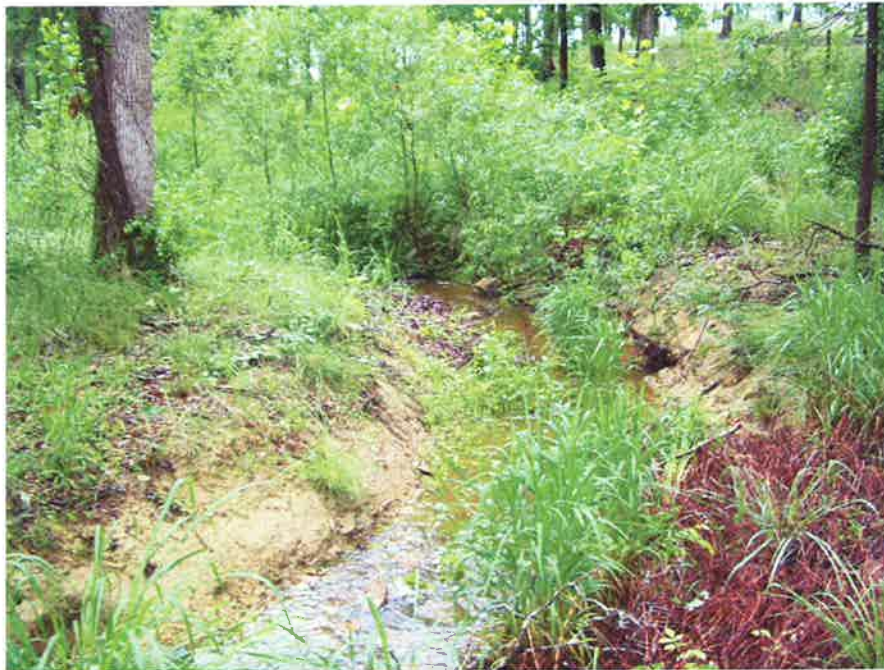
SPA 2

**Scour and erosion along the left and right banks at station 21+50 on Davis Branch.
Concern for stability if vegetation does not develop.
(EMH&T, 9/14/11)**

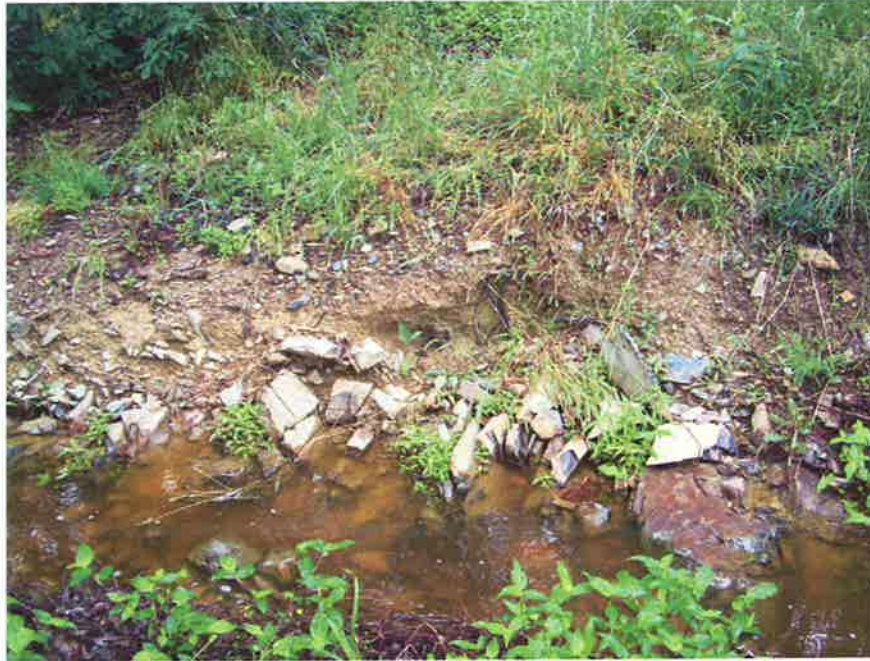
SPA 3

Scour and erosion along the right bank at station 23+50 on Davis Branch. Concern for stability if vegetation does not develop.
