Subject: Year 4 Monitoring Report for Stream Mitigation of Davis Branch
SCO# D06054-F

Year 4 Monitoring Report for Stream Restoration of Davis Branch and Unnamed Tributary

Union County, NC
SCO # D06054-F

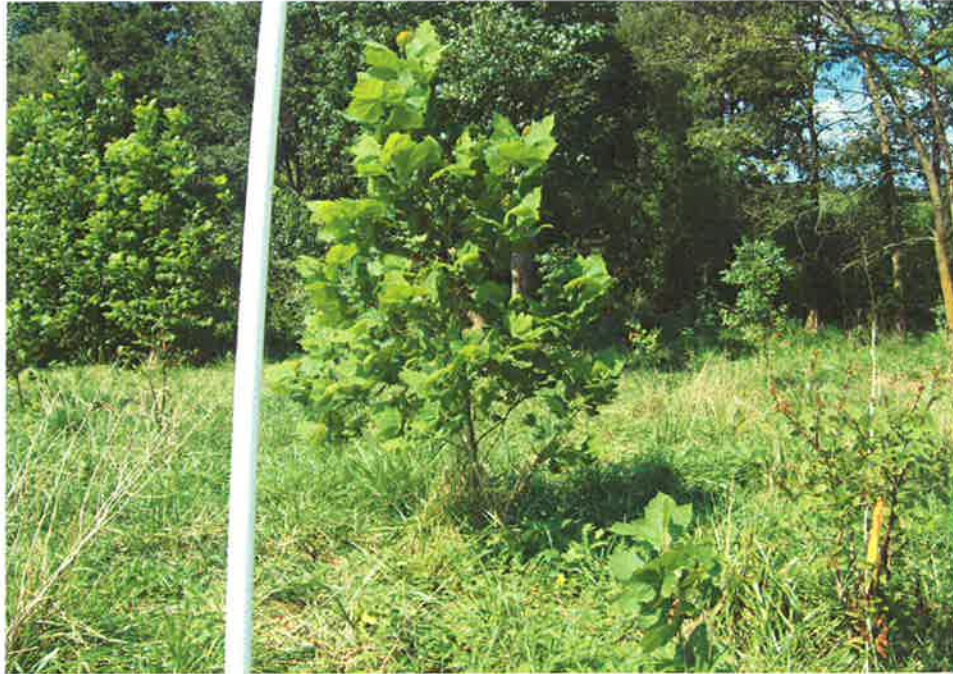
The average stem density of planted species for the site far exceeds the minimum criteria of 288 stems per acre after four years. One plot (plot 3) has a stem density below the minimum. A substantial number of recruit stems have been found across the site, increasing the total stem density by approximately 24%. The number of recruit stems for the individual plots was large enough to bring all plots, except plot 3, into compliance with the four year minimum criteria.

Vegetation Plot 3
Monitoring Year 4
(EMH&T, 9/13/12)

To address the issue of low Year 2 stem counts for planted individuals, specific areas were targeted during the Spring of 2011 and 2012 for supplemental planting within the Davis Branch and Unnamed Tributary riparian corridors, which included the deficient sample plots and surrounding areas within the buffer. The majority of these plantings were concentrated along UT1 and the portion of the Davis Branch EI mainstem reach downstream from the confluence with UT1. Deficient portions of the riparian corridors were supplemented with additional native tree and shrub plantings. These

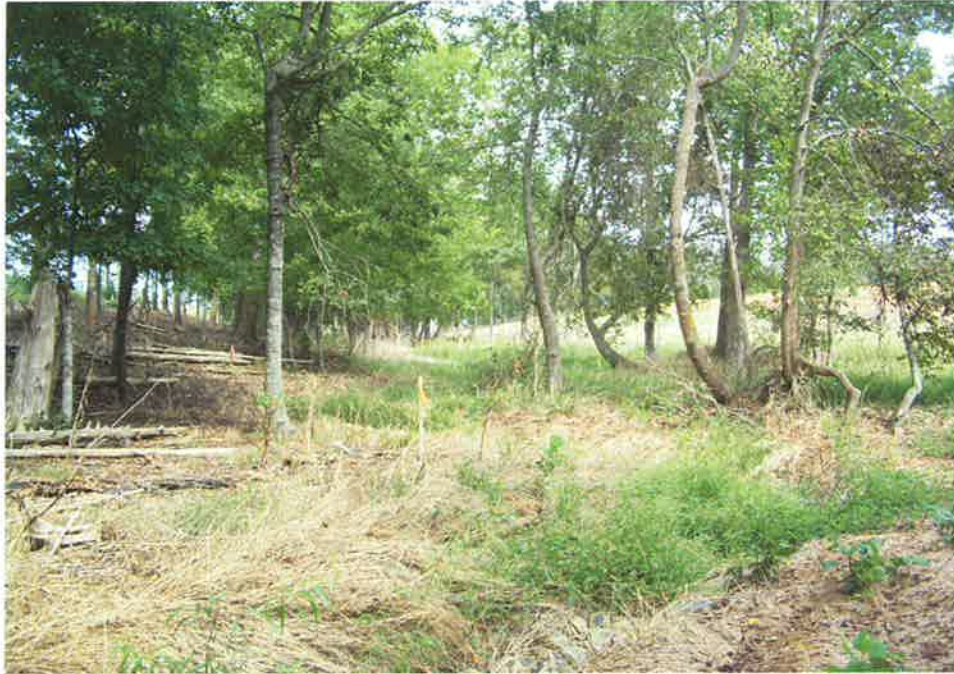
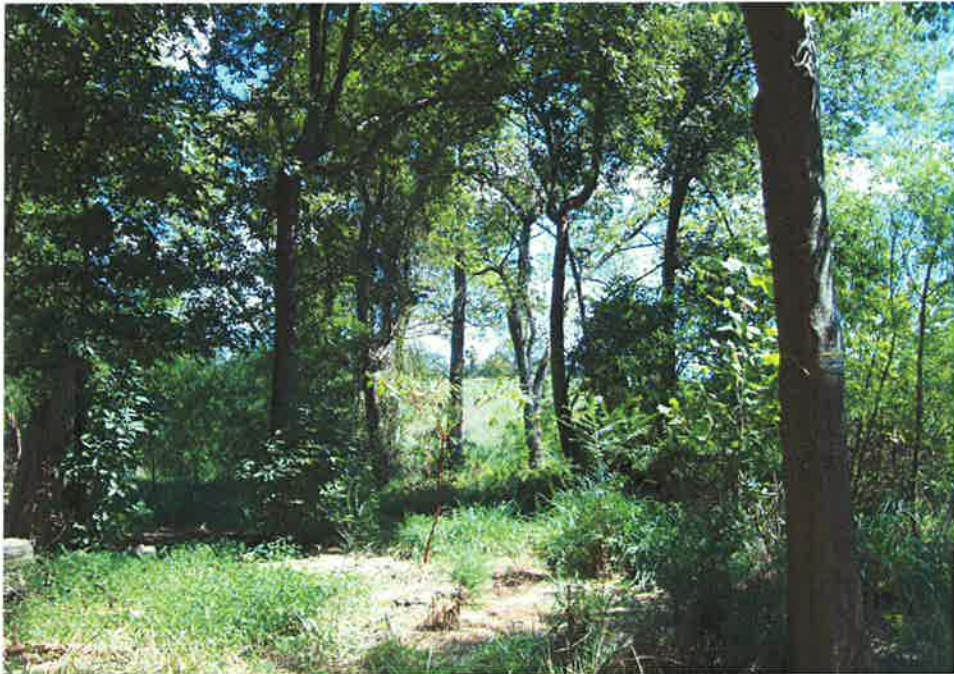
Fixed Station 7

The bare bank issues noted along UT1 in Year 2 have been lessened in Years 3 and 4 due to the colonization of native grasses and herbaceous vegetation. Evidence of the increase in streamside vegetation can be seen in the Fixed Station Photos in Appendix B. It is expected that this native vegetation will continue to fill in bare areas along UT1 in the years to come.

Overview of UT1, looking upstream near Station 6+50.

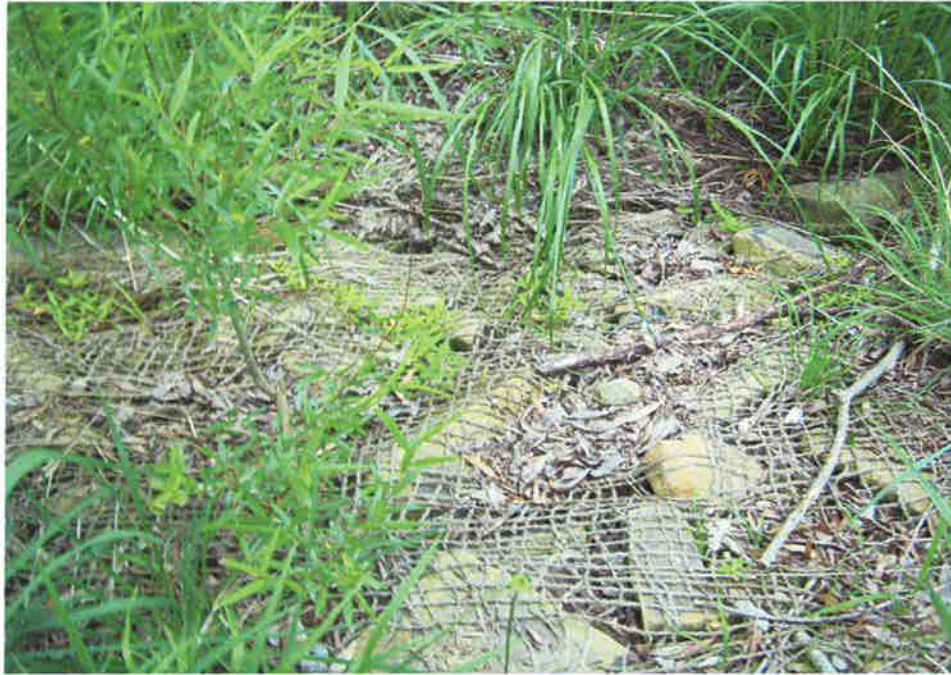
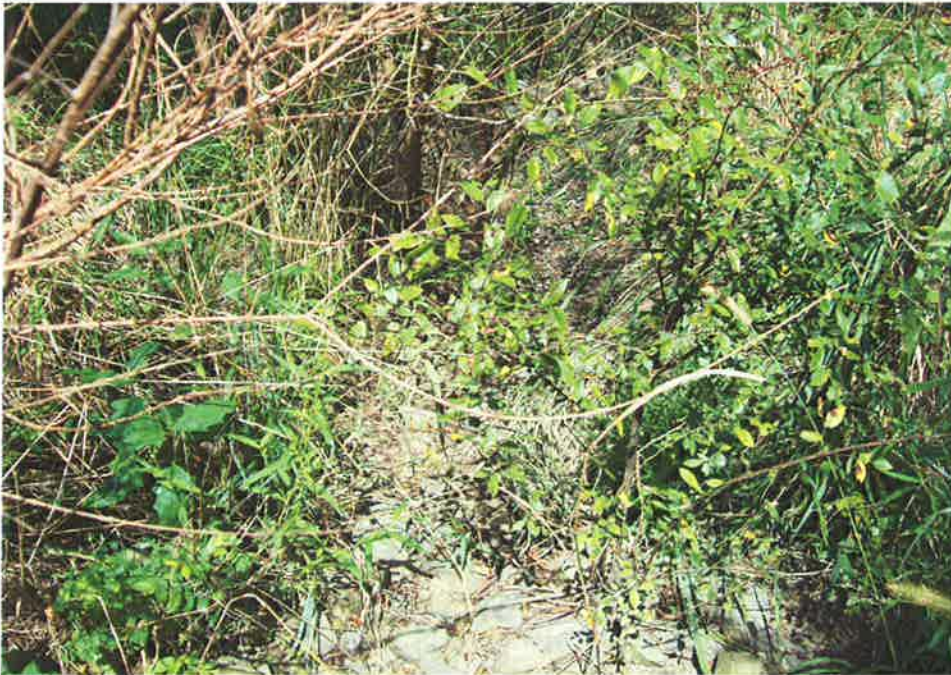
SPA 1

**Bare banks along stream channel bend on Davis Branch near station 8+25. ISSUE
RESOLVED - Vegetation density has increased since 2011.
(Top Photo – Year 3: 9/14/11, Bottom Photo – Year 4: 9/13/12).
(EMH&T)**

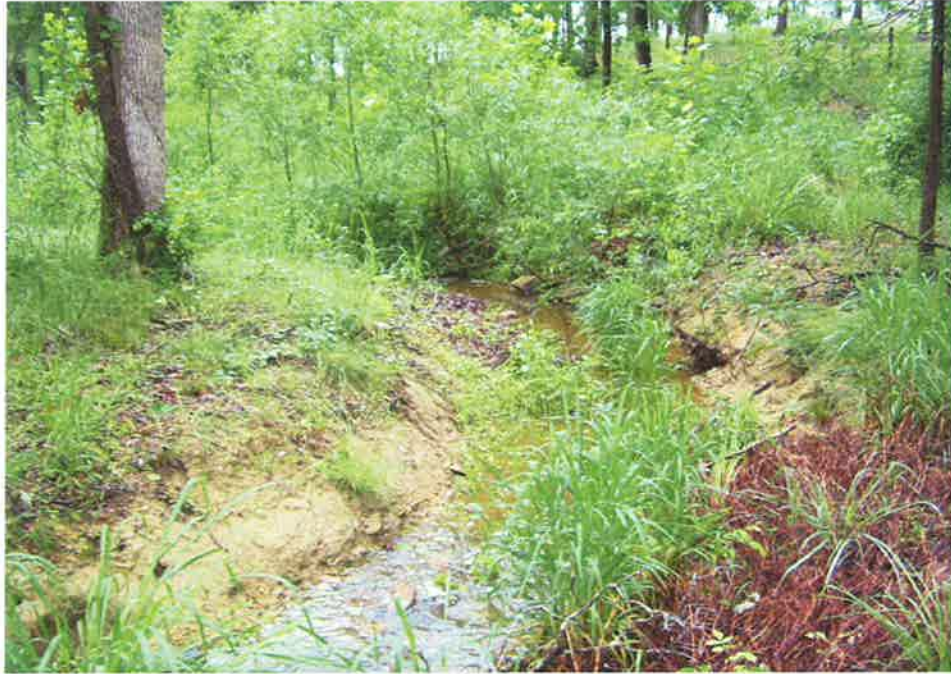
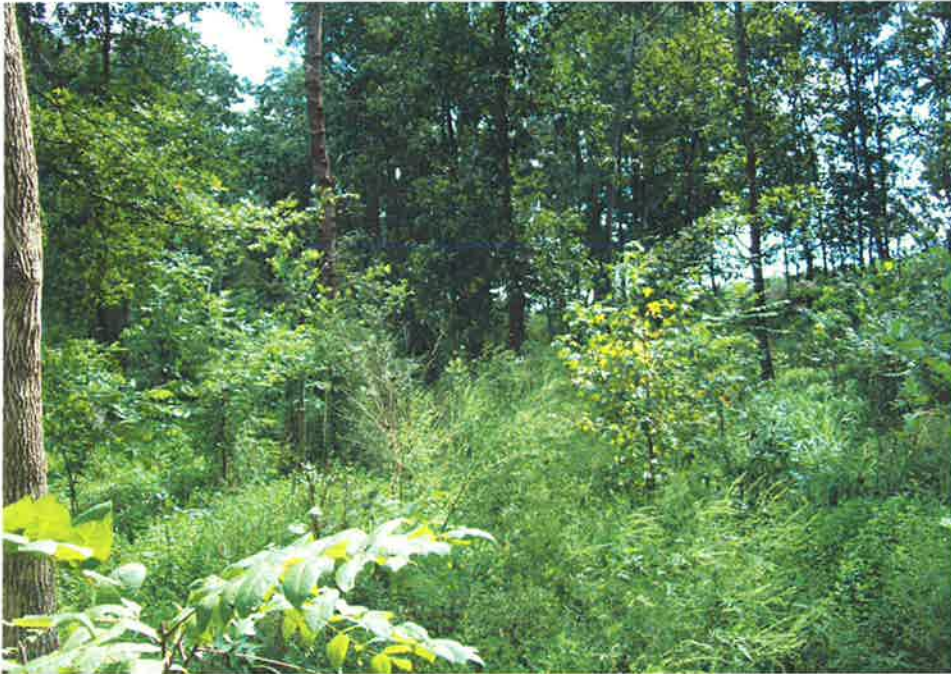
Table X. Stream Problem Areas Davis Branch Stream Restoration / EEP Project No. D06054-F			
Feature Issue	Station Numbers	Suspected Cause	Photo Number
Erosion/Bare Banks	8+00-10+00; Mainstem	Bare banks - concern for future stability if vegetation does not develop (RESOLVED)	SPA 1
	18+00-19+00, 21+00-22+00, and 23+50; Mainstem	Bank erosion (along meander bends) - concern for future stability if vegetation does not develop (RESOLVED)	SPA 2 & SPA 3

Stream problem areas in Year 3 were isolated to a few meander bends along the Davis Branch mainstem. In these places, the right and left banks of the meander bends have little established vegetation to stabilize the slopes. In Year 4, these areas have become increasingly covered with stabilizing vegetation. These areas were considered of low concern in Year 3, as the bends were not in a state of extreme erosion. Additionally, vegetation continues to infiltrate many of the bare areas. This is resulting in an increased root density which provides better stabilization for the stream banks. At this time, remedial maintenance is not warranted. These areas are noted on the Stream Problem Area Map in Appendix B in order that they be watched to catch any erosion problems that may occur before vegetation becomes fully established along these slopes. Actively monitoring these areas will allow developing problems to be caught early and managed without the need for mechanical intervention. If erosion problems arise, the outside meander bends could be stabilized using vegetative methods such as seeding and live stakes, or with a natural fiber (coconut) geotextile. It is expected that streamside vegetation will continue to increase in density over the next year; thus allowing these stream problem areas to be de-listed from Table X and taken off the Stream Problem Area Map in Year 5.

Scour and erosion along the left and right banks at station 21+50 on Davis Branch. ISSUE

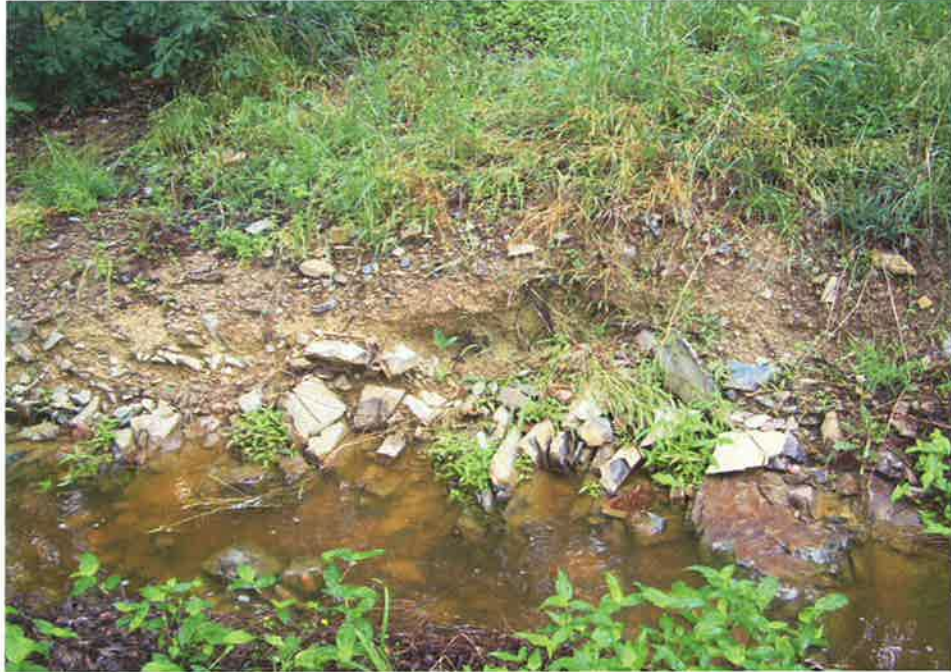
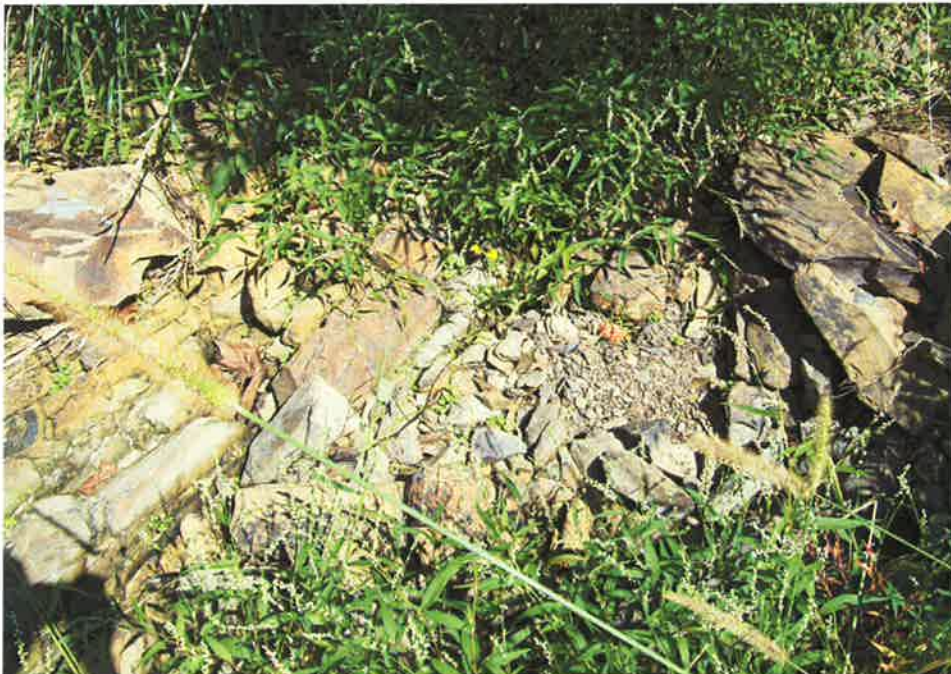
SPA 3

**Scour and erosion along the right bank at station 23+50 on Davis Branch. ISSUE
RESOLVED - Vegetation density has increased since 2011.
(Top Photo – Year 3: 9/14/11, Bottom Photo – Year 4: 9/13/12).
(EMH&T)**

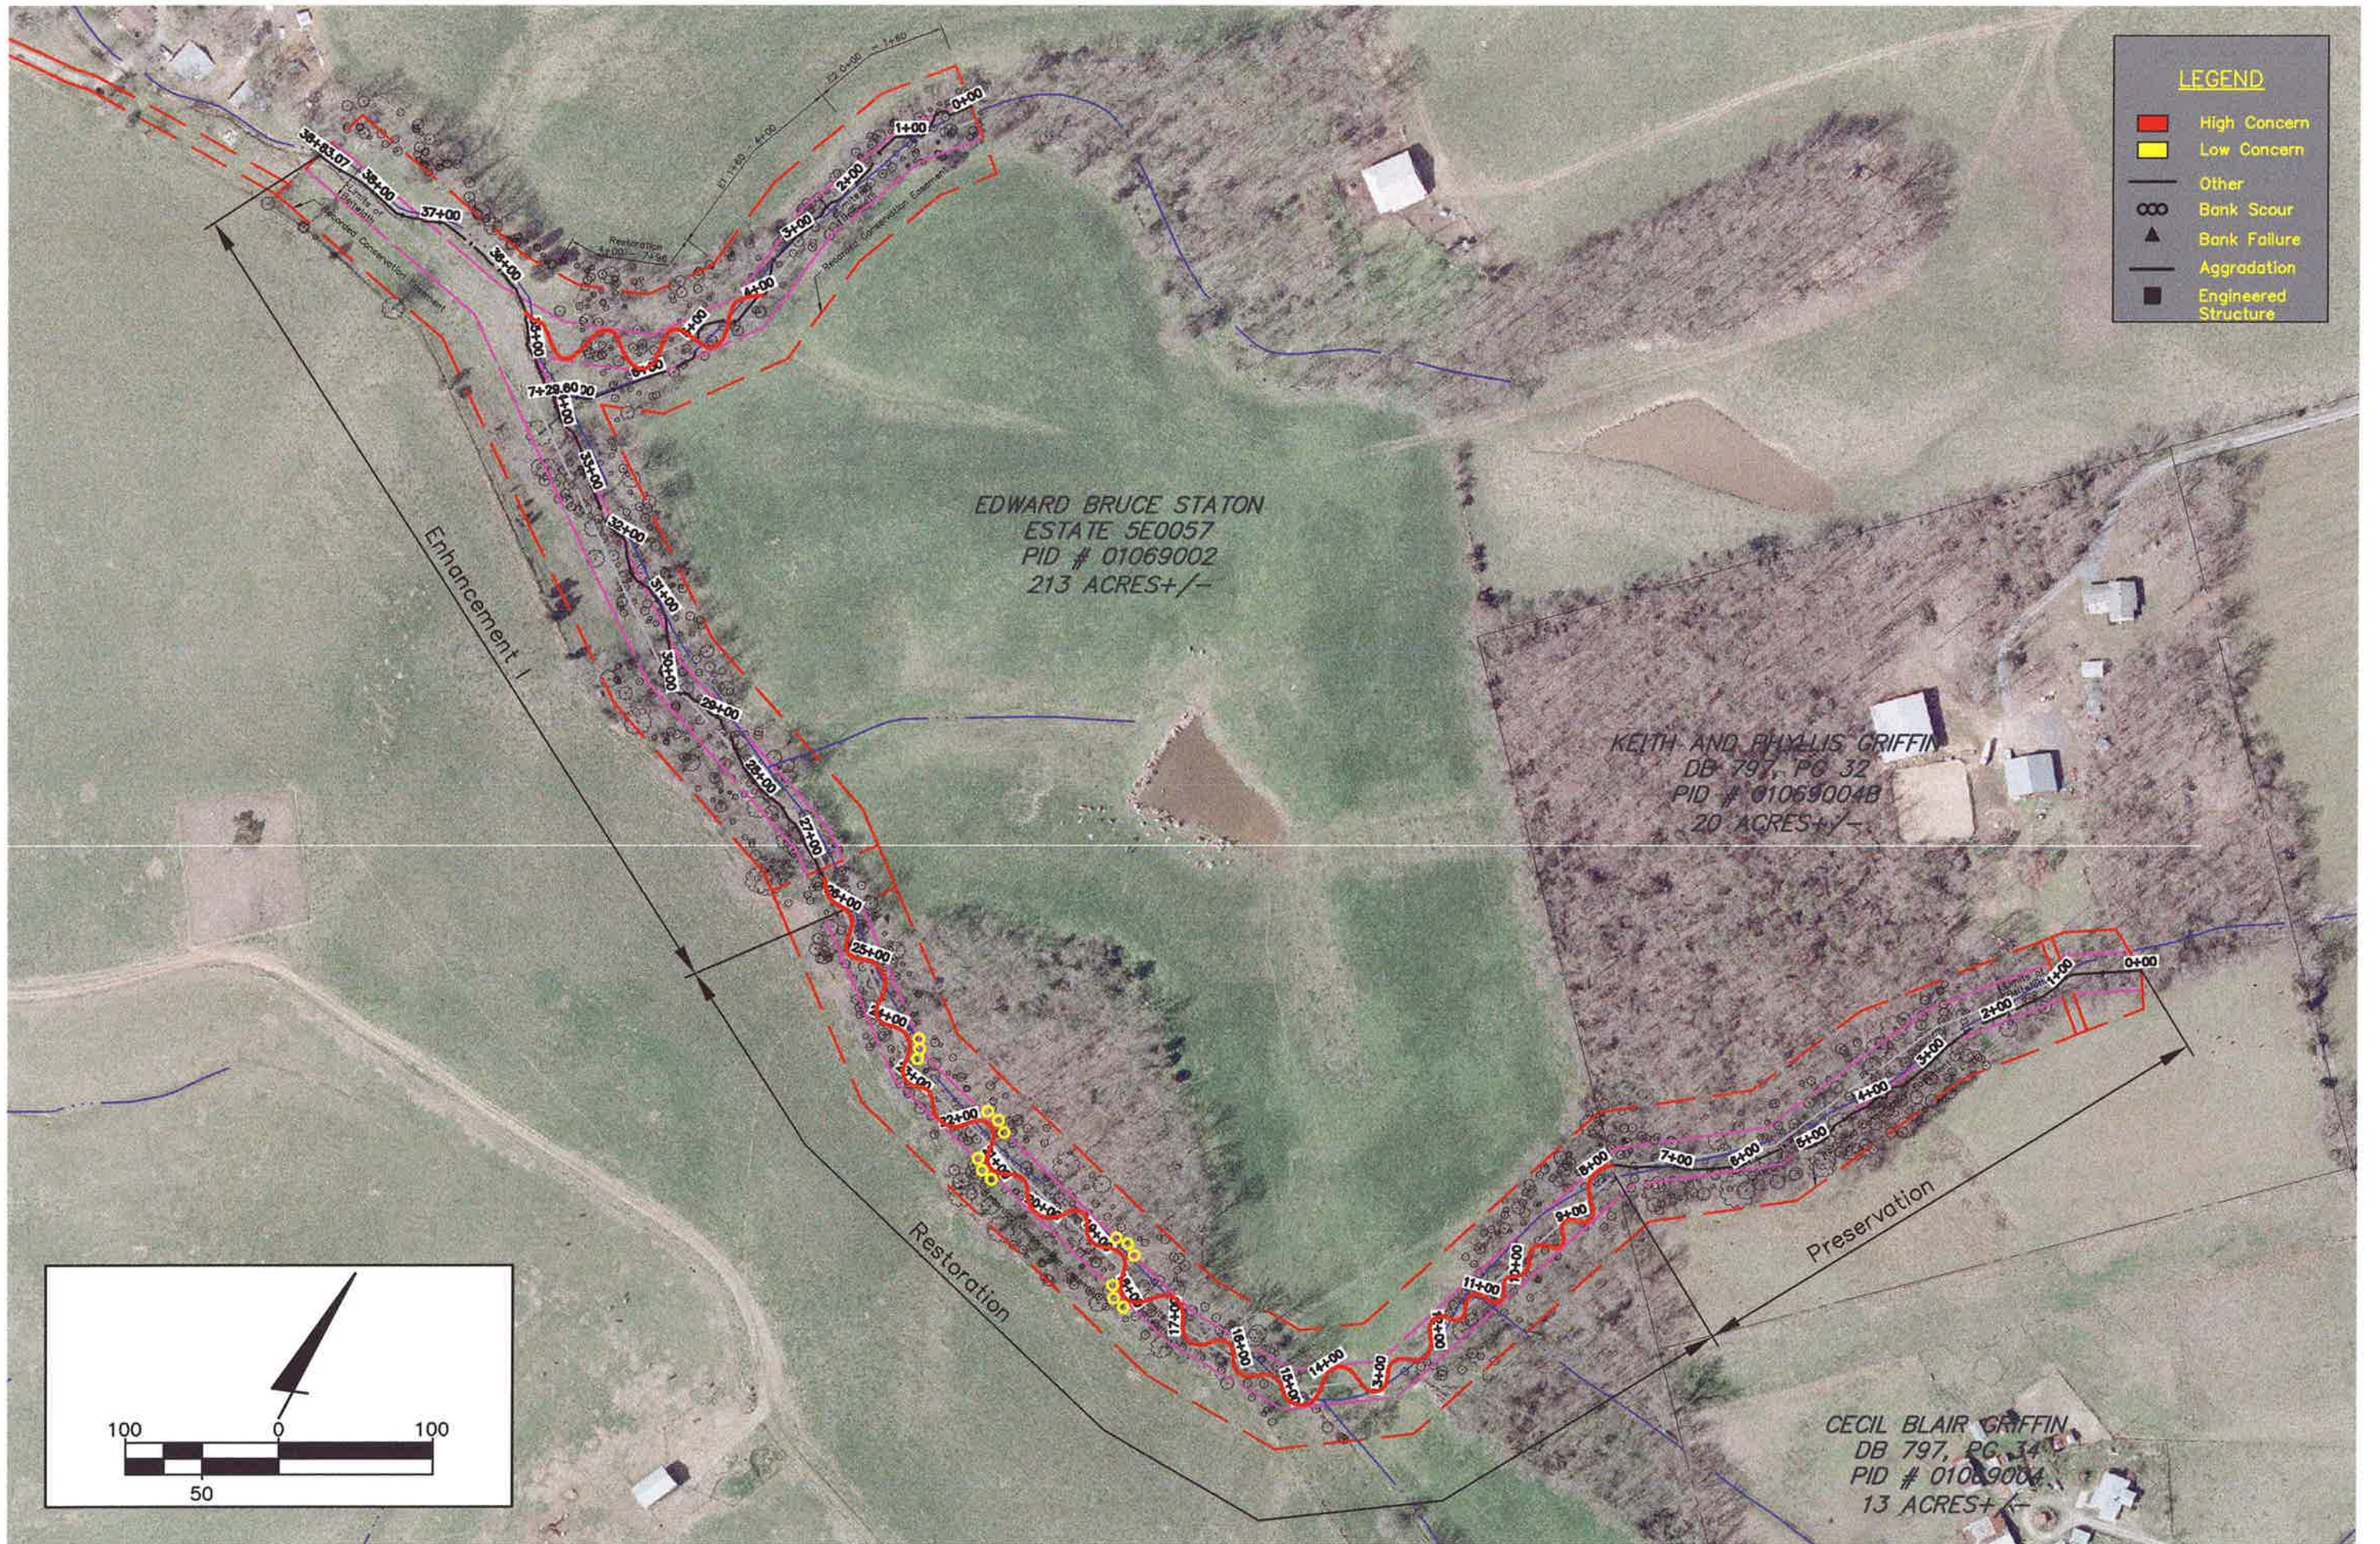
In 2012, less meander scour and erosion was noted along the restoration reach of the mainstem than was observed in 2011. This is due in large part to a generalized increase in the density of herbaceous vegetation along channel banks since 2010. All areas of scour and erosion will again be closely monitored in Year 5 in order to assess trends in stability. If necessary, recommendations will then be given as to the appropriate bank stabilization practices needed.
