Subject: Year 5 Monitoring Report for Stream Mitigation of Davis Branch and UT1; Union County, NC; SCO# D06054-F

# **Year 5 Monitoring Report for Stream Restoration of Davis Branch and Unnamed Tributary**

Union County, NC  
SCO # D06054-F

**Submitted:** January 6, 2014

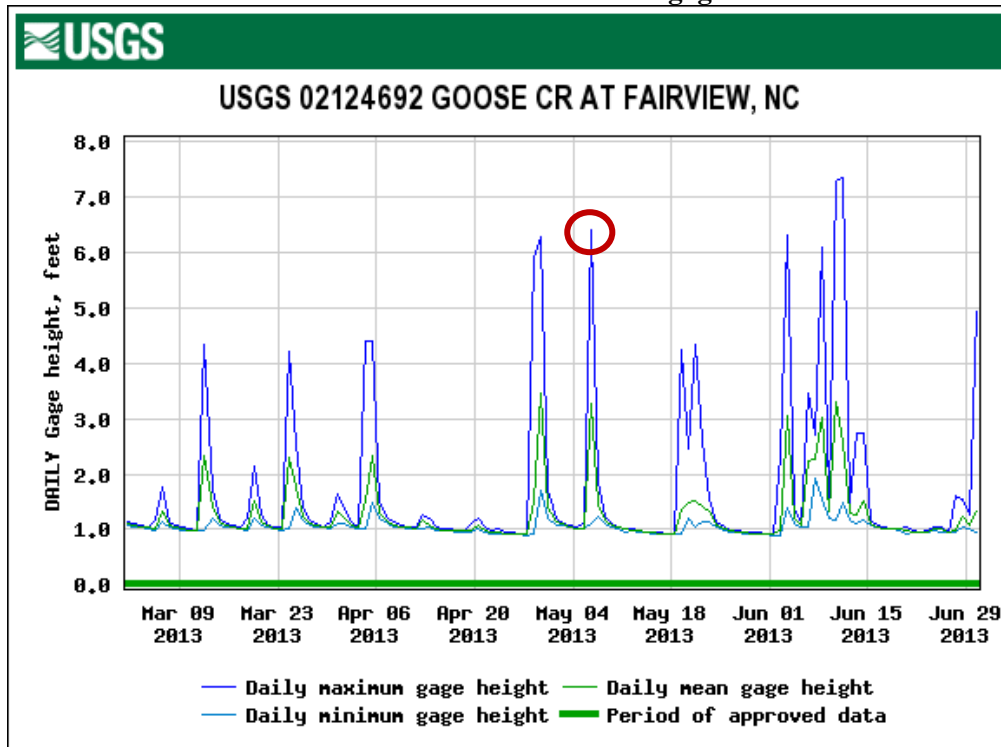
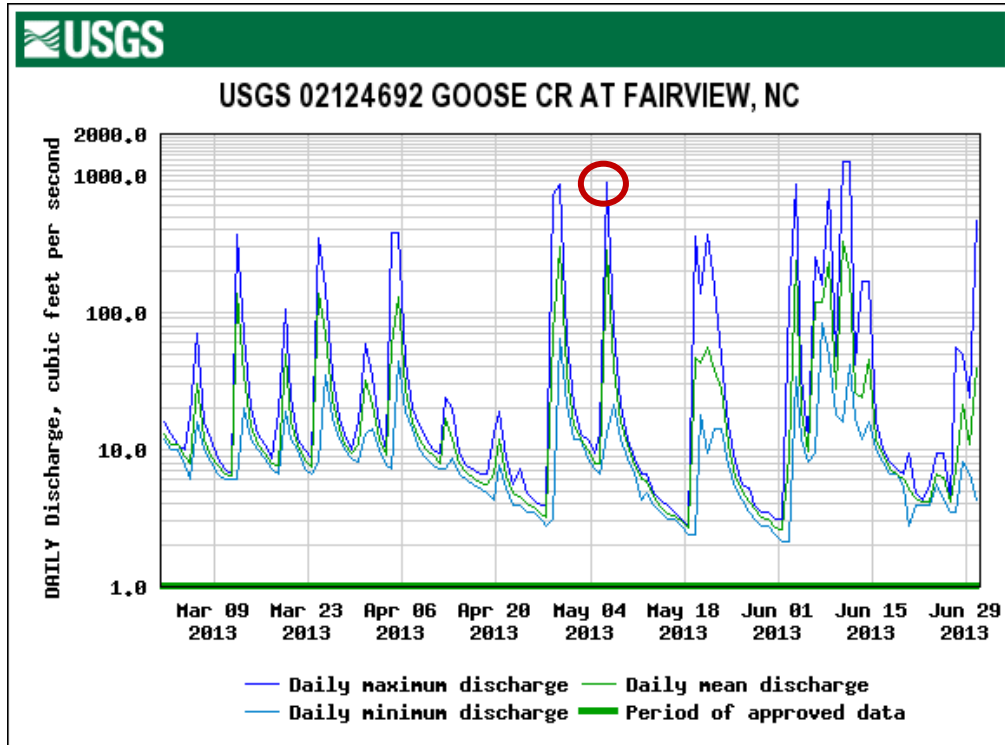
**Years 5 bankfull event – recorded gage data**

Year 5. The most likely date for the recorded bankfull event was after the precipitation event that resulted in the peak stage and discharge recorded at USGS Gage 02124692 Goose Creek at Fairview, NC, on May 6, 2013. On that day, the recorded peak stage elevation was 6.39 feet and the maximum peak discharge at the same station was 892 ft<sup>3</sup>/s. Since this is the largest precipitation event immediately prior to the crest gages were read in 2013, it is likely to be related to the bankfull event recorded by the main stem crest gage within the project reach. The discharge and gage height recorded at the Fairview station for monitoring year 5 are shown on the graphs below.

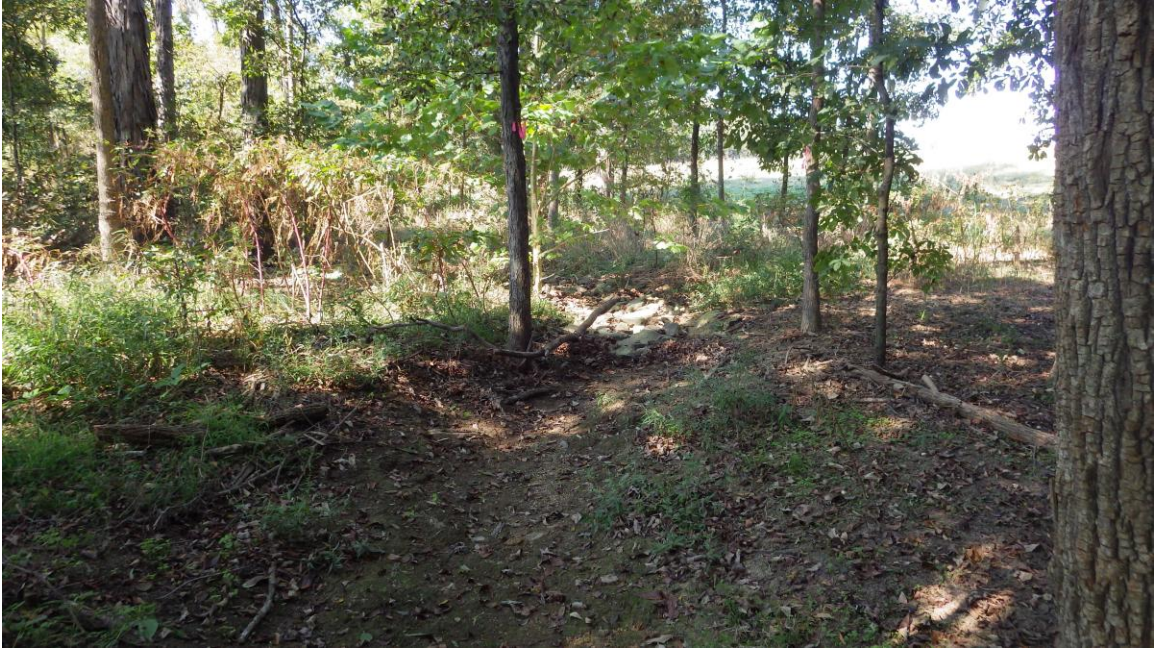
**Fixed Station 1**  
**Overview of Davis Branch, looking downstream at Station 7+80.**  
(EMH&T, 10/1/2013)

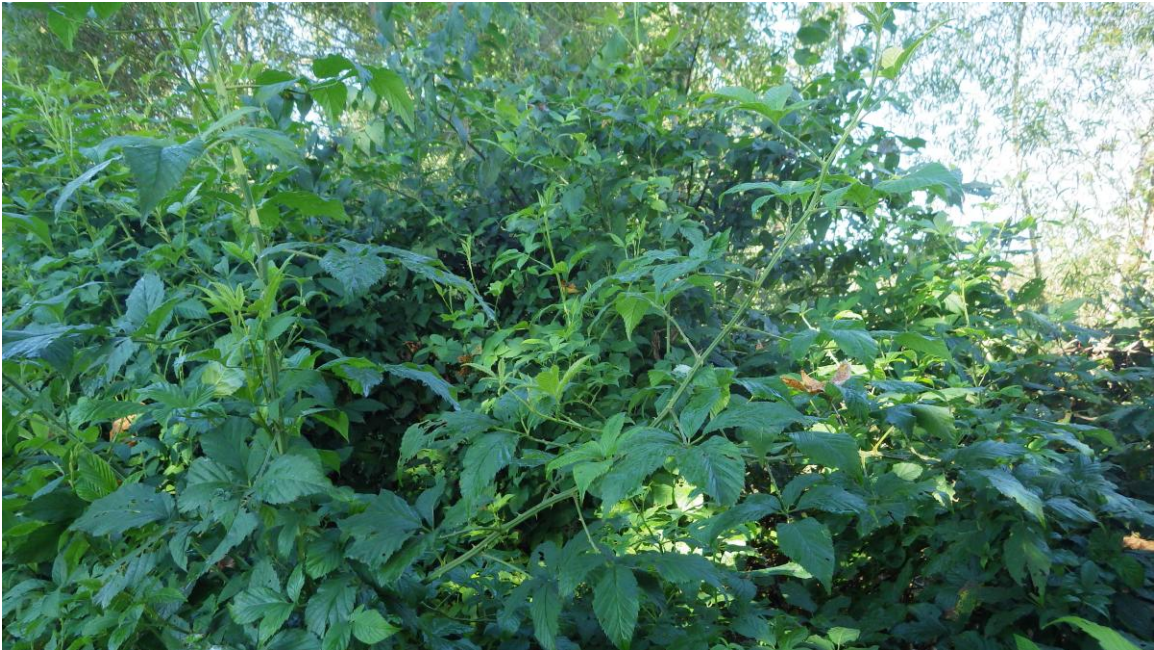
**Fixed Station 2**  
**Overview of Davis Branch, looking downstream near Station 14+75.**  
(EMH&T, 10/1/2013)

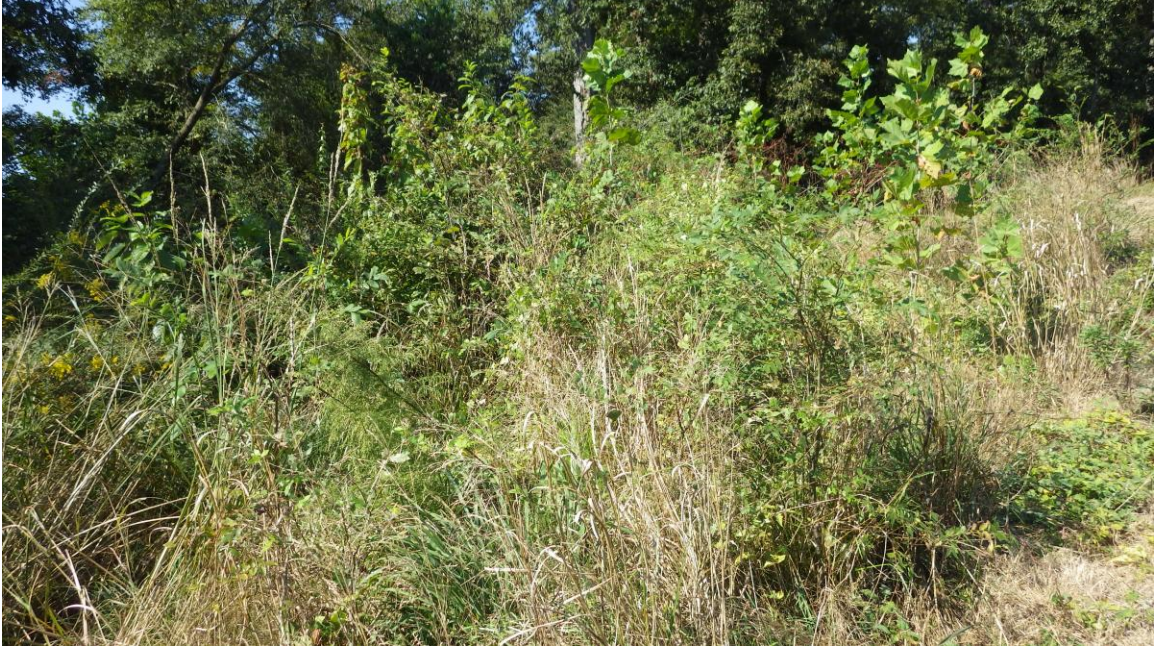
**Fixed Station 3**  
**Overview of Davis Branch, looking downstream near Station 15+50.**  
(EMH&T, 10/1/2013)

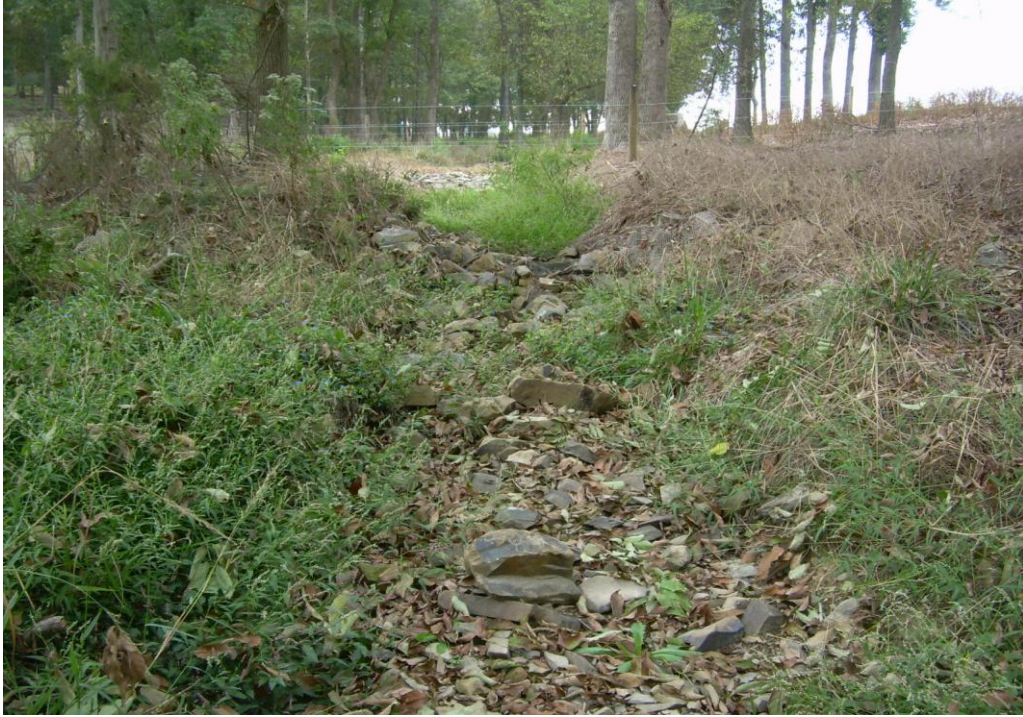
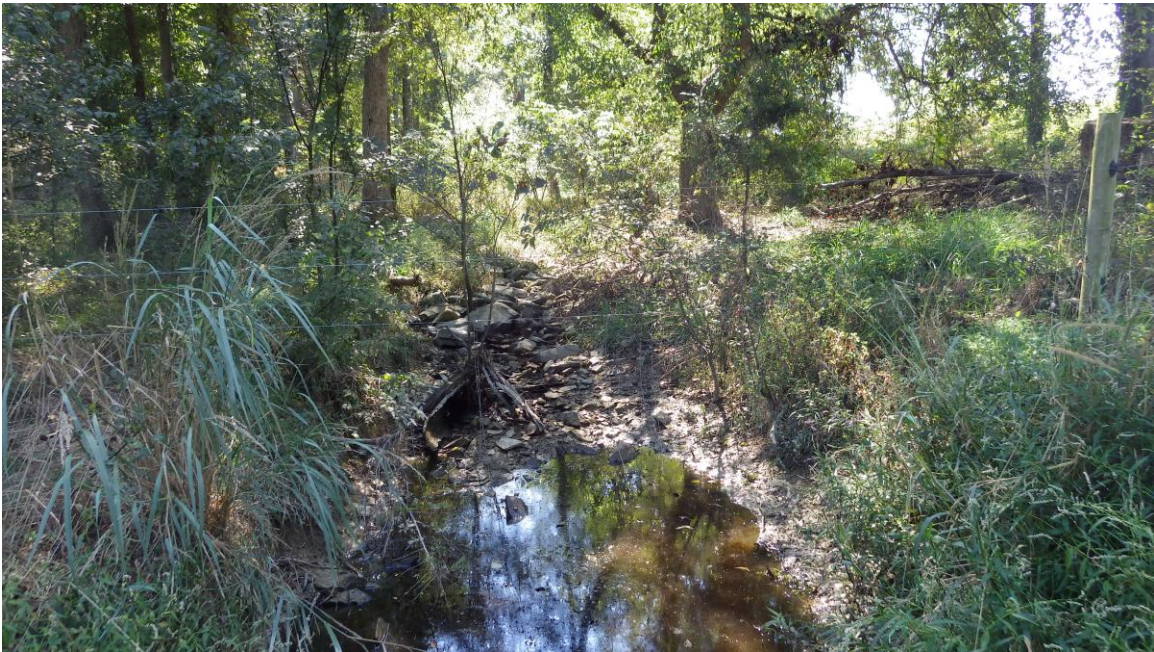
**Fixed Station 4**  
**Overview of Davis Branch, looking upstream near Station 25+75.**  
(Top Photo – Year 1: Sept-2009, Bottom Photo – Year 5: 10/1/2013).  
(EMH&T)

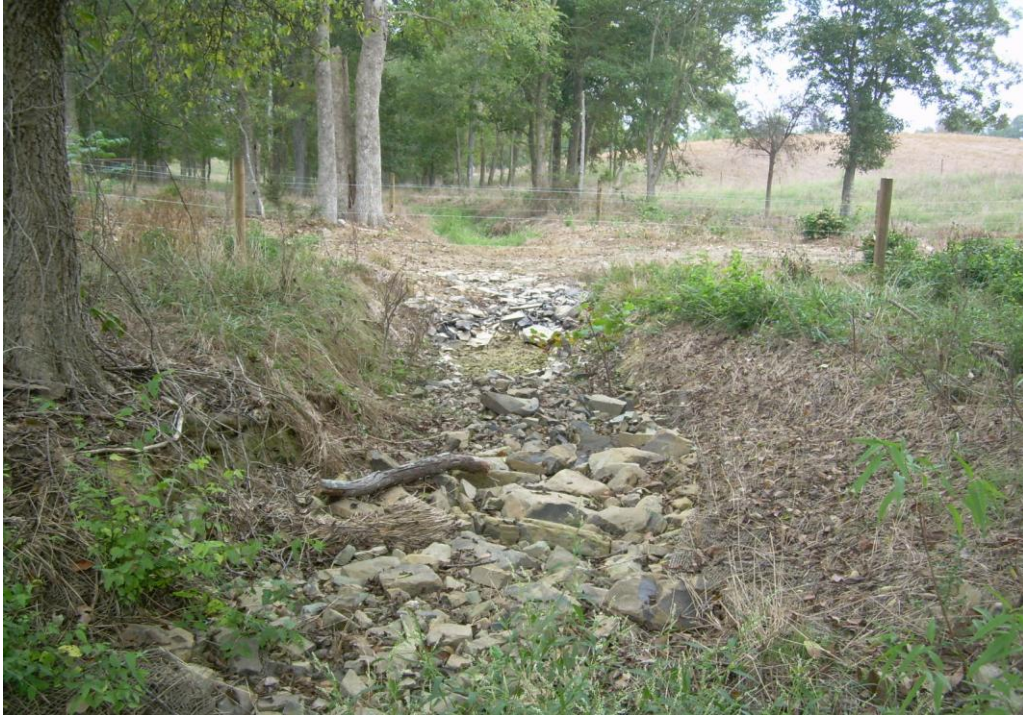
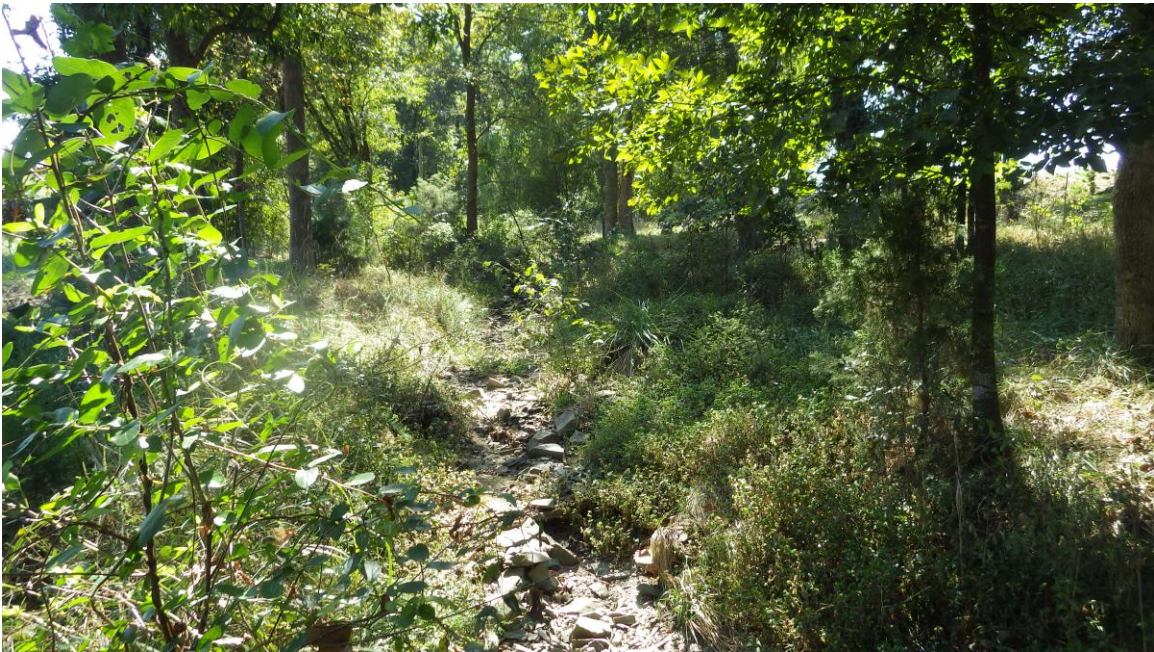
**Fixed Station 5**  
**Overview of Davis Branch, looking upstream near Station 27+25.**  
(Top Photo – Year 1: Sept-2009, Bottom Photo – Year 510/1/2013).  
(EMH&T)

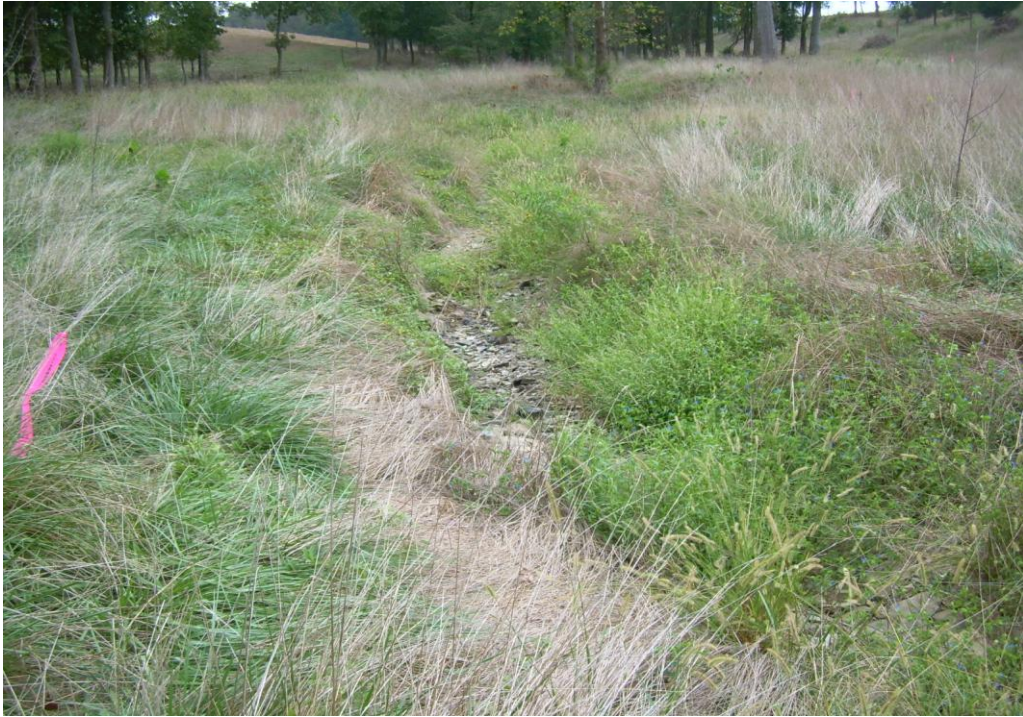
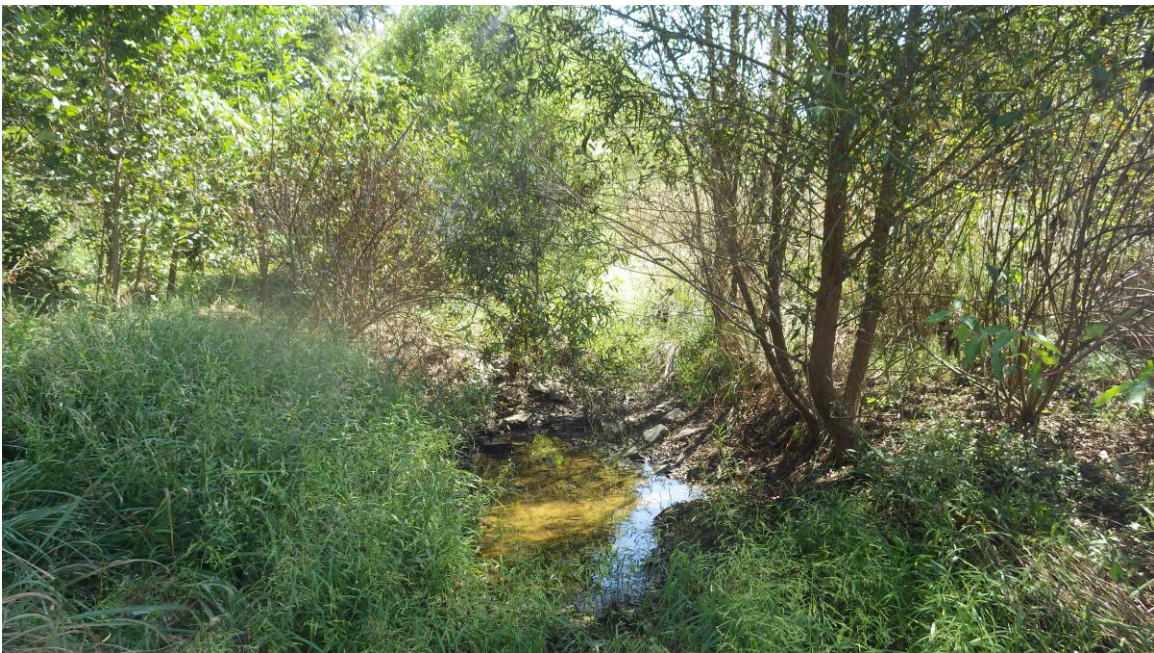
**Fixed Station 6**  
**Overview of Davis Branch, looking upstream near Station 38+75.**  
(Top Photo – Year 1: Sept-2009, Bottom Photo – Year 5: 10/1/2013).  
(EMH&T)

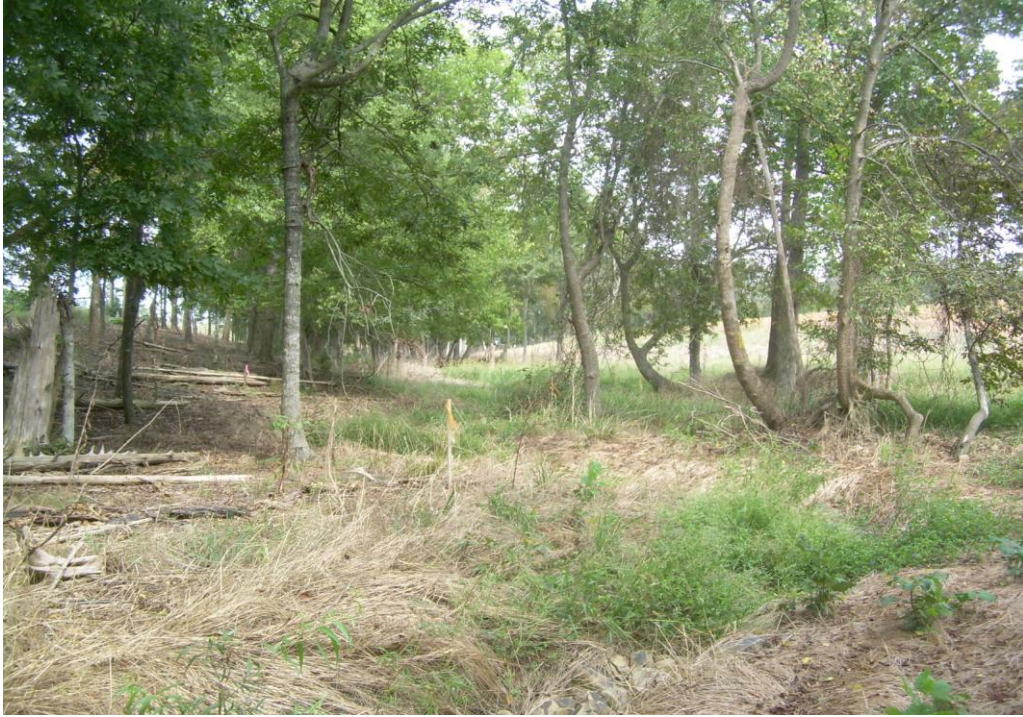
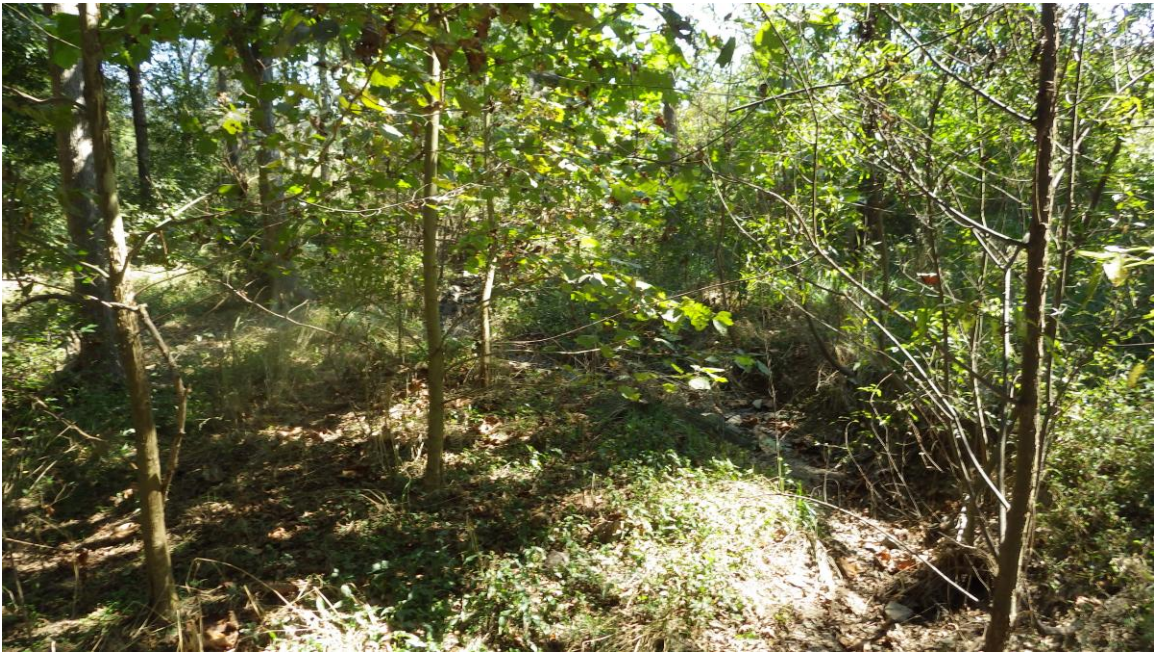
**Fixed Station 7**  
**Overview of UT1, looking upstream near Station 6+50.**  
(Top Photo – Year 1: Sept-2009, Bottom Photo – Year 5: 10/1/2013).  
(EMH&T)

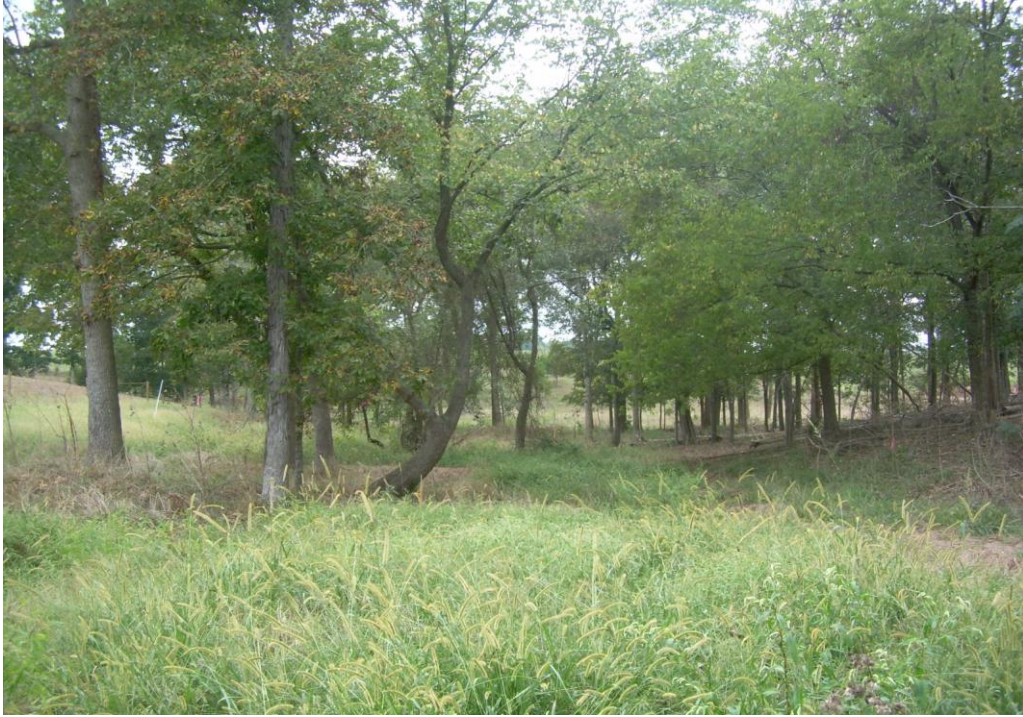
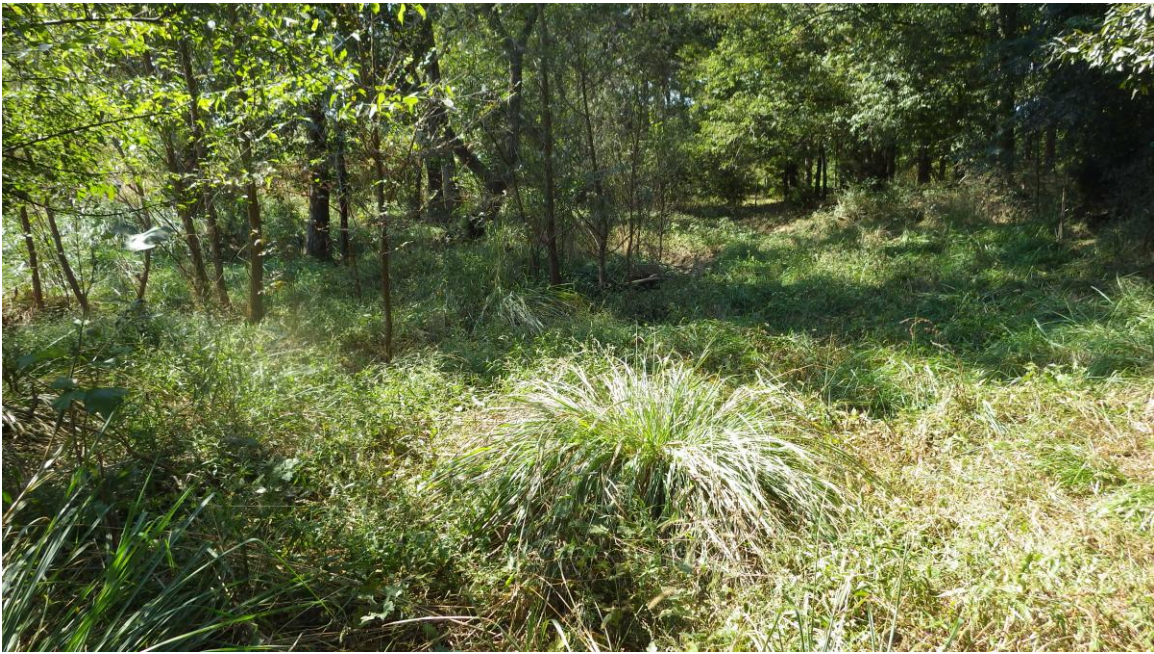
**Fixed Station 8**  
**Overview of UT1, looking downstream near Station 4+50.**  
(Top Photo – Year 1: Sept-2009, Bottom Photo – Year 5: 10/1/2013).  
(EMH&T)

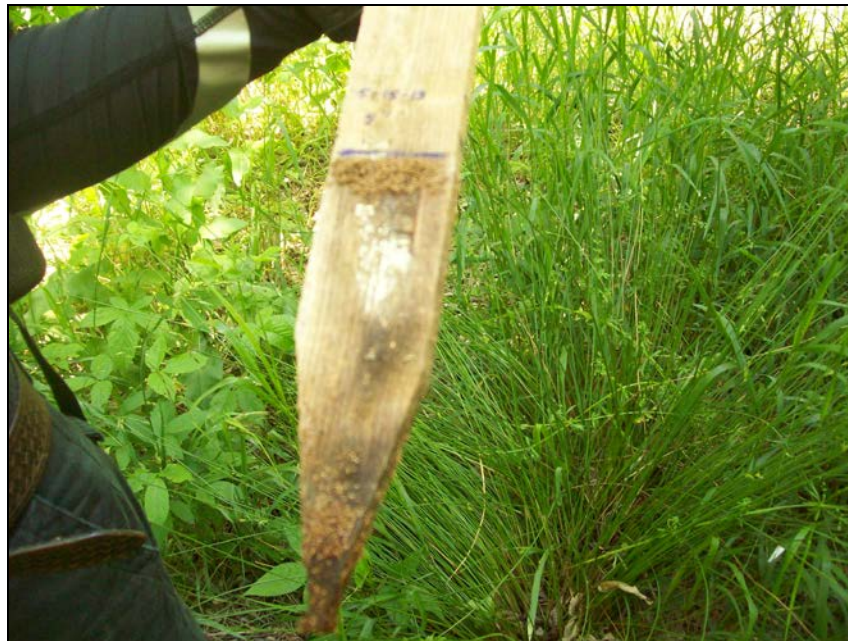
On May 15, 2013, the crest gage on the Davis Branch main stem was observed and indicated a bankfull event at a level of 5 inches above the bottom of the crest gage. The crest gage on UT1 was unable to be opened; therefore, it is unknown whether a bankfull event occurred on the tributary in

**BF 4**  
**Crest Gage on the mainstem of Davis Branch (Year 5).**  
(EMH&T, 5/15/13)
