ANNUAL REPORT FOR 2003

Fork Creek Tributaries Stream Mitigation Site (Deaton Site)
Randolph County
WBS Element 34820.4.1
TIP No. R-2417WM

Prepared By:
Office of Natural Environment & Roadside Environmental Unit
North Carolina Department of Transportation
December 2003

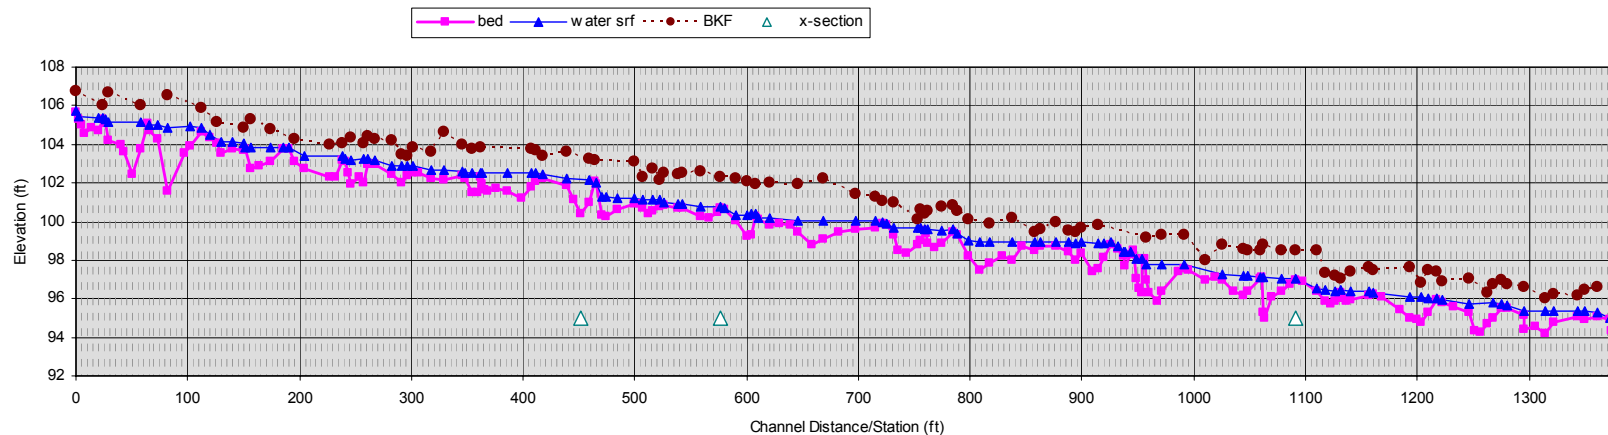
Longitudinal Profile of Deaton North Branch Monitoring Site , 2003

- ◆ Station 1+90 DN. A small transverse bar was observed in the middle of the channel through the riffle section. As a result, the right bank is exhibiting minor toe scour. This reach is within the wooded area at the beginning of the restoration where minimal channel work was performed to save established vegetation. This location should be assessed during the next monitoring period to determine remedial actions, if necessary.

- ◆ Station 4+40 DN. Active erosion was noted on the left bank just upstream from the maximum pool depth. Most of the erosion is due to overland flow spilling over banks with minimal vegetation. This area should be assessed during the next monitoring period to determine remedial actions, if necessary.

- ◆ Station 10+60 DN. Active erosion was noted along right side of cross vane arm. This area should be assessed during the next monitoring period to determine remedial actions, if necessary.

- ◆ Throughout the restored reach, herbaceous vegetation continues to dominate the stream banks and channel areas. This should be assessed during the next monitoring period to determine remedial actions, if necessary.

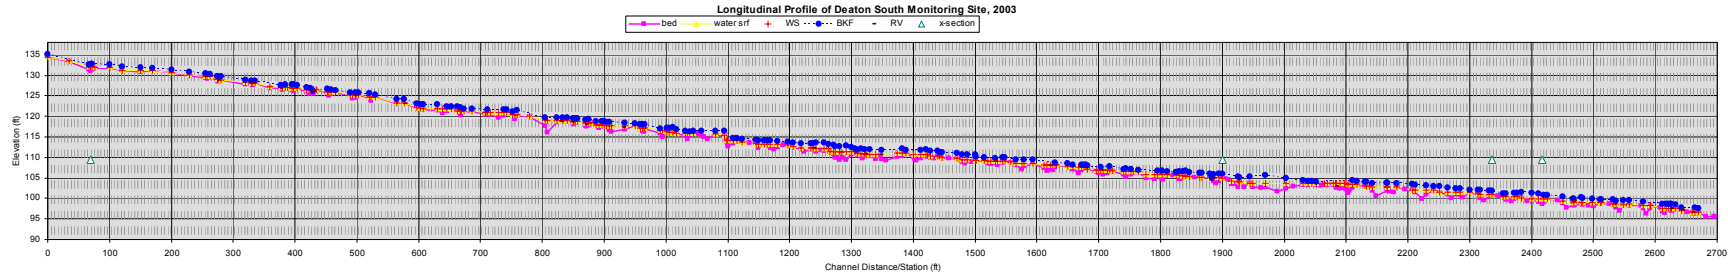
Longitudinal Profile of Deaton South Monitoring Site, 2003

- ◆ Station 2+85 DS. The cross vane and header rock were covered by fine sediment. The sediment may be originating from an area outside the mitigation buffer and immediately upstream of the headwaters. Flushing of the sediment is expected to occur once the vegetation dies back during the winter. This should be assessed during the next monitoring period to determine remedial actions, if necessary.

- ◆ Station 5+77 DS. Gravel has accumulated and filled the pool below the cross vane. This location should be assessed during the next monitoring period to determine remedial actions, if necessary.

- ◆ Station 6+06 DS. Active scour is undercutting the outside of the meander bend. Minimal channel work was performed in this wooded area in order to save established vegetation. This location should be assessed during the next monitoring period to determine remedial actions, if necessary.

- ◆ Station 13+47 DS. Several rocks from the cross vane structure have fallen into the middle of the channel. No erosion was noted, possibly due to the thick herbaceous vegetation growing along the banks and across the channel. This location should be

- ◆ Station 19+12 DS. A possible headcut was observed between Stations 19+12 and 19+15. The thalweg differed approximately 1.3 feet in elevation. The surrounding area is sparsely wooded with several mature willow oak and black walnut trees. Minimal channel work was completed in order to reduce potential impacts to the vegetation. This location should be assessed during the next monitoring period to determine remedial actions, if necessary.

- ◆ Station 23+67 DS. Scour associated with the outside of the meander bend has undercut the bank behind the erosion control matting. This location should be assessed during the next monitoring period to determine remedial actions, if necessary.

- ◆ Station 24+67 DS. Several rocks from the cross vane structure have fallen into the middle of the channel. No erosion was noted, possibly due to the thick herbaceous vegetation growing along the banks and across the channel. This location should be assessed during the next monitoring period to determine remedial actions, if necessary.
