ANNUAL REPORT FOR 2004

Fork Creek Tributaries Stream Mitigation Site (Deaton Site)
Randolph County
WBS Element 34820.4.1
TIP No. R-2417WM

Prepared By:
Office of Natural Environment & Roadside Environmental Unit
North Carolina Department of Transportation
October 2004

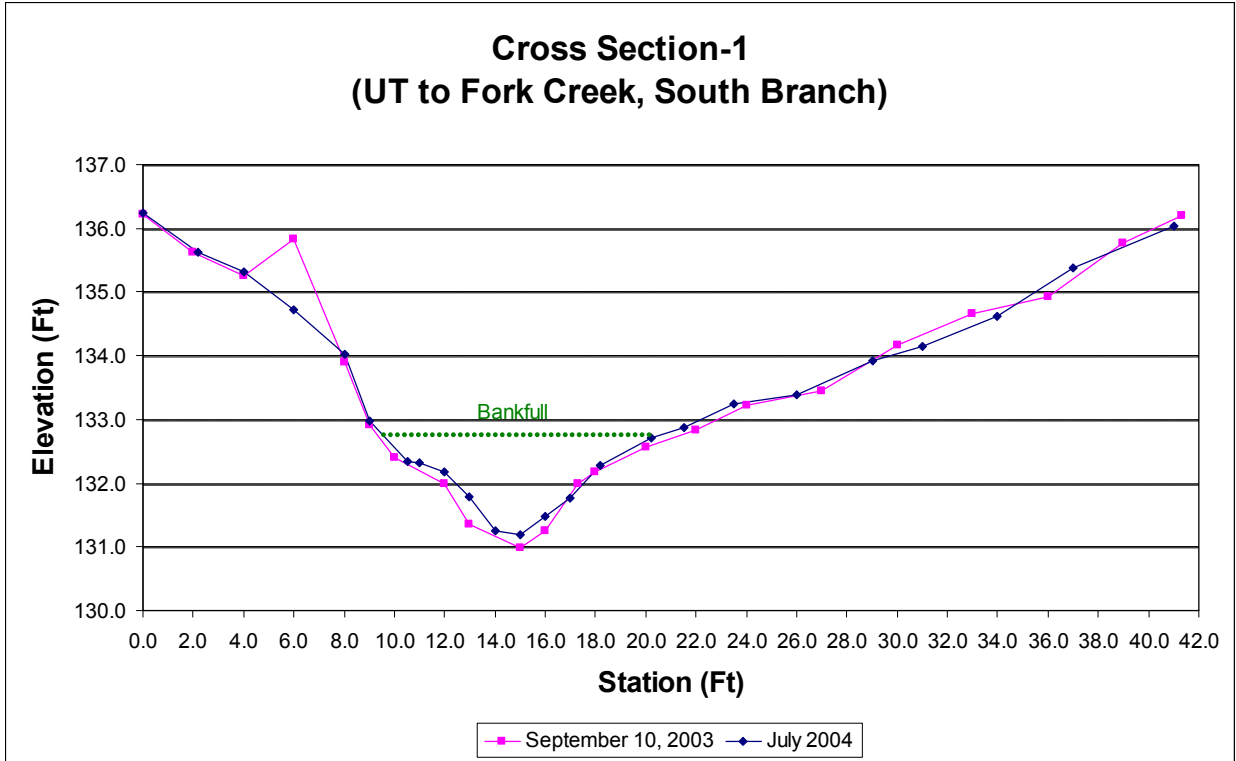
Cross-Section #1 (Pool) Abbreviated Morphological Summary*

2003	2004	2005	2006	2007
Bankfull Cross Sectional Area (ft ²)	6.3	8			
Maximum Bankfull Depth (ft)	1.4	1.5			
Bankfull Mean Depth (ft)	0.7	0.8			
Bankfull Width (ft)	9.2	10.6

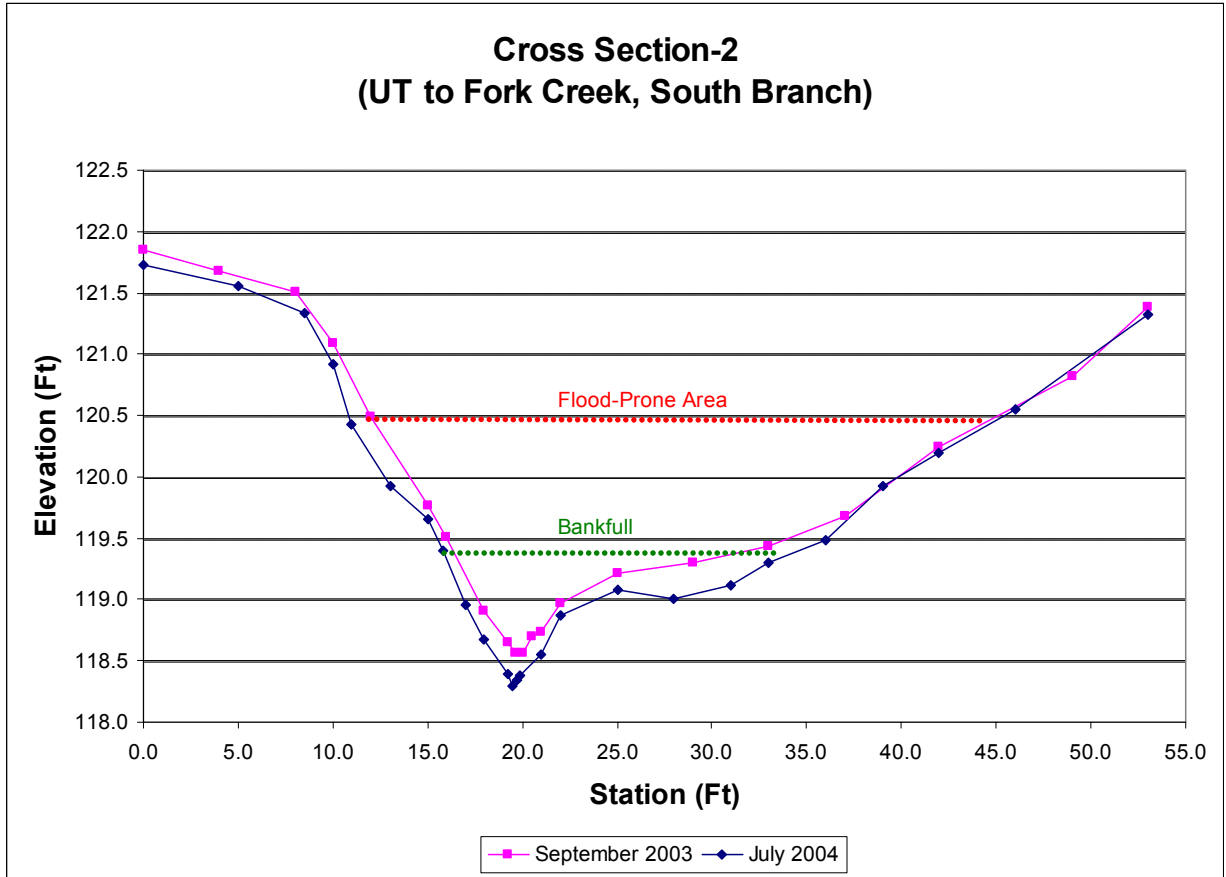
Cross-Section #2 (Riffle) Abbreviated Morphological Summary

2003	2004	2005	2006	2007
Bankfull Cross Sectional Area (ft ²)	3.3	8.2			
Maximum Bankfull Depth (ft)	0.7	1.1			
Bank Height (ft)	0.3	0.4			
Width/Depth Ratio	46	43.4			
Entrenchment Ratio	2.6	1.7			
Bankfull Width (ft)	12.3	18.9

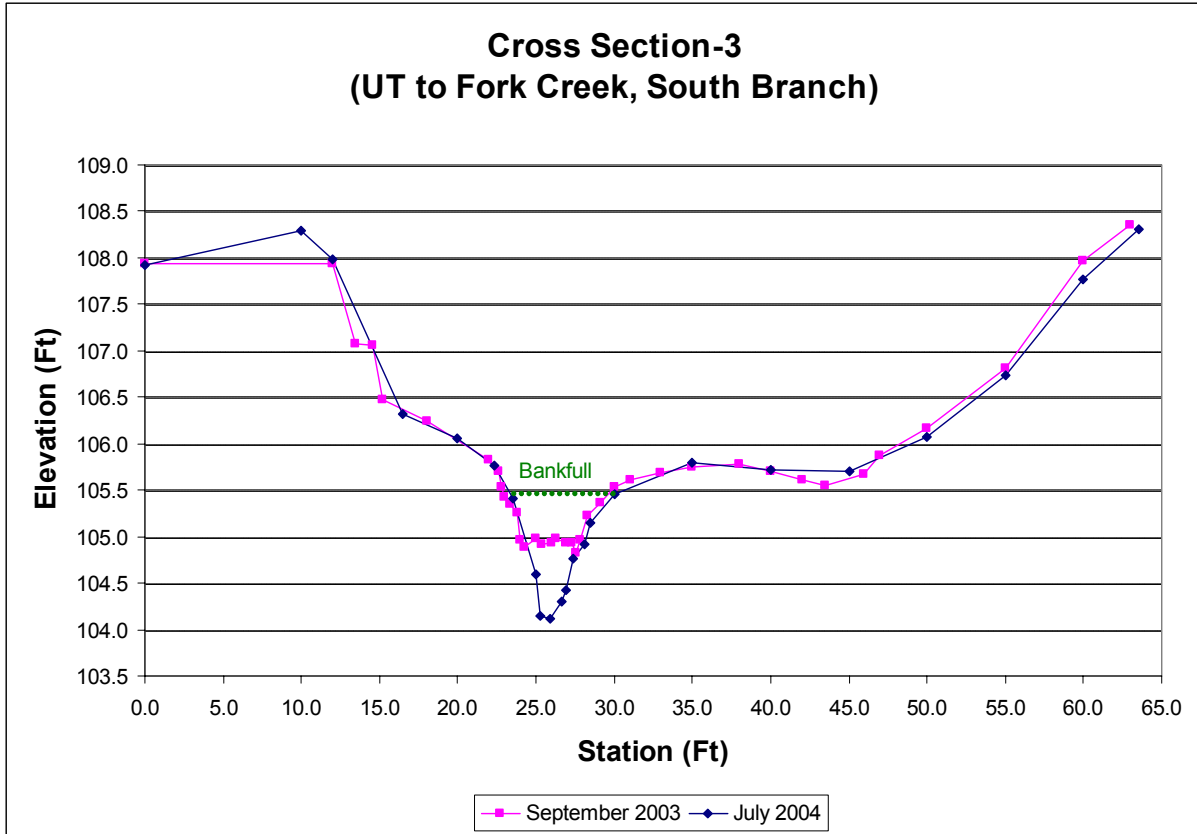
Cross-Section #3 (Glide) Abbreviated Morphological Summary*

2003	2004	2005	2006	2007
Bankfull Cross Sectional Area (ft²)	4.8	4			
Maximum Bankfull Depth (ft)	0.9	1.3			
Bankfull Mean Depth (ft)	0.3	0.6			
Bankfull Width (ft)	16.1	6.3

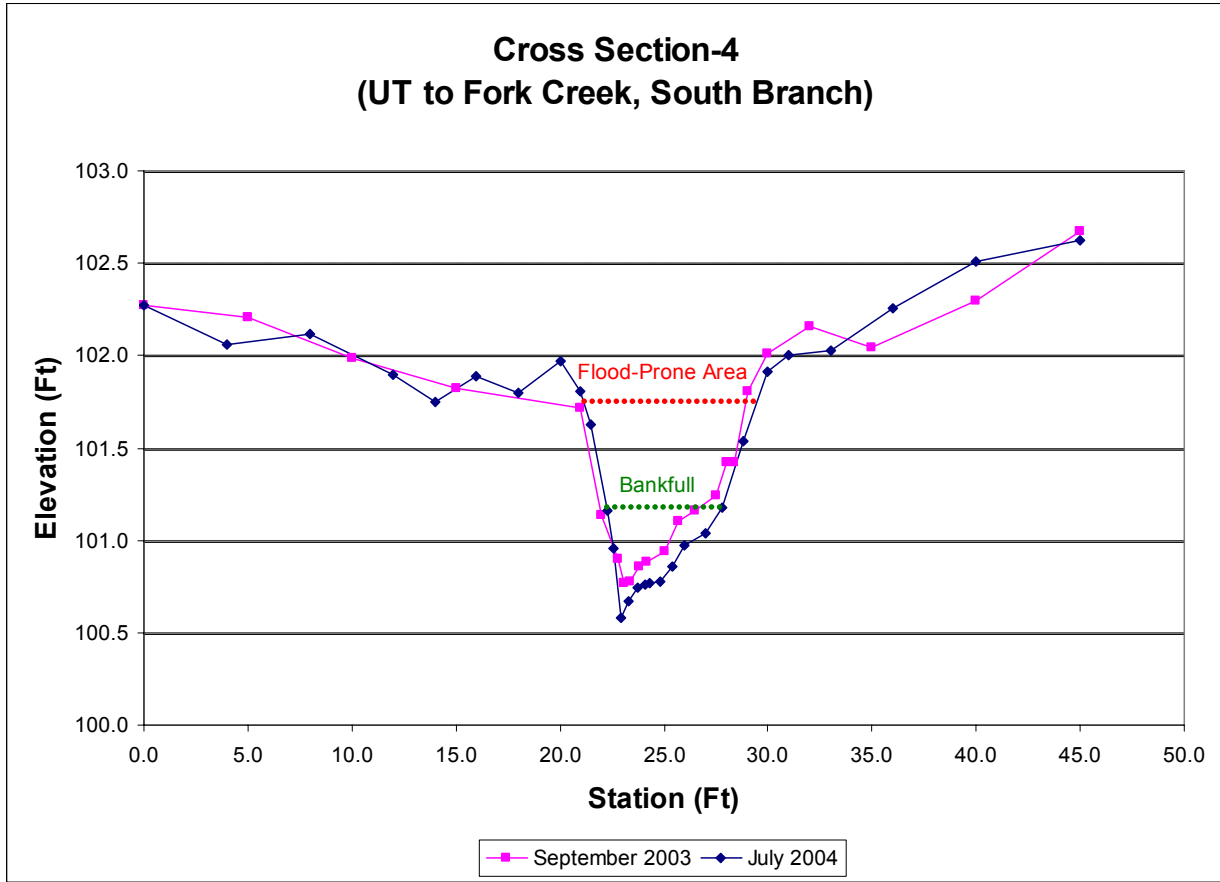
Cross-Section #4 (Rifle) Abbreviated Morphological Summary

2003	2004	2005	2006	2007
Bankfull Cross Sectional Area (ft ²)	4.6	1.6			
Maximum Bankfull Depth (ft)	1	0.6			
Bankfull Mean Depth (ft)	0.6	0.3			
Width/Depth Ratio	13.4	18.7			
Entrenchment Ratio	7.6	10.8			
Bankfull Width (ft)	7.9	5.5

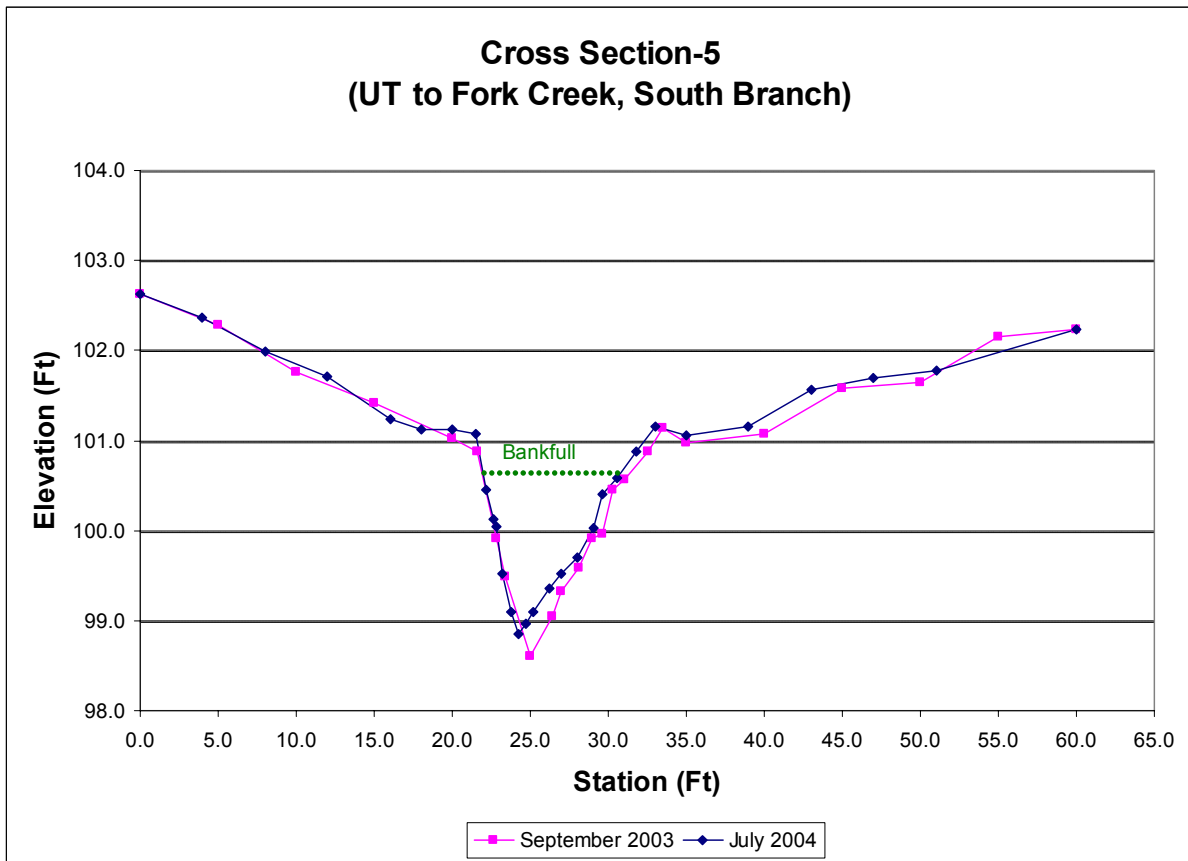
Cross-Section #5 (Pool) Abbreviated Morphological Summary*

2003	2004	2005	2006	2007
Bankfull Cross Sectional Area (ft²)	12.2	7.9			
Maximum Bankfull Depth (ft)	2.3	1.7			
Bankfull Mean Depth (ft)	1.1	0.9			
Bankfull Width (ft)	10.9	8.5

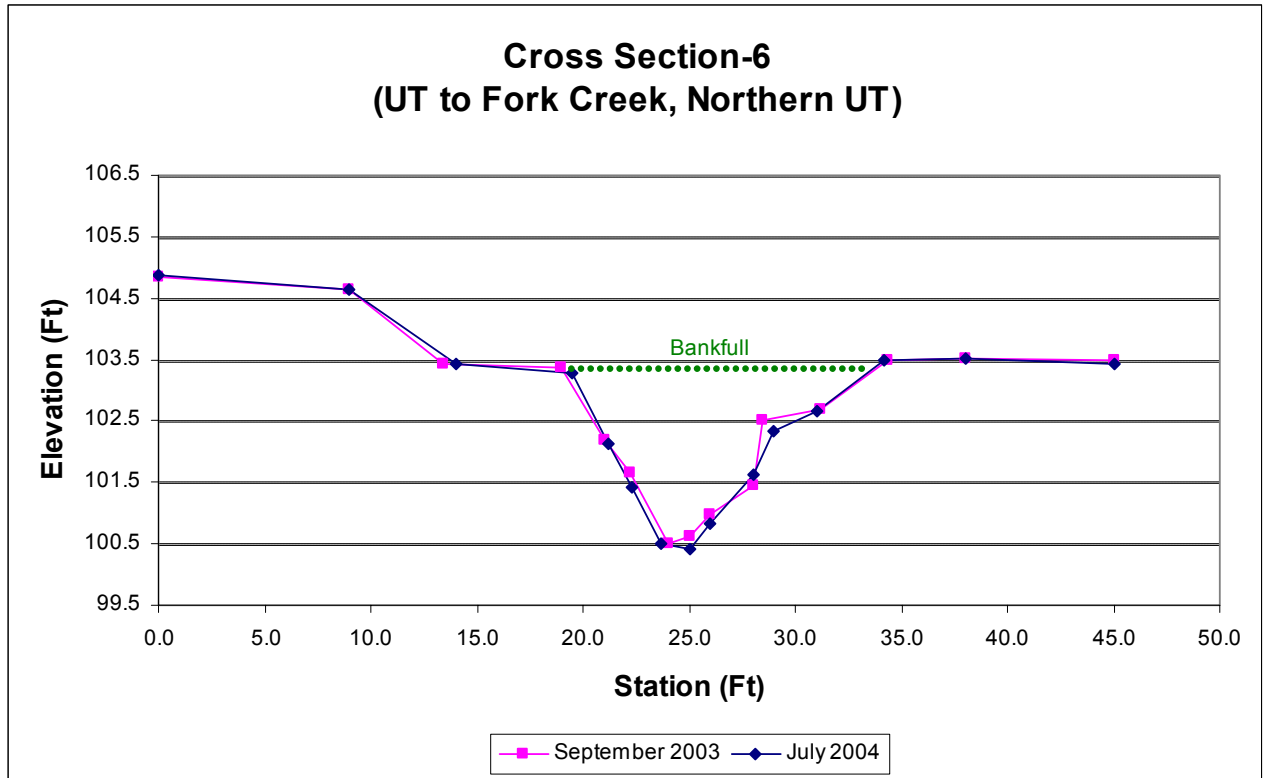
Cross-Section #6 (Pool) Abbreviated Morphological Summary*

2003	2004	2005	2006	2007
Bankfull Cross Sectional Area (ft²)	11.5	19.9			
Maximum Bankfull Depth (ft)	2.2	2.9			
Bankfull Mean Depth (ft)	1	1.4			
Bankfull Width (ft)	11	13.9

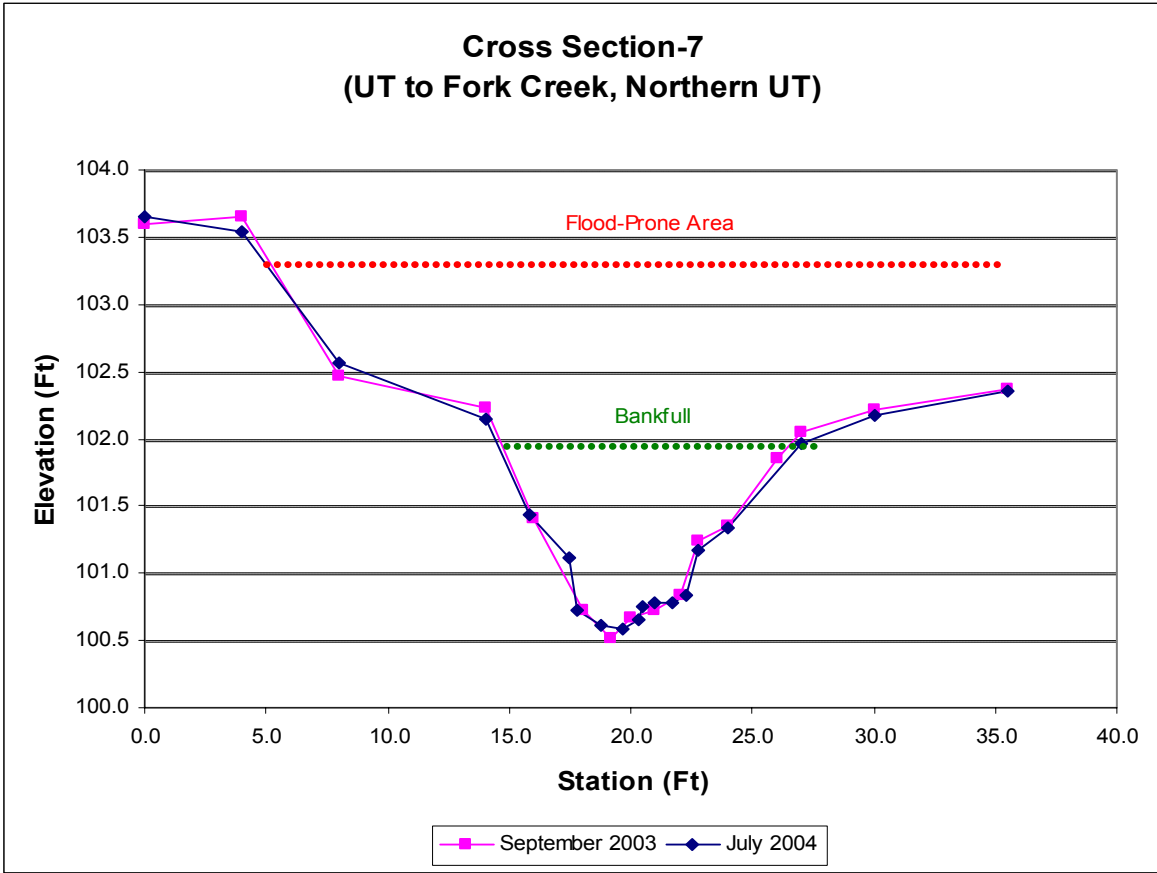
Cross-Section #7 (Riffle) Abbreviated Morphological Summary

2003	2004	2005	2006	2007
Bankfull Cross Sectional Area (ft ²)	10.7	12.3			
Maximum Bankfull Depth (ft)	1.5	1.6			
Bankfull Mean Depth (ft)	0.9	0.8			
Width/Depth Ratio	14.8	19.4			
Entrenchment Ratio	8	6.5			
Bankfull Width (ft)	12.6	15.5

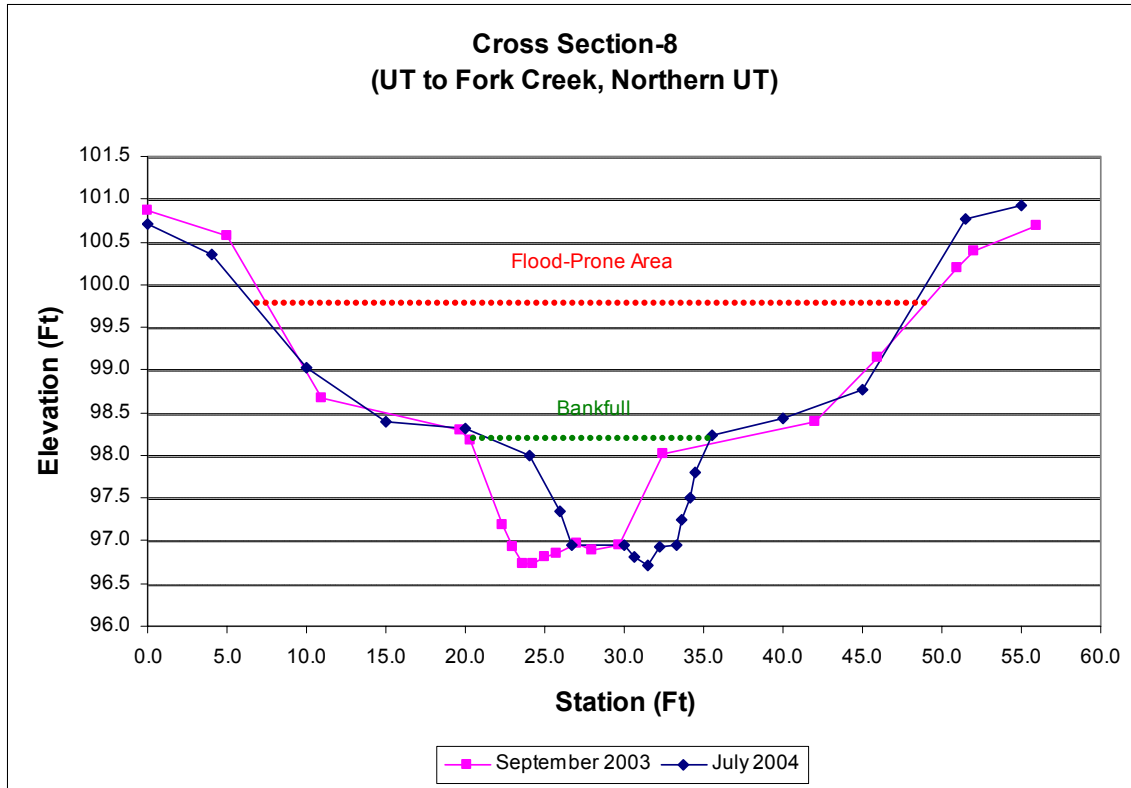
Cross-Section #8 (Riffle) Abbreviated Morphological Summary

2003	2004	2005	2006	2007
Bankfull Cross Sectional Area (ft ²)	10	12.3			
Maximum Bankfull Depth (ft)	1.3	1.5			
Bankfull Mean Depth (ft)	0.9	0.8			
Width/Depth Ratio	13.2	17.1			
Entrenchment Ratio	3.4	2.8			
Bankfull Width (ft)	11.8	14.5
