ANNUAL REPORT FOR 2006 (Year 4)

Fork Creek Tributaries Stream Mitigation Site (Deaton Site)
Randolph County
EEP Project No. 110

January 2007

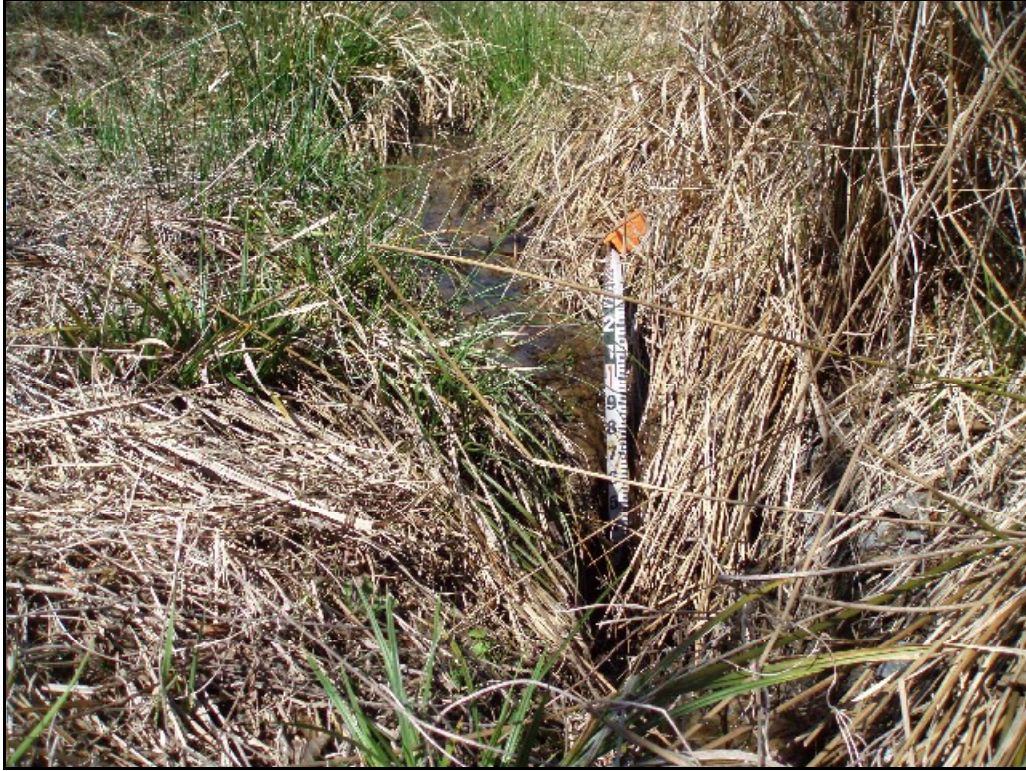
Deaton 2006. PA #1

- ◆ STA 11+10. There is an active headcut approximately one foot deep at this location. If not repaired the headcut is expected to migrate upstream. This should be assessed during the future monitoring periods.
- ◆ STA 27+90. The left bank is eroded on the outside meander bend. This location should be assessed during the next monitoring period.

Exhibit Table C.1. Integrated Project Problem Areas Deaton (EEP Project No. 110)			
Feature Issue	Station Numbers	Suspected Cause	Photo Number
Headcut approximately one foot high	11+10	Downstream structure failure	PA #1
Erosion on left bank	27+90	Lack of bank stabilization, improper design	PA #2
Cross vane failure	58+80	Improper installation	PA #3

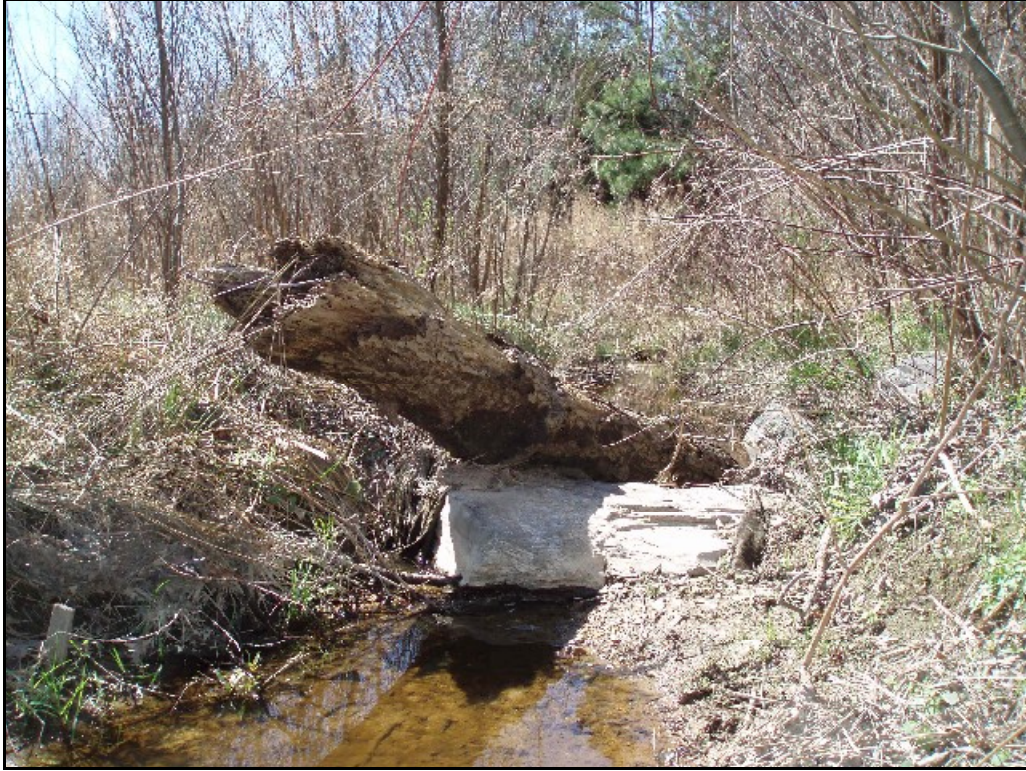
Deaton 2006. PA #3

- ◆ STA 58+80. A cross vane structure has failed at this location. This is most likely due to improper installation. This area may remain stable if the grade is controlled by adjacent structures. However, repairs may be required if a headcut forms and migrates upstream. This should continue to be assessed during the future monitoring periods to determine whether or not remedial actions are necessary.
