ANNUAL REPORT FOR 2007 (Year 5)

Fork Creek Tributaries Stream Mitigation Site (Deaton Site)
Randolph County
EEP Project No. 110

WK Dickson and Co., Inc.
720 Corporate Center Drive
Raleigh, NC 27607
(919) 782-0495

**DEATON STREAM RESTORATION
2007 MONITORING REPORT**

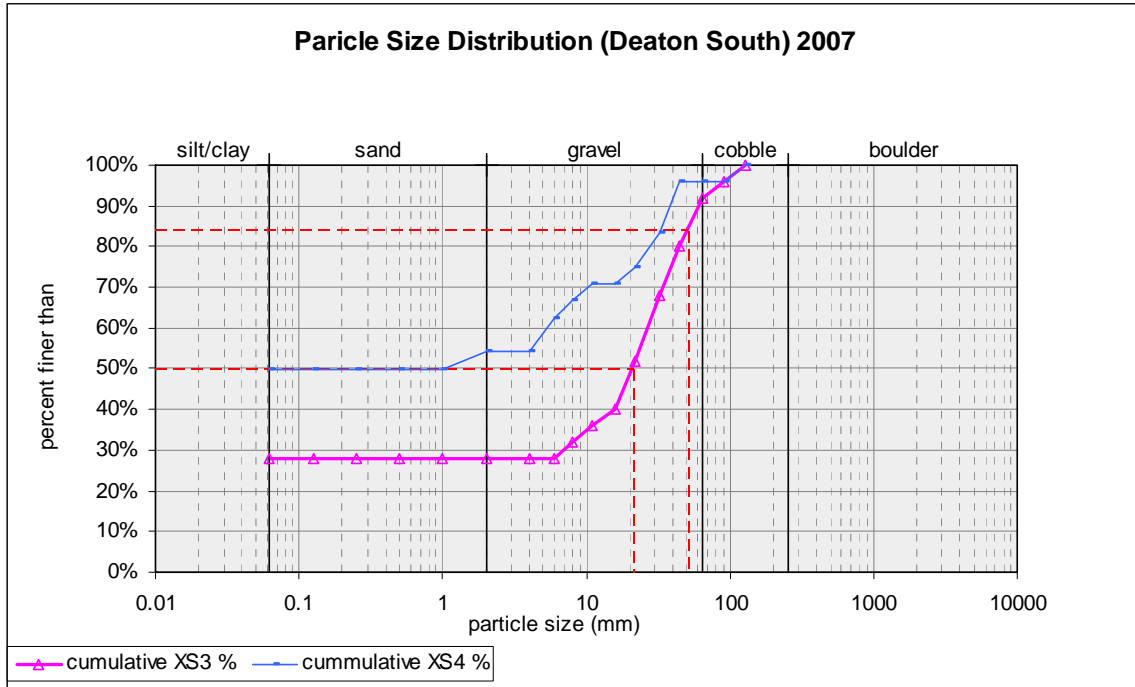
Figure 3. 2007 Deaton South Particle Size Distribution

Pebble counts were conducted at each riffle cross section to determine the composition of bed material during the monitoring period. The comparison of pre-construction bed material data with subsequent monitoring data indicates that a drop in particle size in years 2 and 3 may have been temporary. Charts noting the particle size distributions are presented for the northern and southern UTs in Figures 3 and 4.

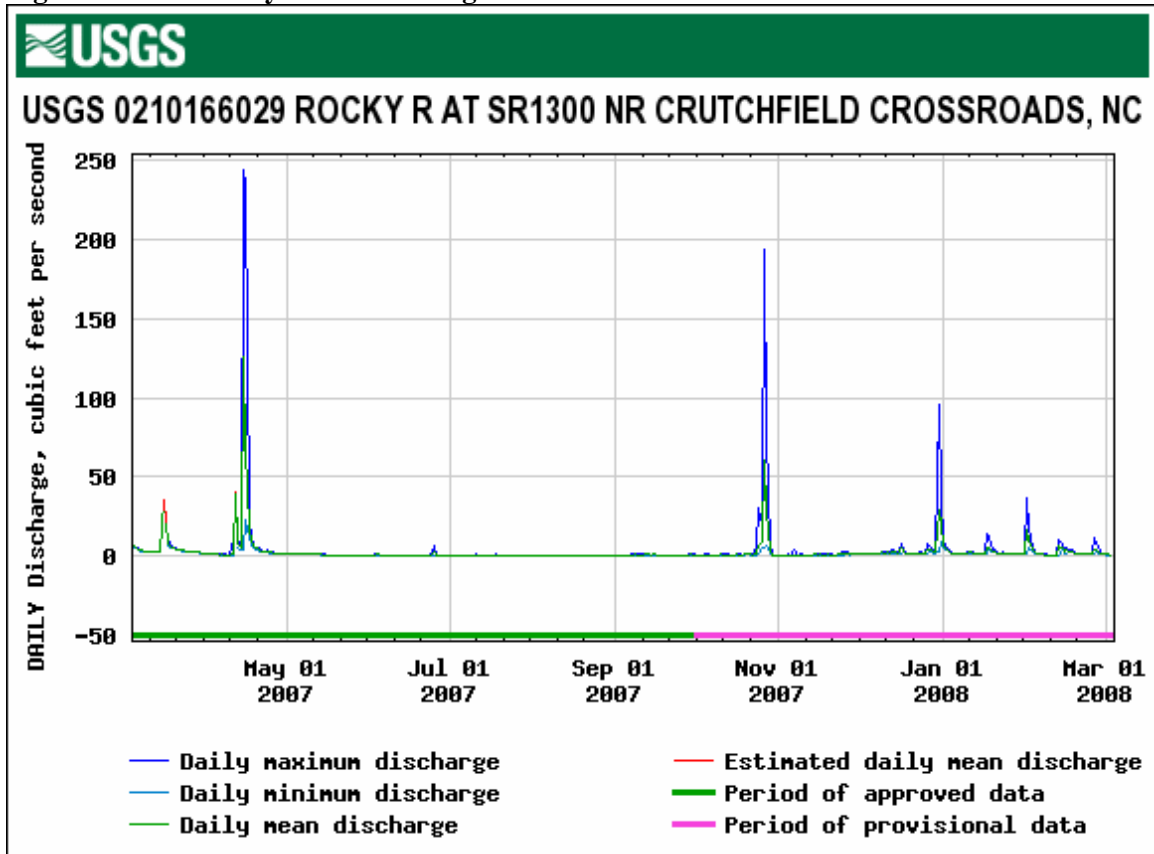
Figure 5. 2007 Rocky River Discharge

Monitoring requirements state that at least two bankfull discharge events must be documented during the five year monitoring period in order for the project to be deemed successful. No stream gauging station exists on Fork Creek or the two unnamed tributaries restored as a result of this project. A crest gauge was set up in Fall of 2007 at coordinates X: 1804467.621, Y: 682801.607. Previous monitoring reports identified the Rocky River USGS stream gauge (02126000) as a suitable gauge to make inferences about flow events at the Deaton project site (Figure 5). This stream gauge has been used to establish the occurrence of bankfull flows for the history of this project. The technique used involves the comparison of discharge data at the gauge site with North Carolina Rural Piedmont discharge regional curve predictions of bankfull discharge. The number of flow events that exceeded the regional curve prediction of bankfull discharge at the gauge was assumed to be the number of bankfull or out-of-bank flow events at the project site. The technique described above utilizing the Rocky River stream gauge would indicate that multiple bankfull or out-of-bank events occurred during 2007. Field observations of bankfull flows at Deaton include wrack lines and flattened vegetation

It is not possible to definitively establish the occurrence of a bankfull flow event at the project site utilizing the above methodology.

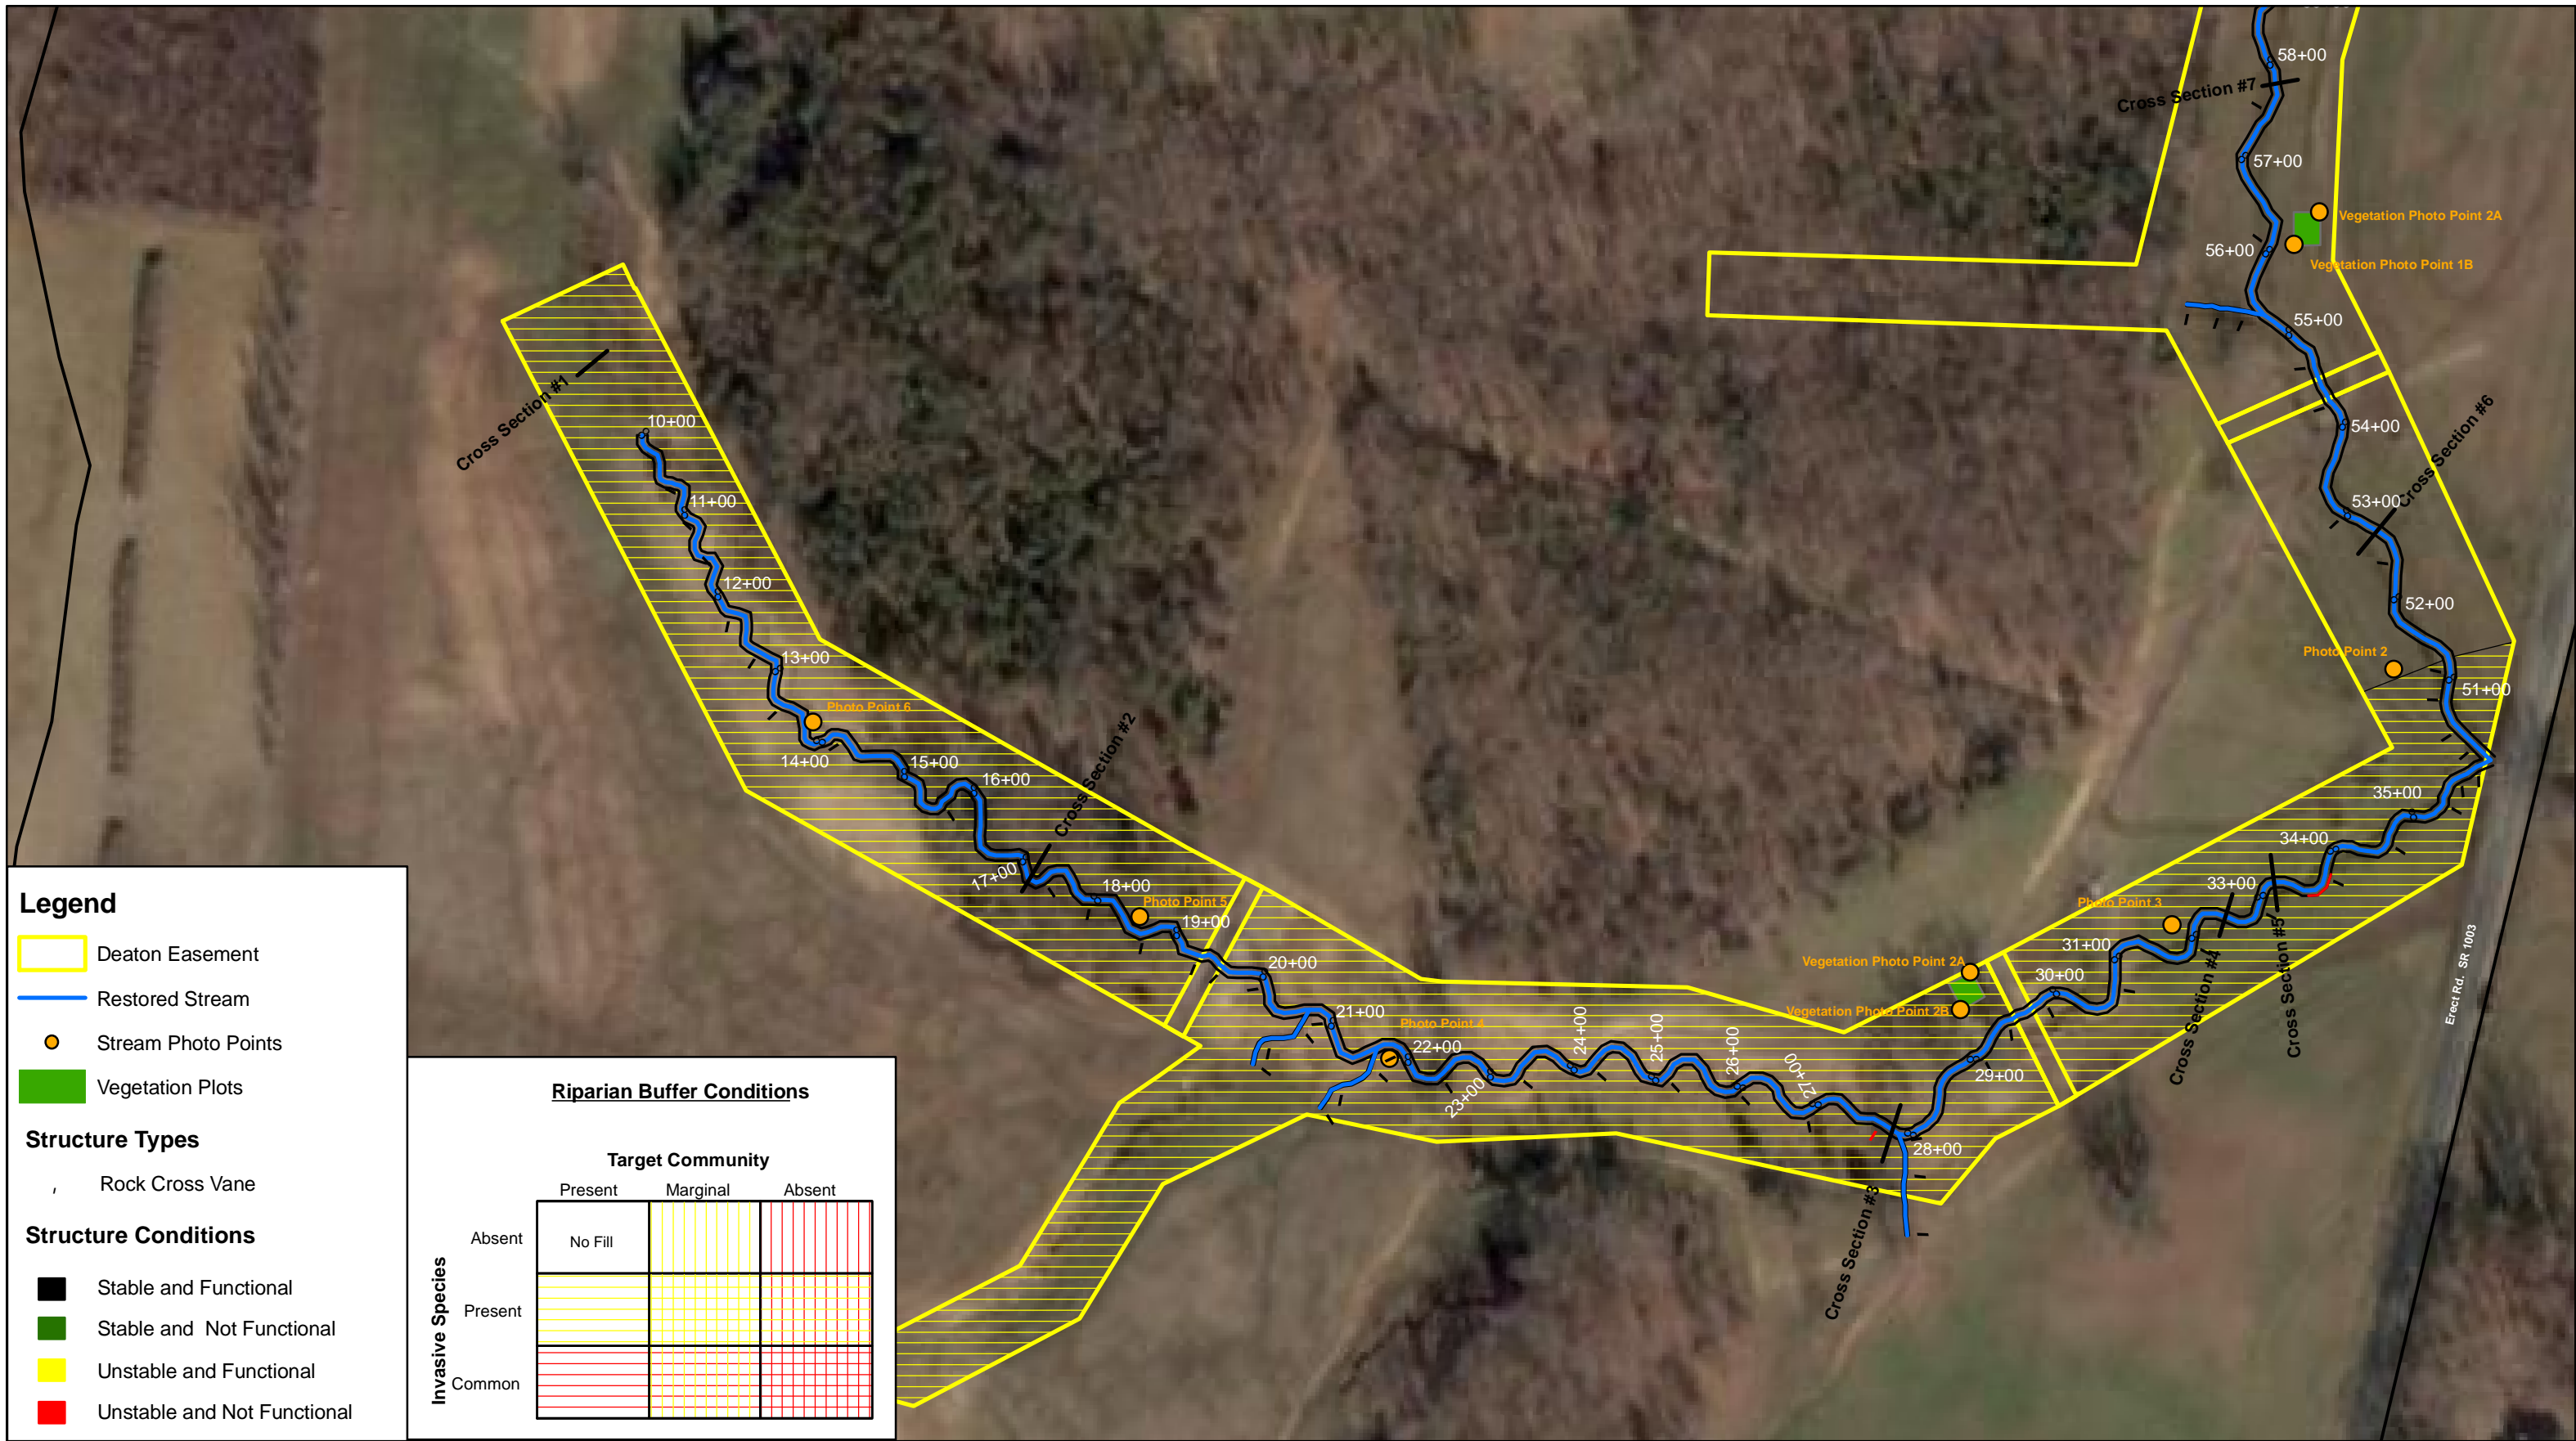
Deaton Current Conditions Plan View A
 Southern Tributary
 Year 5 Monitoring
 November 2007

An assessment of the stability of the channel was preformed on August 27, 2007, by WK Dickson and Co., Inc. Several areas of concern were observed and documented including structure failure and bank erosion. These problem areas are called out on the Deaton Current Conditions Plan View which is located in Appendix C.

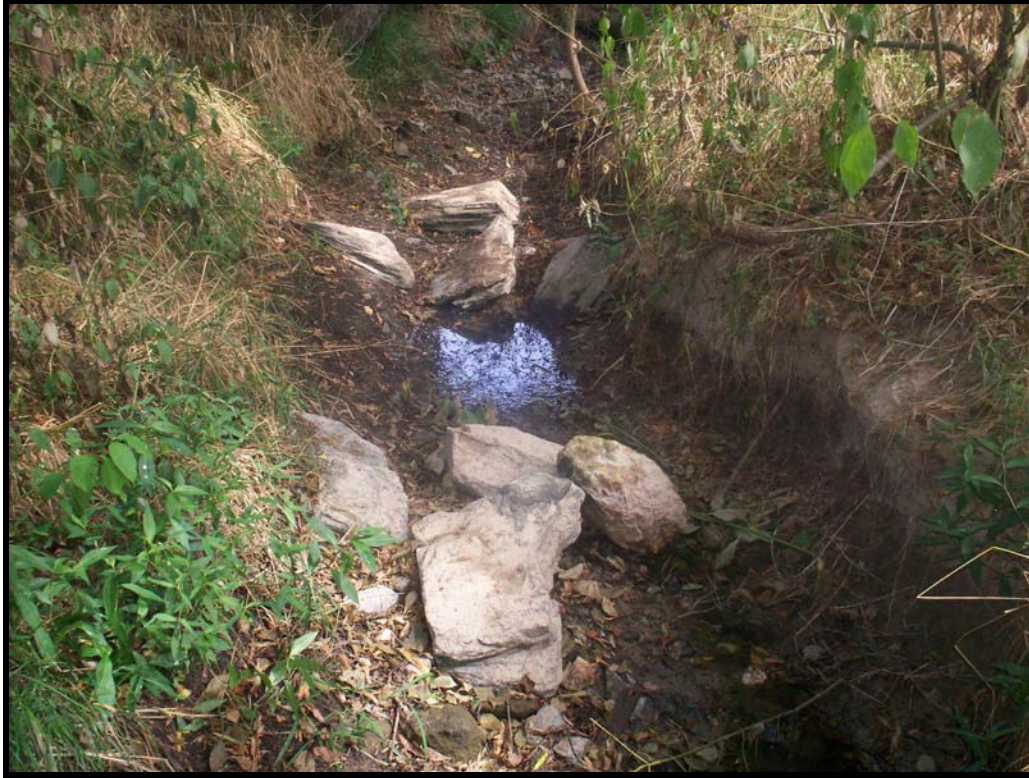
Table VIII. Stream Problem Areas Deaton Farm Stream Restoration Site (EEP Project No. 110)			
Feature Issue	Station Numbers	Suspected Cause	Photo Number
Rock Cross Vane Failure	28+10 (South)	Improper installation, boulders have become displaced and are in mid-channel.	PA #1
Erosion on right bank	33+60 (South)	Lack of bank stabilization	PA #2
Rock Cross Vane Failure	59+00 (North)	Improper installation, boulders have become displaced and are in mid-channel.	PA #3

The current problem areas are considered to be no threat to the success of this project. The displaced boulders from the rock cross vanes could create debris jams and/or minor bed erosion such as scouring and head cuts. Other minor areas of erosion and aggradation were noted during field investigations. These areas were deemed minor and no threat to channel stability or project goals. Problem areas mentioned in the 2006 year 4 monitoring report were reexamined during the monitoring activities and appeared to be stable.

PA # 1 RCV structure failure. Boulders in mid-channel.
STA 28+10 (South Trib.)

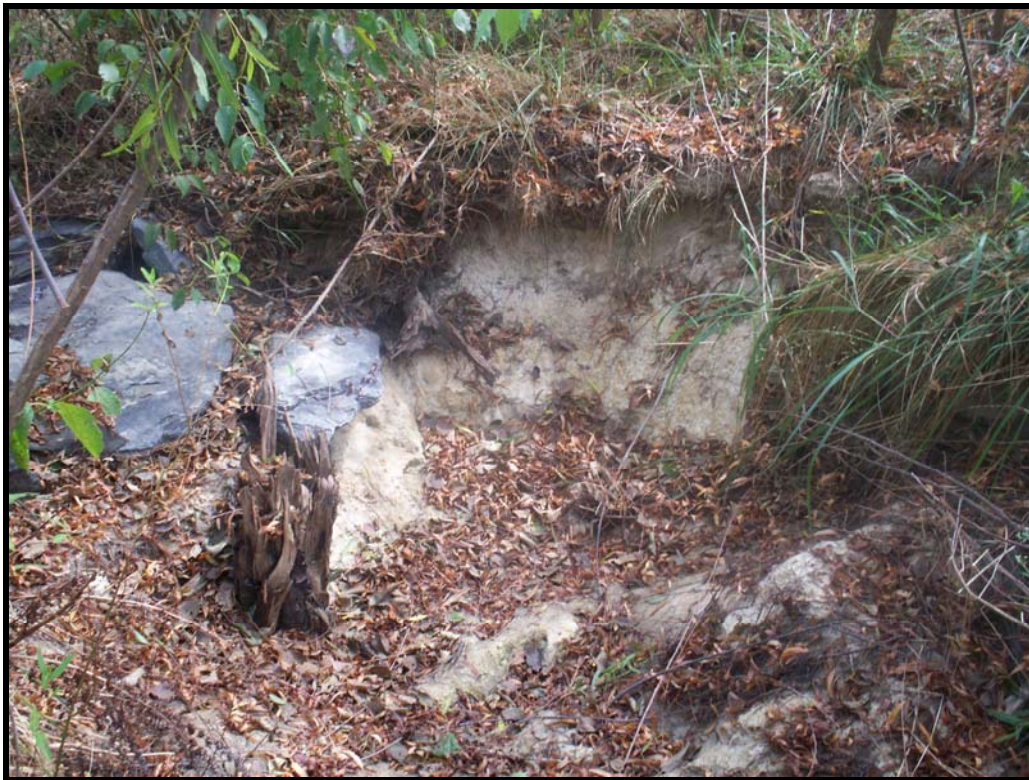
Pa #2 Right bank erosion @ STA 33+60 (South Trib.)

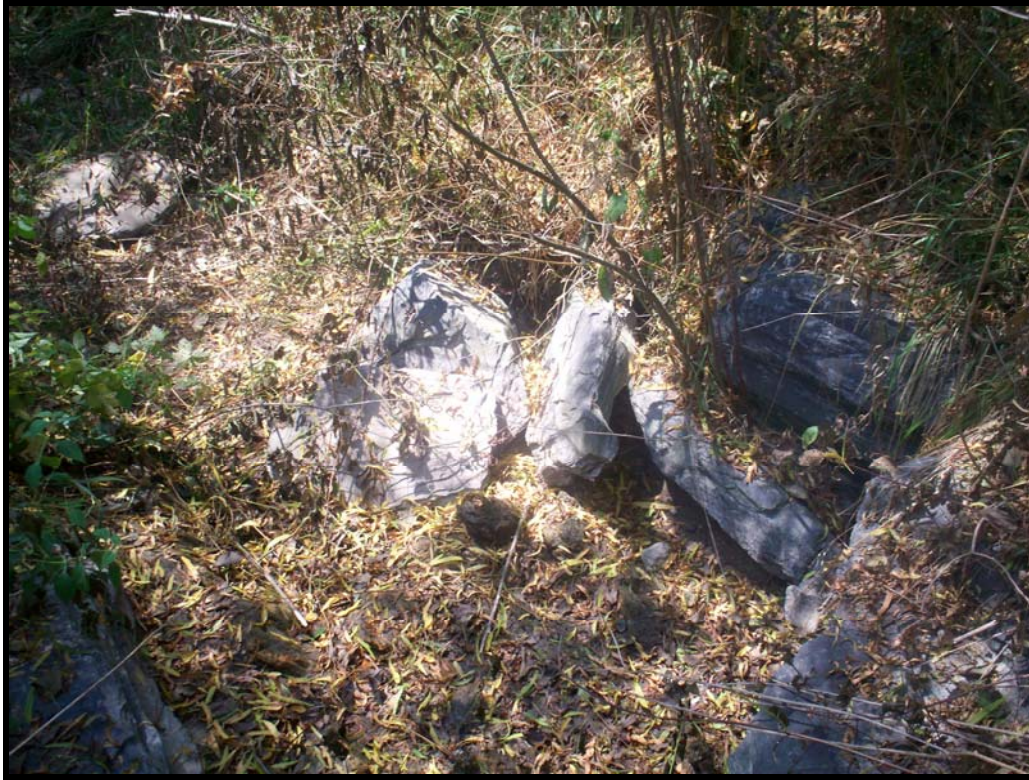
PA # 3 RCV structure failure. Boulders in mid-channel.
STA 59+00 (North Trib.)
