MONITORING YEAR 3 ANNUAL REPORT

DEEP MEADOW MITIGATION SITE

Union County, NC
Yadkin River Basin
HUC 03040105

DMS Project No. 97131
NC DEQ Contract No. 6887
DWR Certification No. 18-0264
USACE Action ID No. SAW-2012-01107
Data Collection Period: March 2022 – November 2022
Final Submission Date: February 2023

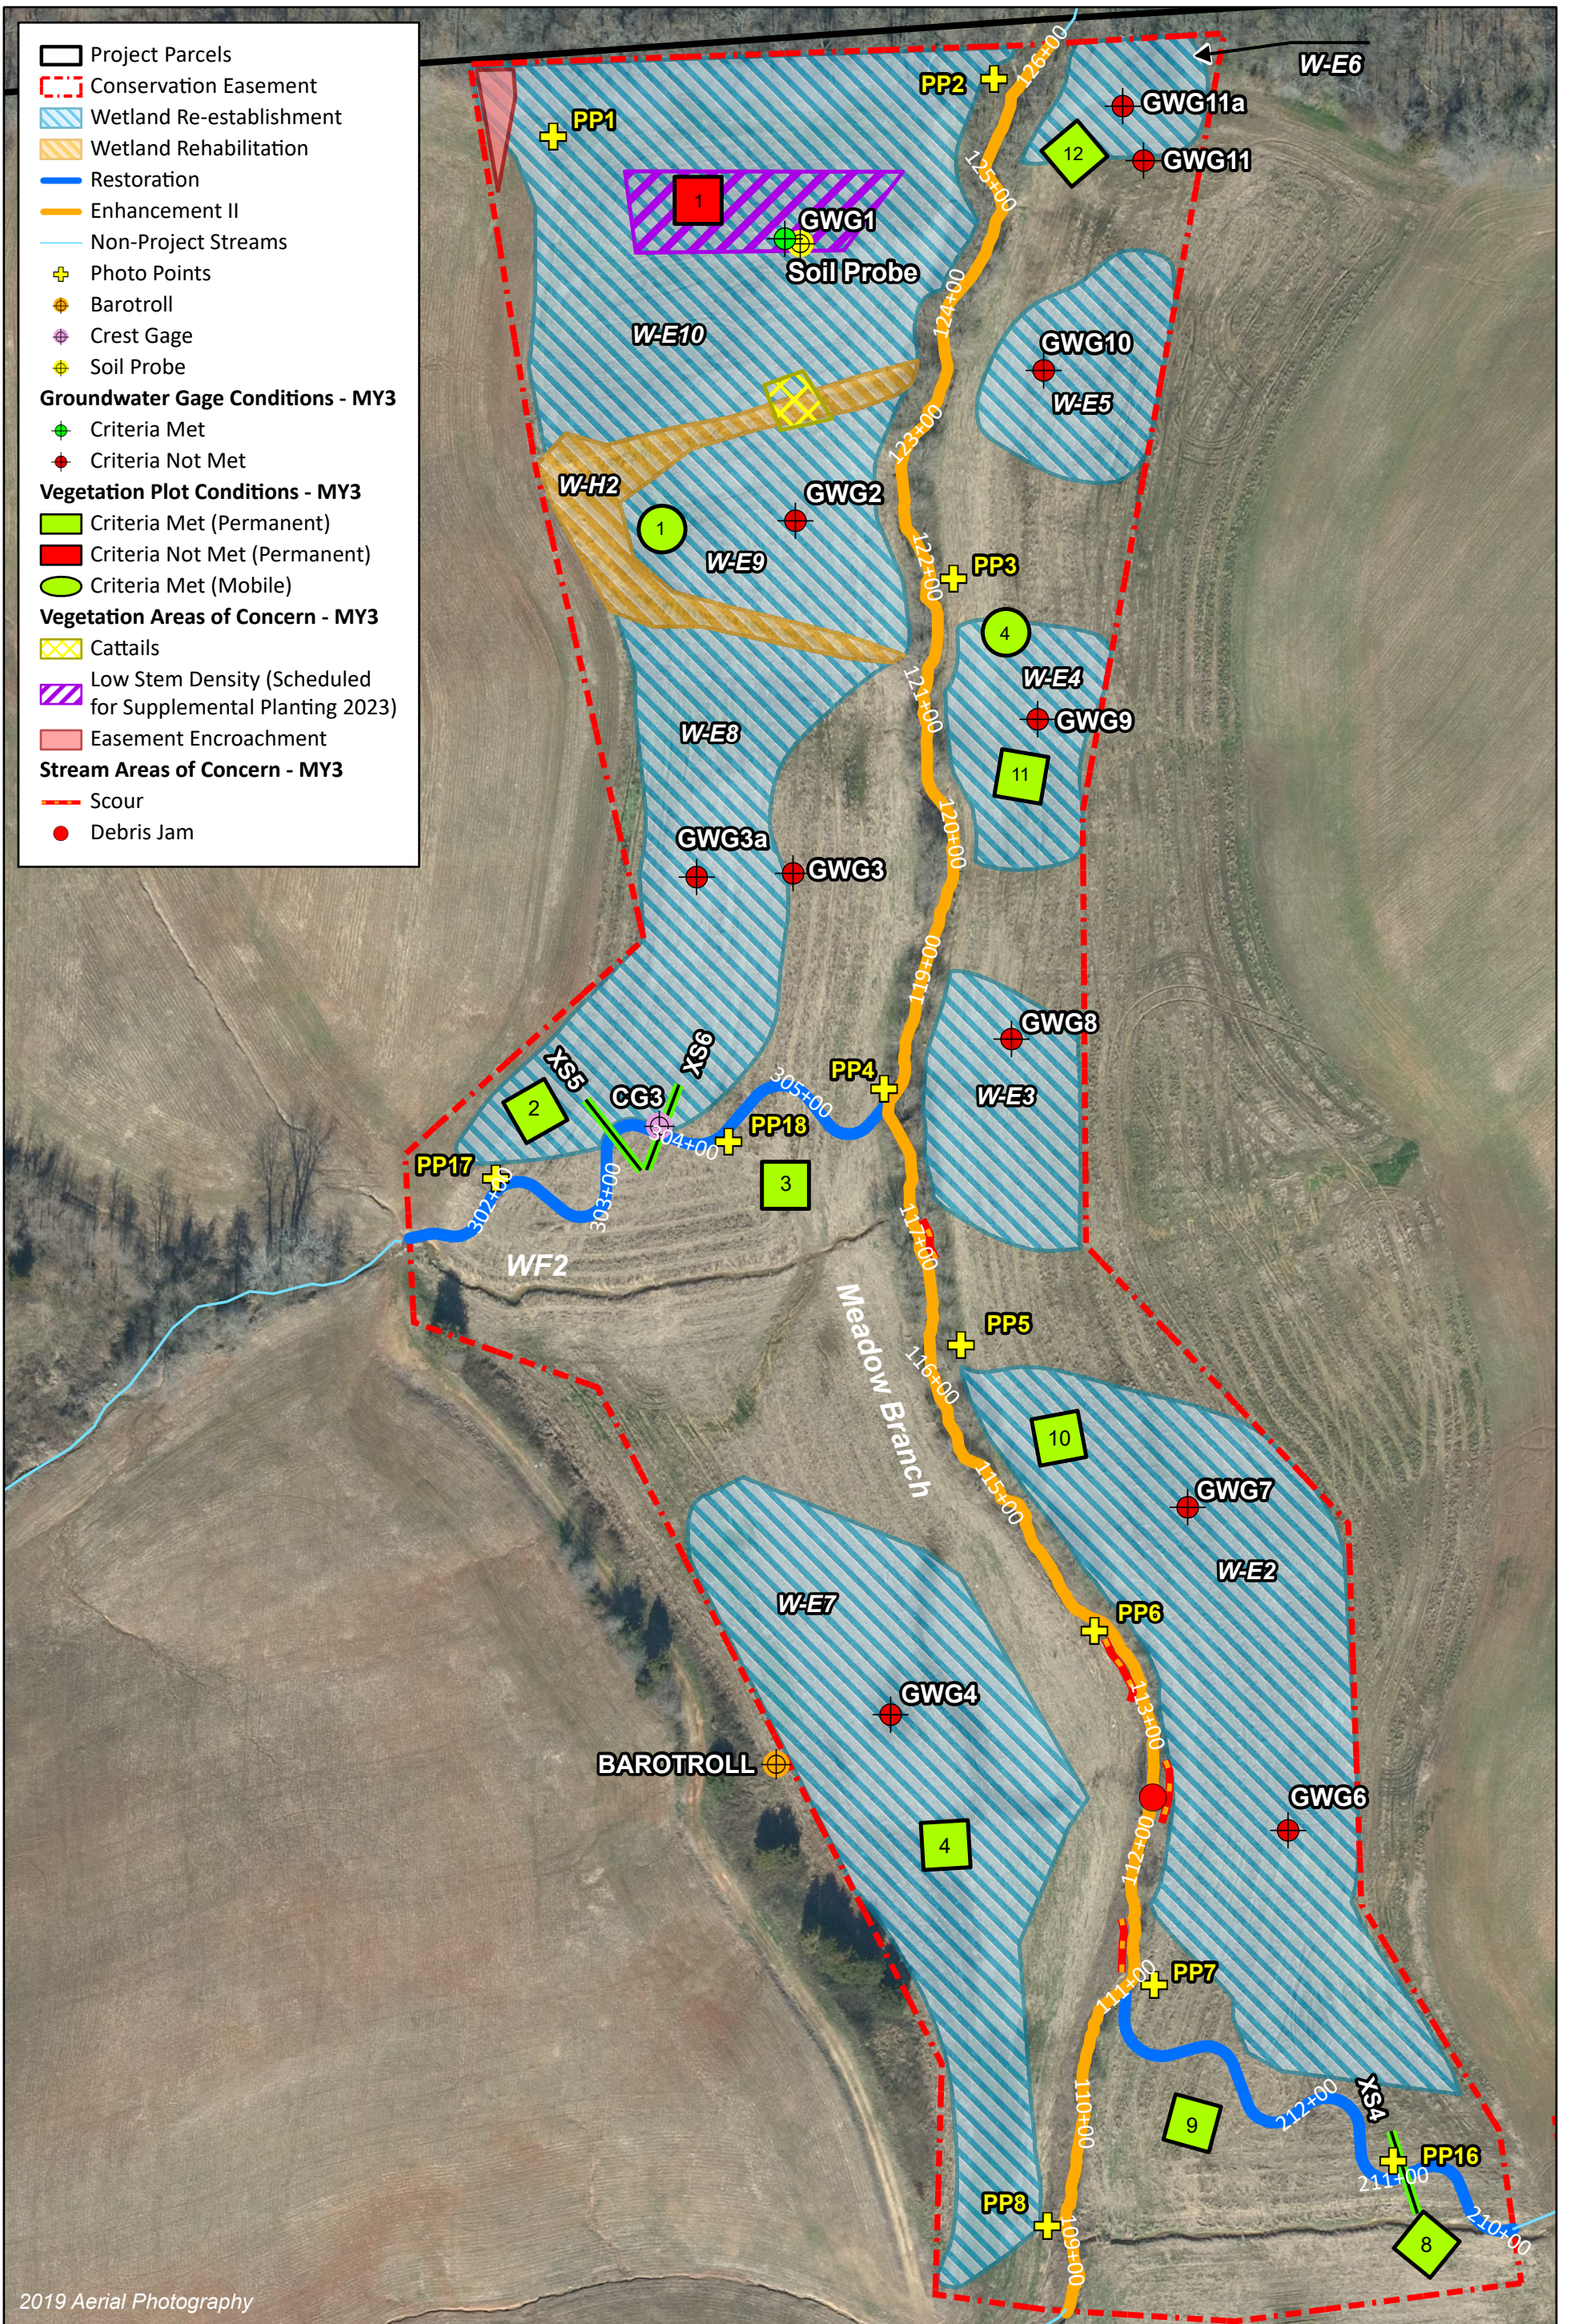
Figure 3.1 Current Condition Plan View
 Deep Meadow Mitigation Site
 DMS Project No. 97131
 Monitoring Year 3 - 2022
 Union County, NC

Based on MY3 visual assessments, restoration reaches WF2 and EF1 are 100% stable and performing as intended. Minimal areas of concern including instances of scour and localized aggradation on the enhancement II stream, Meadow Branch were revealed in MY3. Minor bank scour was observed on Meadow Branch at stations 111+20, 113+50 and station 117+00. A large debris jam at station 112+40 is facilitating scour in this area. Currently, these areas are not negatively impacting overall stream function or stability; however, Wildlands plans to remove the debris jam and restabilize these areas by adding additional live stakes to the banks in MY4. These areas will continue to be monitored in subsequent years for signs of accelerated instability. On the upstream section of Meadow Branch near station 101+80, a mid-channel bar has developed where a recurring beaver dam used to be. The dam was removed several times in MY2 and MY3, but the remnant sediment aggradation due to the dams persists. Wildlands expects winter storms to transport accumulated sediment through the system. Wildlands will continue to monitor these areas and remedial actions will be implemented if areas of concern begin to threaten the stability of the project.

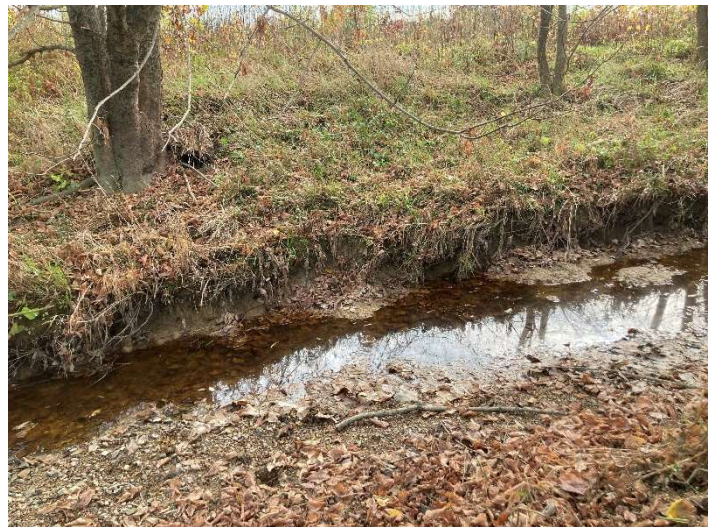
Meadow Branch, station 112+50 – Bank scour (11/02/2022)

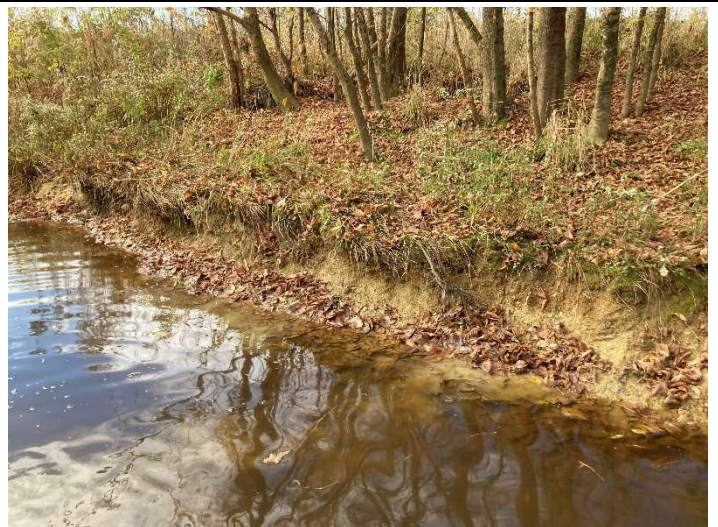
Meadow Branch, station 117+00 – Bank scour (11/02/2022)

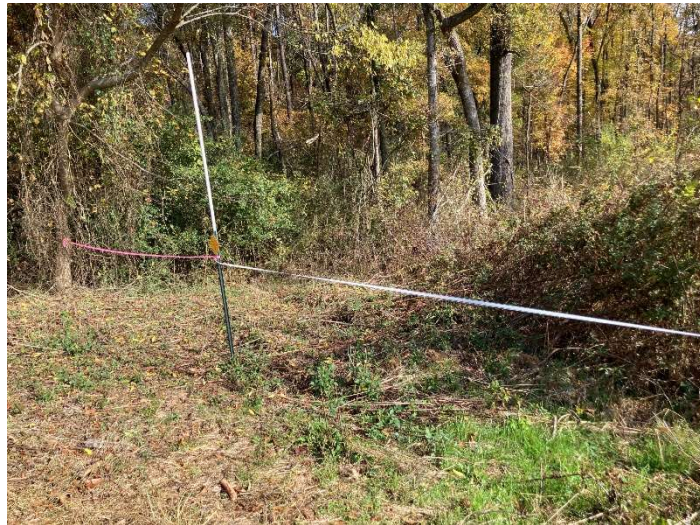
During the MY3 visual assessment, Wildlands observed minor encroachments attributable to bent or missing signposts. Encroachments consisted of minimal easement scalloping associated with the management of the adjacent agriculture fields. However, the Site has maintained an adequate buffer as the encroachments caused inconsequential damage to planted stems. To resolve the issue, the missing corner monument near the upstream end of Meadow Branch was re-surveyed and replaced by Turner Surveyors in August 2022. Wildlands also added additional signage, PVC markers, and horse tape throughout the Site, and is currently working with the landowner to address these encroachment issues. These areas will continue to be monitored closely in MY4 and throughout the remainder of the monitoring period.

Meadow Branch, easement boundary – Encroachment (11/02/2022)

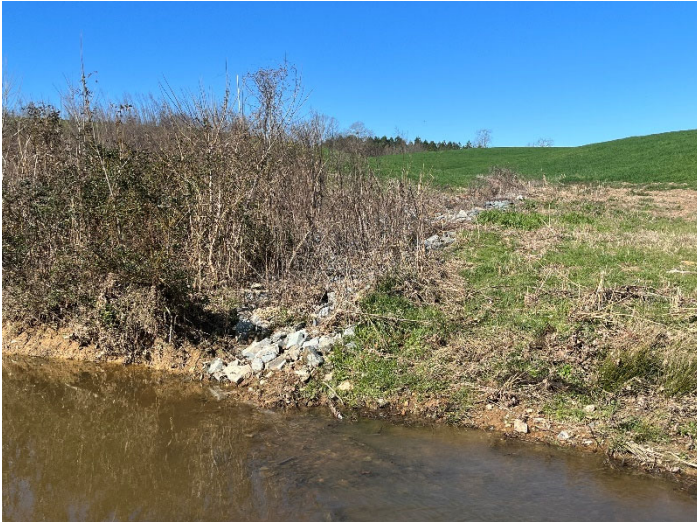
Meadow Branch, station 107+10 – Repaired gully (02/06/2023)

In MY3, repairs were completed on an erosion gully near the ford crossing on Meadow Branch. In December 2021, the property owner partially filled in the portion of the gully that lies outside of the easement. Wildlands resumed this floodplain stabilization work within the easement boundary in May 2022. Repairs consisted of laying back the banks of the gully and installing a series of stone check dams to prevent gully reformation and excess sediment from entering the stream.

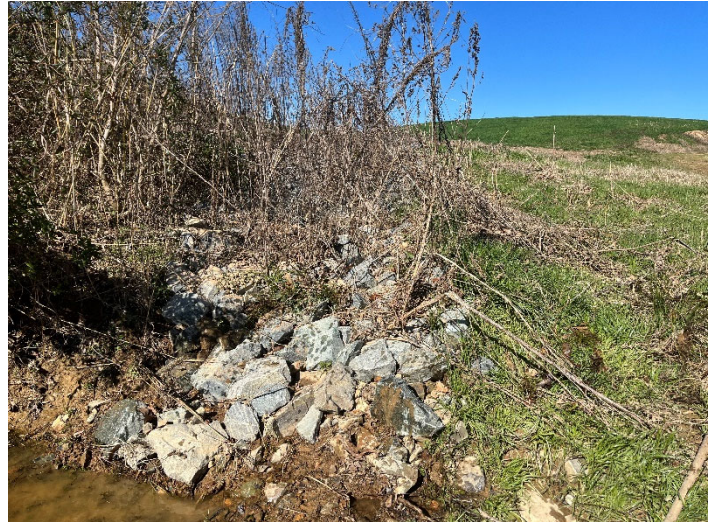
Meadow Branch, station 107+10 – Repaired gully (02/06/2023)

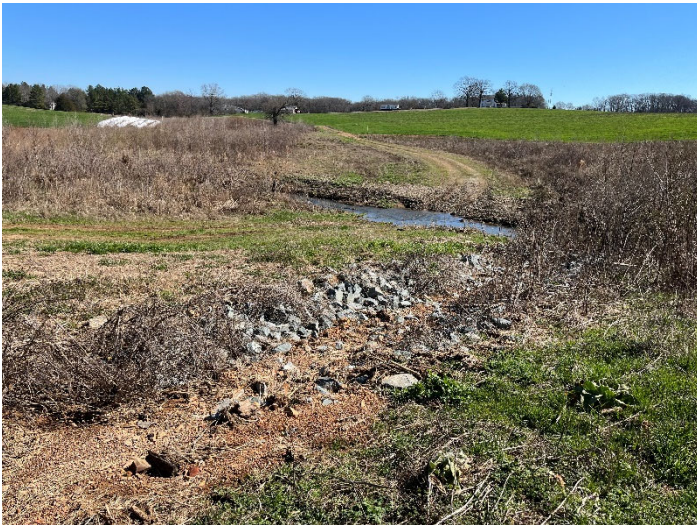
Meadow Branch, station 107+10 – Repaired gully (02/06/2023)

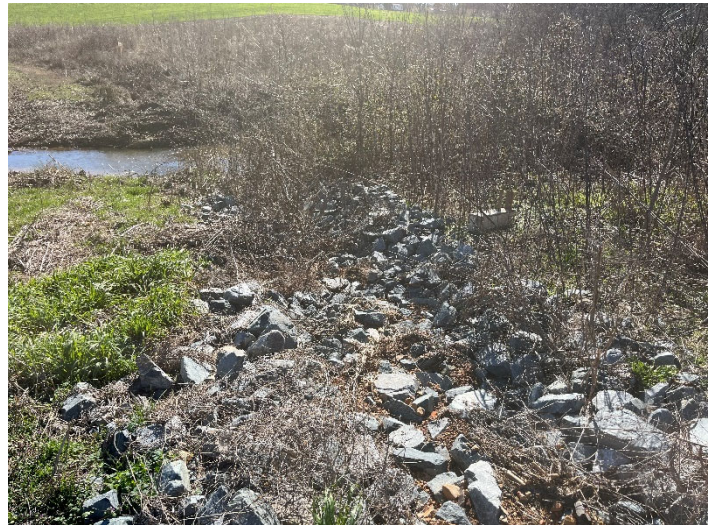
Meadow Branch, station 107+10 – Repaired gully (02/06/2023)
